APPENDIX 12C

Images

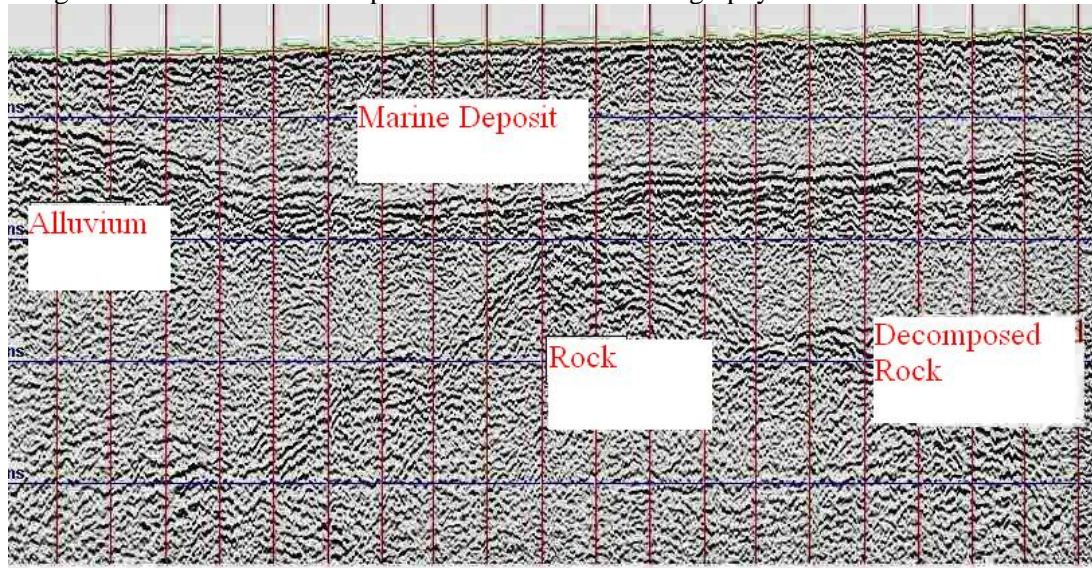
Image 9 The main components of the seabed stratigraphy

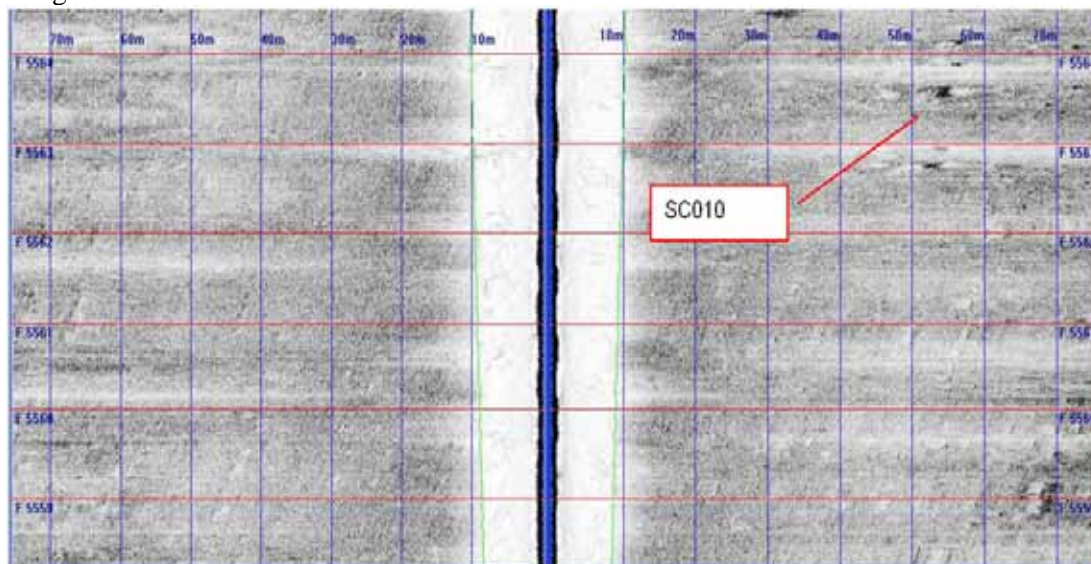
Image 13 Side scan sonar contact SC010

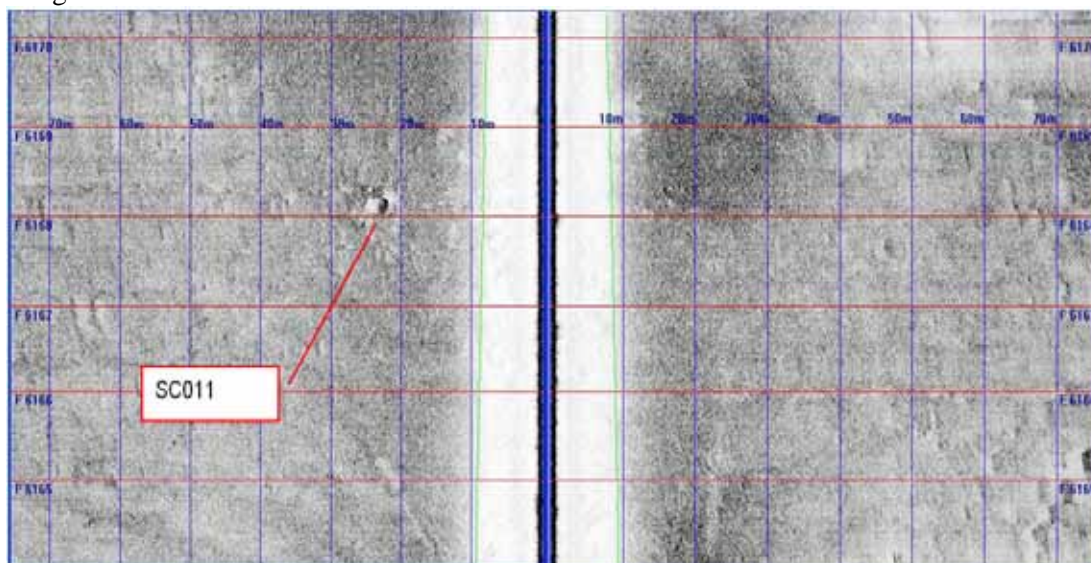
Image 14 Side scan sonar contact SC011
