APPENDIX I2 – MARINE GEOPHYSICAL REPORT

Survey Objectives and Equipment

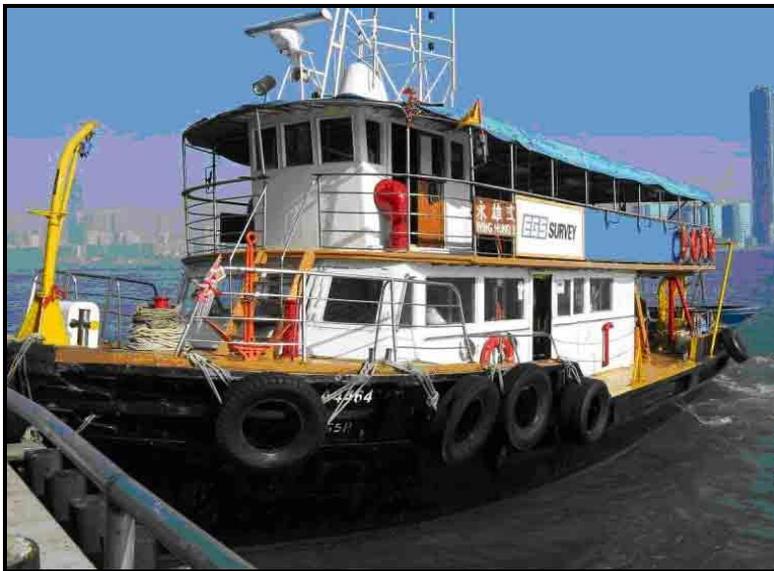
Plate 1: Wing Hung 2, Class IV commercially licensed survey vessel

The swath (multibeam echo sounding), seismic, side scan sonar and magnetic surveys were carried out from a Class IV survey vessel, M V Wing Hung 2 and a sampan used for the echo sounding survey. The vessels are shown in Plate 1 and 2 below.

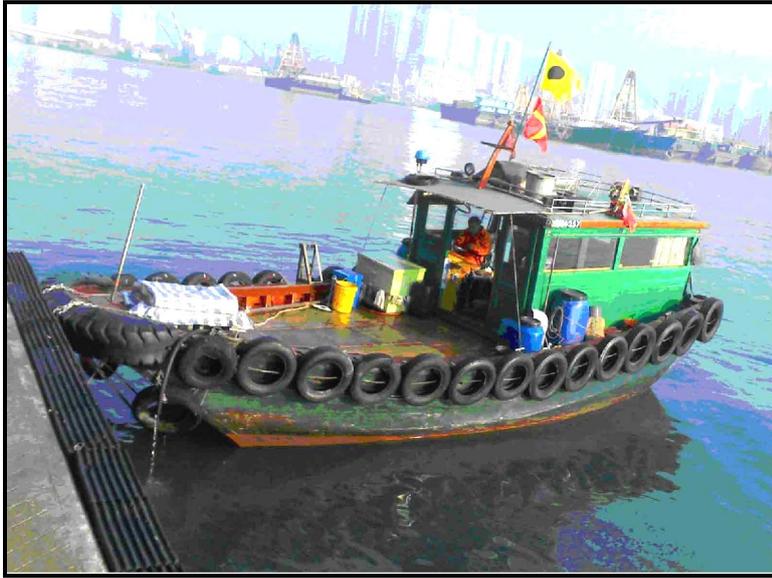
Plate 2: The sampan used for the echo sounding survey

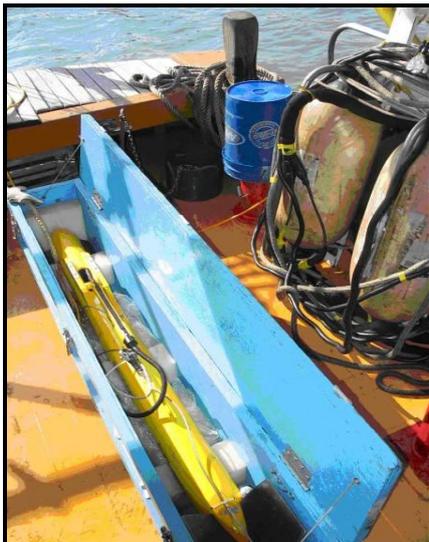
Plate 3: The DF-1000 used in the side scan sonar survey

Side Scan Sonar Survey: Prior to the commencement of the survey, the side scan sonar system was tested to ensure the system was working correctly. The side scan sonar tow fish was towed from the stern of the survey vessel, at a depth of around 5m beneath the sea surface, depending on the water depth. The equipment used in the side scan sonar survey is shown in Plate 3 below.

- Vessel speed: 1.5 – 1.8 m/sec
- Fix interval: 10 seconds
- Source frequency: 100 kHz and 500 kHz
- Pulse length: 25 us
- Gain setting: Manually controlled

- Slant range: 75m

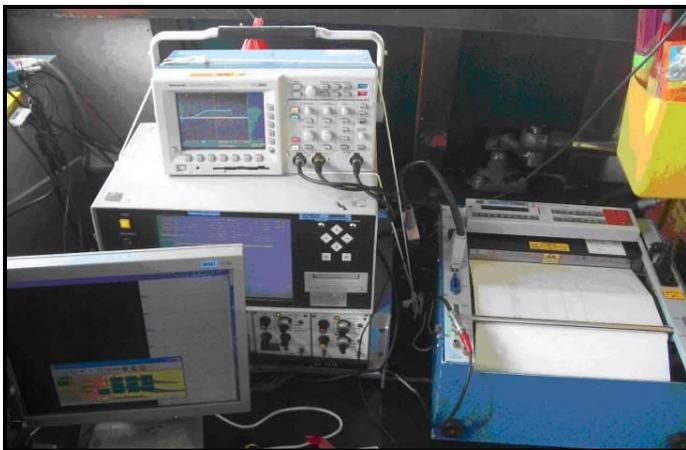
Plate 4: Seismic acquisition and printing system

The Seismic acquisition and printing system and boomer are shown in Plates 4 and 5 below.

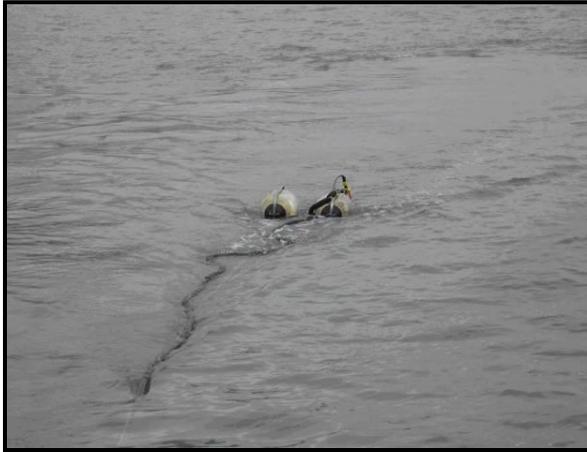
Plate 5: The EGS boomer was towed astern of the vessel for sub-bottom seismic profiling

Seismic Reflection Survey: Prior to the commencement of survey the EGS boomer was tested to ensure the system was working correctly. The EGS boomer was towed from the stern of the survey vessel, at a distance of 20m such that noise from the survey vessel was kept to a minimum. The recording parameters for the seismic reflection survey were as follows:

- Vessel Speed: 1.5 – 1.8 m/sec
- Fix Interval: 10 seconds
- Out put power: +/- 500 volts
- Sweep: 80ms (paper)
- Delay: 0ms
- Gain setting: Manually controlled

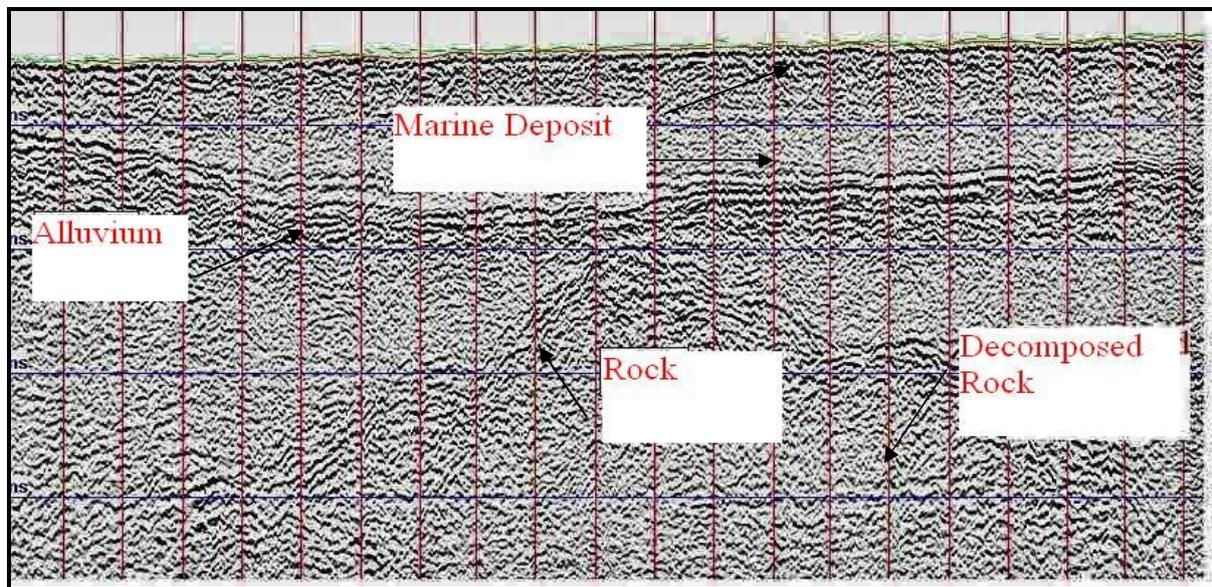
Figure AI.1 The Main Components of the Seabed Stratigraphy

Seismic Data: Although there are large masked zones over the north boundary and south portion of the survey area, the quality of the seismic records was good and acceptable. The interpretation of the seismic records sought to quantify the elements of the offshore geological succession detailed in Table AI.1 below and shown in Figure AI.1

Marine deposits are generally soft or very soft clays or silts, and as such are readily identifiable on seismic records as a clear conformable horizon sometimes with an unconformity represented by a desiccated layer or by local re-working of deposits by ancient river systems.

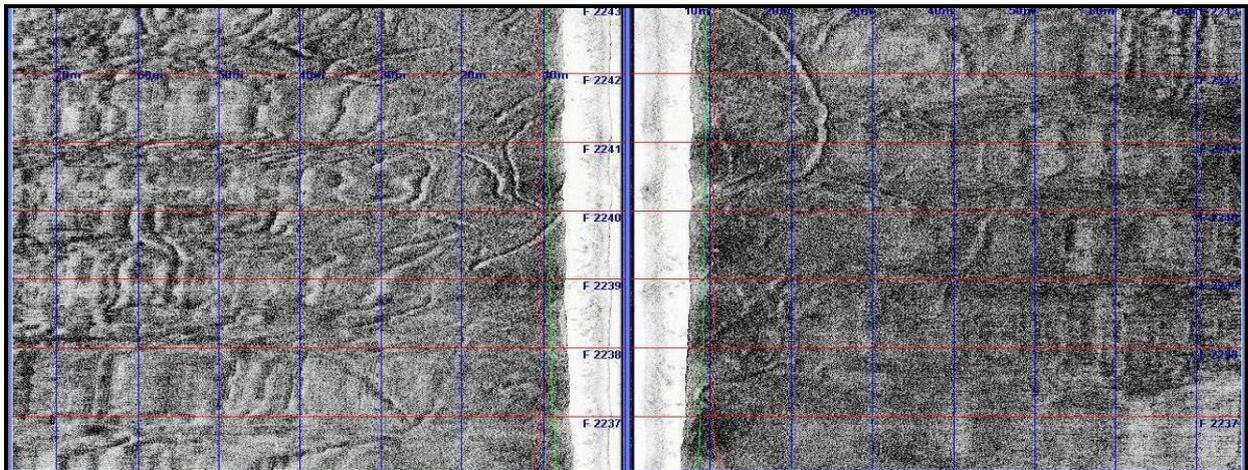
Figure AI.2 Seabed Heavily Disturbed by Anchoring of Vessels

Sea bed Features (Charts 11.1-11.5): As shown on the charts and in Figure AI.2, sandy clays and silts are common features on the seabed, with numerous trawl marks, anchor scars, and scattered modern debris.

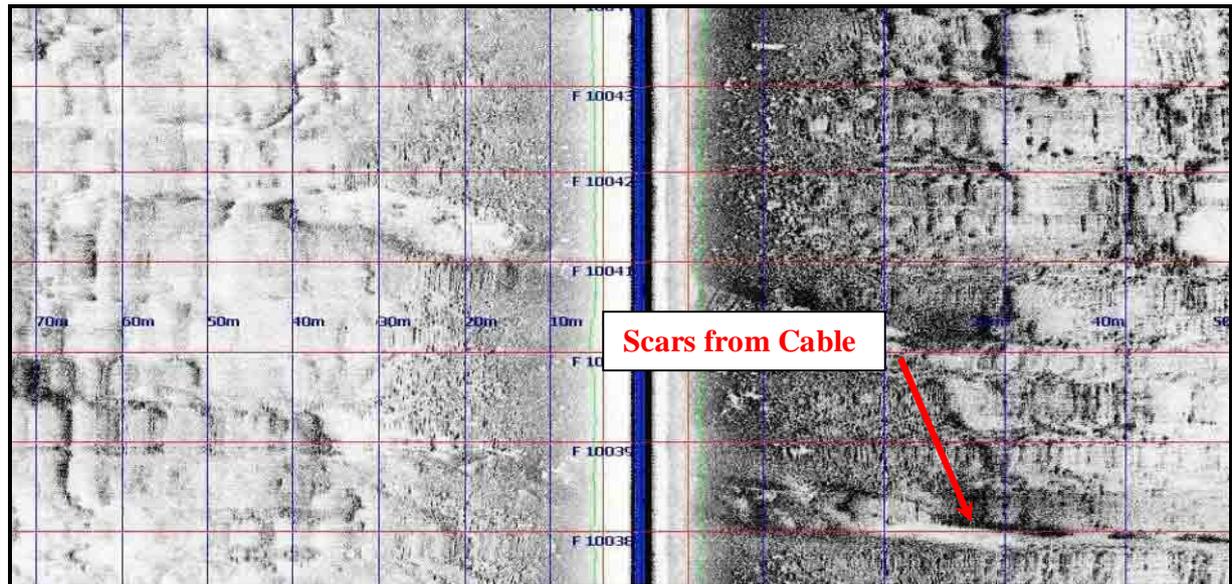
Figure AI.3 Seabed Disturbance caused by Submarine Cables

Cable Alignments (Charts 11.1 to 11.5): Four submarine cables run through the study area. These are important for the MAI as they represent areas of previous disturbance as shown in Figures AI.3 and AI.4 below

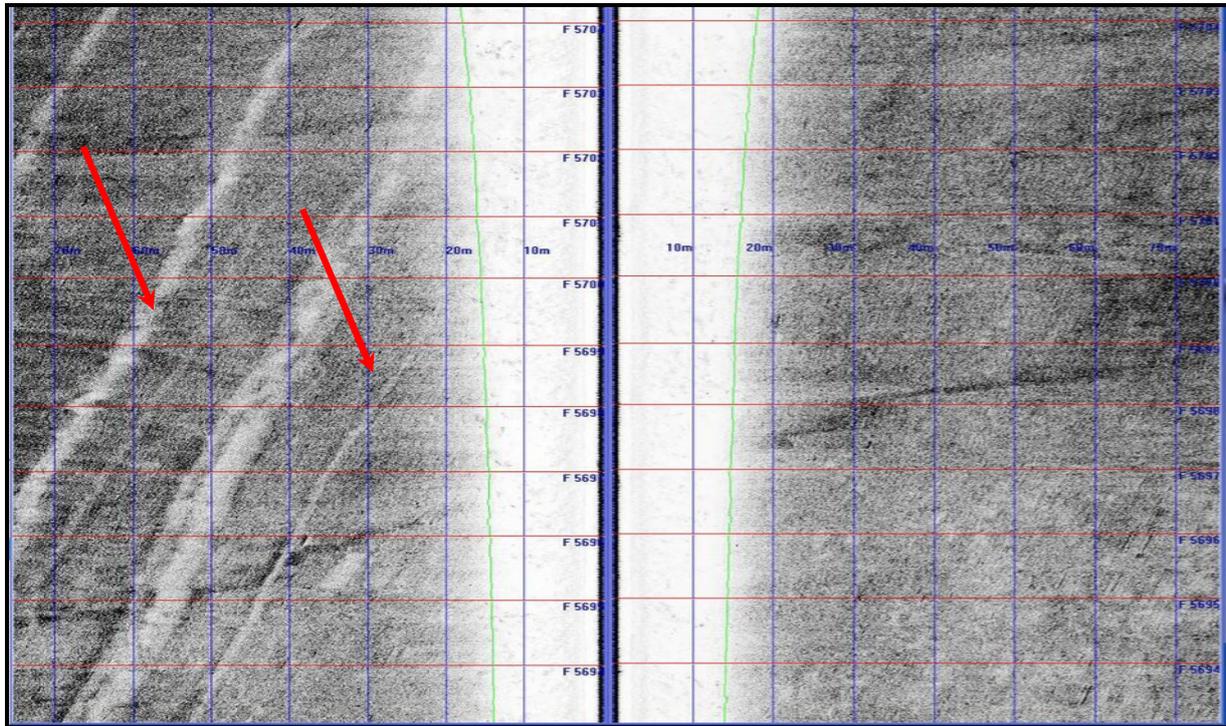
Figure AI.4 Scars from the Existing Buried Utility Cables

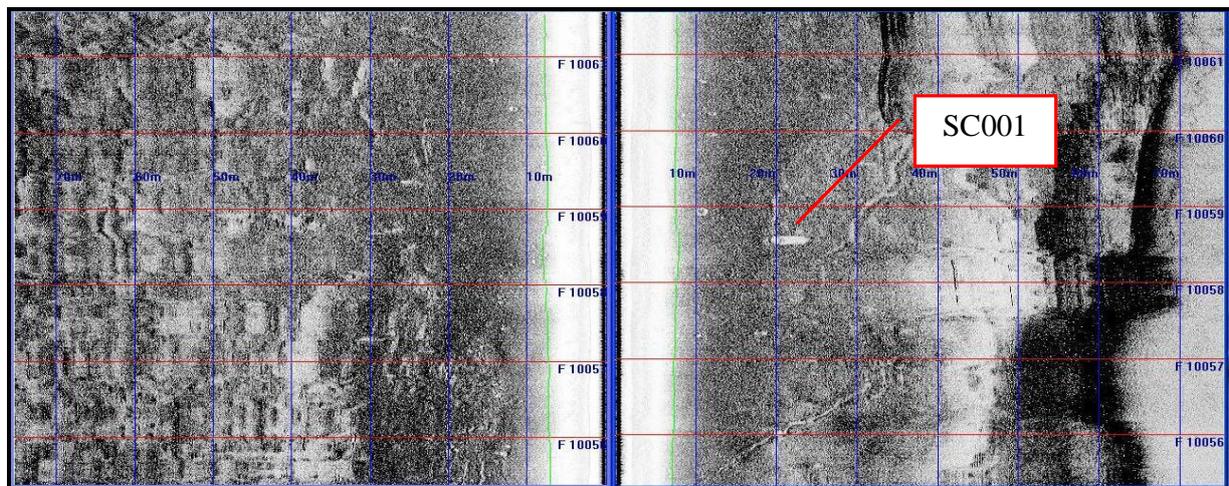
Figure AI.5: Side Scan sonar data showing Sonar Contact SC001.

| Contact Number | Easting Northing | Dimensions (m) | Distance from Alignment |
|---|---|---|---|
| SC001 | 812966.1E 825342.7N | 0.4x0.9x0.4 | 294.1 |

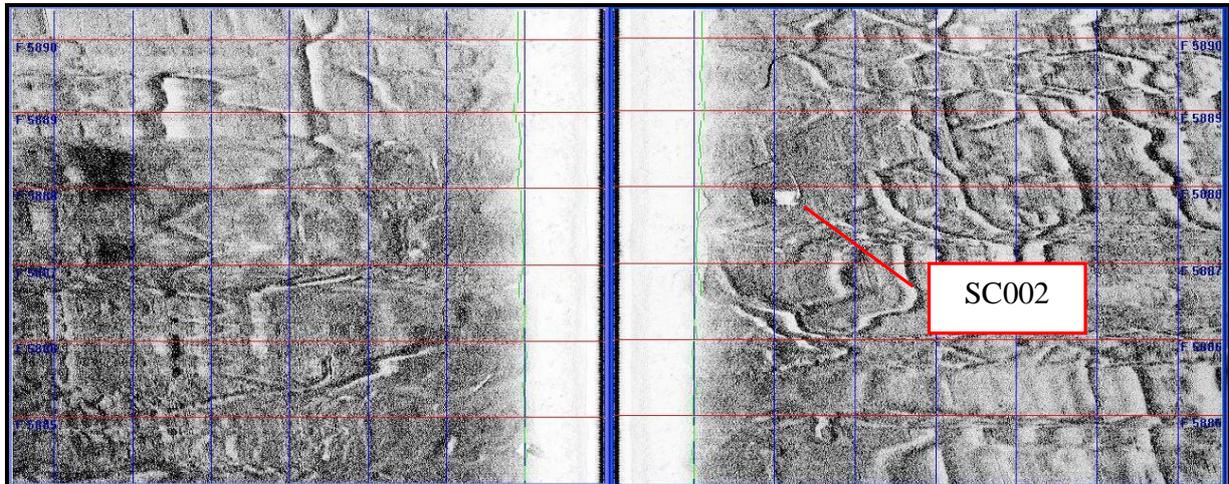
Figure AI.6: Side Scan sonar data showing Sonar Contact SC002.

| Contact Number | Easting Northing | Dimensions (m) | Distance from Alignment |
|---|---|---|---|
| SC002 | 812963.0E 825122.1N | 3.5x3.3x1.2 | 228.6 |

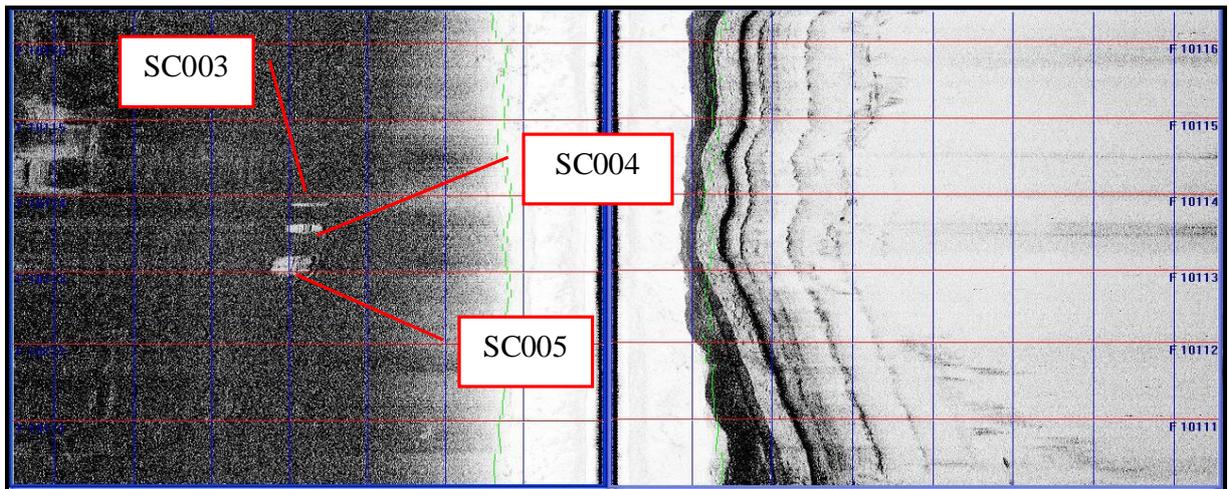
Figure AI.7: Side Scan sonar data showing Sonar Contact SC003, SC004 & SC005.

| Contact Number | Easting Northing | Dimensions (m) | Distance from Alignment |
|---|---|---|---|
| SC003 | 812736.4E 824639.9N | 4.3x0.9x0.9 | 107.1 |
| SC004 | 812731.2E 824632.3N | 2.4x0.5x0.9 | 92.8 |
| SC005 | 812728.0E 824626.5N | 0.8x0.5x0.9 | 101.3 |

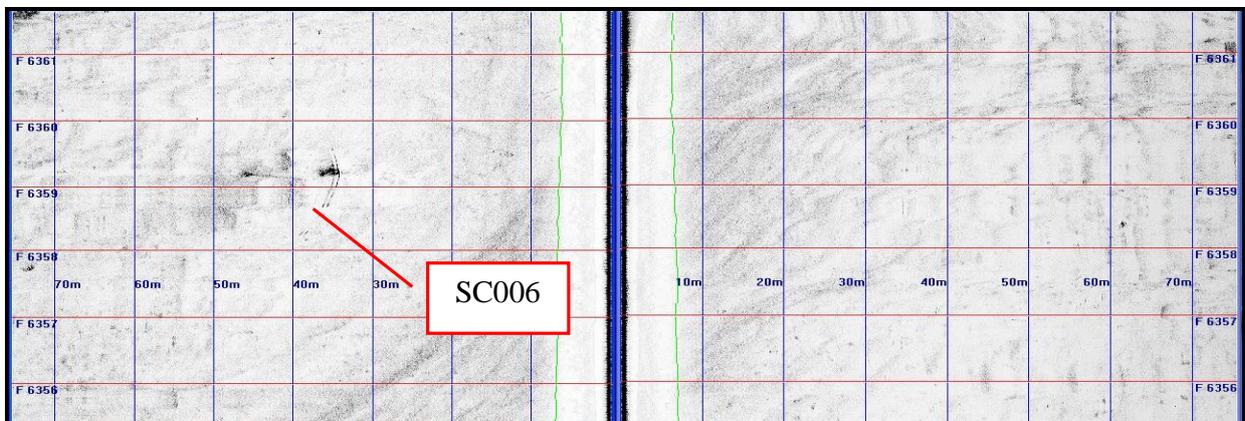
Figure AI.8: Side Scan sonar data showing Sonar Contact SC006.

| Contact Number | Easting Northing | Dimensions (m) | Distance from Alignment |
|---|---|---|---|
| SC006 | 812594.0E 819664.9N | 1.7x1.3xnmh* | 1215.4 |

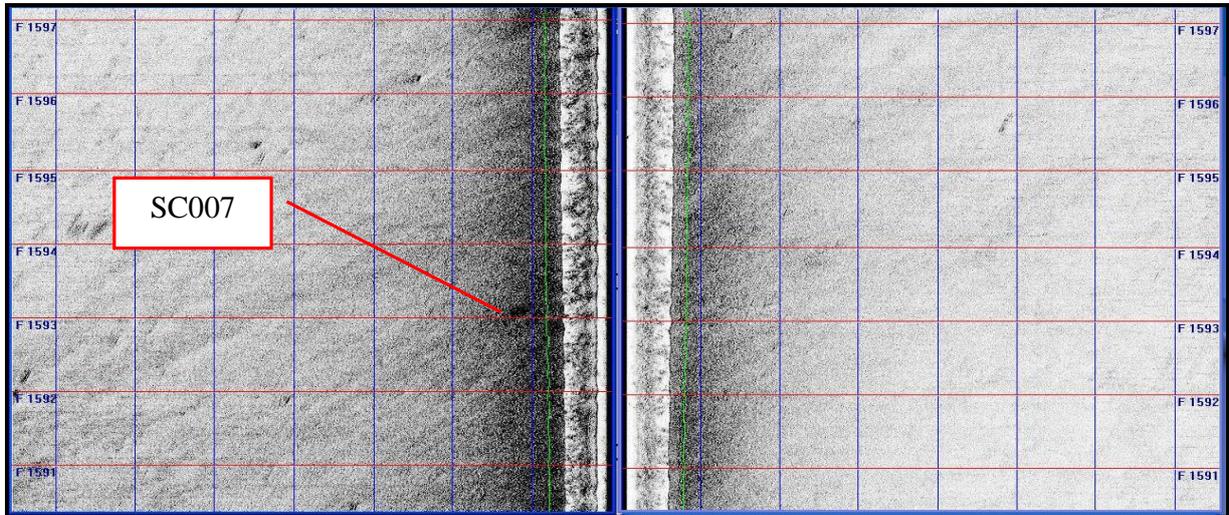
Figure AI.9: Side Scan sonar data showing Sonar Contact SC007.

| Contact Number | Easting Northing | Dimensions (m) | Distance from Alignment |
|---|---|---|---|
| SC007 | 813541.2E 821884.9N | 2.1x1.5xnmh | 197.9 |

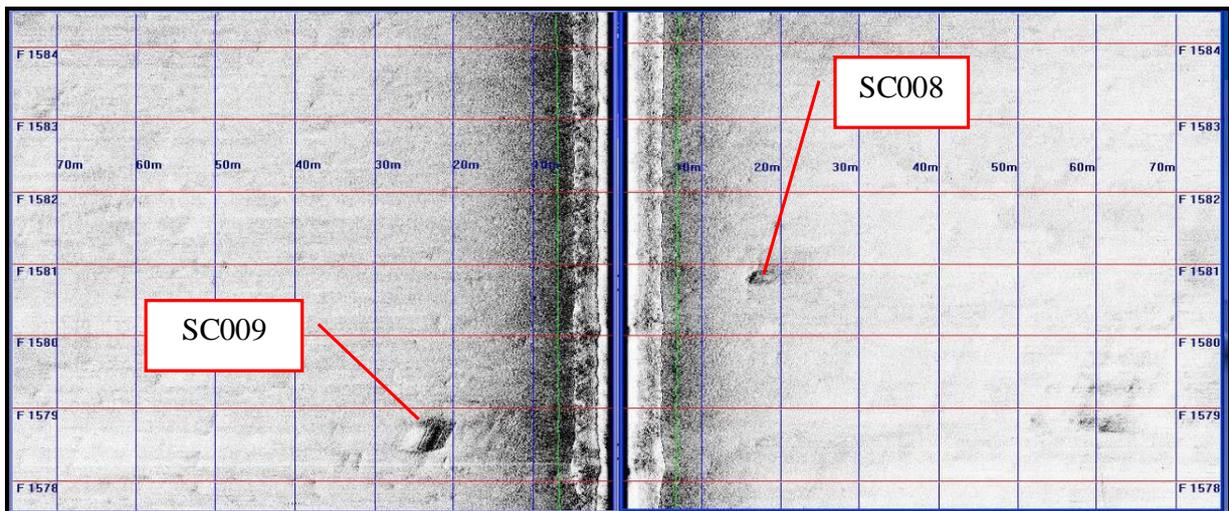
Figure AI.10: Side Scan sonar data showing Sonar Contacts SC008 & SC009

| Contact Number | Easting Northing | Dimensions (m) | Distance from Alignment |
|---|---|---|---|
| SC008 | 813566.2E 821663.3N | 1.2x1.7xnmh | 243.4 |
| SC009 | 813528.8E 821626.4N | 6.9x2.8xnmh | 198.5 |

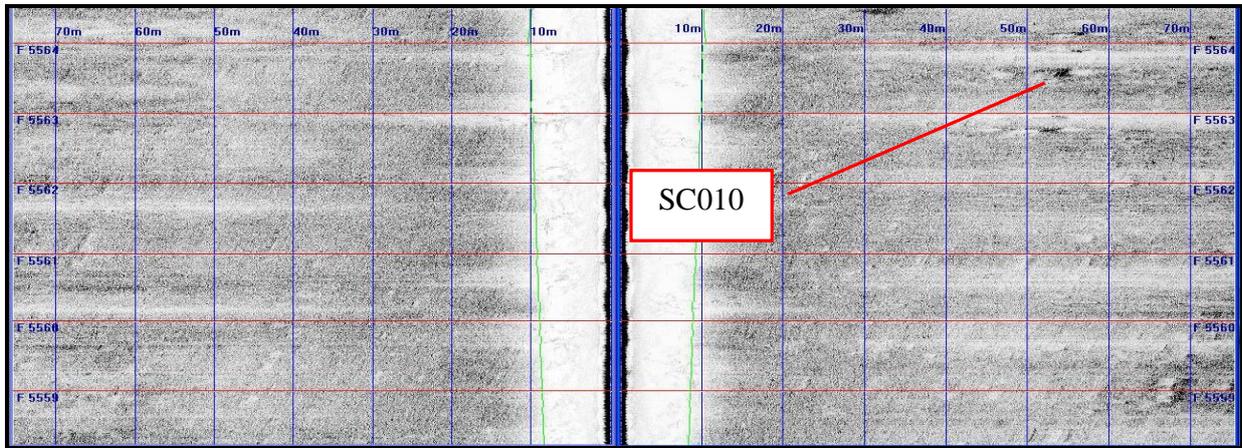
Figure AI.11: Side Scan sonar data showing Sonar Contact SC0010.

| Contact Number | Easting Northing | Dimensions (m) | Distance from Alignment |
|---|---|---|---|
| SC010 | 813205.2E 820466.6N | 1.4x0.8x0.4 | 777.4 |

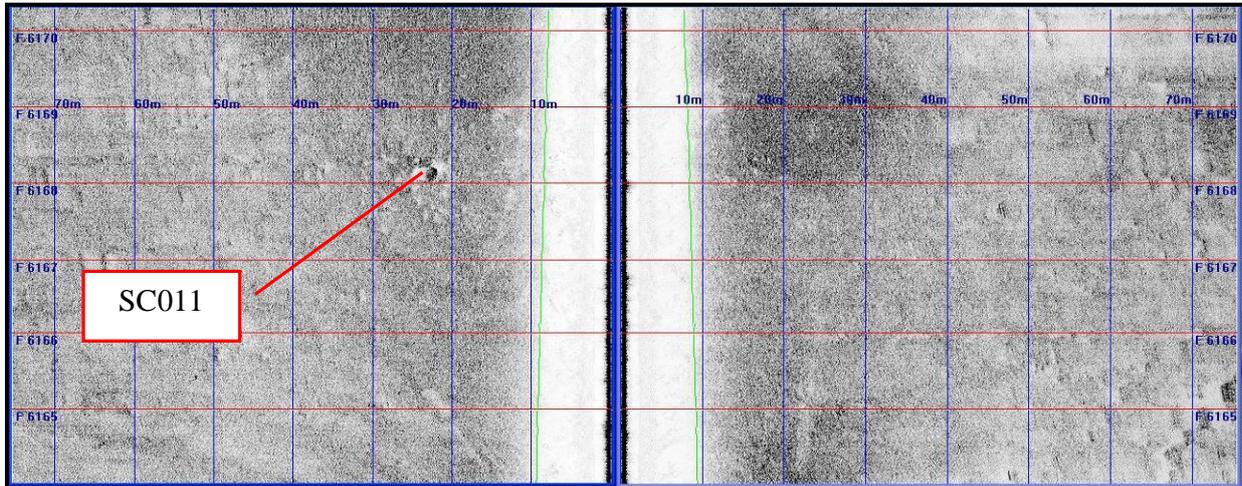
Figure AI.12: Side Scan sonar data showing Sonar Contact SC0011.

| Contact Number | Easting Northing | Dimensions (m) | Distance from Alignment |
|---|---|---|---|
| SC011 | 812981.7E 820426.6N | 1.4x2.0x0.3 | 938.9 |

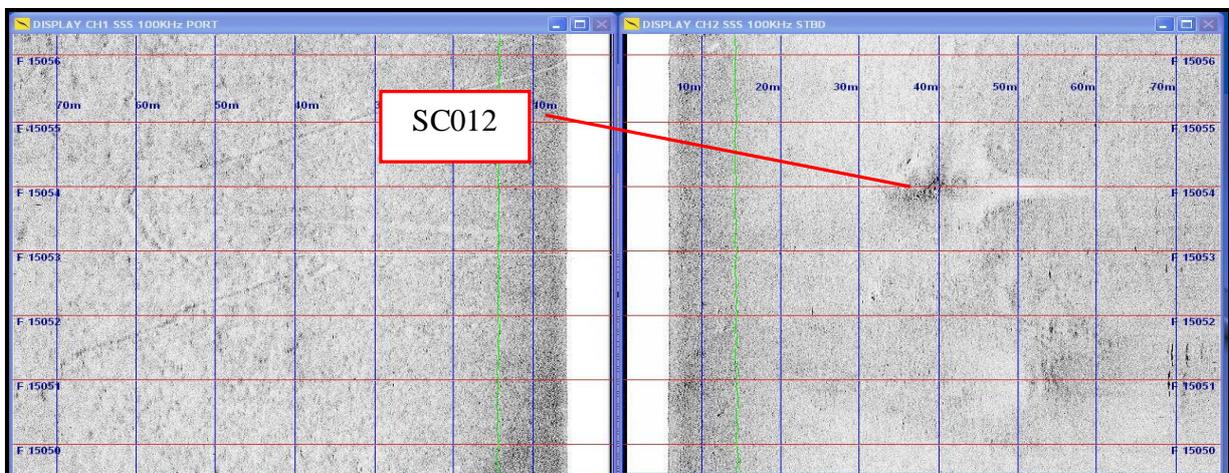
Figure AI.13: Side Scan sonar data showing Sonar Contact SC0012.

| Contact Number | Easting Northing | Dimensions (m) | Distance from Alignment |
|---|---|---|---|
| SC012 | 813419.7E 822676.3N | 15.4x11.2x1.1 | 106.9 |
