Contamination Assessment Report (including CAP)

Regulation of Shenzhen River
Stage IV EIA Study:
Contamination Assessment Plan

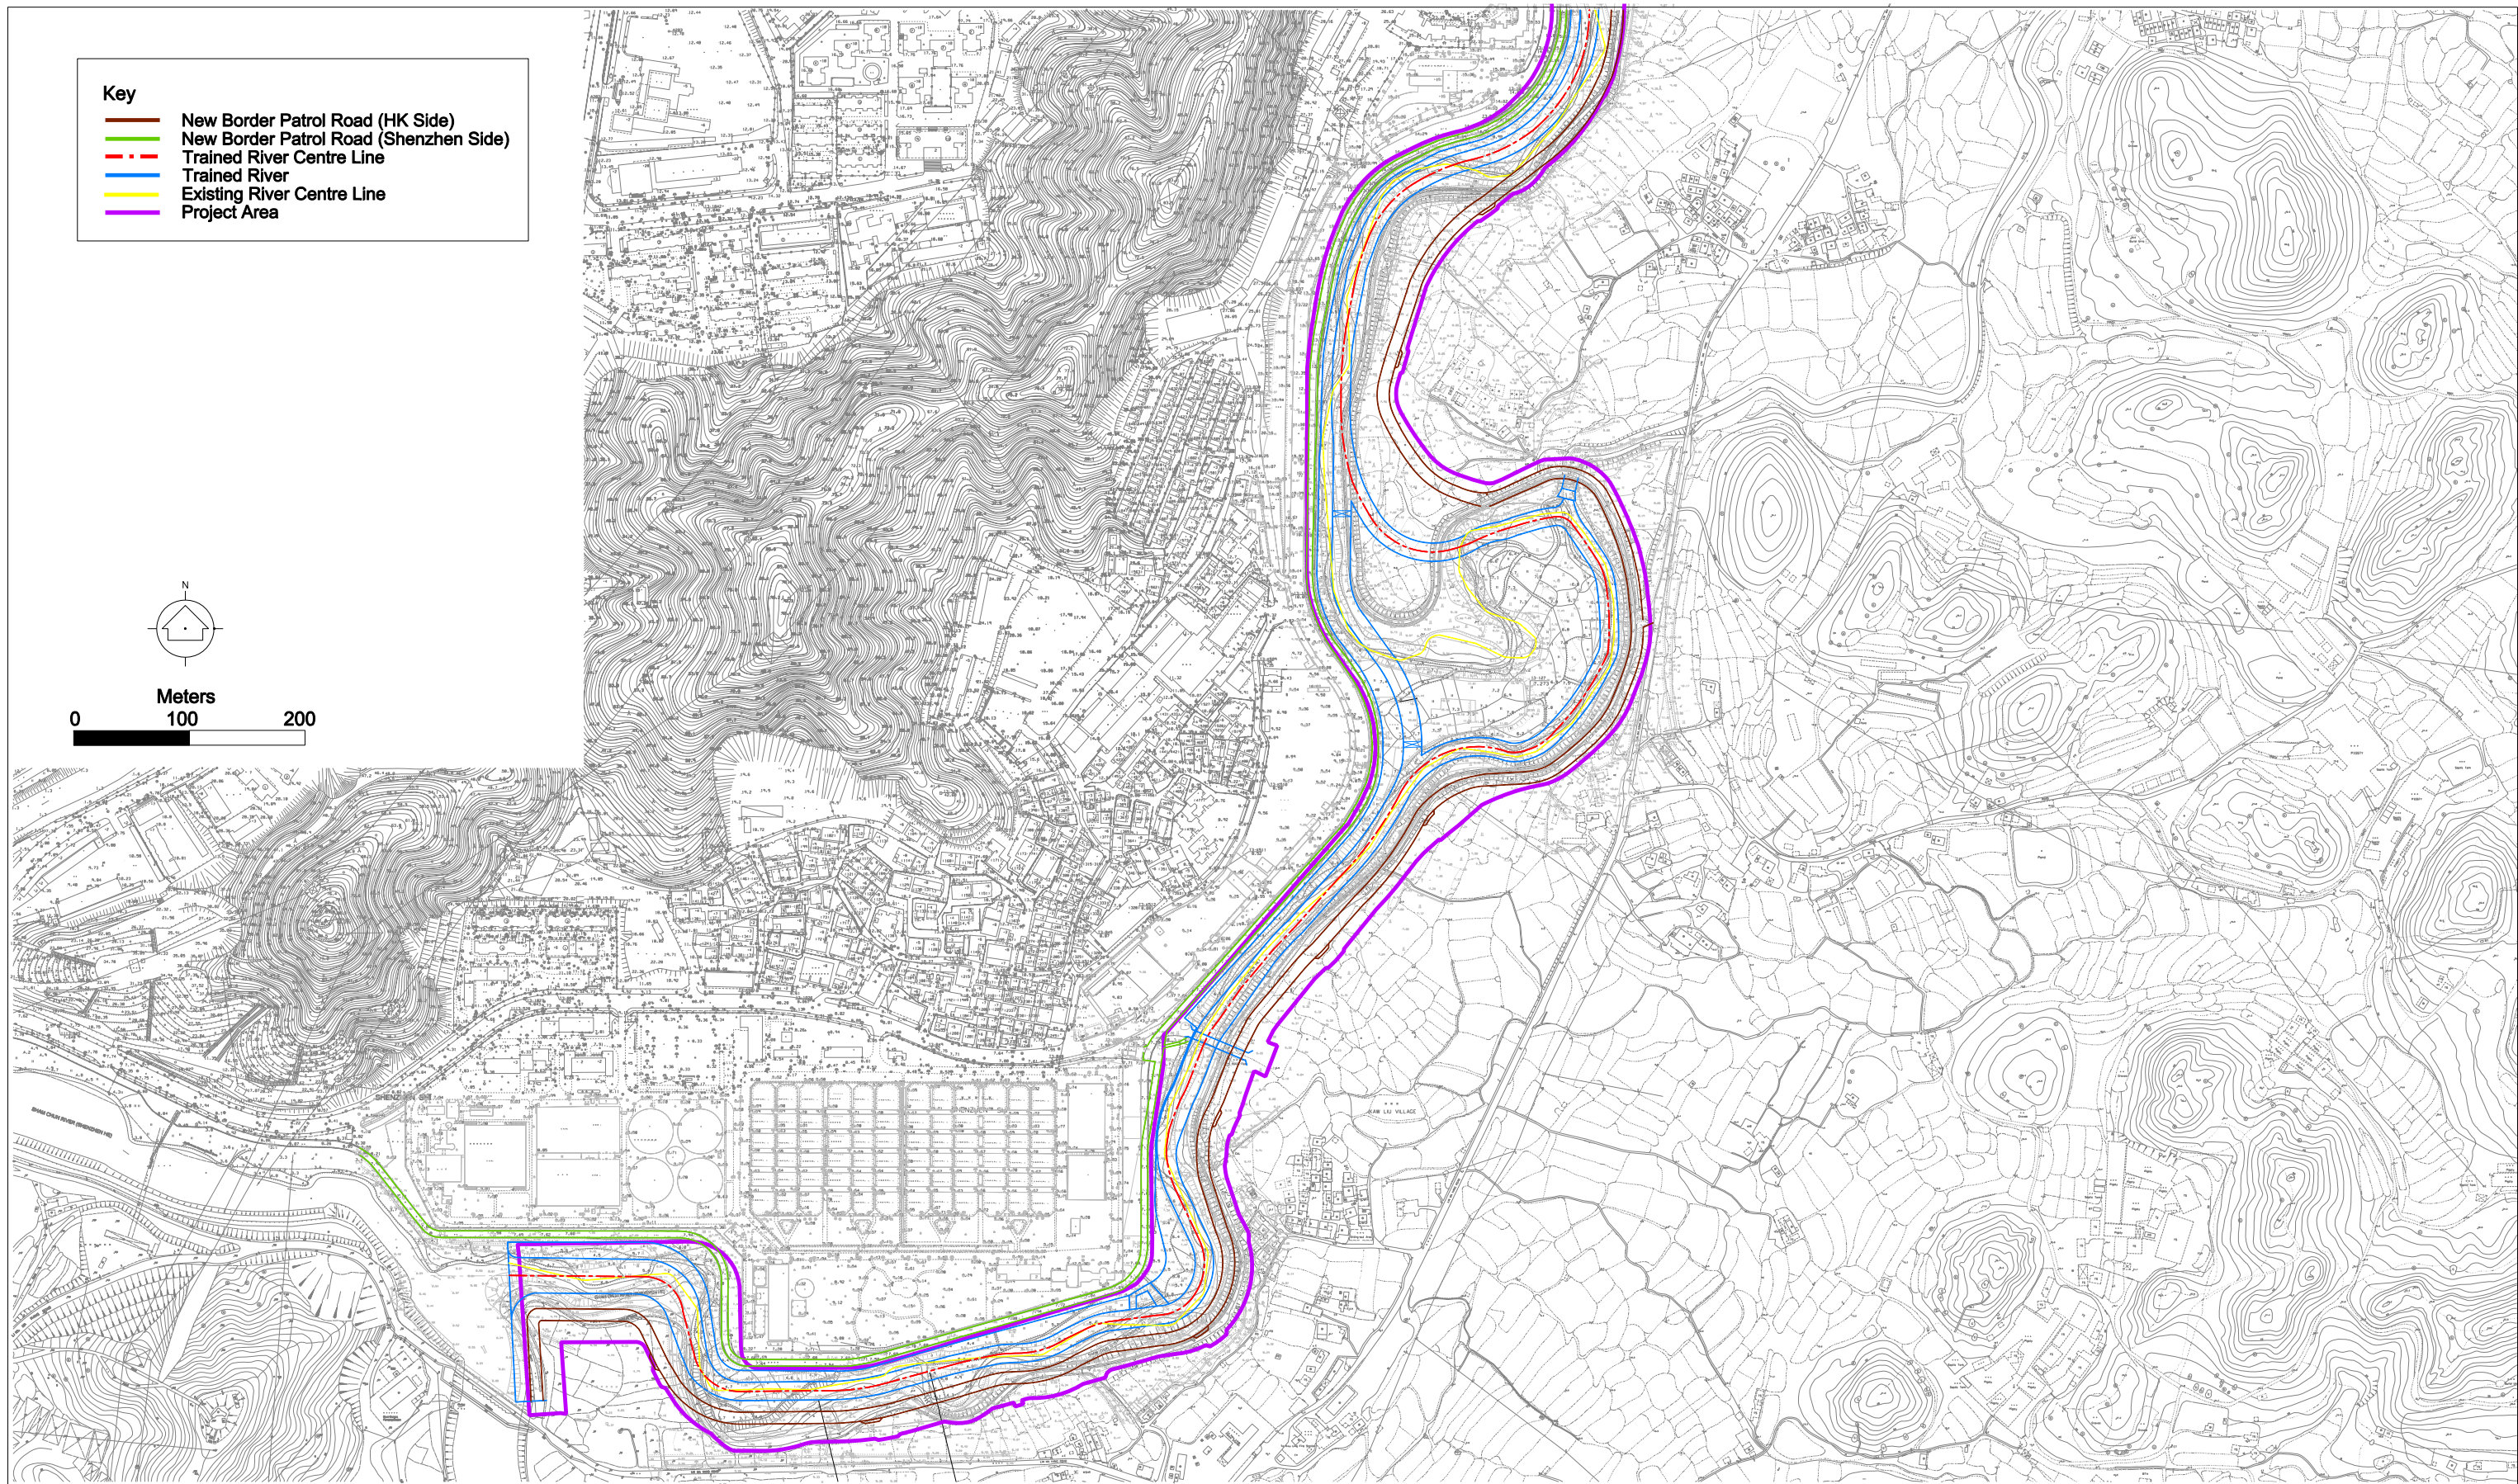
Figure A1-2

General Layout and Extent of the Trained River
(1 of 2)

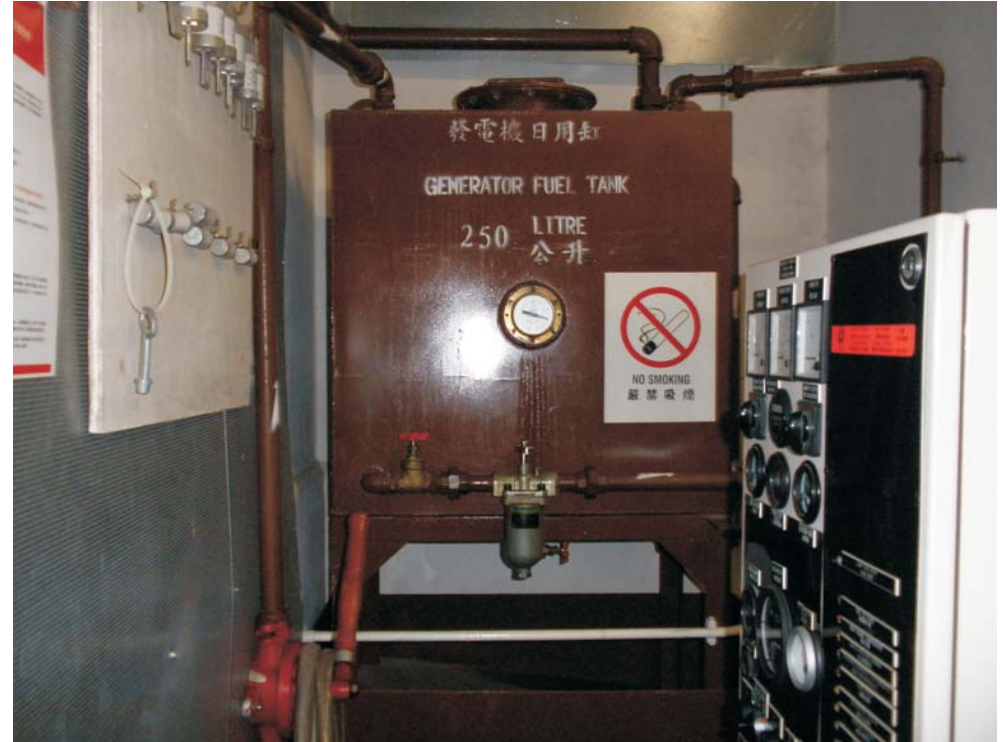
Above ground oil storage tank

store is paved and with no sign of chemical spillage. The potential for land contamination of the Project area due to the operation of the DG store and the above ground oil storage tank is considered low. No further contamination investigation for these areas is recommended.

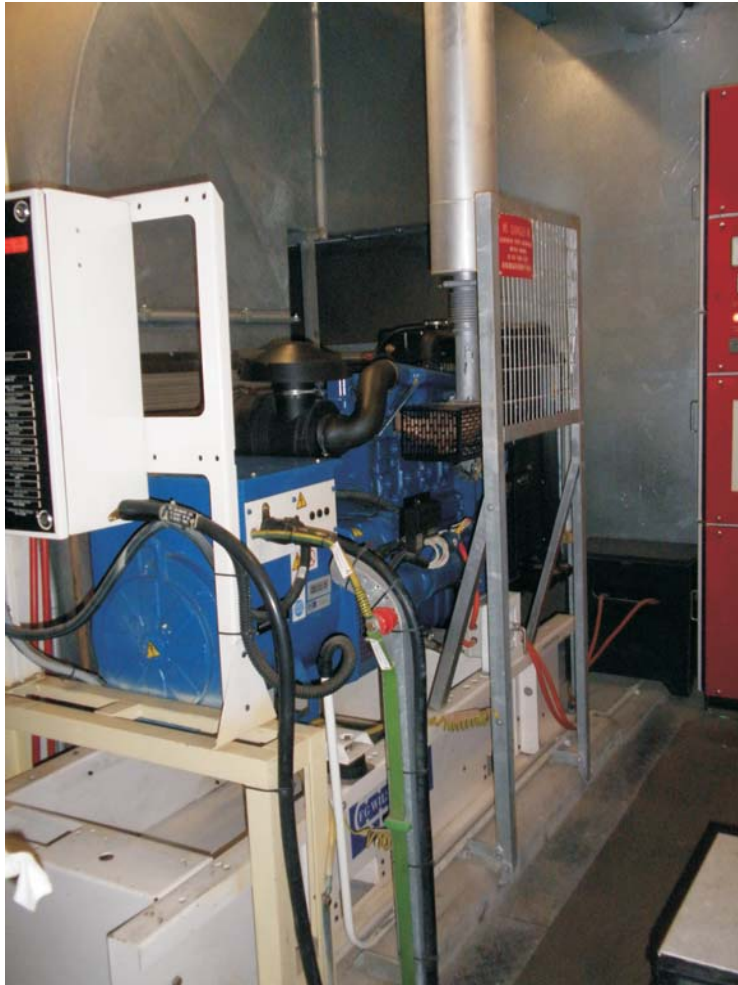
Emergency generator

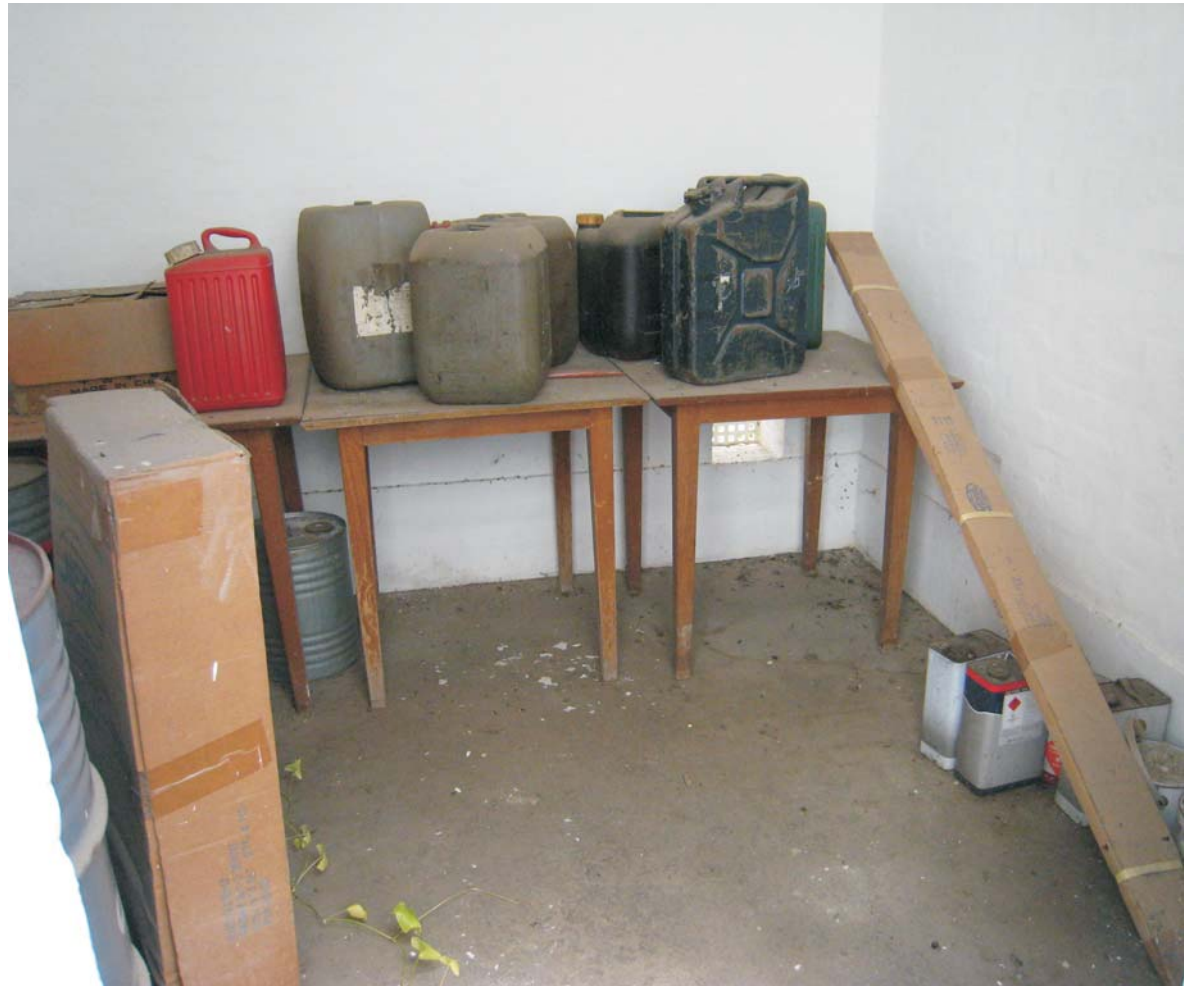
The dangerous goods storeroom

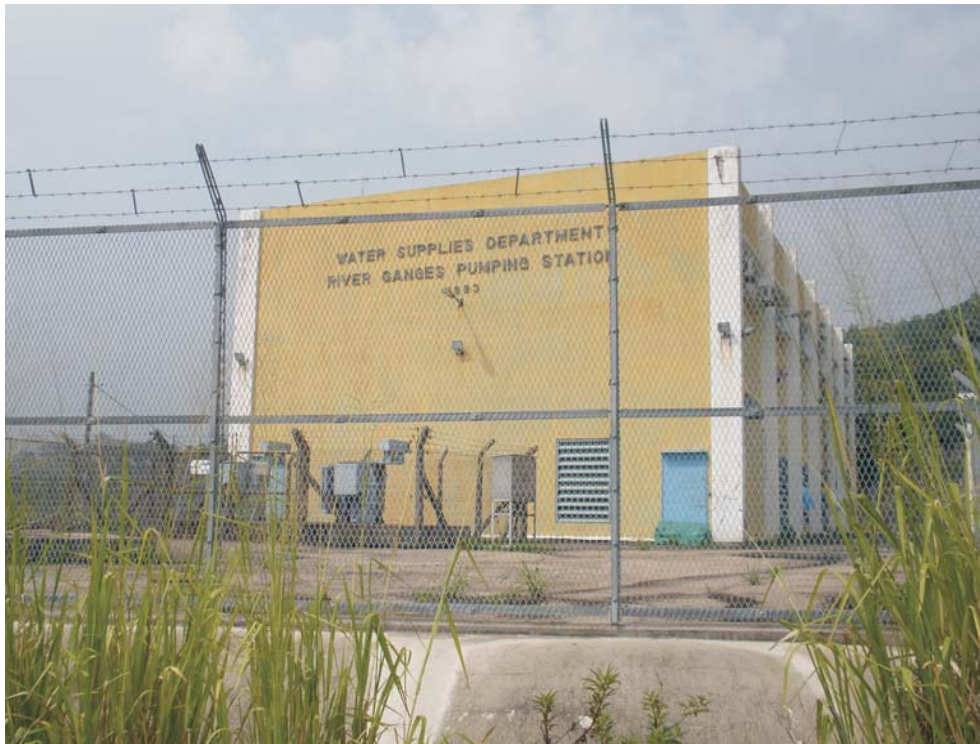
River Ganges water pumping station

Site 6 is a water pumping station (located at about 90m from the Project area) for the Ping Yuen River (River Ganges). As the Ping Yuen River has been widened and pumping station is seldom used. Four small above ground transformers were found on site (two within the pumping station site and two at the CLP substation near to the pumping station) which are mounted on paved area. No visual evidence of leakage of transformers oil at the pumping station site and CLP substation site was observed. It is confirmed that no emergency generator or underground fuel storage tank is provided in the pumping station. The operations of the water pumping station and the CLP substation are not considered to be significant off site sources that could cause significant on-going contamination at the Project area. No further contamination investigation for these areas is recommended.

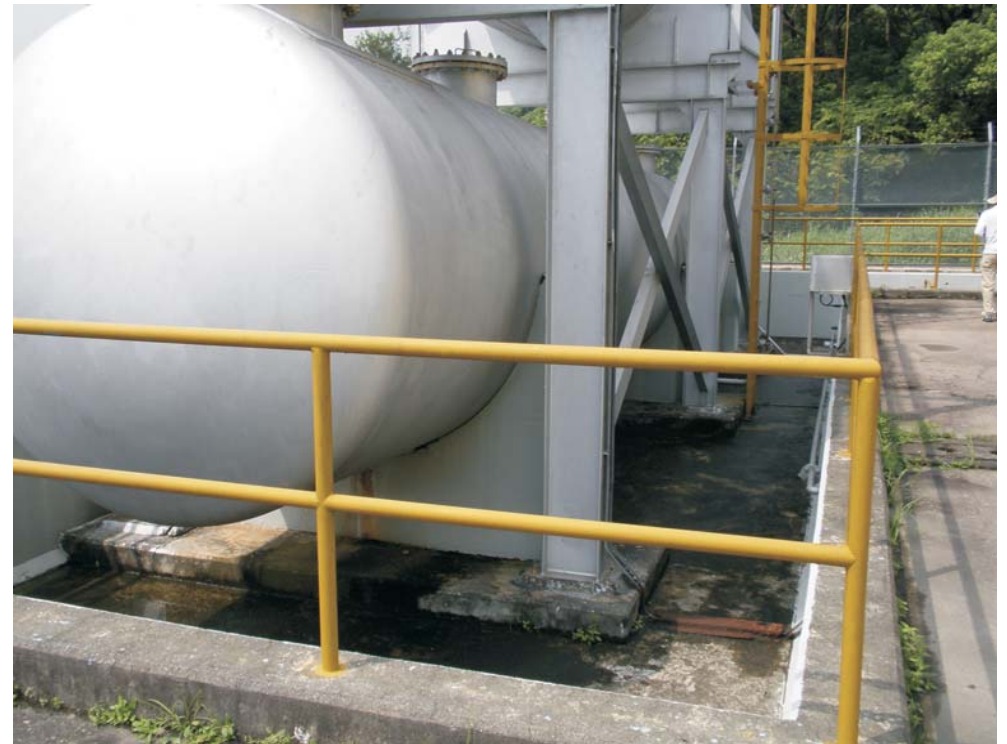
Above ground storage tanks

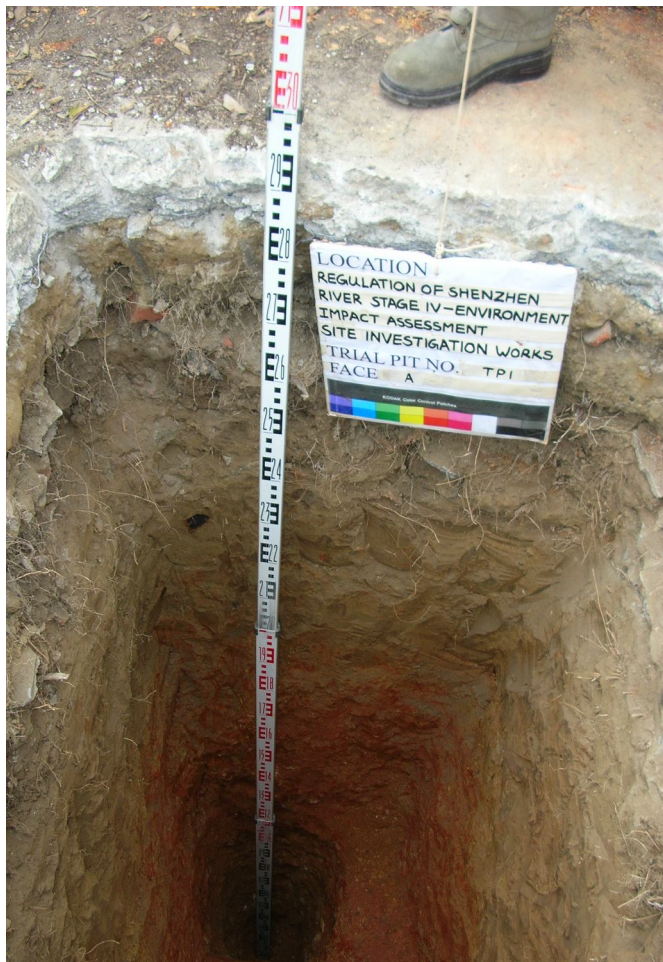
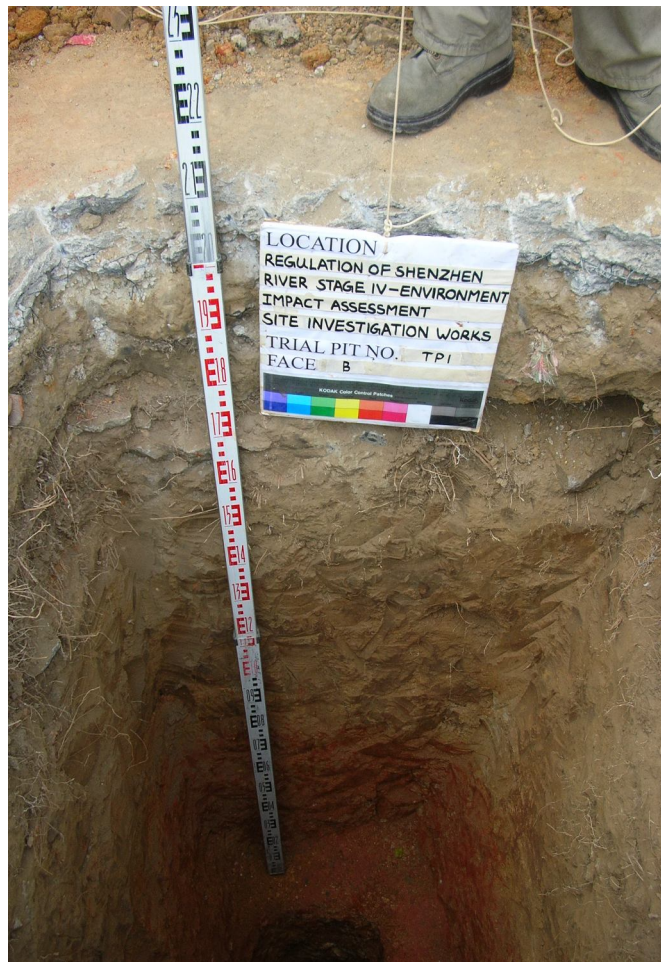
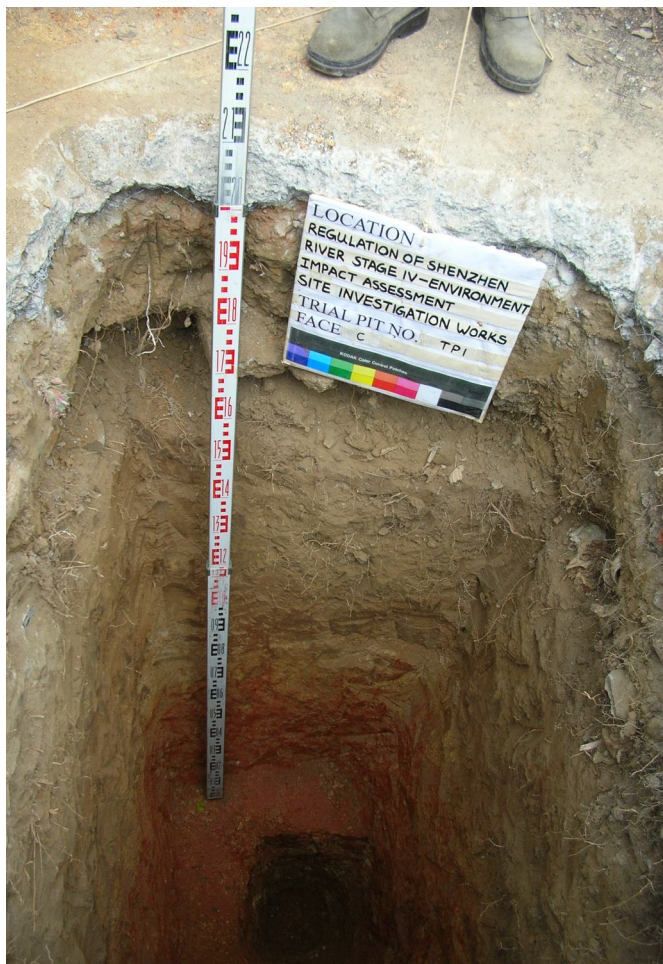
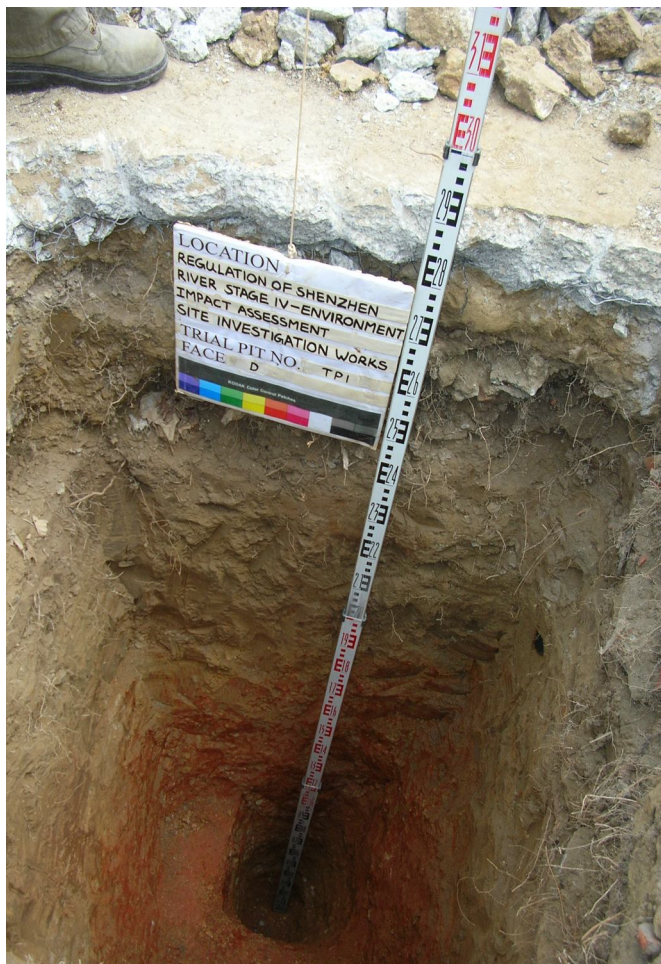
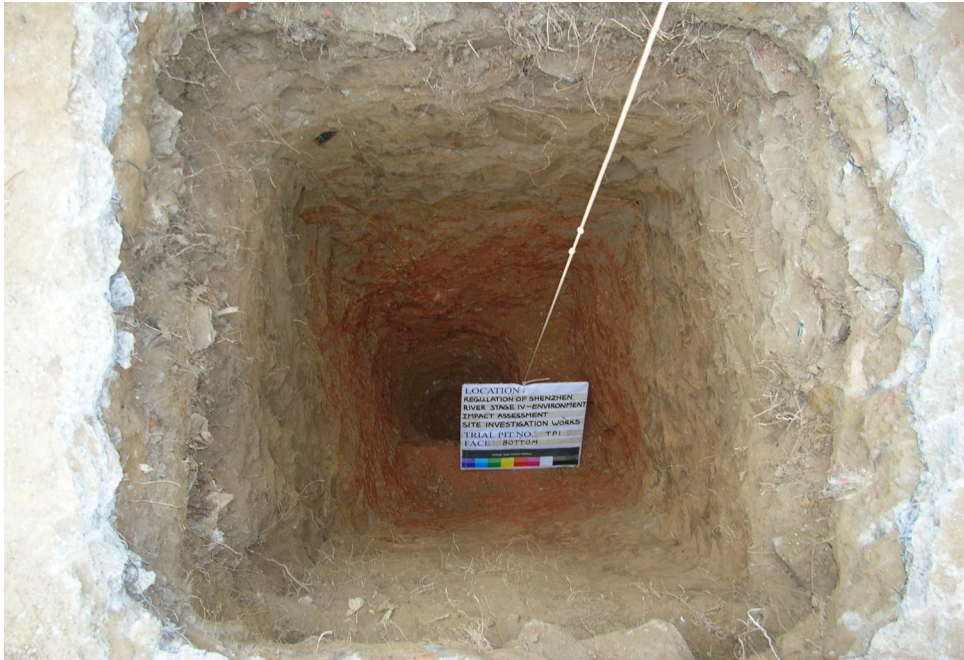
Location: Regulation of Shenzhen River Stage IV – Environmental Impact Assessment Site Investigation Works		Trial pit No.: TP1		Sheet 1 of 1	
Logged by: LKM Checked by: AW		Excavation method: Hand Dug		Excavated: 21/1/2010	
Date: 21/1/2010		Coordinates: E 833679.521 N 845169.243		Backfilled: 22/1/2010	
Samples & Test	Depth (m)	Face A: width: 1.20 m	Face B: width: 1.20 m	Face C: width: 1.20 m	Face D: width: 1.20 m

0.00	Datum line +9.30 mPD			
	0.50				
	1.00				
	1.50				
	2.00				
	2.50				
	2.90				
Remarks:					
Legend	Description	Grade	Plan (not to scale)		
	Grey, CONCRETE.				
	Loose, grey, silty SAND with many red brick & concrete fragments. (FILL.)				
	Extremely weak, reddish and yellowish grey, completely decomposed TUFF. (Firm, sandy SILT.)	V			
	Extremely weak, reddish and yellowish grey, completely decomposed TUFF. (Very dense, silty SAND with many fine to coarse quartz gravels.)	V			
	BOULDER.				
	Plate bearing test			Small disturbed sample	
	Insitu density test			Large disturbed sample	
	Moisture content test			Water sample	
	Photograph			Seepage	
	Undisturbed sample hor.			Bulk sample	
	Undisturbed sample ver.			Block sample
