Appendix 11b.3

**Inventory of
Cultural Heritage
Sites for the
IWMF at the
artificial island
near SKC**

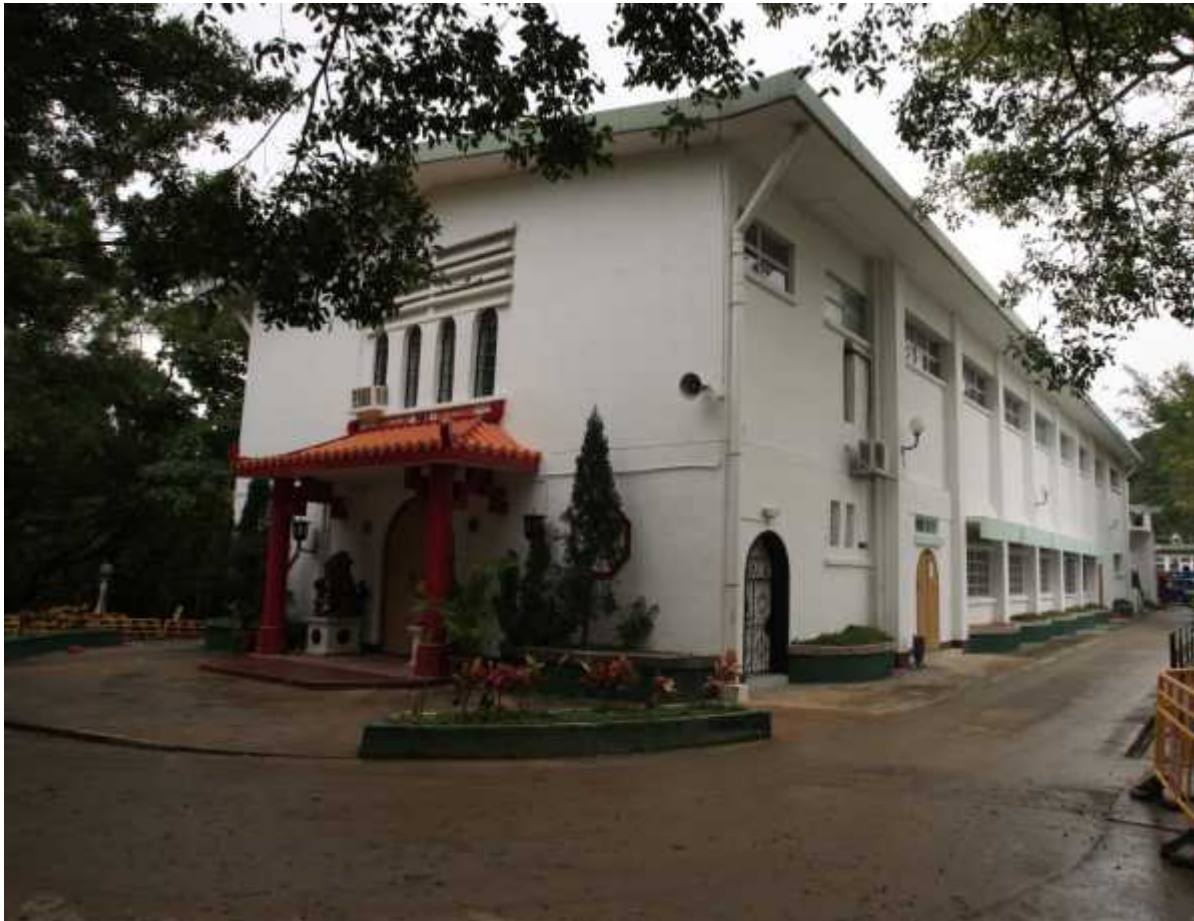
Area	Administrative Block and Assembly Hall of SARDA	Reference No.	SK1
Building Type	European Style Building	Construction Date	1962
Original Use	Administrative	Current Use	Administrative
Existing Condition	Good	Construction Materials	Stone
Grading Information	Not graded

The administrative block and assembly hall of SARDA was built in 1962 as part of the Drug Rehabilitation complex and is still currently in use. The building is currently not graded and is in good condition.

Entrance of Assembly Building

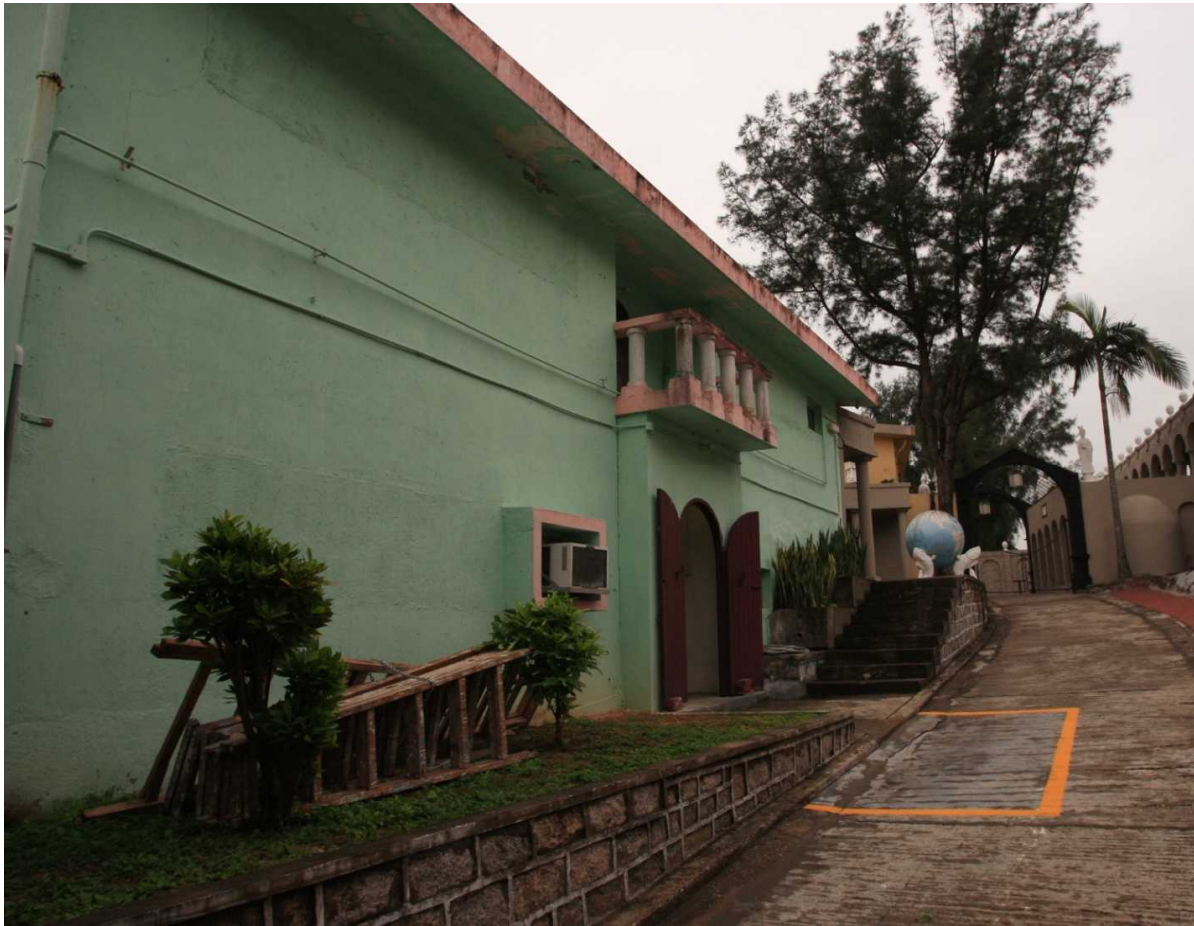
Area	Recovery House of SARDA Complex	Reference No.	SK2
Building Type	European Style Building	Construction Date	1962
Original Use	Recovery House	Current Use	Recovery House
Existing Condition	Good	Construction Materials	Concrete
Grading Information	Not graded

The recovery house was built in 1962 as a center for recovering drug abusers, and was built in a European style. There are currently 4 recovery houses which currently remain in use and are in good condition.

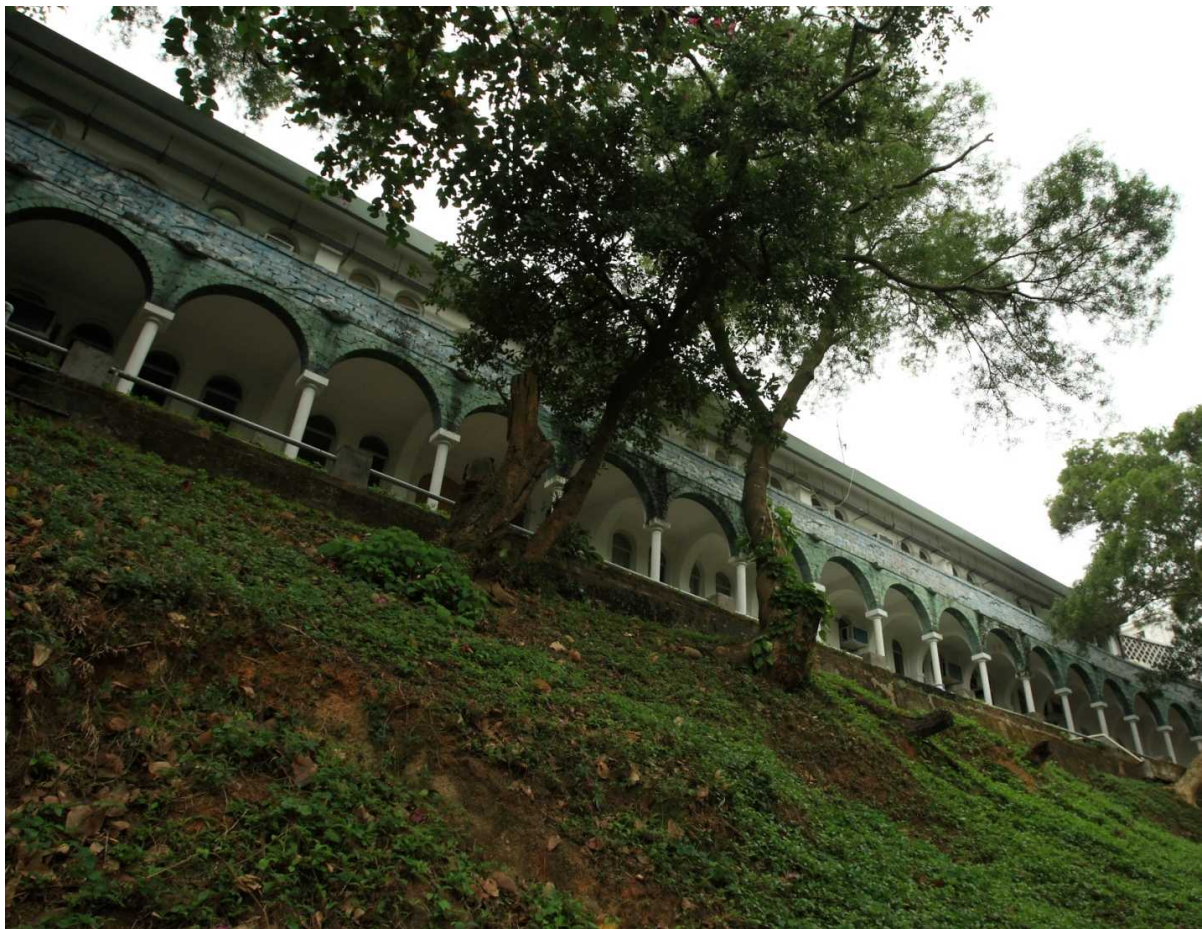
Area	Office Block of SARDA	Reference No.	SK3
Building Type	European Style Building	Construction Date	1962
Original Use	Administrative	Current Use	Administrative
Existing Condition	Good	Construction Materials	Concrete
Grading Information	Not graded

The Office Building was built in 1962 as a center for recovering drug abusers, and was built in a European style. The building remains in use and is located next to the courtyard complex, and is in good condition.

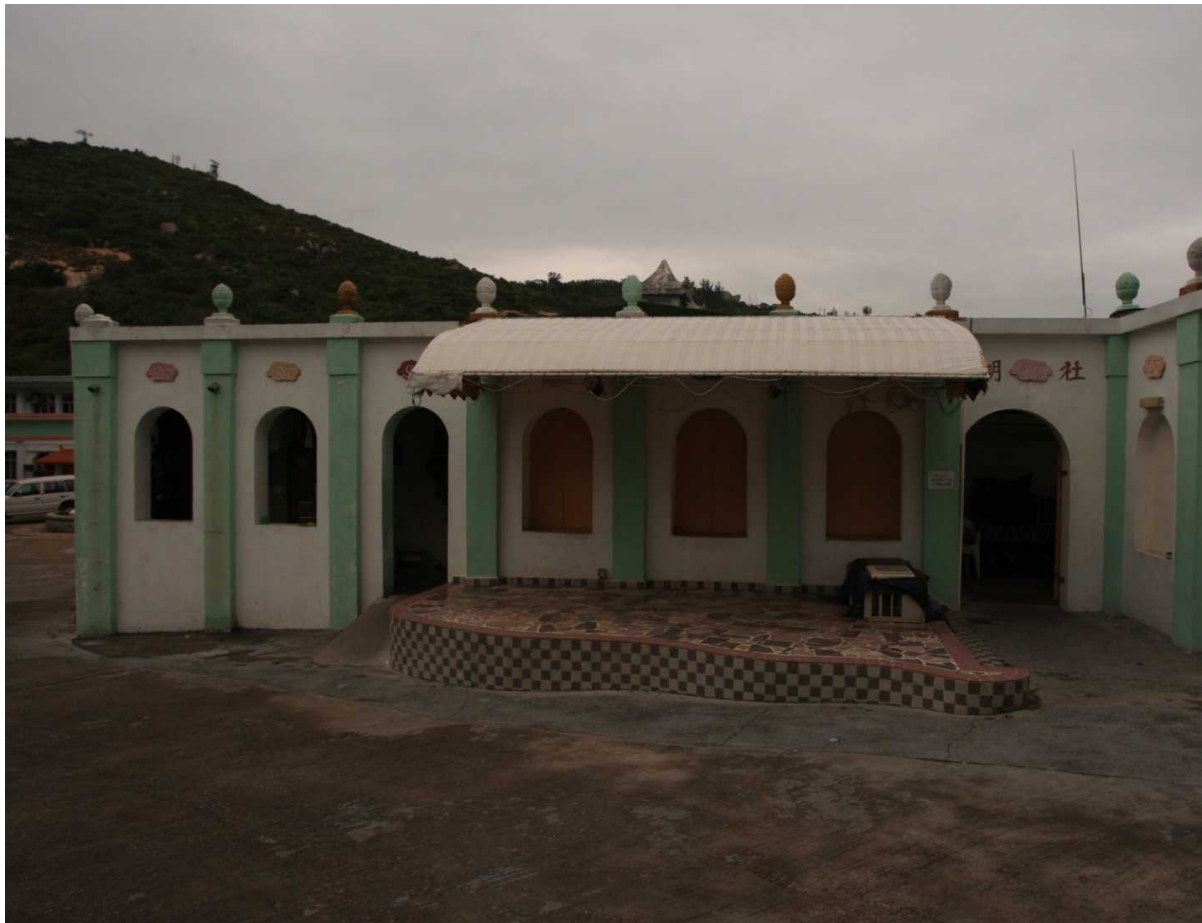
Area	Mei House and Ming House, SARDA	Reference No.	SK4
Building Type	Modern	Construction Date	1962
Original Use	Production / Rehabilitation	Current Use	Production / Rehabilitation
Existing Condition	Good	Construction Materials	Concrete
Grading Information	Not graded

The Mei House and Ming House were built in 1962 to house rehabilitating drug abusers, and were built as a gathering place for patients, including a workshop for patients to engage in productive activities. The buildings are currently in good condition. The buildings are located close to the Administrative Blocks.

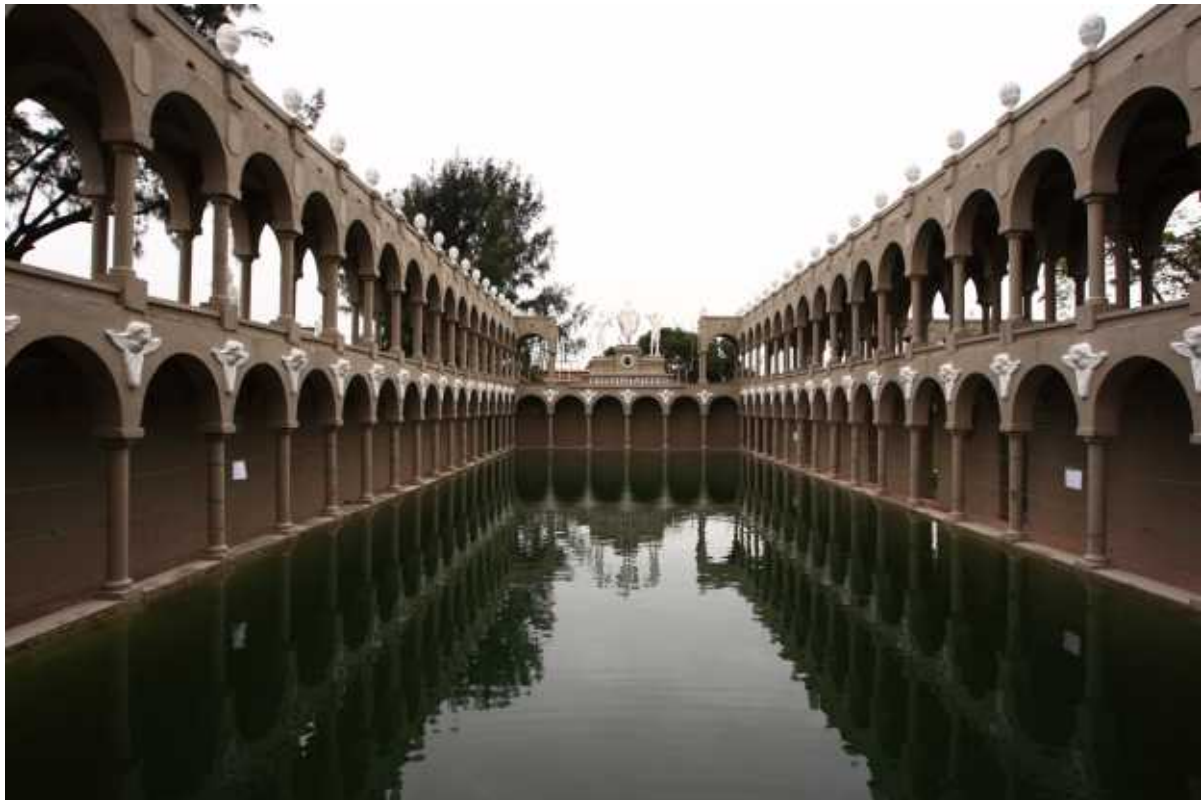
Area	Shek Kwu Chau	Reference No.	SK5
Building Type	Roman-Style Architecture	Construction Date	1971
Original Use	Water Storage	Current Use	Water Storage / Decoration
Existing Condition	Good	Construction Materials	Stone
Grading Information	Grade 3

The Courtyard Complex for SARDA was built by the inhabitants of the facility in 1971 as part of SARDA's rehabilitation process as well as to build a water storage facility. Since Shek Kwu Chau does not contain fresh water, the courtyard serves as a source of SARDA's water supply, as is integrated into the newcomers' home complex (i.e. the treatment blocks) of SARDA.

The Courtyard, used as a Water Storage Facility

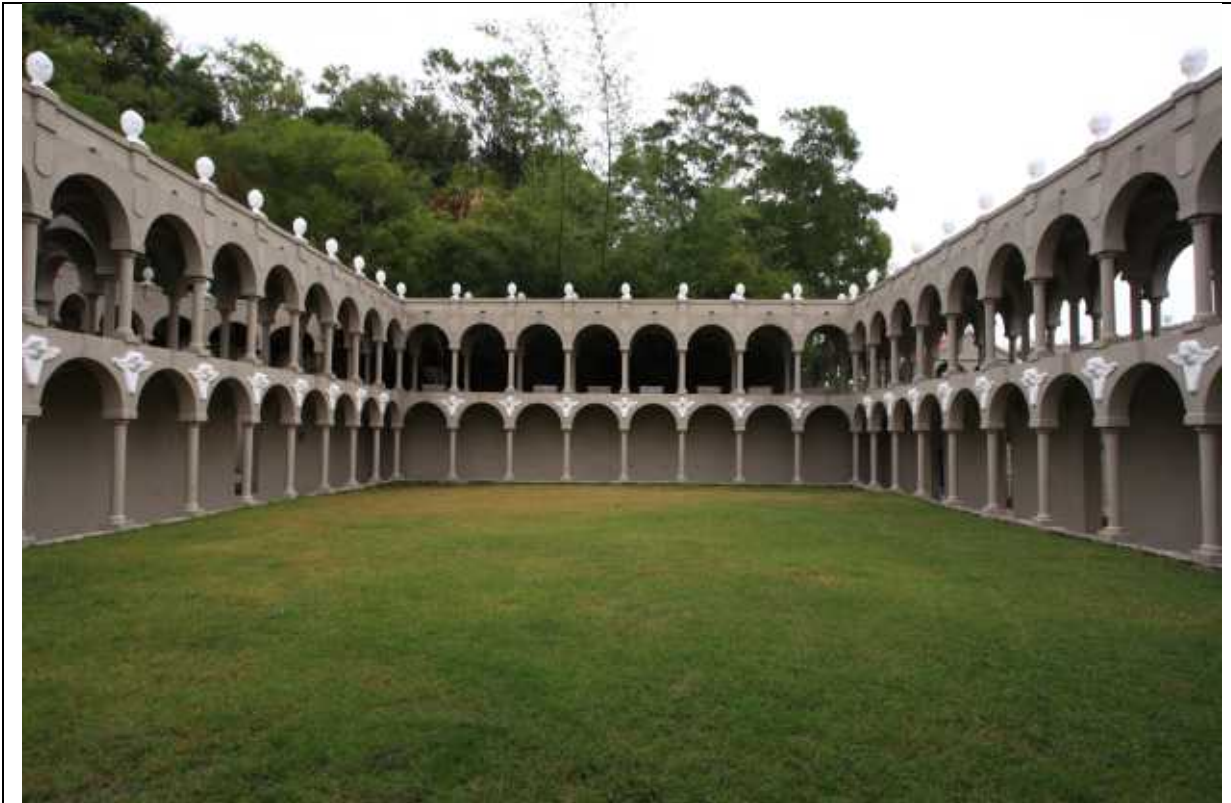
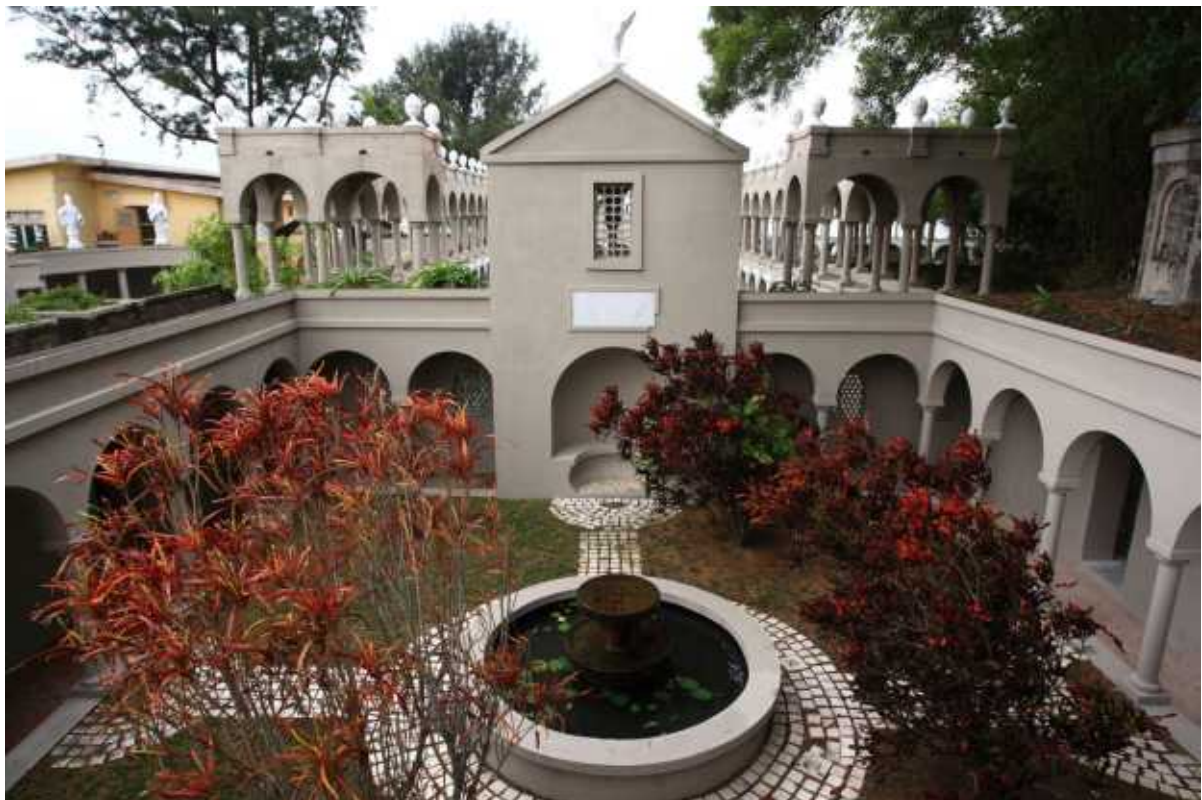
Lawn and Garden of Courtyard Complex
