## <u>Shatin to Central Link – Stabling Sidings at Hung Hom Freight Yard</u> <u>EIA Study Brief (ESB-233/2011)</u> <u>Contamination Assessment Plan (CAP)</u>

Shatin To Central Link (SCL) Consultancy Agreement No. NEX/2206

Stabling Sidings at Hung Hom Freight Yard – Contamination Assessment Plan

25445 Draft | September 2011

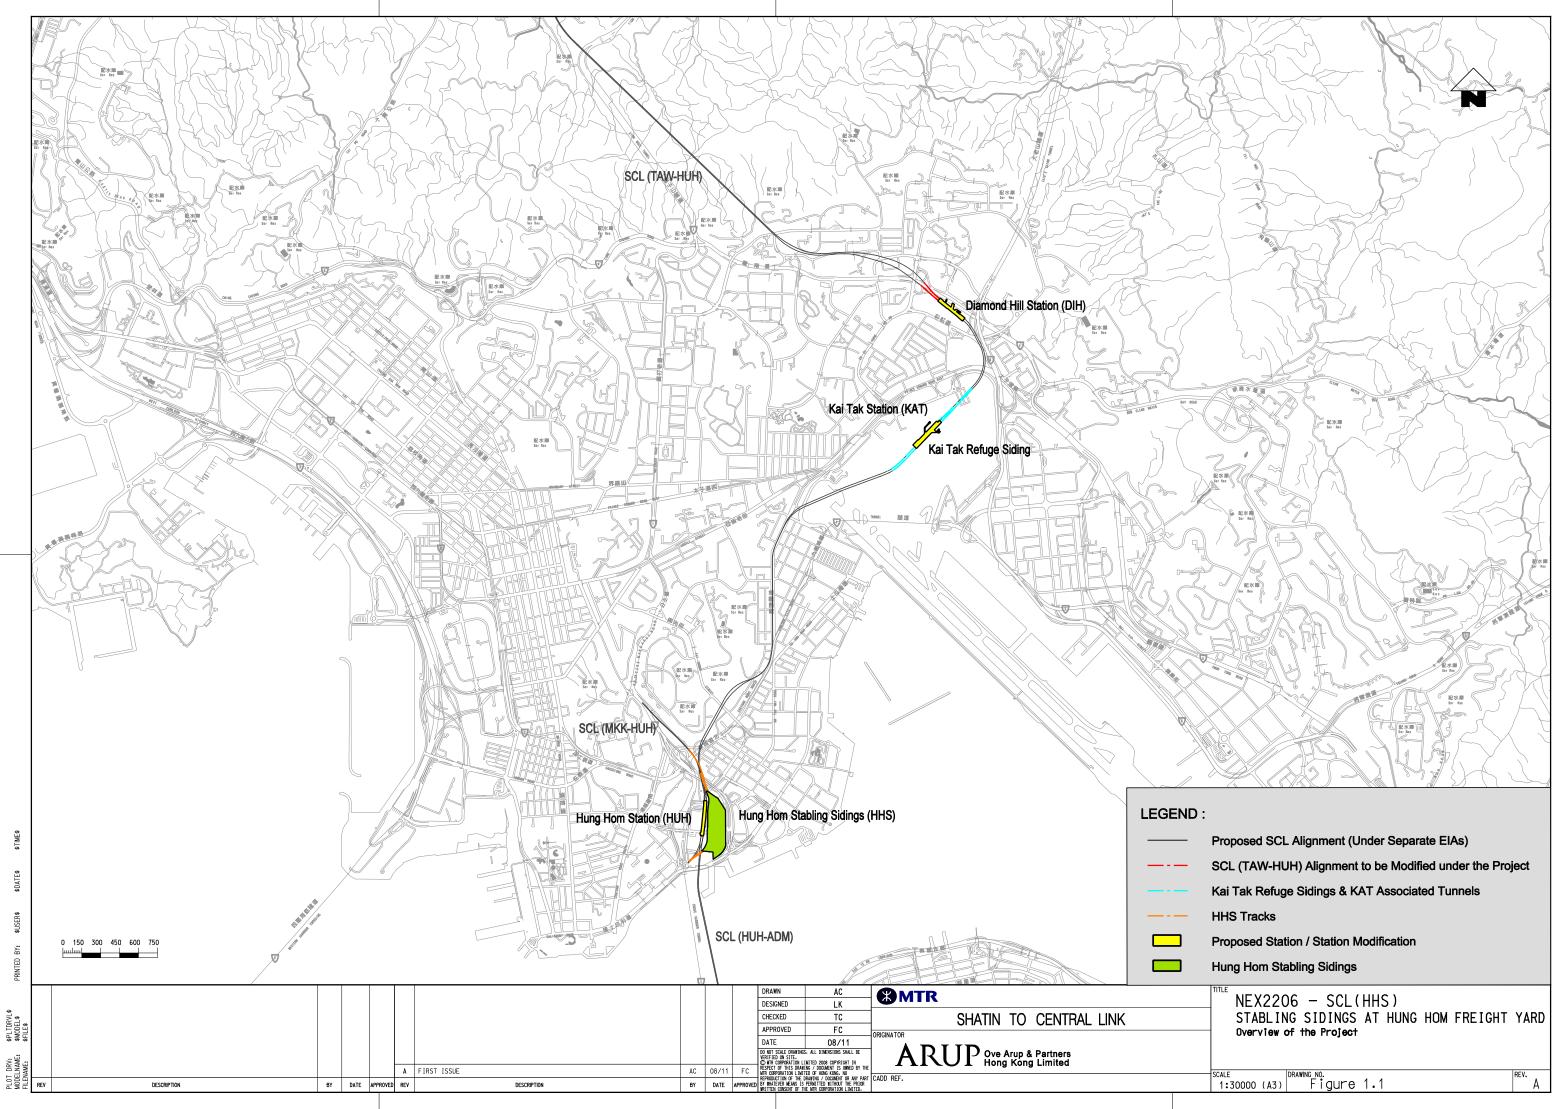
NEX2206 — SCL(HHS) STABLING SIDINGS AT HUNG HOM FREIGHT Overview of the Project	YARD
 scale   Drawing no. 1:30000 (A3)   Figure 1.1	REV. A

and facilities. These works are collectively referred to as the Project in this EIA (**Figure 1.1**).

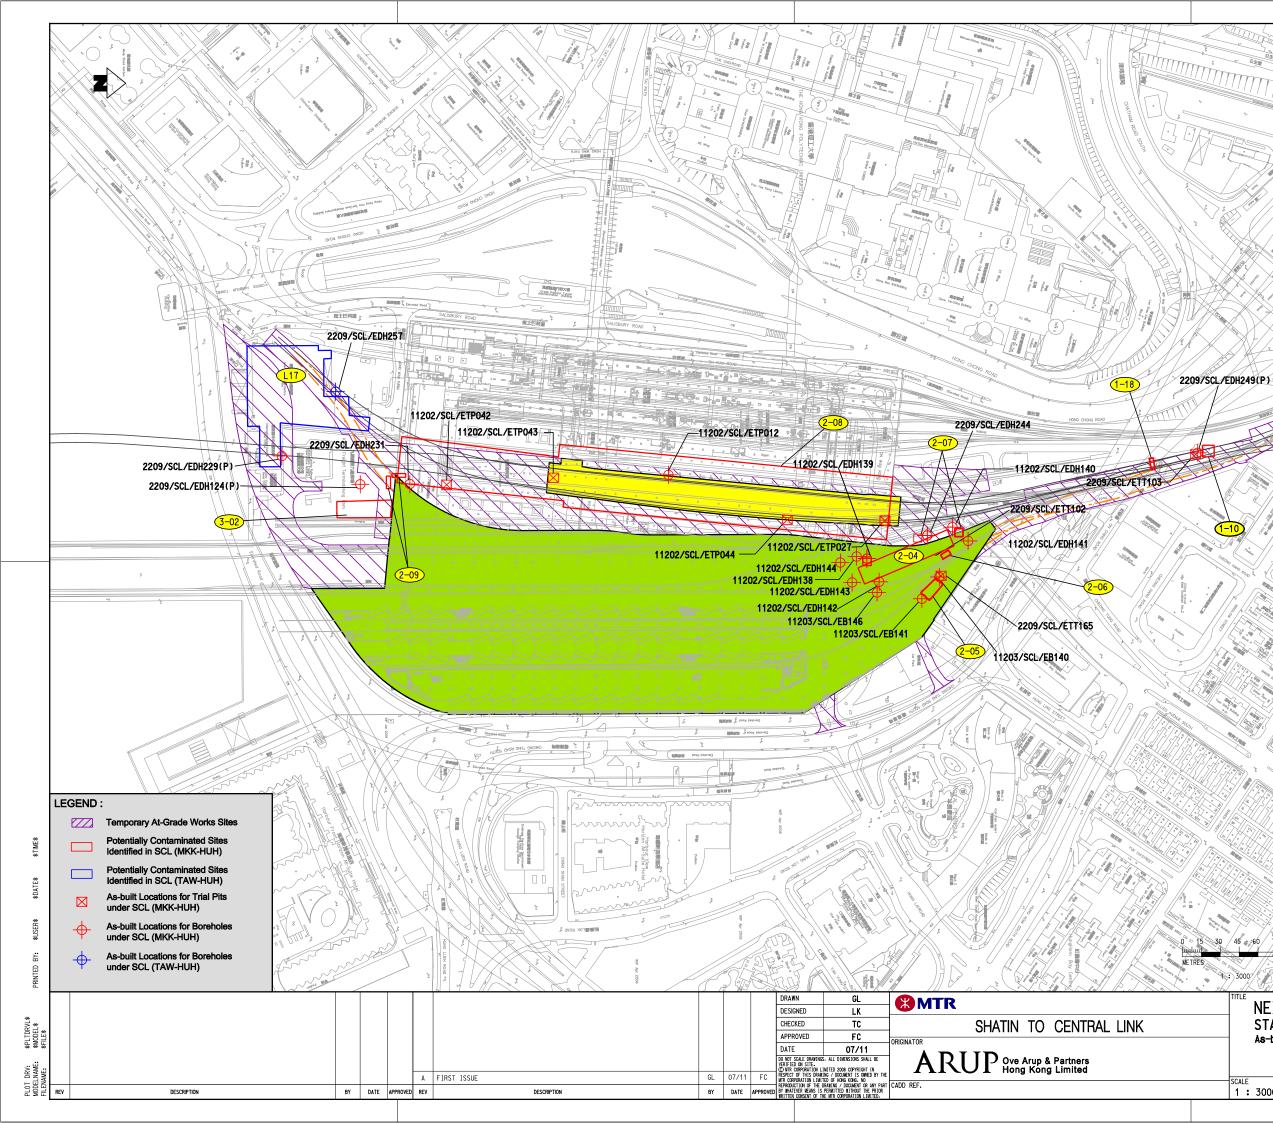
NEX2206 — SCL(HHS) STABLING SIDINGS AT HUNG HOM FREIGHT YARD As-built sampling Locations in Hung Hom Work Site

Ì	Potenti	al Contaminated Sites Identified	11
12.4	Site ID	Site Description	
	1-10	Open storage and previous paint storage	X
	1-18	Emergency generator room and fuel tank room	$\langle \rangle$
/ ( 1 m 2	1-22	Historic railway maintenance facility	
SILIE M	2-04	Locomotive running shed	
12/2	2-05	Underground storage tanks	/
	2-06	Aboveground lubricating oil storage tank	1
	2-07	Dispenser	100
19 2 C	2-08	Railway tracks	1411
) Internet	2-09	D.G. storage containers	//~
M N	3-02	Container stacker refuelling and maintenance area at Hung Hom	
	L17	International mail centre	/
~	1 1		/
2:	206 – S	SCL(HHS)

To sum up, a total of 32 sampling locations have been established within the Study Area of SCL (HHS) under SCL (TAW-HUH) and SCL (MKK-HUH) land contamination studies. A total of 240 soil samples and 22 groundwater samples were collected and all samples were complied with the RBRGs (industrial) levels.

As shown in **Figures 2.1 - 2.2** and discussed in **Section 2.1.2**, the data collected under SCL (TAW-HUH) and SCL (MKK-HUH) EIA studies have only covered the northern, southern and western portion of the Hung Hom Works Site and the Works Site at KAT and DIH, while the potential land contamination concern at the eastern part of the Hung Hom Works Site within the Study Area of SCL (HHS) has not been assessed.

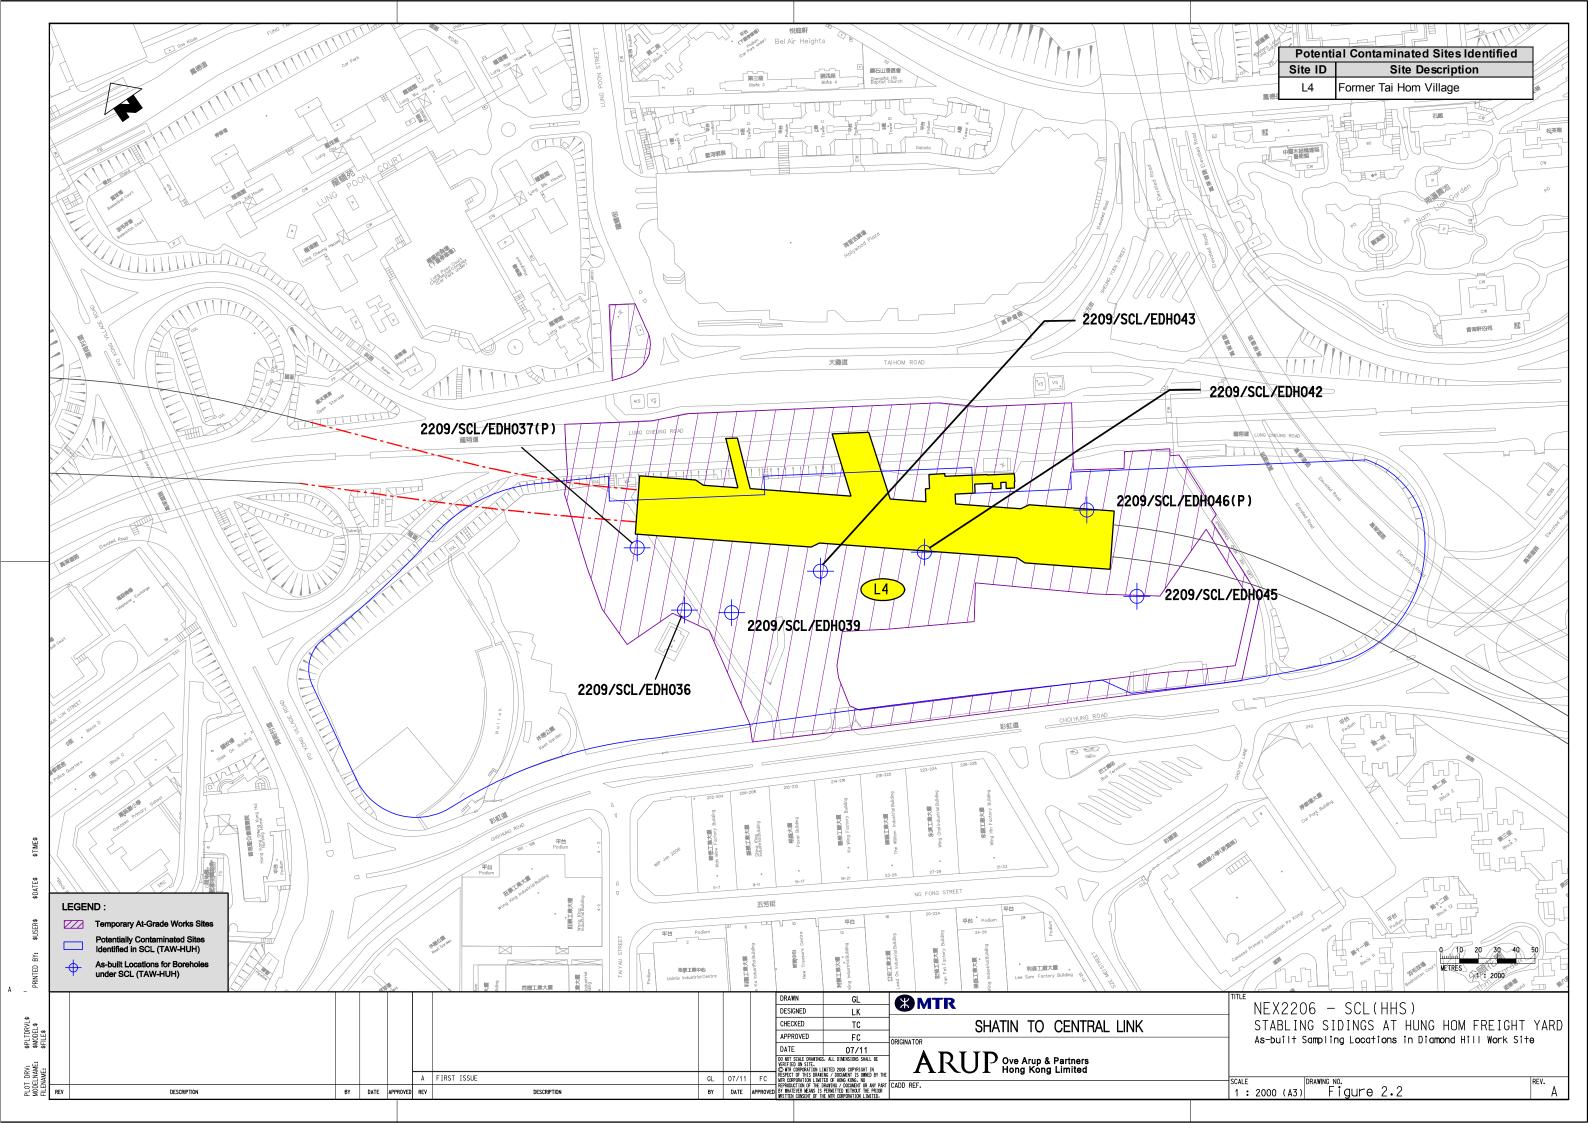
Site investigations were undertaken to investigate the nature, scale and extent of possible contamination at Tai Hom Village located at DIH Works Site and International Mail Center located at Hung Hom Works Site, A total of 8 boreholes were drilled for soil and groundwater sampling. The as-built sampling locations are shown in **Figures 2.1** - **2.2** and the summary of the SI works is presented in **Table 2.2**. Results of SI indicated that the 68 soil samples and 8 groundwater samples collected within DIH Works Site and Hung Hom Works Site were all complied with the RBRGs (industrial) levels and no remediation of soil or groundwater is required.

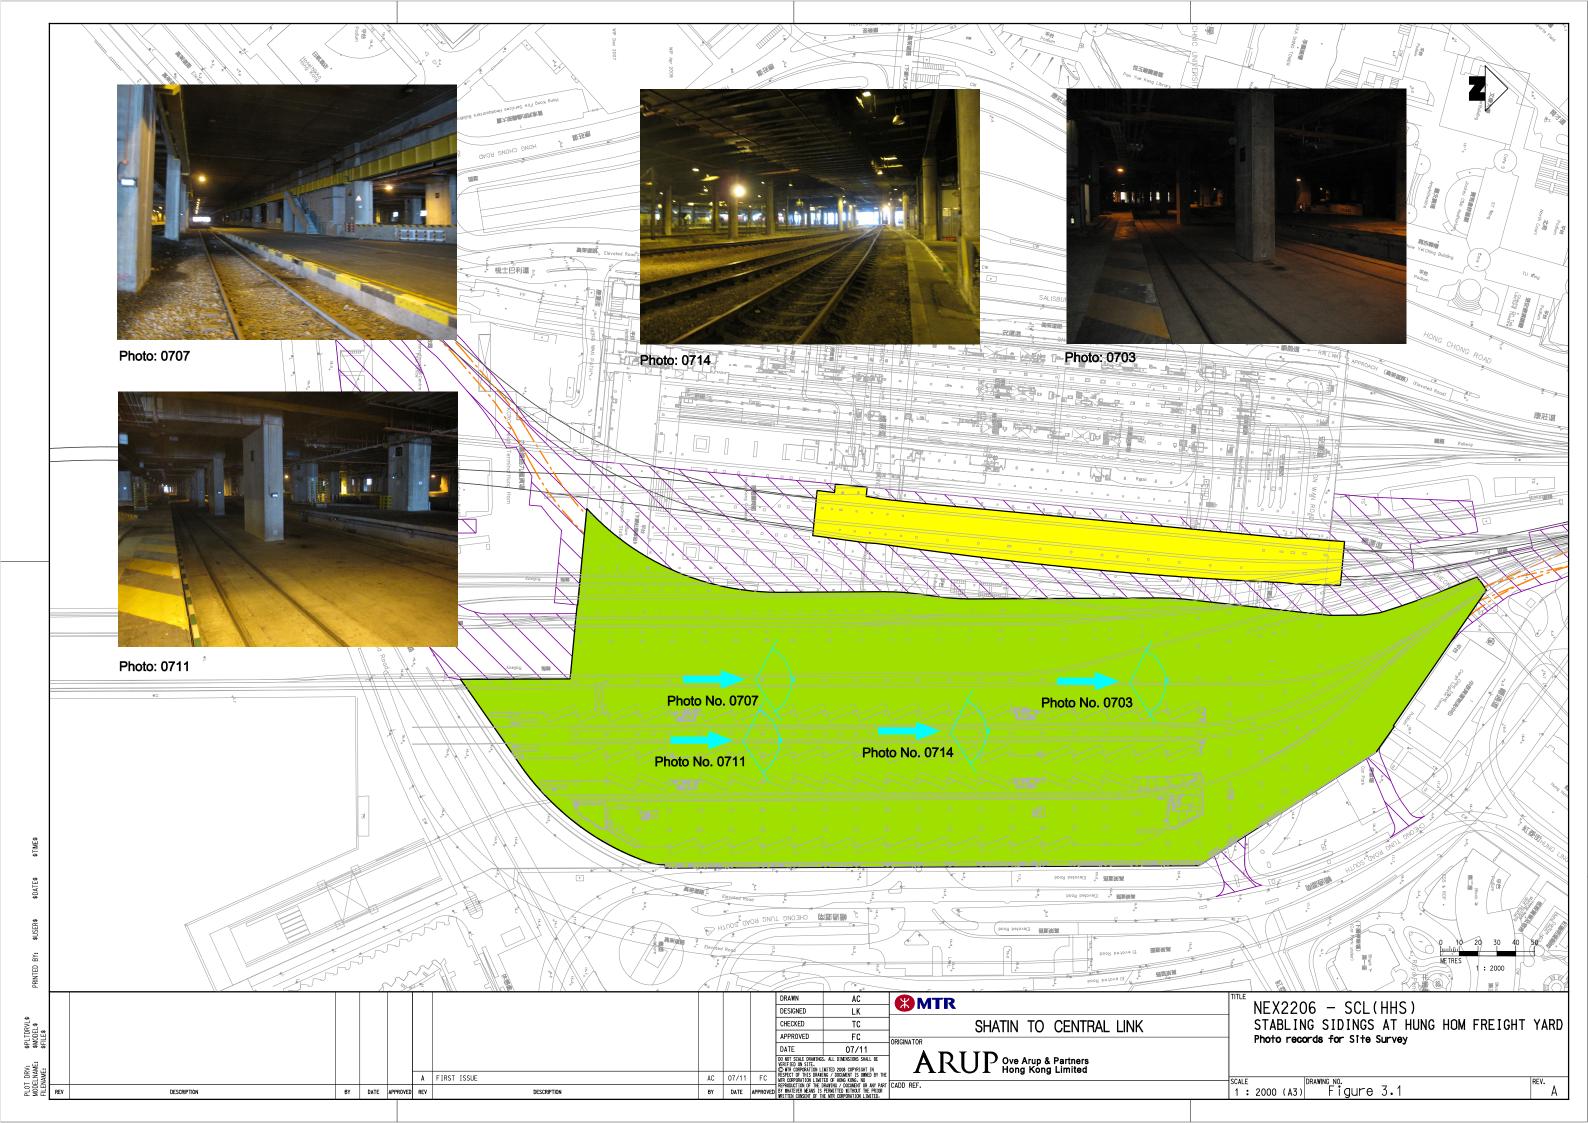
During site survey, the eastern part of the Hung Hom Works Site was identified as the track area of disused Hung Hom Freight Yard which consists of both ballast-based and concrete based tracks. **Figure 3.1** shows the photo records of this site survey. According to the site personnel, there has been no record of chemical spillage/leakage during the operation of the Hung Hom Freight Yard.

As observed, the site condition of the track area was similar to the railway tracks for goods yard (Site 2-08 of **Table 2.1** refers) assessed in the land contamination assessment of SCL (MKK-HUH). Results of site investigation under SCL (MKK-HUH) as summarized in **Table 2.2** indicated that all samples collected along the railway tracks are in compliance with the RBRG levels for industrial purpose. With similar type of land uses, adverse land contamination impact at the eastern part of the Hung Hom Works Site is therefore not expected
