**Shatin to Central Link – Cross Harbour Section**  
**(Phase I – Mong Kok East to Hung Hom) EIA Study Brief (ESB-192/2008)**  
**Contamination Assessment Plan (Version C)**

Shatin to Central Link -  
 Consultancy Agreement No. NEX/2213

**Environmental Impact Assessment  
 (EIA) of Cross Harbour Section  
 (Phase I – Mong Kok East to Hung Hom)**

**Contamination Assessment Plan**  
 Sep 2009

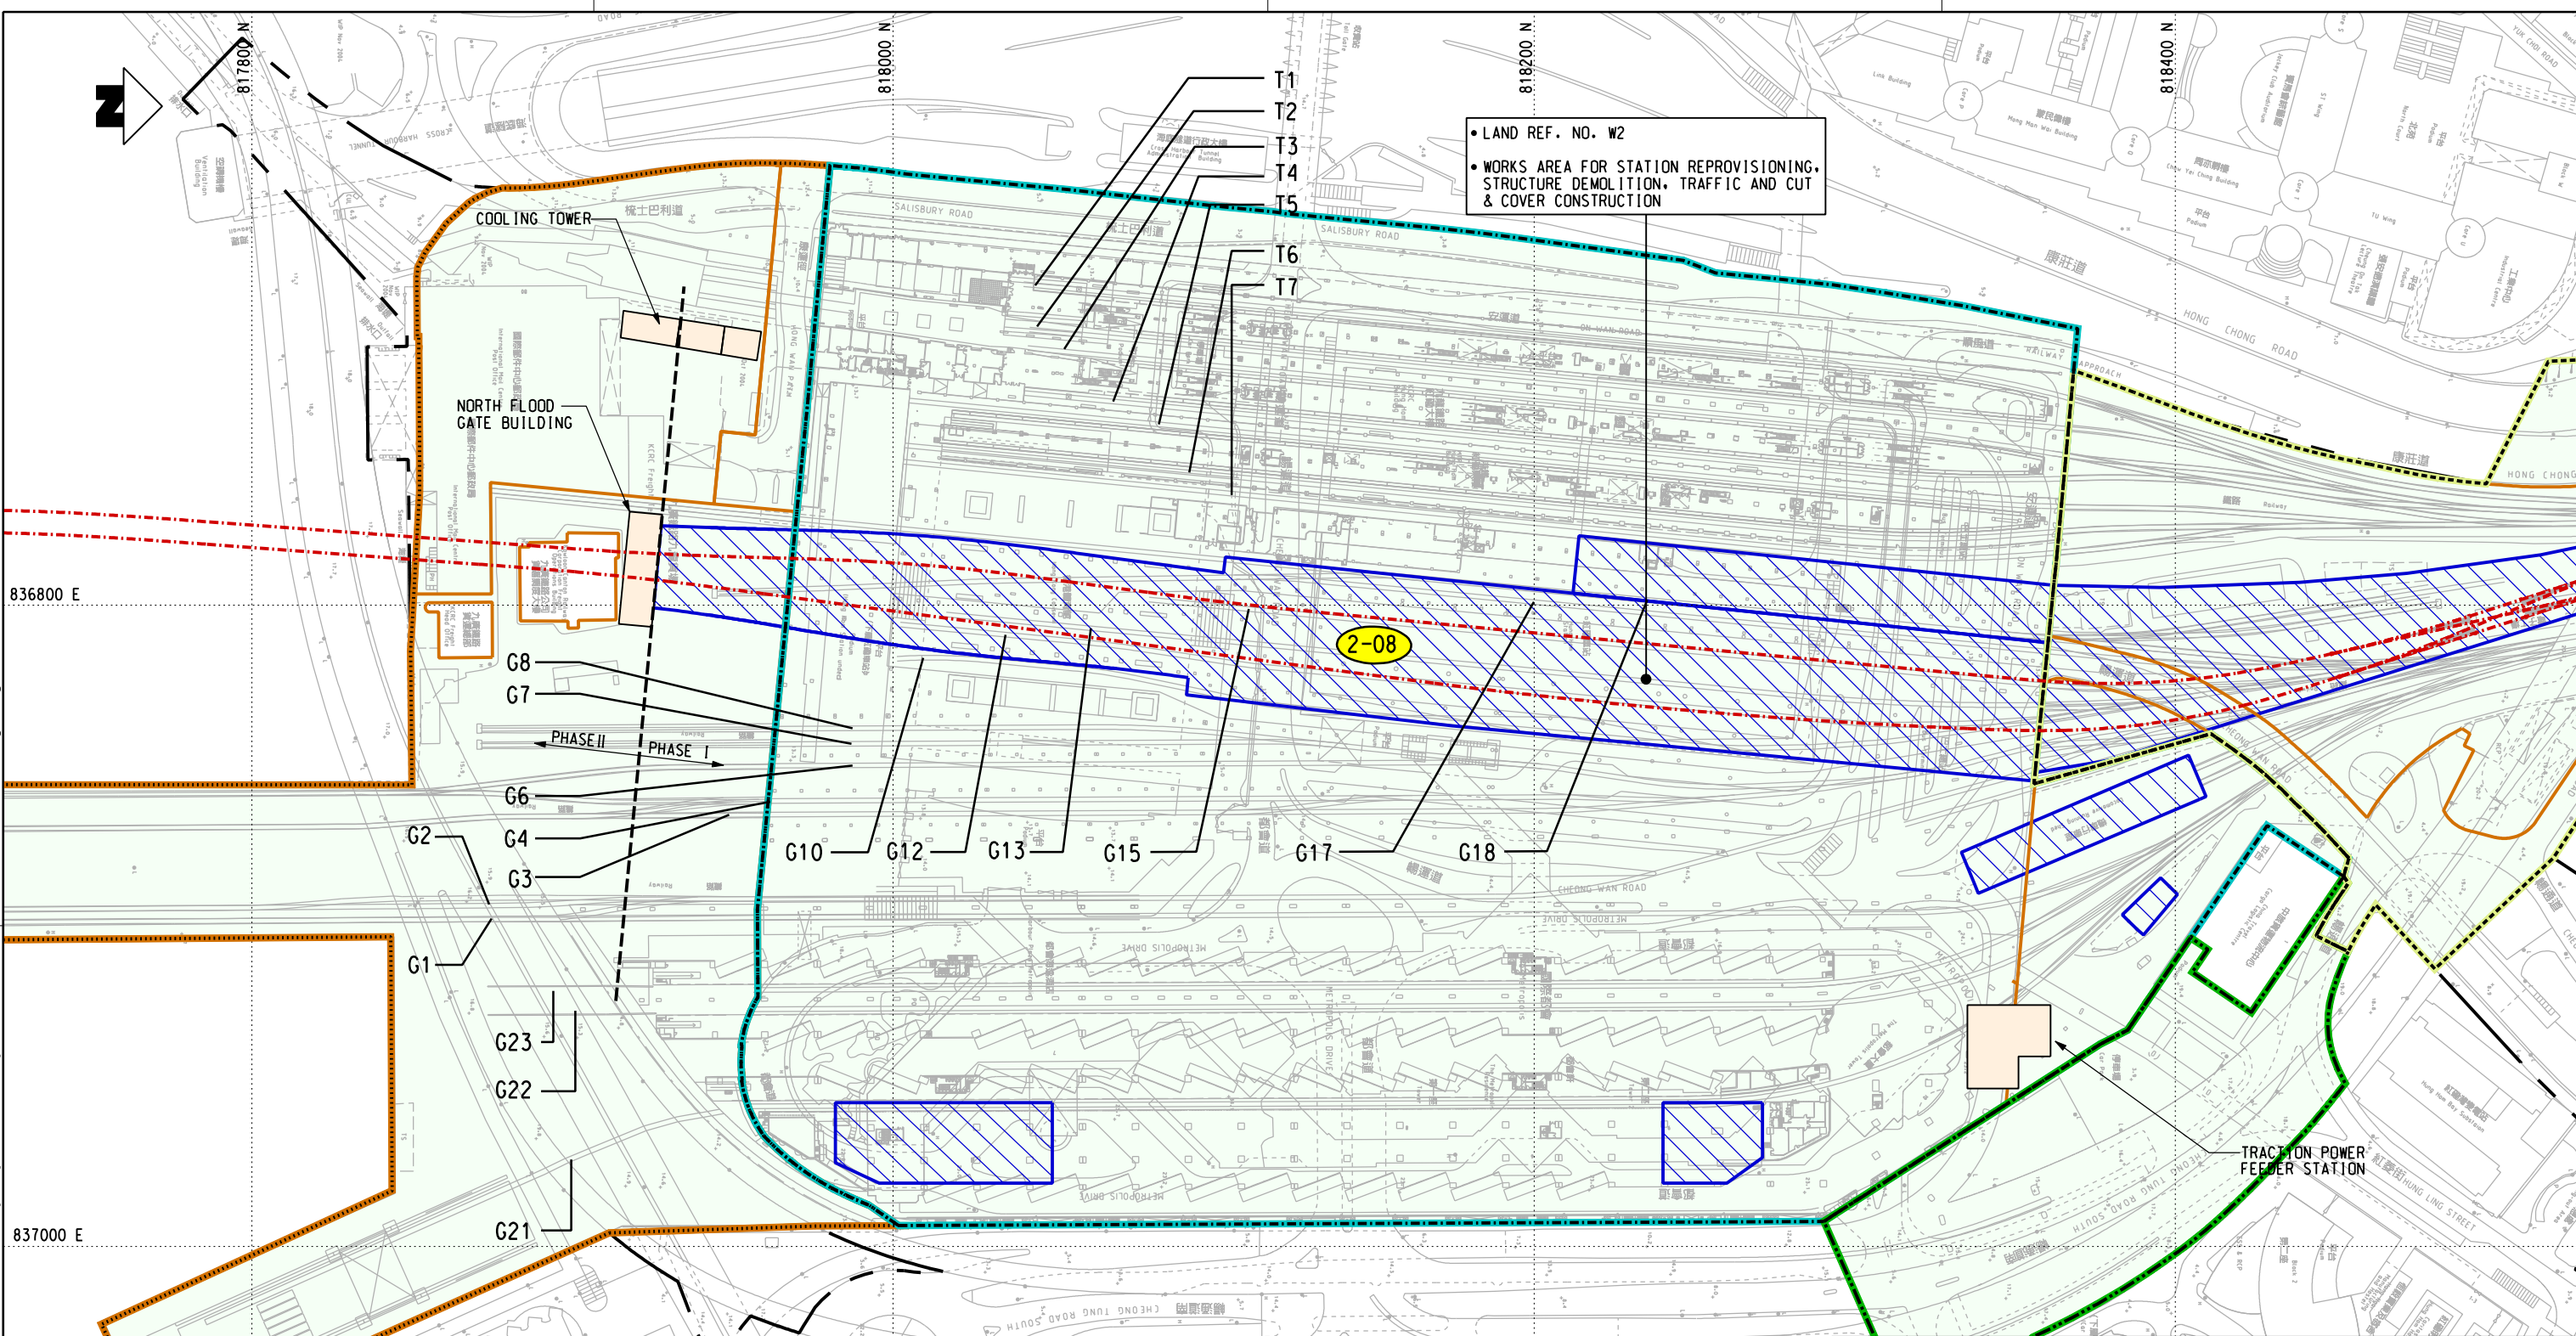
• LAND REF. NO. W2  
 • WORKS AREA FOR STATION REPROVISIONING, STRUCTURE DEMOLITION, TRAFFIC AND CUT & COVER CONSTRUCTION

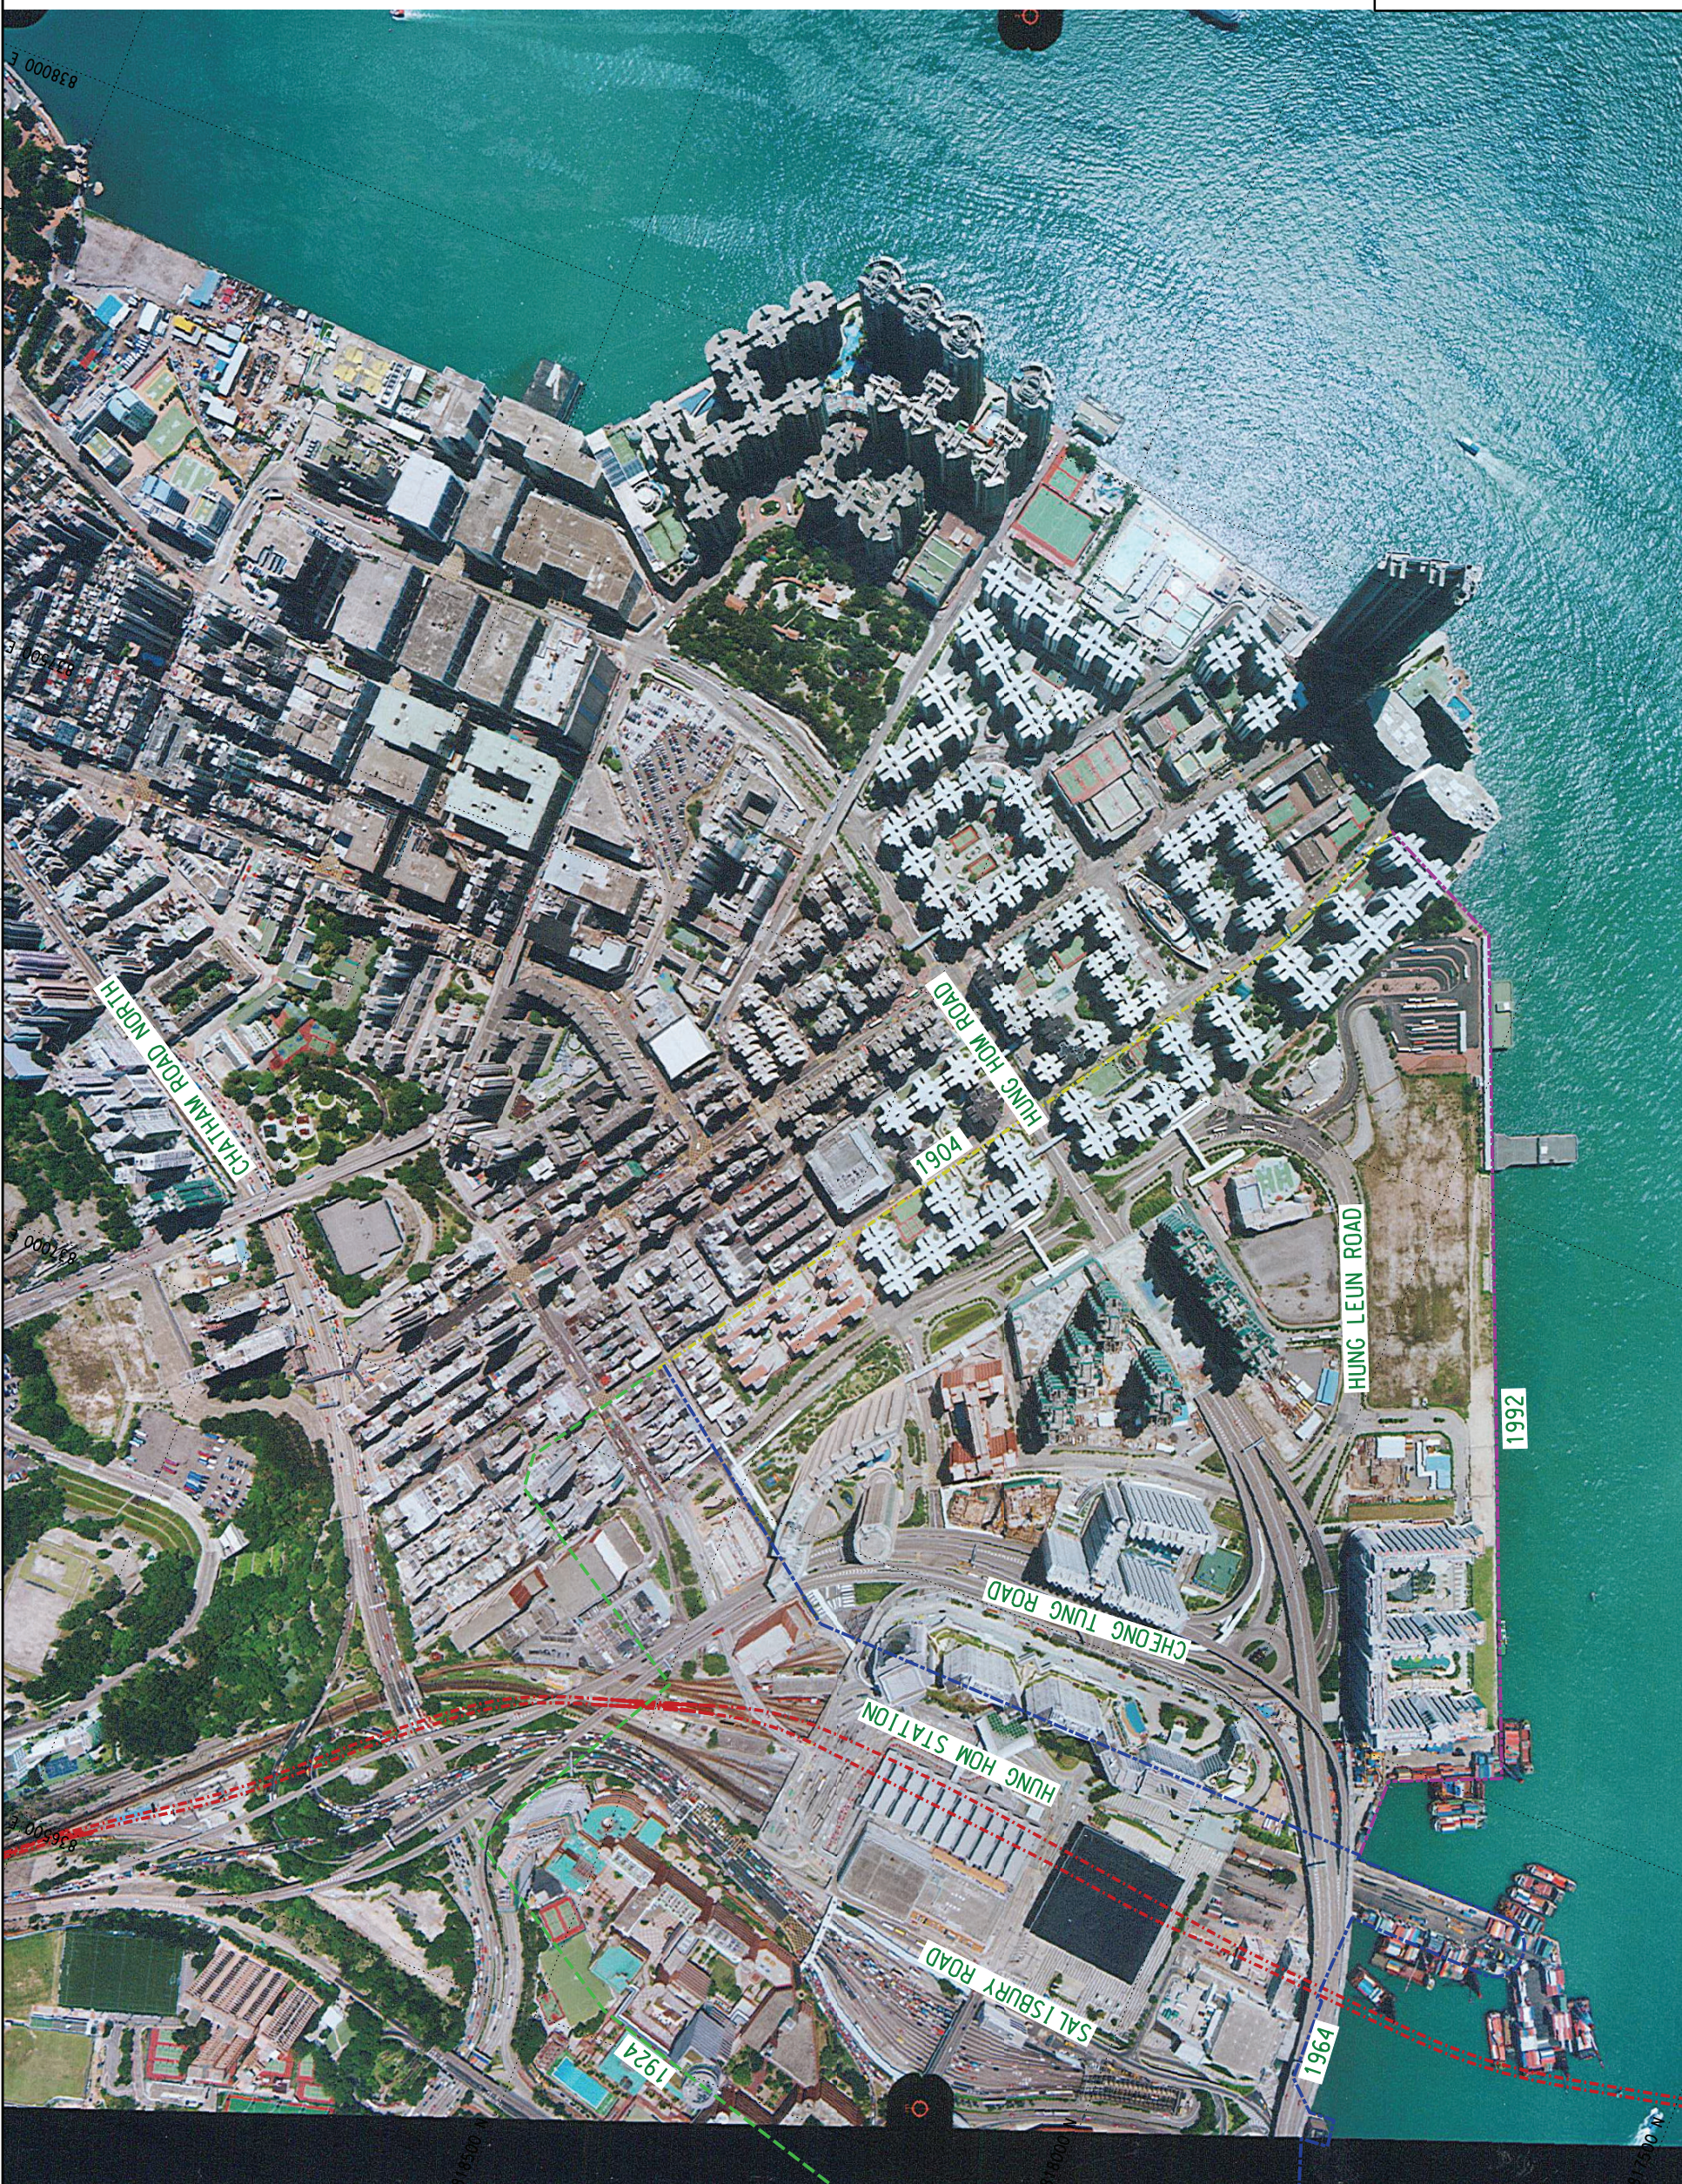
- PROPOSED SCL ALIGNMENTS
  - 1904
  - 1924
  - 1964
  - 1992
- RECLAMATION YEAR

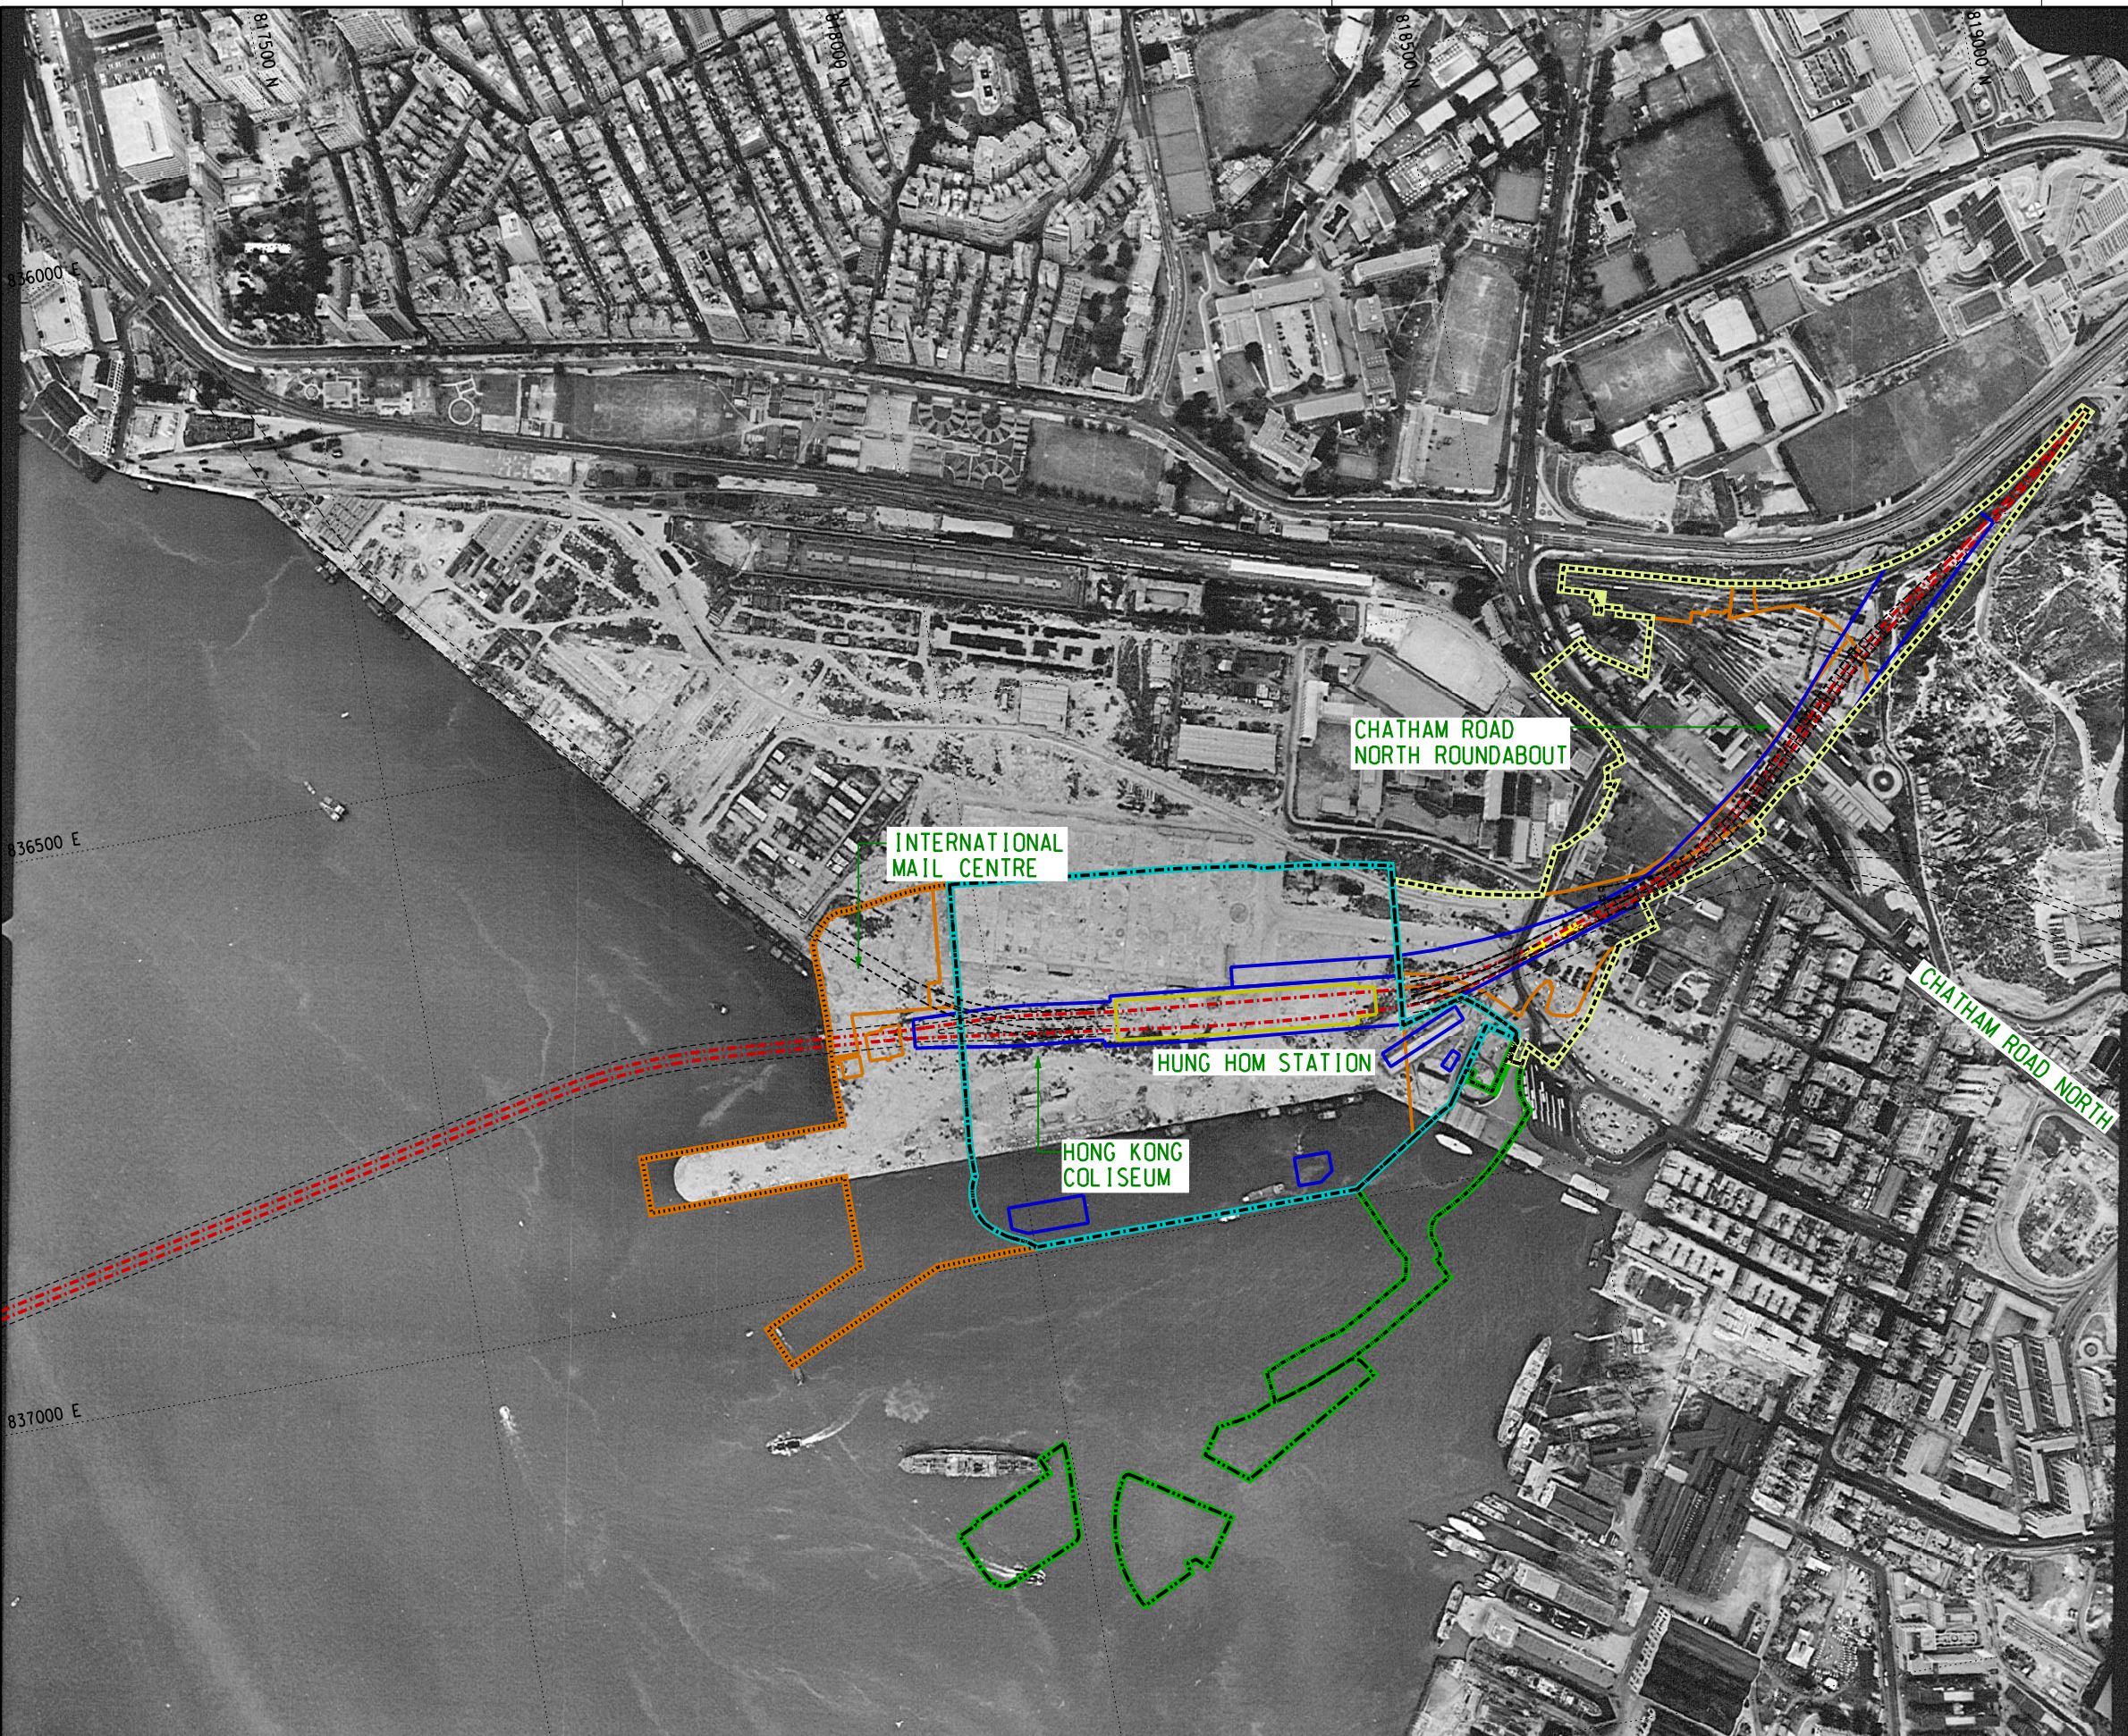
TITLE		NEX/2213 - CROSS HARBOUR SECTION EIA STUDY AERIAL PHOTOGRAPHS PHASE I - MONG KOK EAST TO HUNG HOM CONTAMINATION ASSESSMENT PLAN
SCALE	FIGURE NO.	REV.
1 : 6000 (A3)	NEX2213/C/361/ENS/M57/103	A

- NOTE:**  
 LOCATION: HUNG HOM  
 YEAR: 1967  
 PHOTO NO: 5415  
 DRAWING IS INDICATIVE ONLY.  
 THE LAYOUT MAY NOT BE TO SCALE
- LEGEND:**
- - - PROPOSED SCL ALIGNMENTS
  - TENTATIVE WORKS AREA UNDER NSL
  - TENTATIVE WORKS AREA UNDER NSL WITH MAJOR EXCAVATION / DISTURBANCE OF SOIL
  - AREA 1
  - AREA 2
  - AREA 3
  - AREA 4

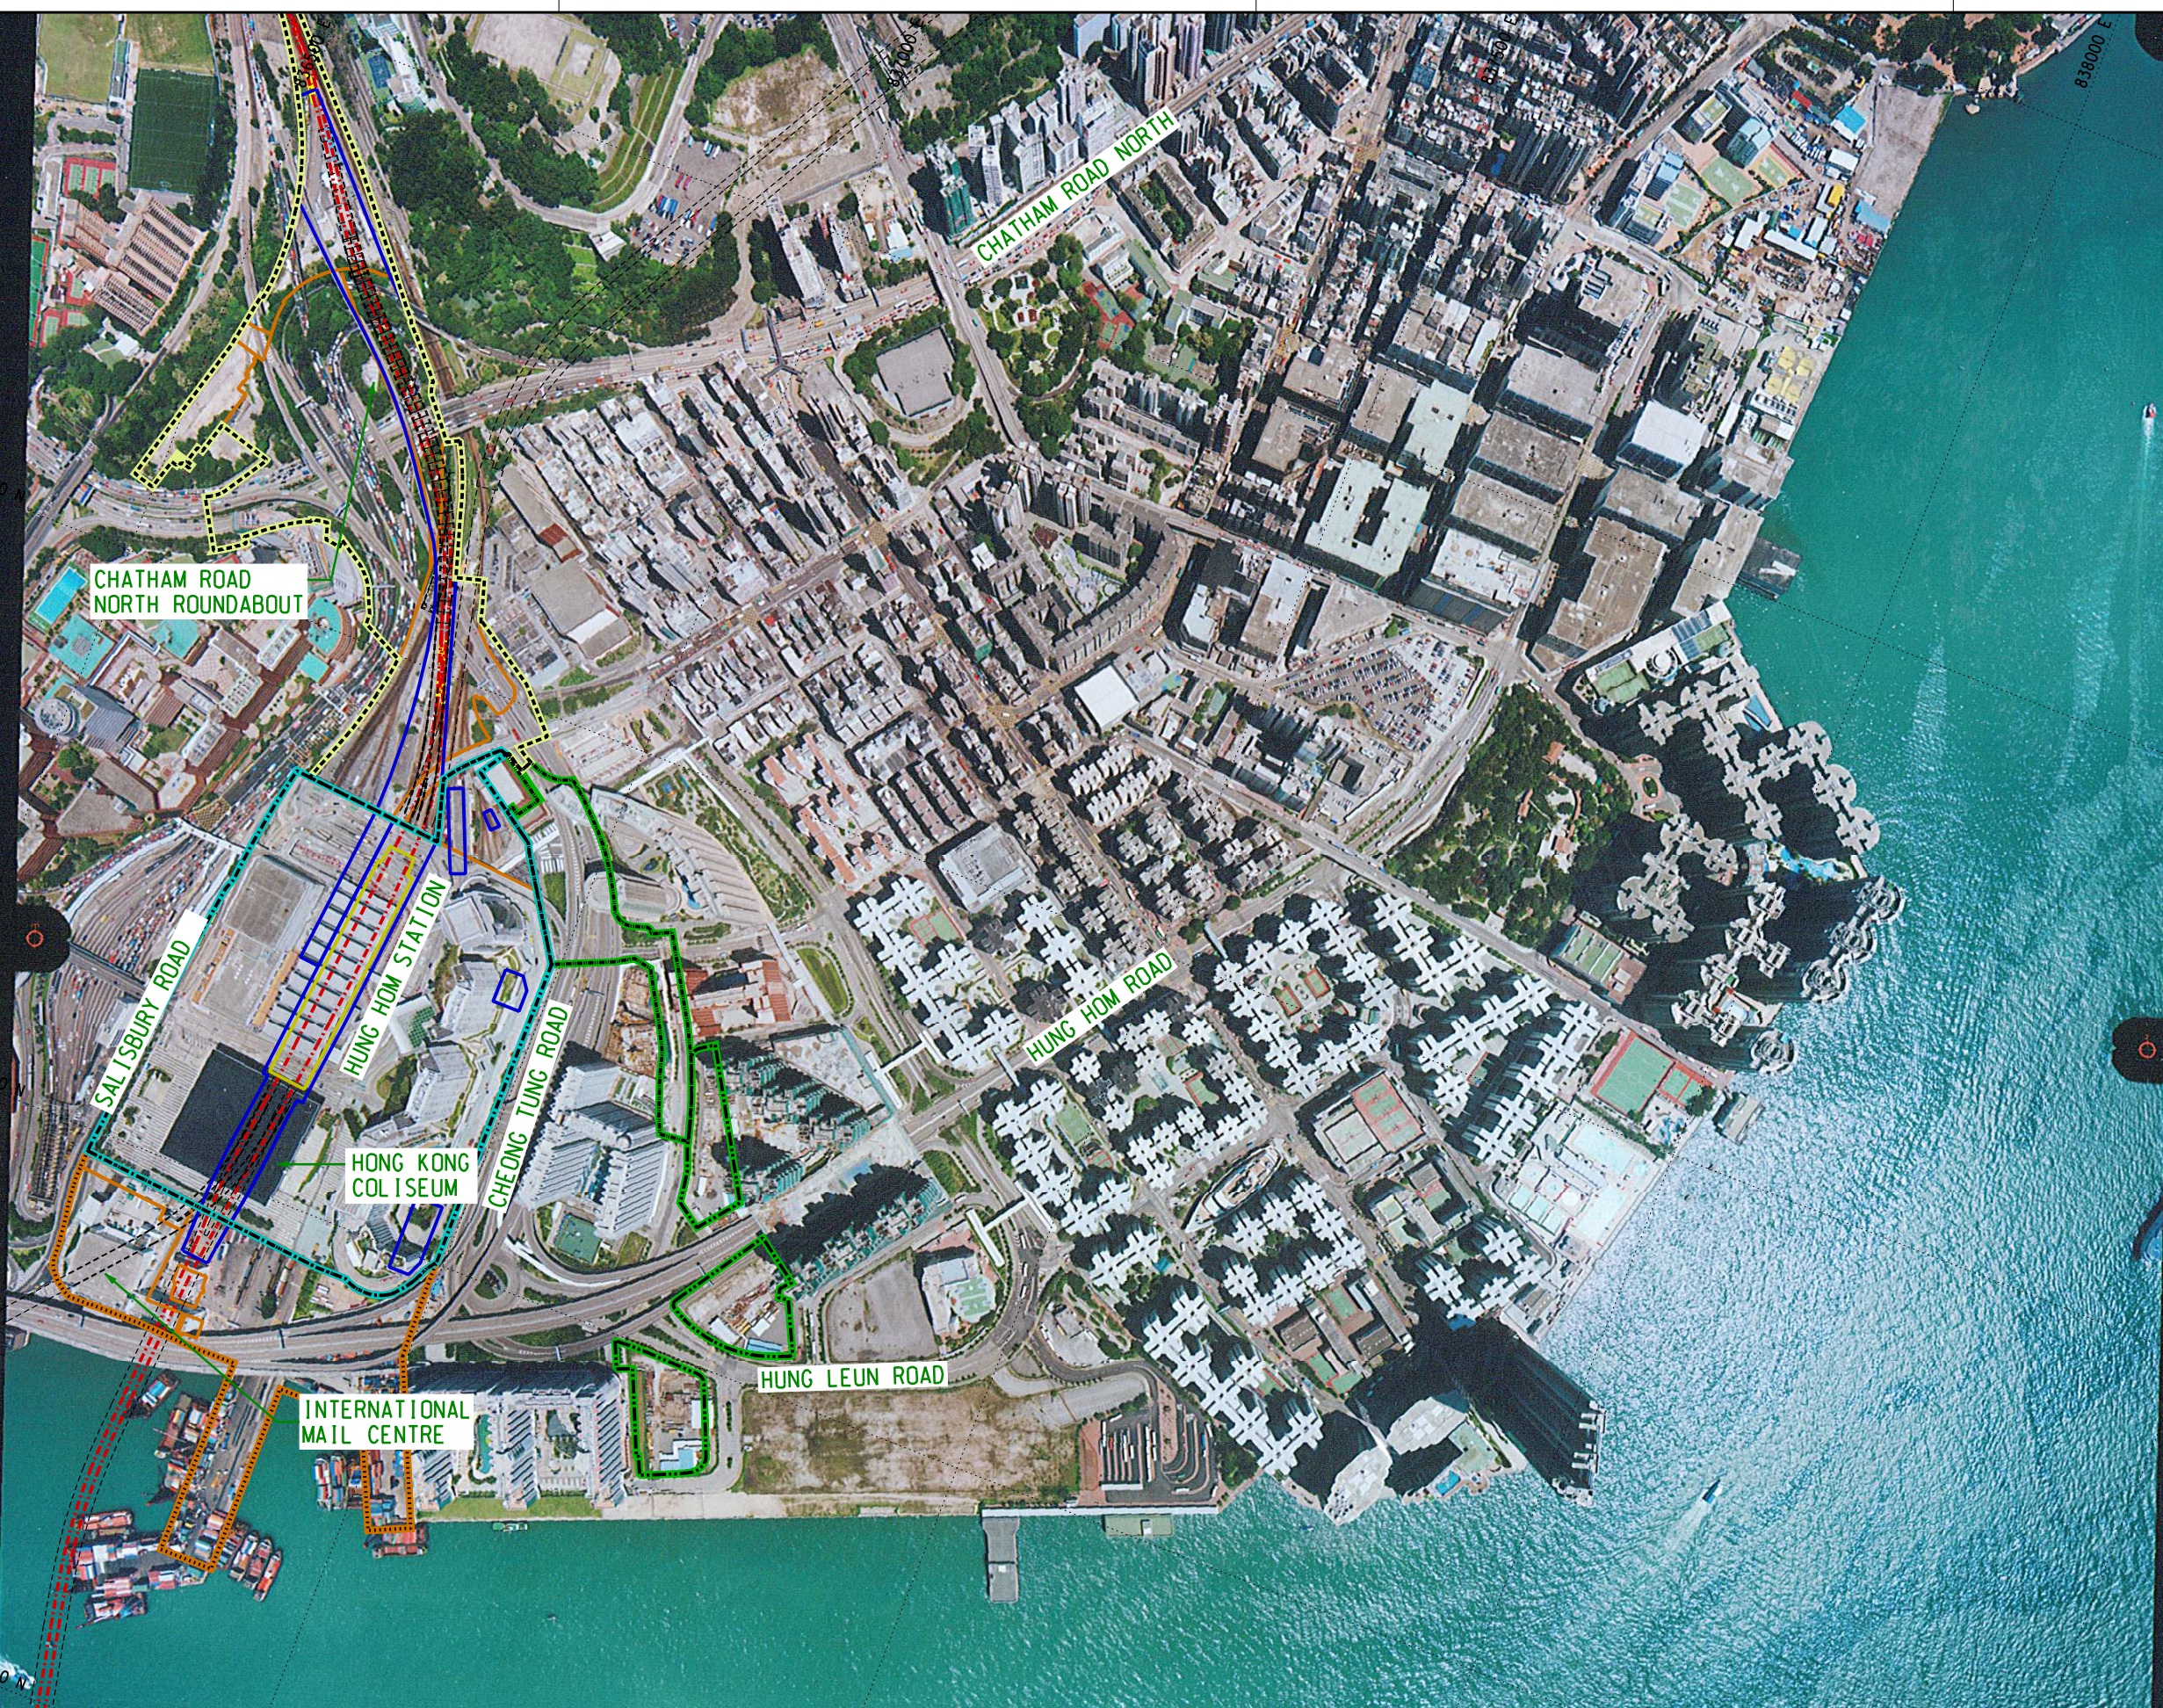
**NOTE:**  
 LOCATION: HUNG HOM  
 YEAR: 2006  
 PHOTO NO: CW71959  
 DRAWING IS INDICATIVE ONLY.  
 THE LAYOUT MAY NOT BE TO SCALE
