Consultancy Agreement No. NEX/2213

**Environmental Impact Assessment
(EIA) Study for Shatin to Central Link -
Mong Kok East to Hung Hom Section****Contamination Assessment Report**

August 2011

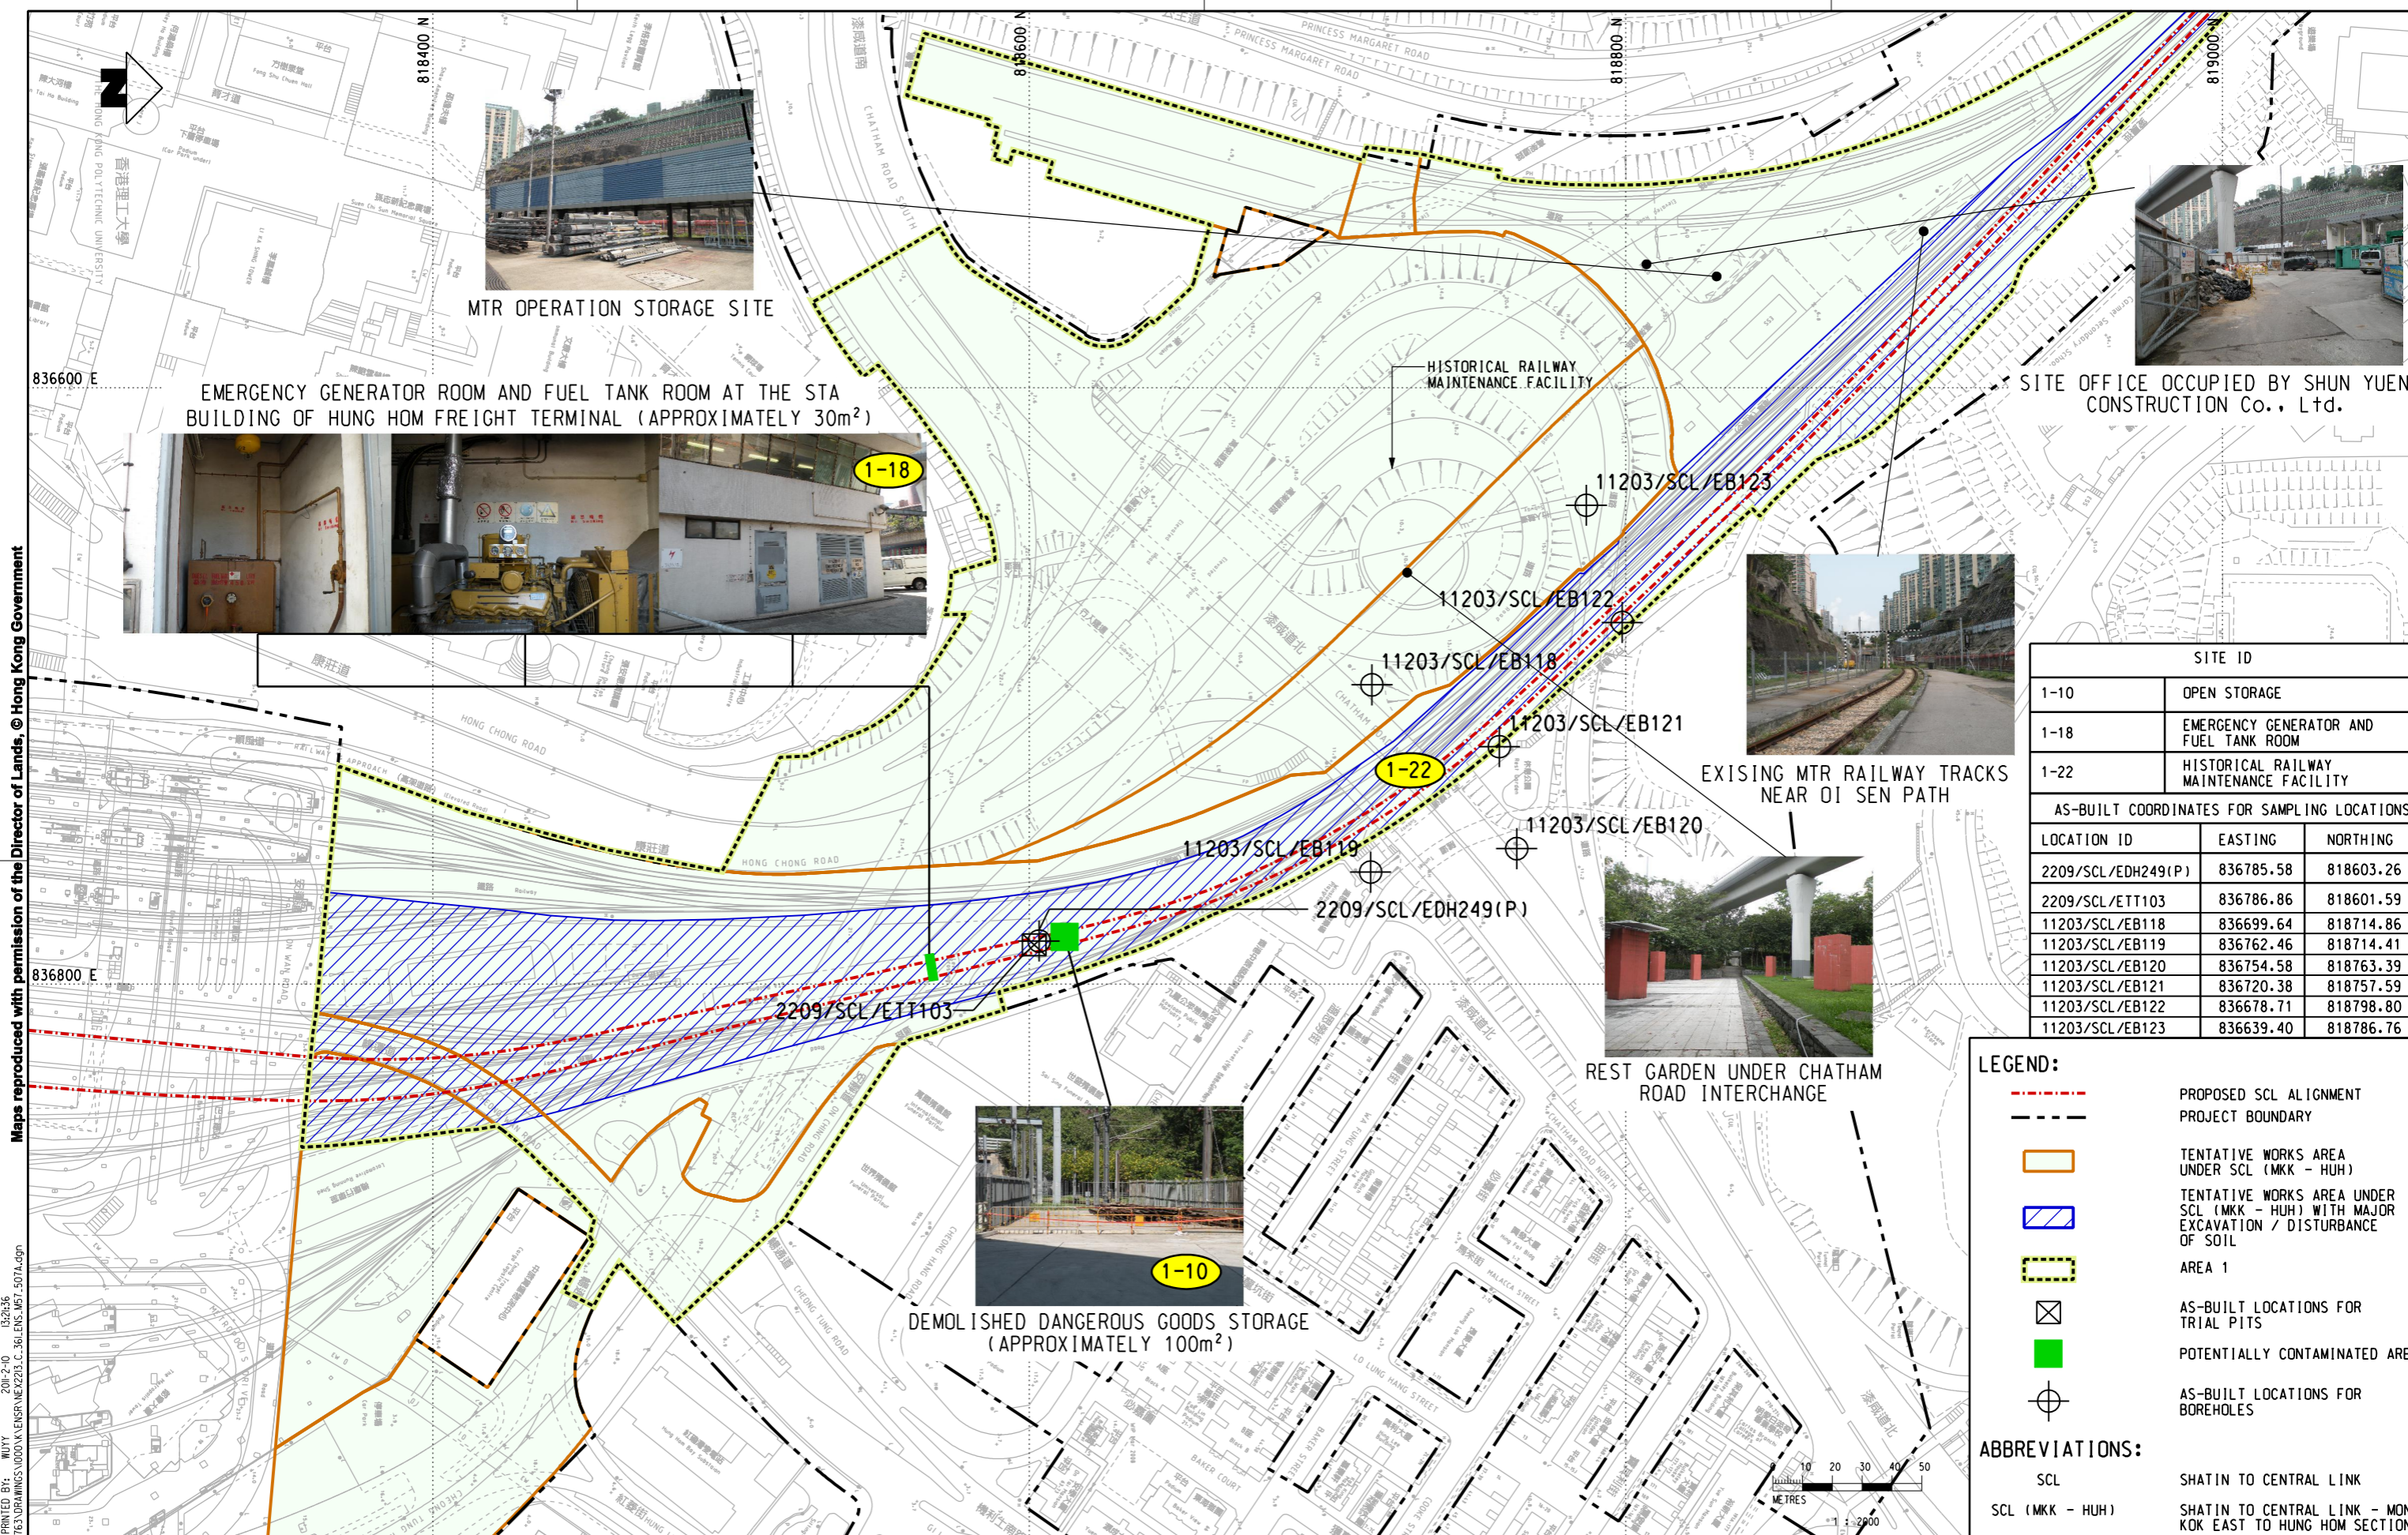
SITE ID	
1-10	OPEN STORAGE
1-18	EMERGENCY GENERATOR AND FUEL TANK ROOM
1-22	HISTORICAL RAILWAY MAINTENANCE FACILITY

AS-BUILT COORDINATES FOR SAMPLING LOCATIONS		
LOCATION ID	EASTING	NORTHING
2209/SCL/EDH249(P)	836785.58	818603.26
2209/SCL/ETT103	836786.86	818601.59
11203/SCL/EB118	836699.64	818714.86
11203/SCL/EB119	836762.46	818714.41
11203/SCL/EB120	836754.58	818763.39
11203/SCL/EB121	836720.38	818757.59
11203/SCL/EB122	836678.71	818798.80
11203/SCL/EB123	836639.40	818786.76
