## **Appendix 11.3**

### **Seabed Features Chart**

**WORKS ORDER NO. GE/2010/02.50**  
**AGREEMENT NO. CE/43/2010(HY)**  
**CENTRAL KOWLOON ROUTE - DESIGN AND CONSTRUCTION**  
**MARINE GROUND INVESTIGATION AND GEOPHYSICAL SURVEYS**

**SEA BED FEATURES**

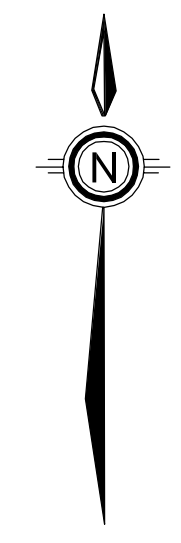
FIGURE NUMBER : 3

- Survey boundary
- Extend coverage
- Disturbed seabed
- Disused fuel dolphin
- Possible dumped materials
- Seafloor with numerous debris
- ▲ SC001 1.5x1.5x2 Debris  
Sonar contact (length x width x height in metres)
- ▲ MC001 11x4.5x1 Ferry vessel  
Magnetic contact
- ▲ SD001 Possible dumped pipe  
Seismic contact
- Anchor scar
- As found pipeline
- Depression
