# Agreement No. CE 42/2008 (CE) Tseung Kwan O – Lam Tin Tunnel and Associated Works – Investigation

# Working Paper on Terrestrial Archaeological Review and Marine Archaeological Investigation (Final)

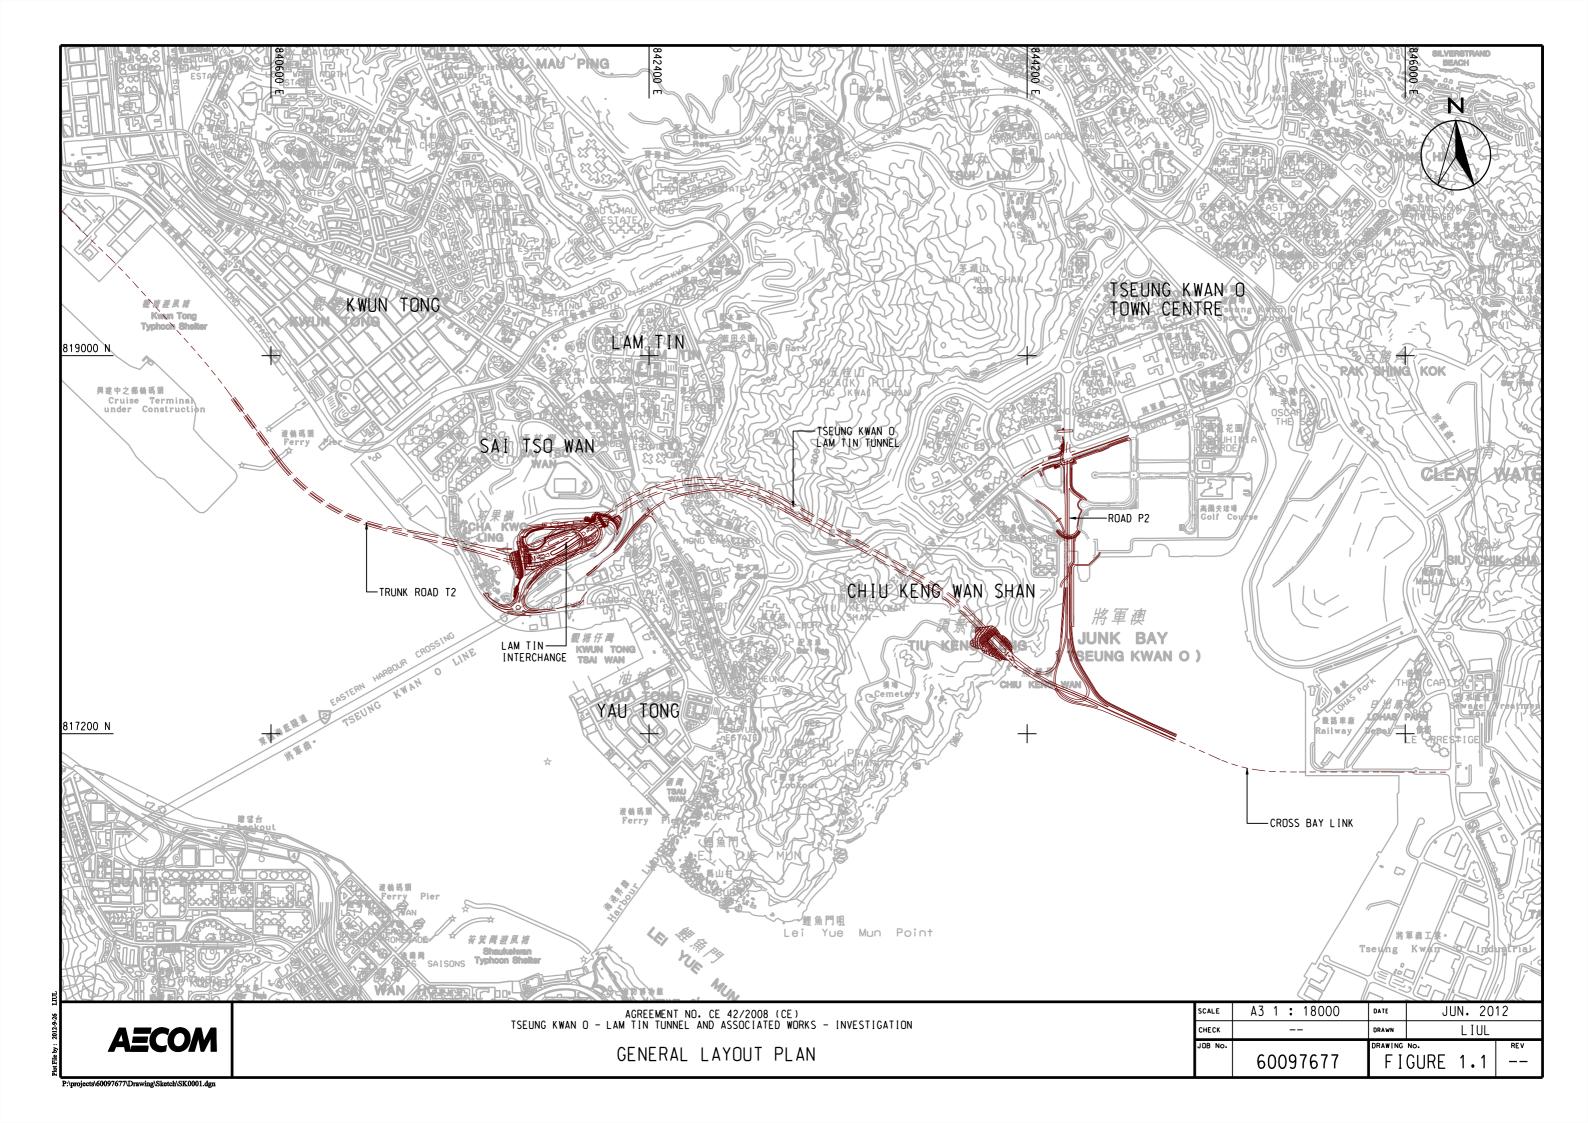
- 1.1.3 AECOM Asia Co. Ltd. was appointed by CEDD to carry out the Assignment on Tseung Kwan O – Lam Tin Tunnel and Association Works – Investigation (hereafter referred to as "the Project"). The Assignment commenced on 16 March 2009 and shall be completed within 30 months, i.e. by mid-September 2011. Figure 1.1 shows the general layout plan of the Project.

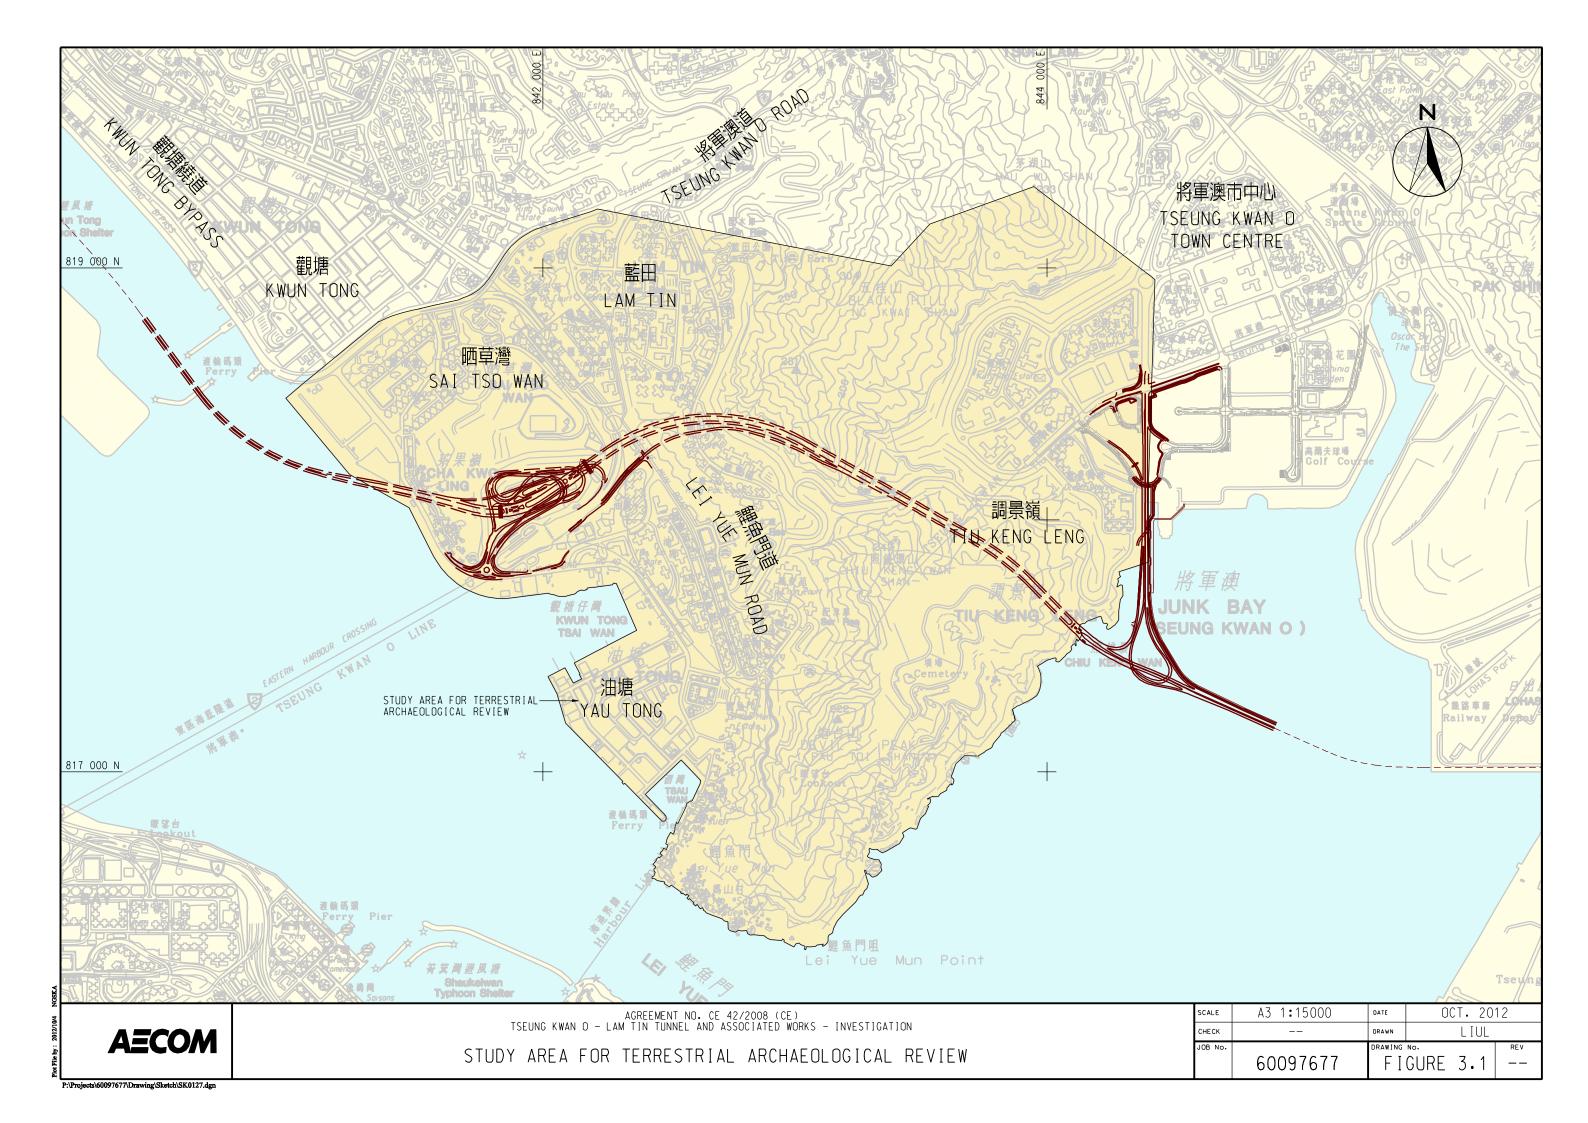
- 3.2.1 The Study Area of the terrestrial archaeological review is shown in **Figure 3.1**.
- 3.2.2 Based on the current scope of the Project, areas of concern would be the aboveground works areas at Cha Kwo Ling Village (CKLV) in Lam Tin area and the western shoreline of Junk Bay in TKO. No archaeological potential is anticipated within deep underground tunnel alignment, neither as in the heavily urbanized Lam Tin area.

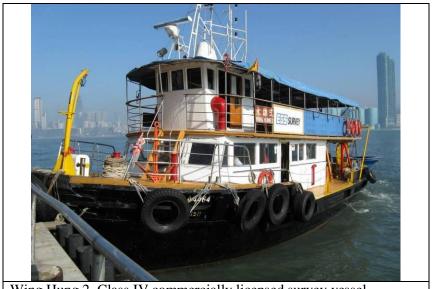
Wing Hung 2, Class IV commercially licensed survey vessel

The single and multi beam echo sounding, seismic reflection survey and side scan sonar survey were carried out from a Class IV survey vessel, MV Wing Hung 2.

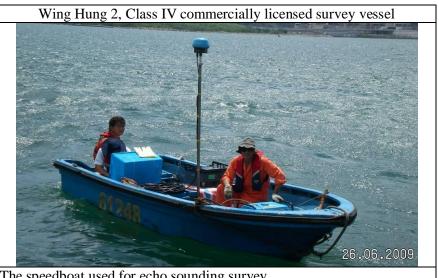
The speedboat used for echo sounding survey

Echo sounding survey was carried out using the small speedboat as shown in the picture below.

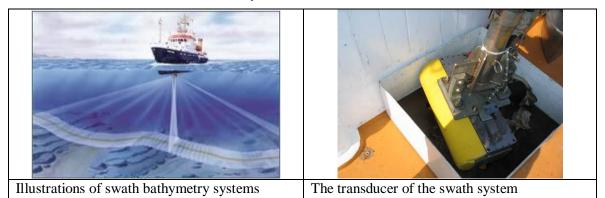
Seabed level observations were made with a multi beam echo sounder system with the transducers mounted over the starboard side of the survey vessel. The GcGPS antenna was mounted directly above the transducers and as such the swath transducer acted as the datum for the survey vessel.

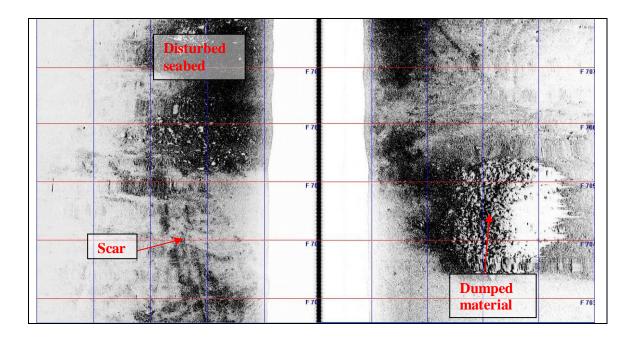
Examples of side scan images are shown below for reference.

Eights sonar contacts, WH2-SC001 to WH2-SC008 were found from the survey. Copies of the data showing each contact are presented in Appendix B.1

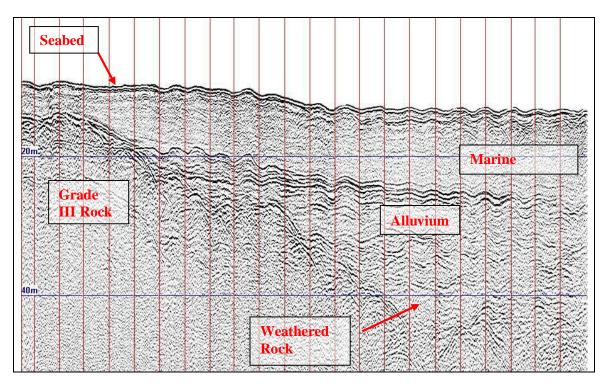
Here is an example of the seismic data from the survey.

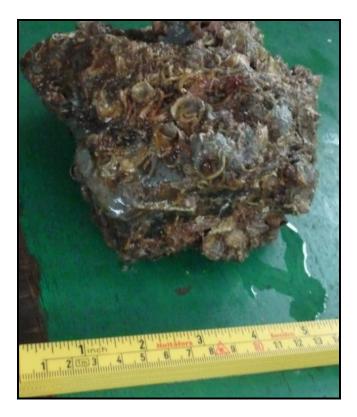
Figure 10: Modern building rubble retrieved at the location of SC003 and brought to the surface for validation.

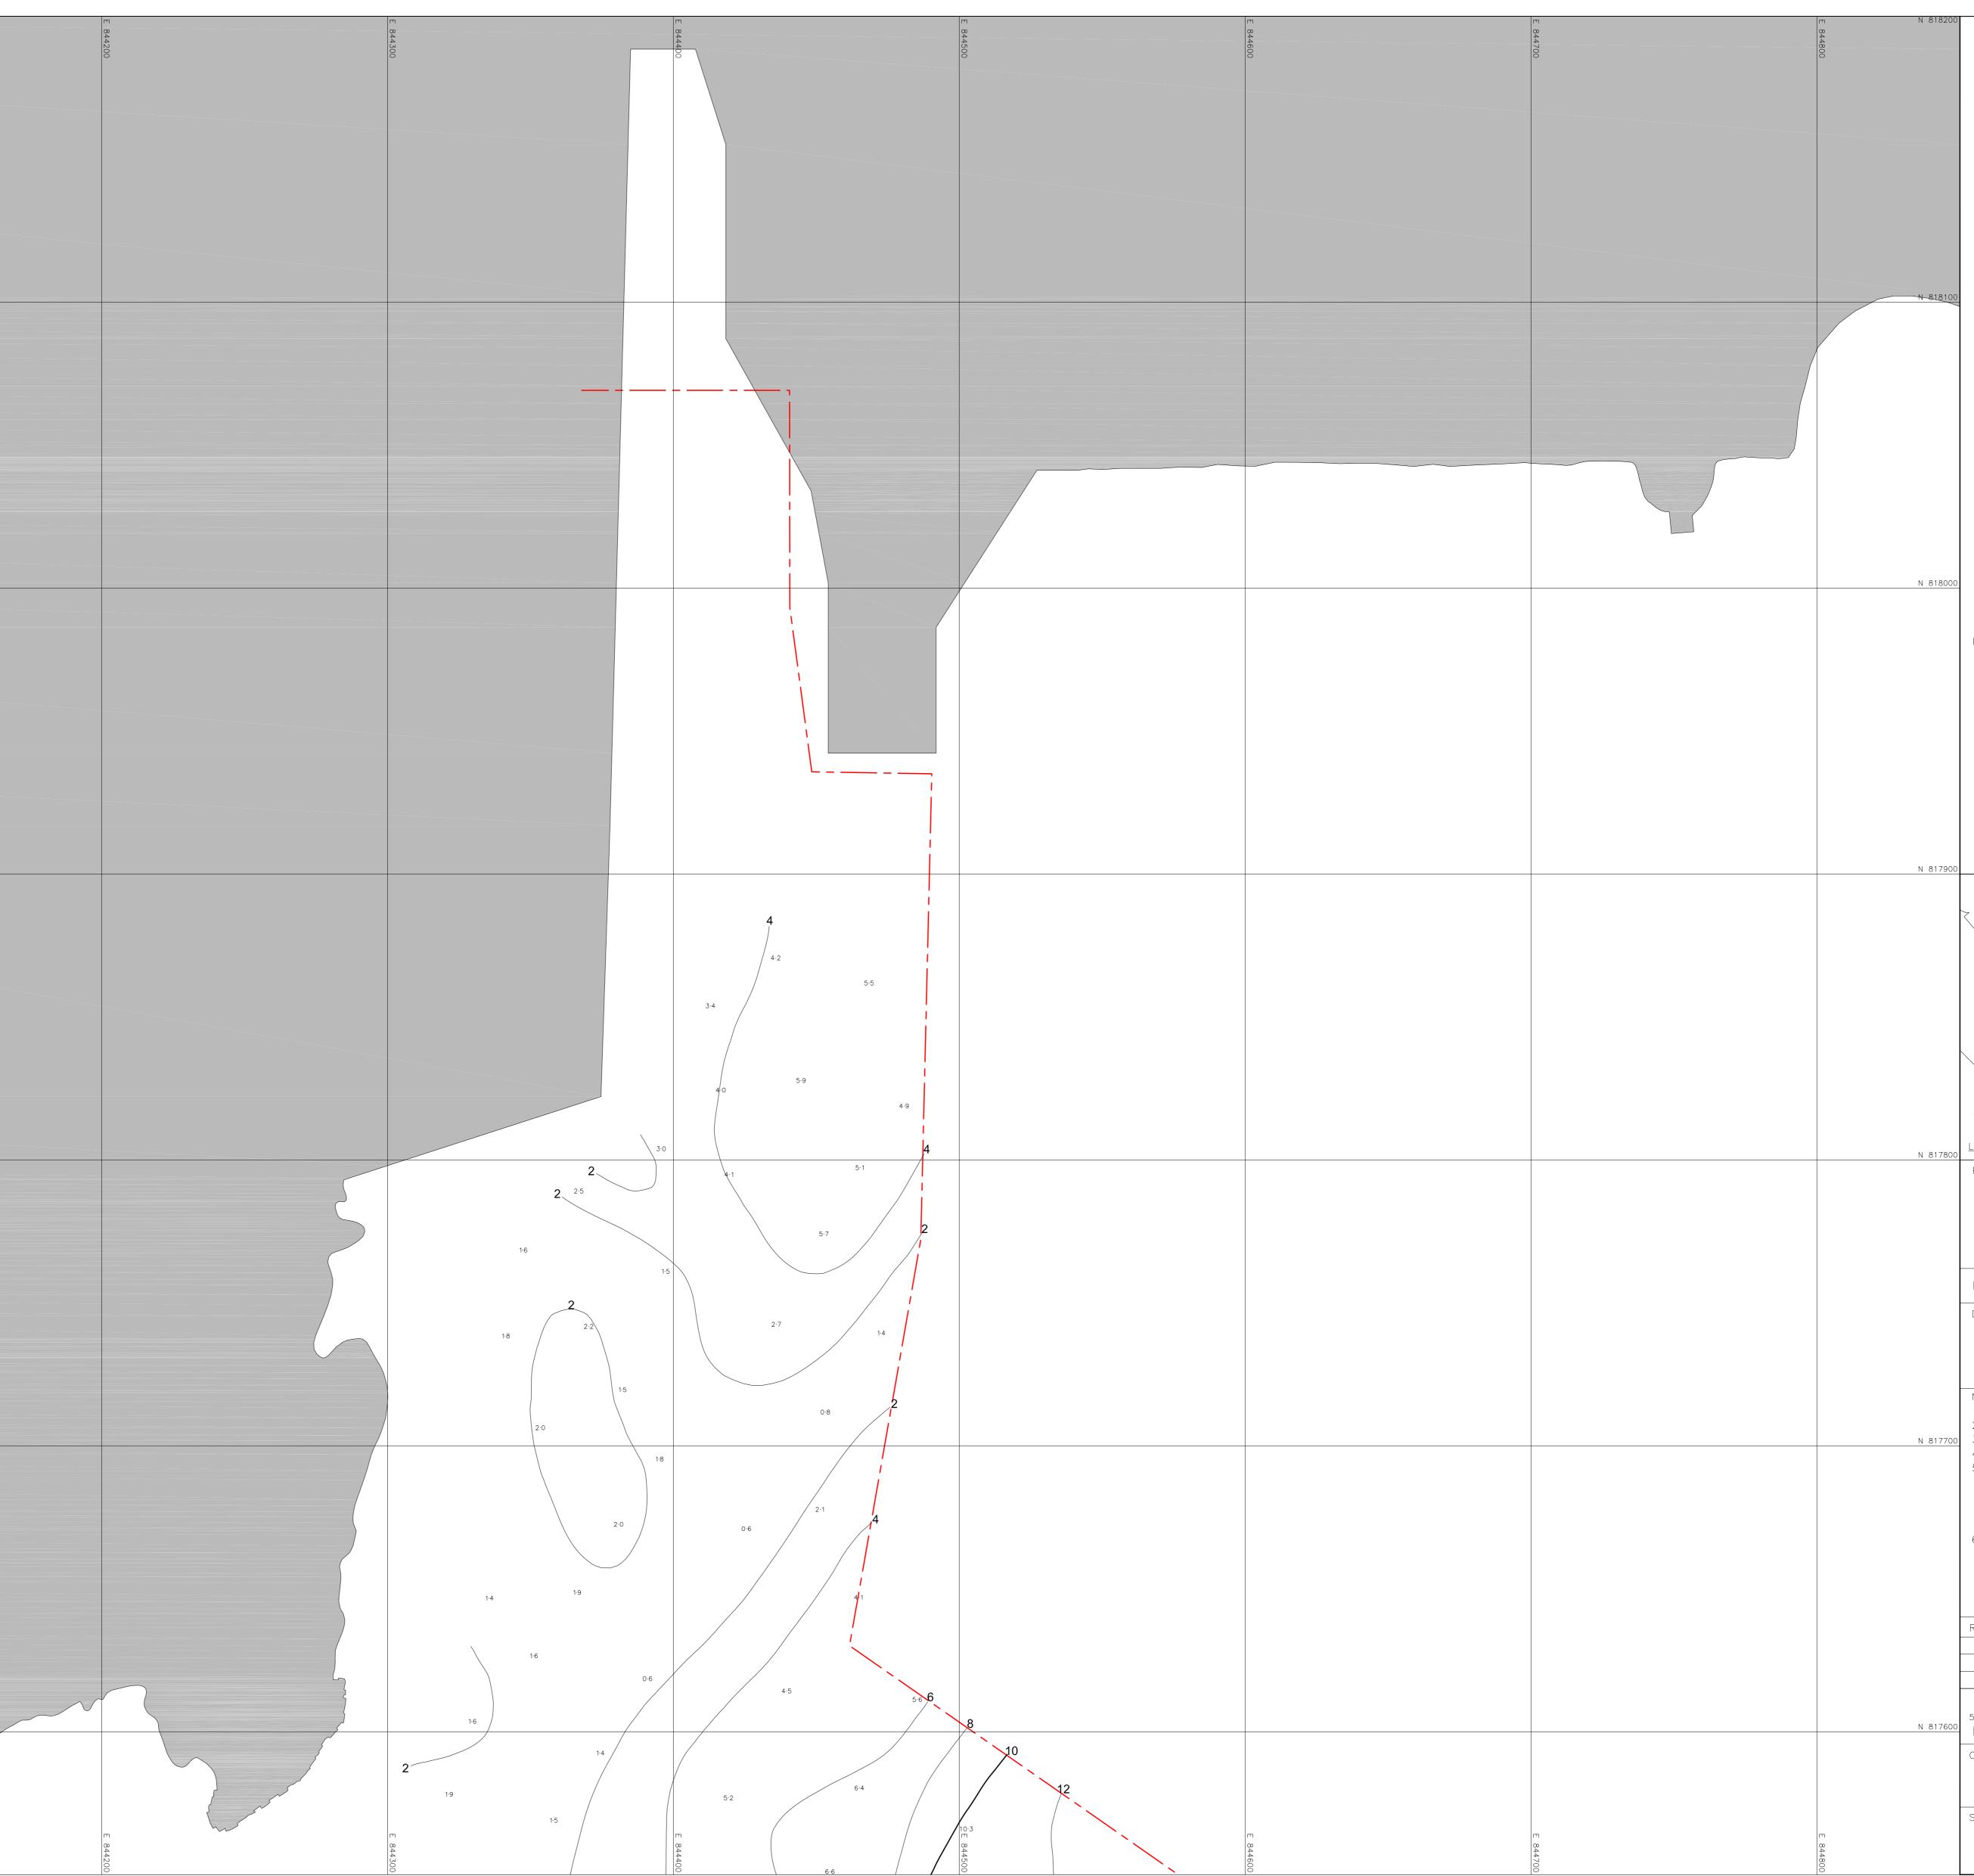
_	N 010000	
	m N 818200 0 44 8 00 0	
	8 00 0	
		V
_	N 818100	
/		
<b>'</b>		
	N 818000	
ļ		
		Legend :
		9-5 Isopachs value in metres
		Contour at 2 metre interval
		——————————————————————————————————————
_	N 817900	
		Tseung Kwan O
		Junk Bay
		the second secon
		Shau Kei Wan
		e contraction of the second
	N 817800	Location Plan
		Project : WORKS ORDER NUMBER GE/2007/04.27
		AGREEMENT NO. CE 42/2008 (CE)
		TSEUNG KWAN O - LAM TIN TUNNEL AND ASSOCIATED WORKS - FIRST STAGE G.I. REQUEST FOR GEOPHYSICAL SURVEY
		AT WEST COAST OF TSUENG KWAN O
		FIGURE NUMBER : 9.1

Drawing Title :
		CONTOURED ISOPACHS OF ALLUVIUM
		Notes
		Notes : 1. Survey Date : 25—26th June, 2009
	N 817700	2. Survey Grid : Hong Kong Metric Grid
	IN 017700	4. Positioning : C-Nav GcGPS (Globally corrected GPS)

Isopachs of Alluvium are presented on Figures 9.1 and 9.2. The survey results show that alluvium is missing near the rock outcrop areas. It gets thicker away from the shore with the maximum thickness of 14m.
