PLANNING AND ENGINEERING
STUDY ON DEVELOPMENT OF
LOK MA CHAU LOOP
- INVESTIGATION

**Contamination Assessment Plan
for Associated Infrastructure
outside Lok Ma Chau Loop
April 2013**

REP/CAP_Associated Infrastructure/04

Draft 5 | April 2013

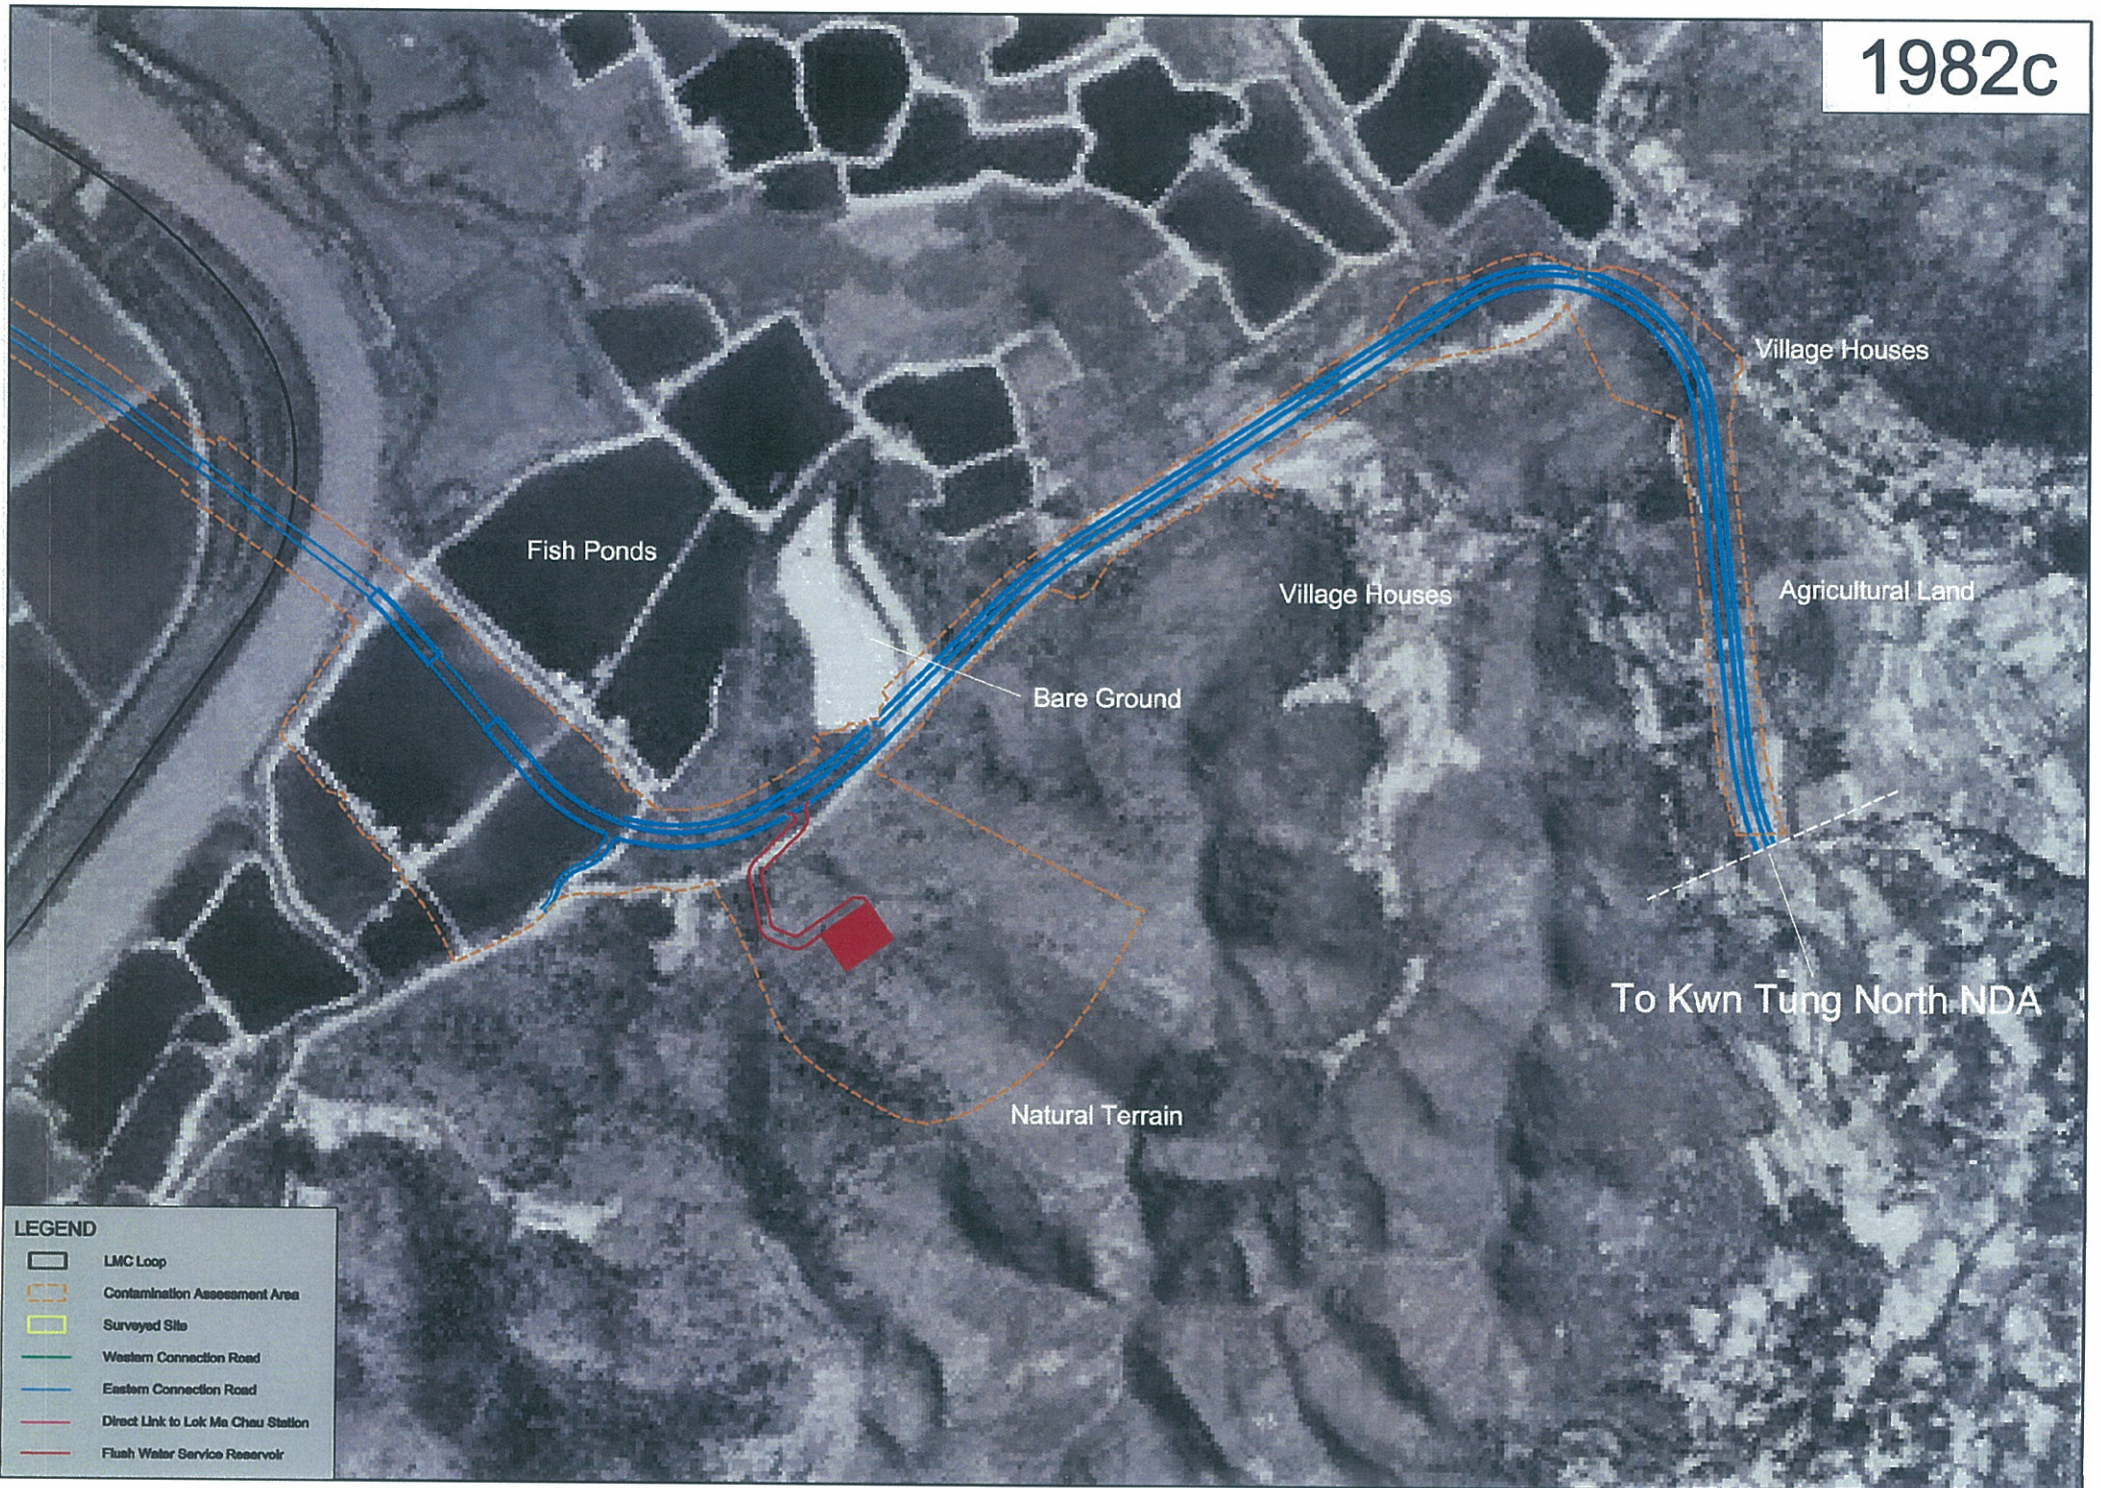
1982c

No significant change in land use was observed as compared with Year 1973 except that there was an increase in the number of fish ponds in the surrounding area. An open bare ground was observed next to the fish ponds (1982c of **Appendix A**).

No significant change in land use was observed as compared with Year 1973 (1982c of **Appendix A**).

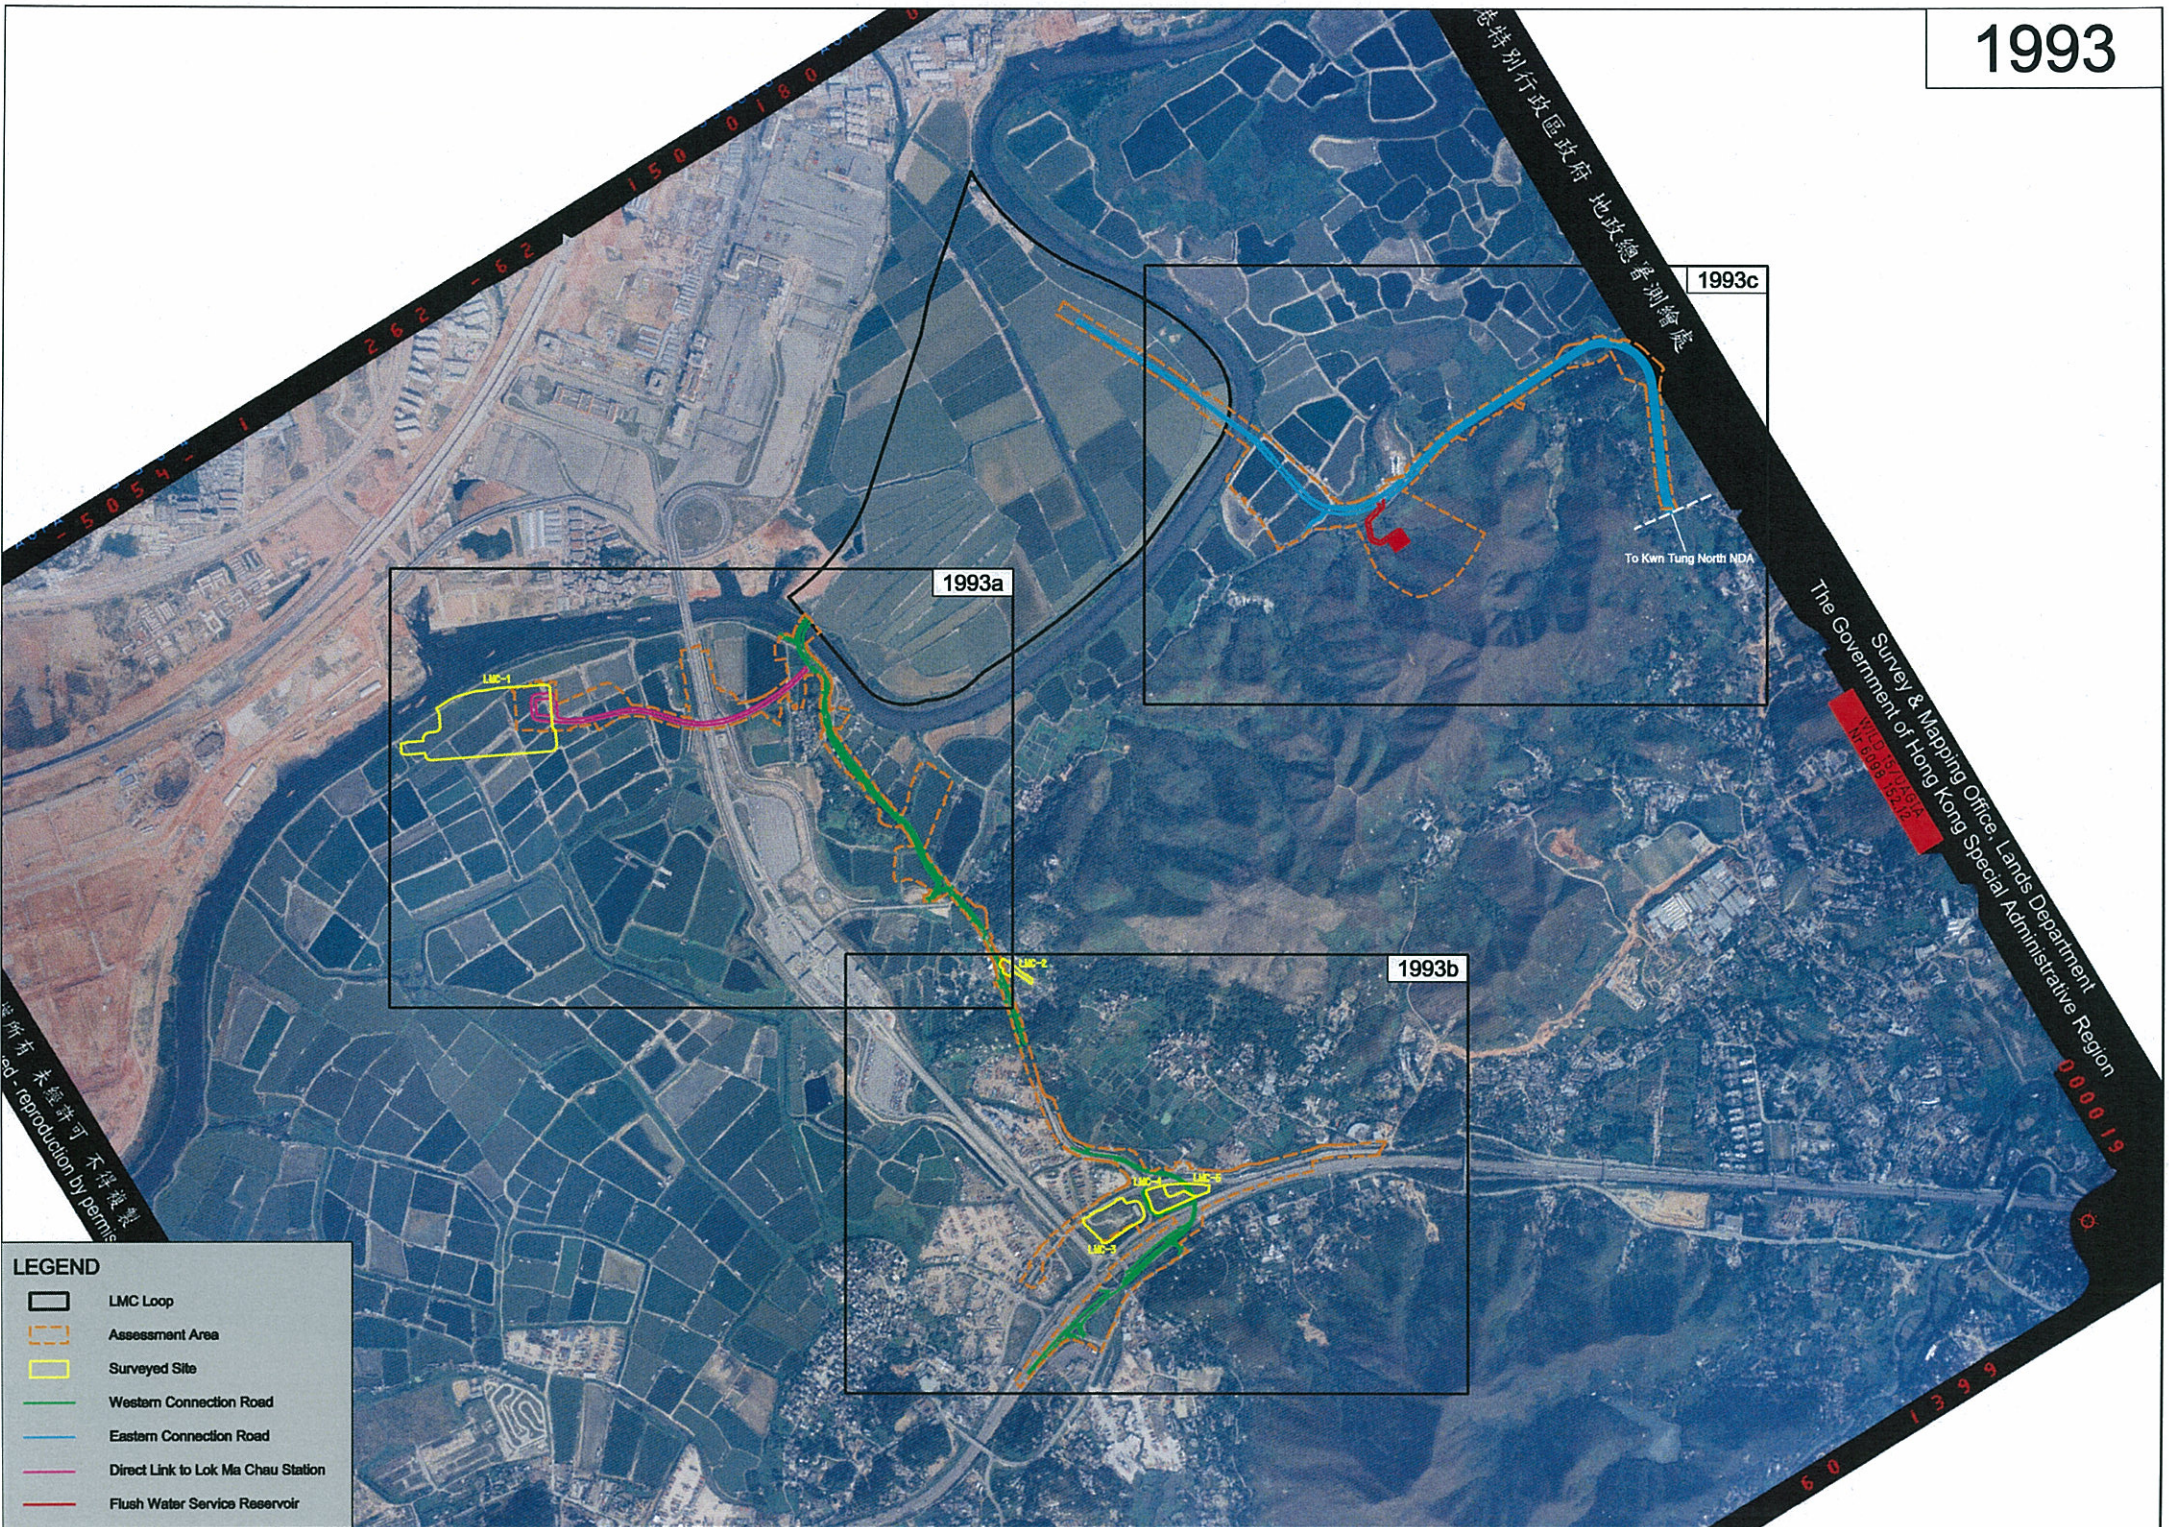
1993a

Construction of San Sham Road and Lok Ma Chau Border Control Point was completed and in operation. No significant change in land use was observed in the surrounding area as compared with Year 1982 (1993a of **Appendix A**).

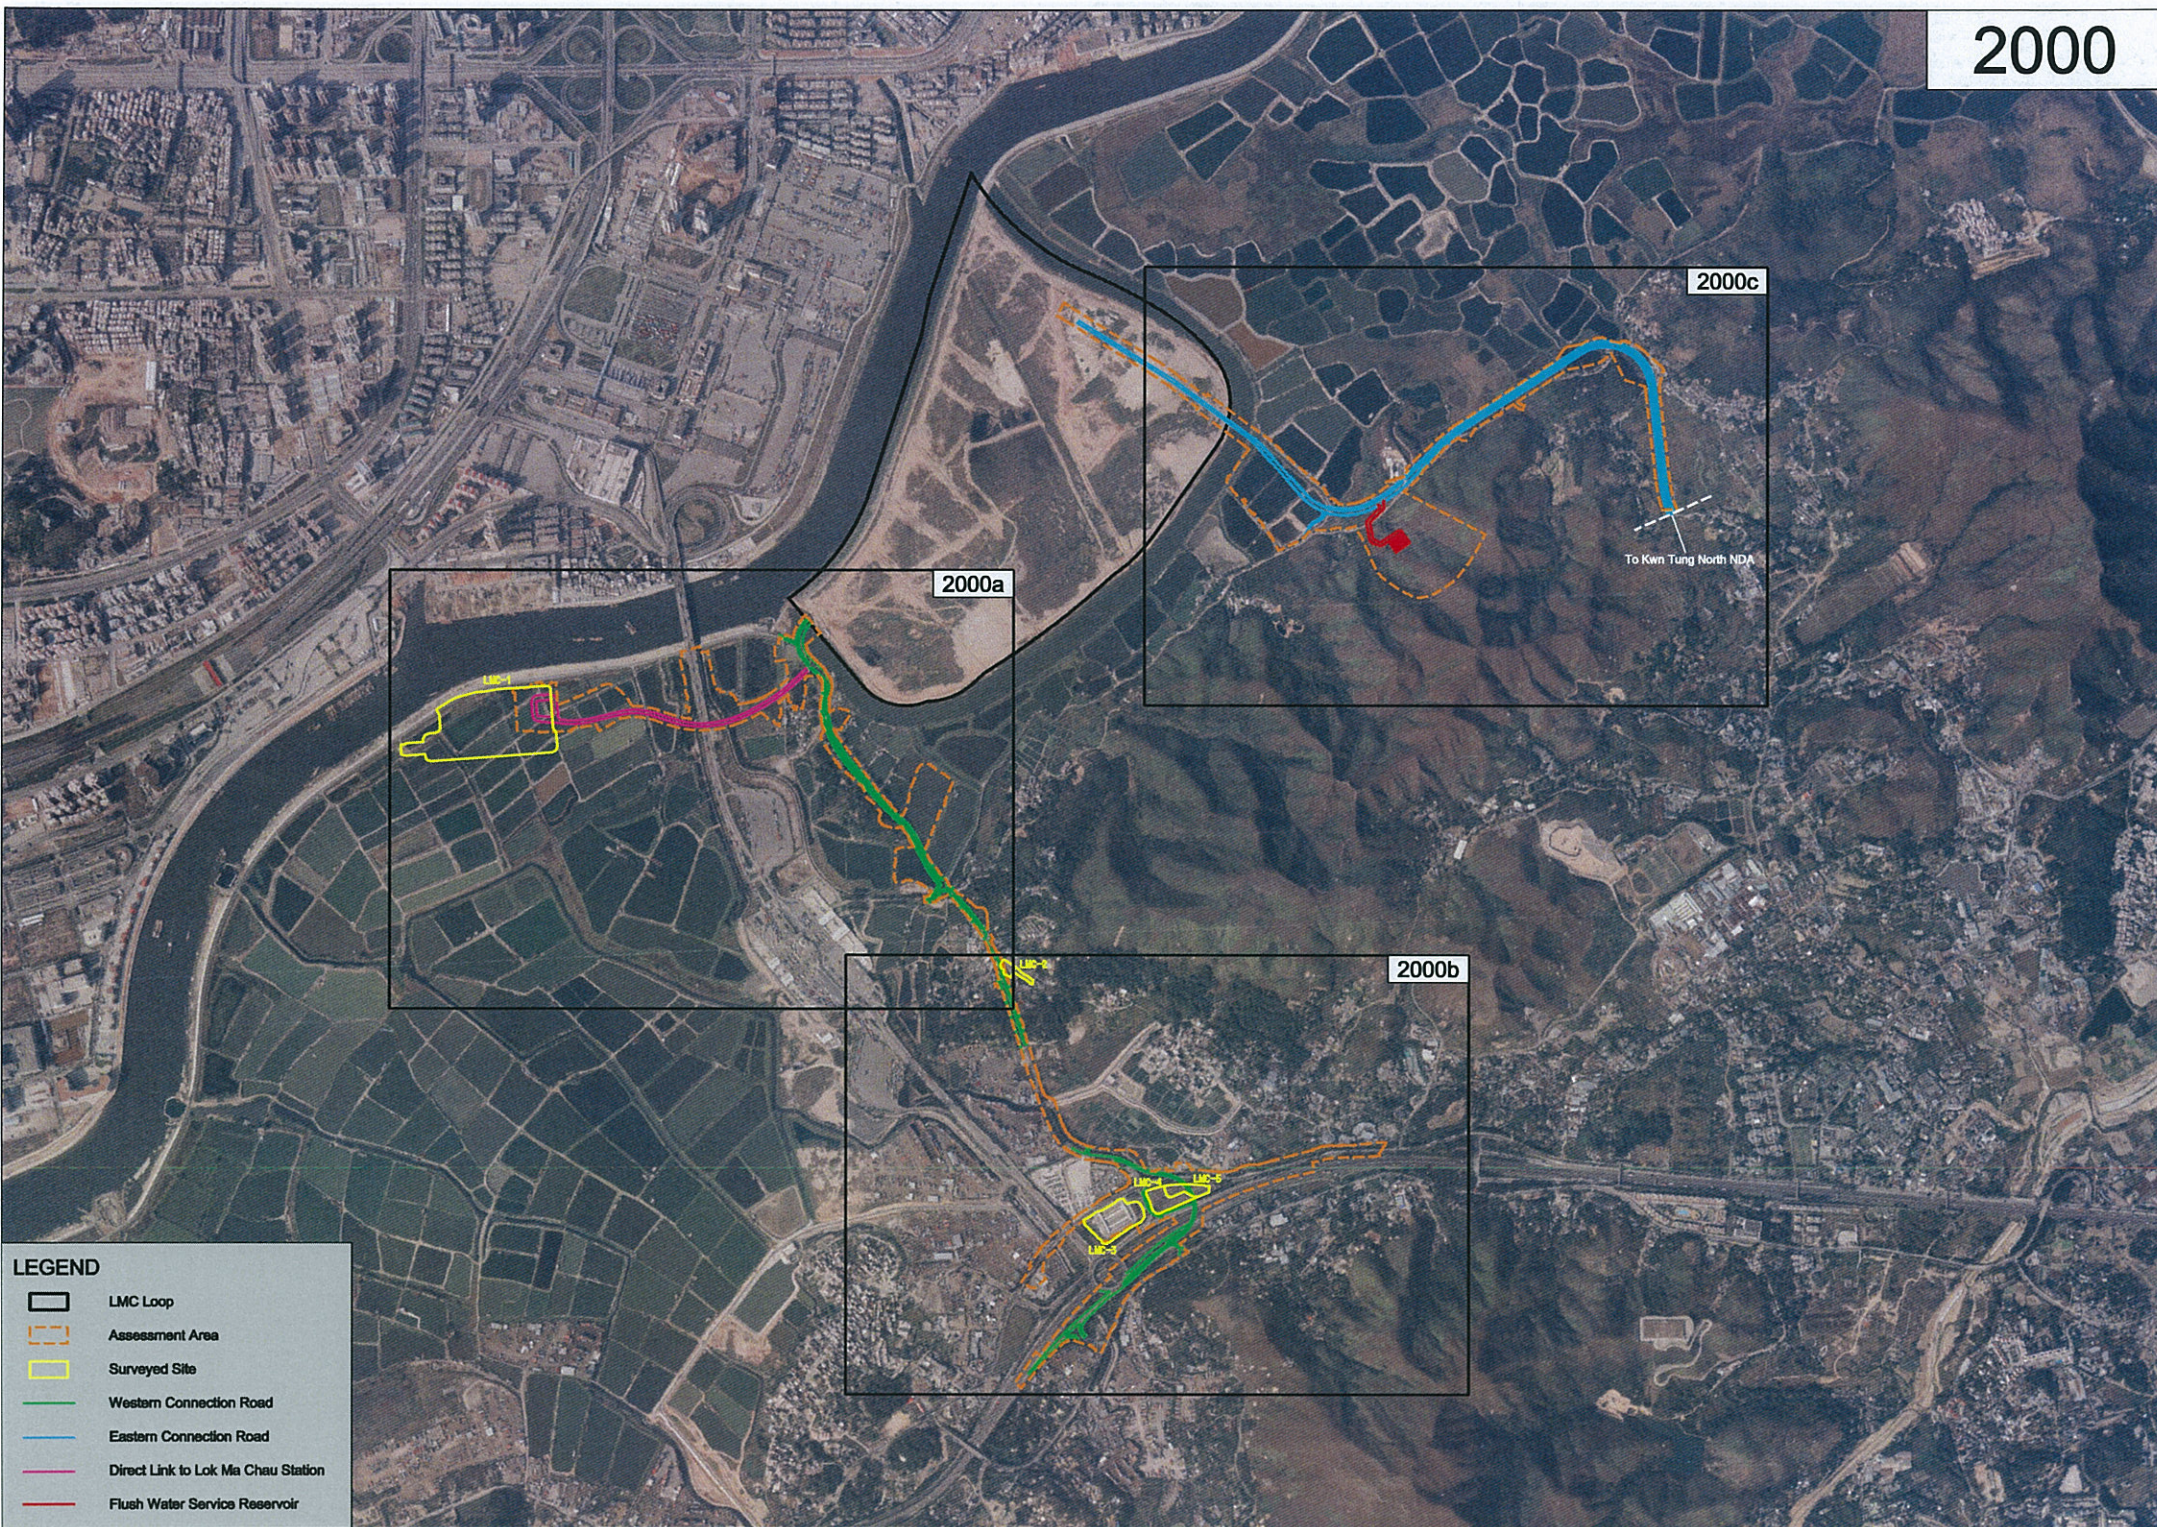
2000a

No significant change in land use was observed as compared with Year 1993 (2000a of **Appendix A**).

No significant change in land use in the upper section was observed as compared with Year 1993. For the lower section, construction of Chau Tau West Road, Chau Tau South Road and the Lok Ma Chau Public Transport Interchange was in progress. A nullah was also observed at the south of Fanling Highway (2000a and b of **Appendix A**).

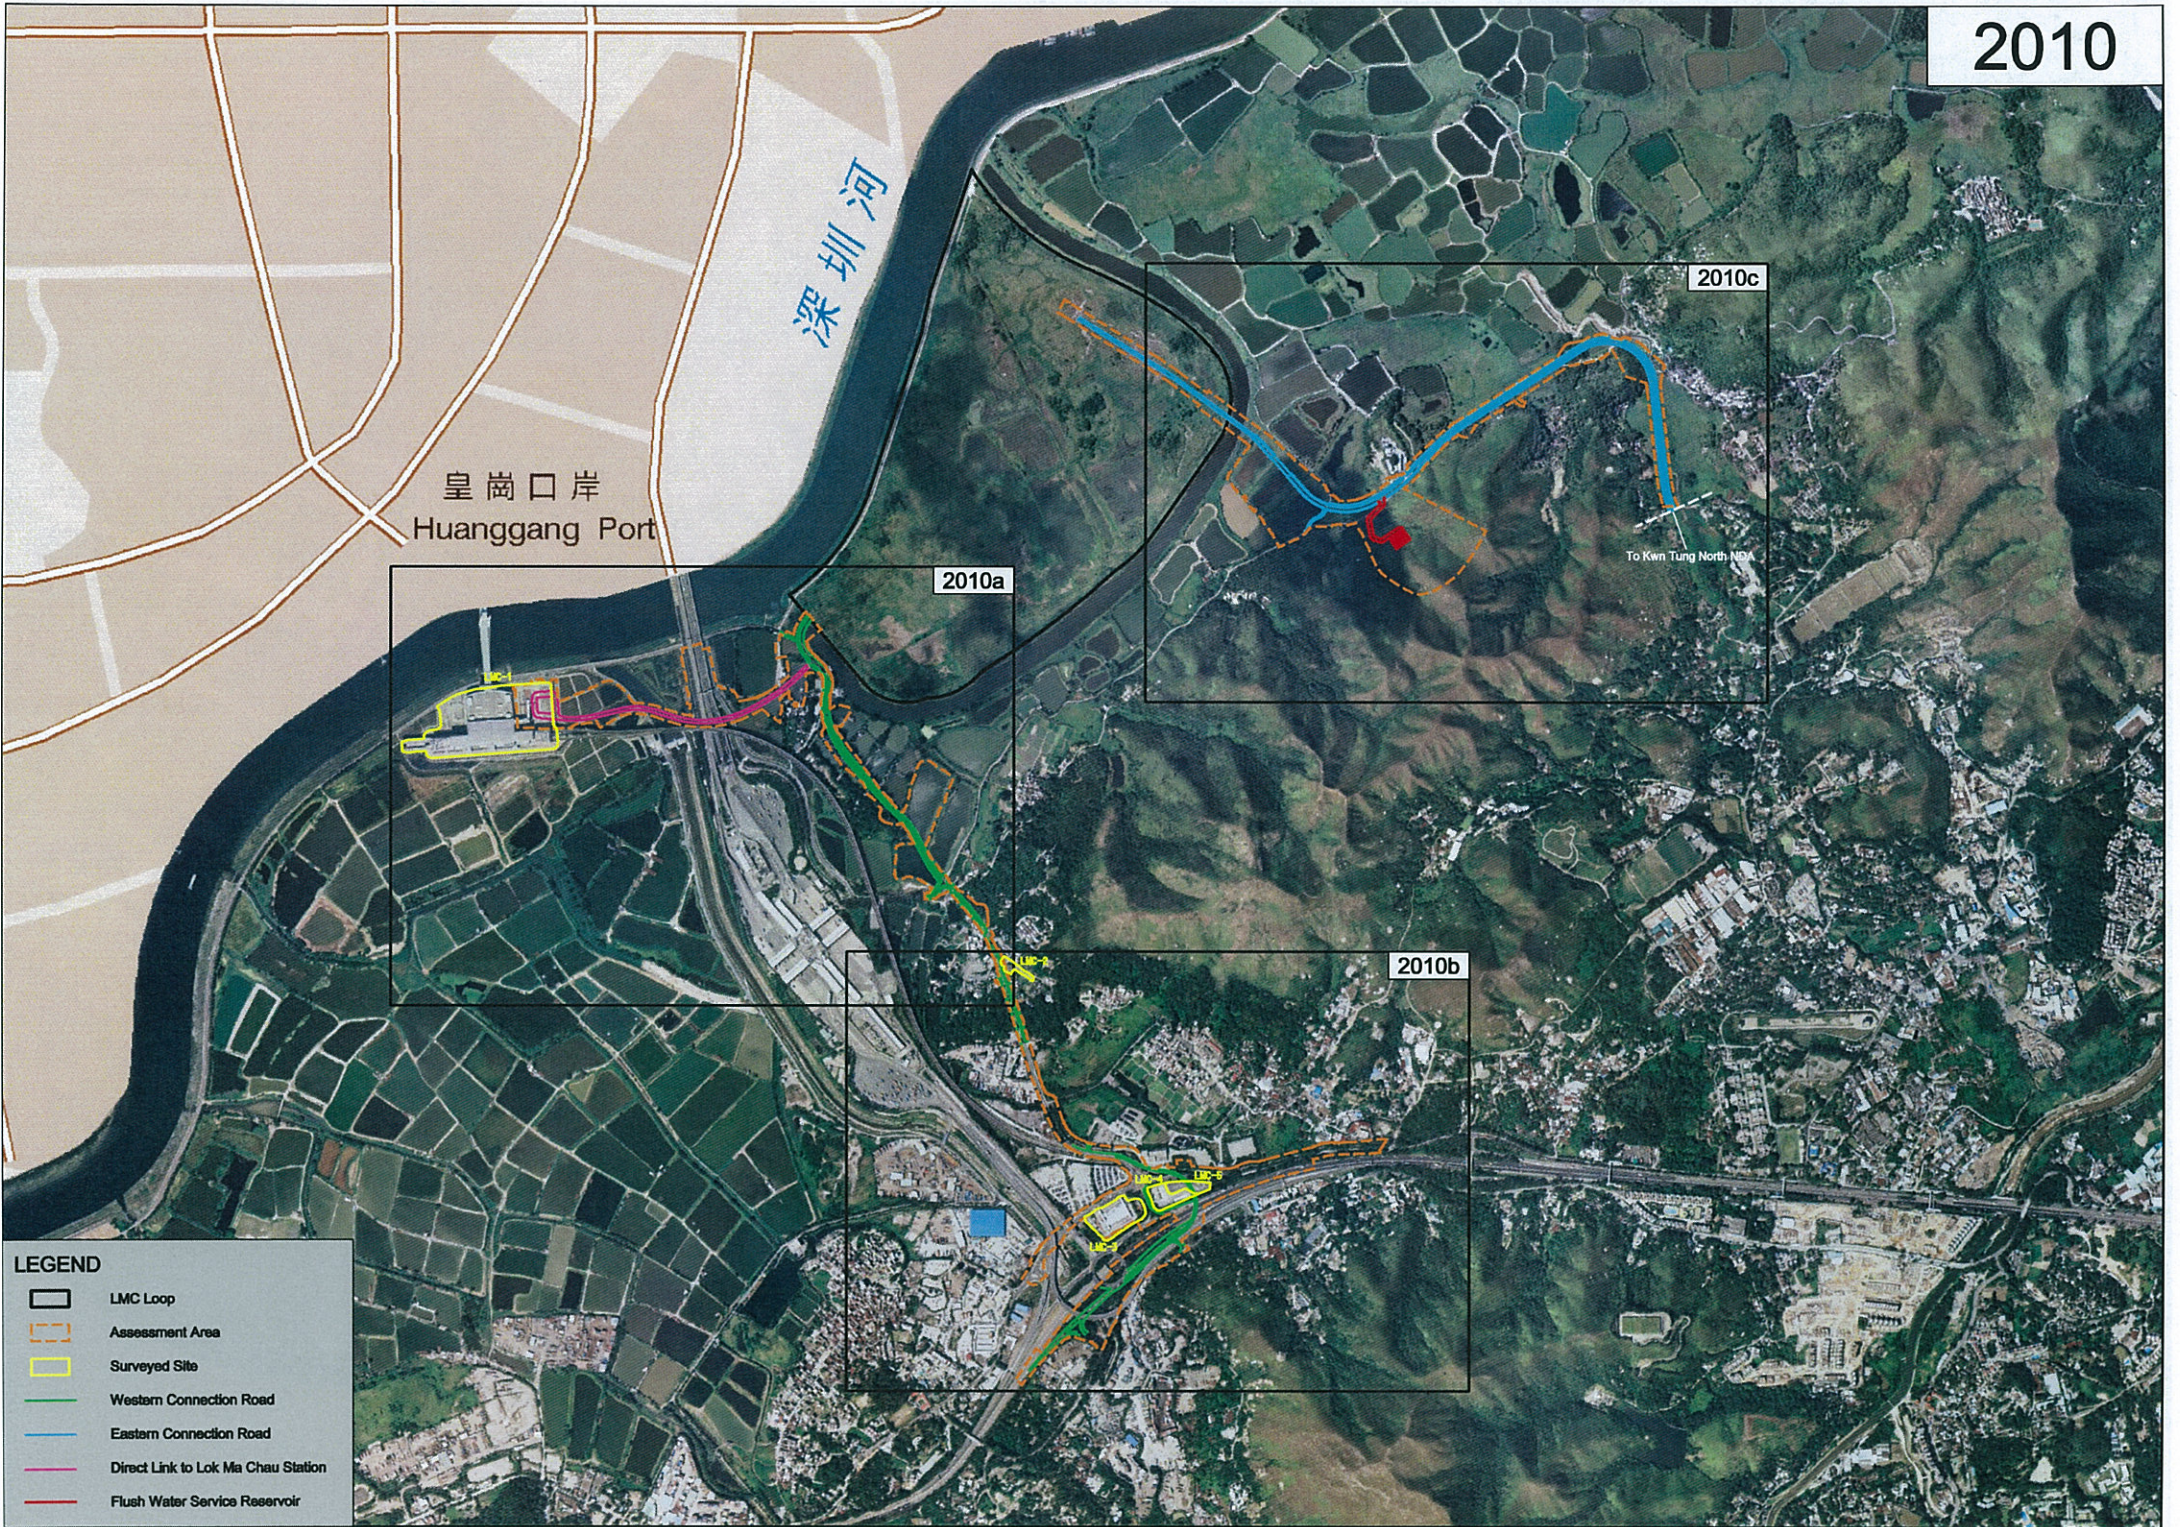
2010a

Lok Ma Chau Station was in operation and the nullah was constructed. Vegetation was observed near Lok Ma Chau Station. No significant change in land use was observed in the surrounding area as compared with Year 2005 (2010a of **Appendix A**).

No significant change in land use in the upper section was observed as compared with Year 2005. The viaduct construction between San Sham Road and San Tin Highway was completed and in operation. The previous MTR Spur Line Site Office was changed to taxi chit waiting area. The unpaved area at the south of Fanling Highway was re-vegetated (2010a and b of **Appendix A**).

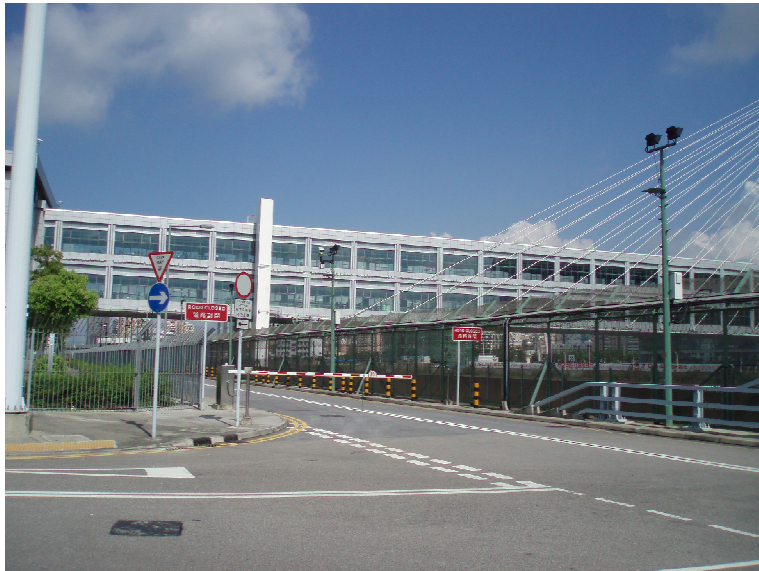
Photo No. P7080064

Site Survey Information and Recommendation	
Date of Survey:	Feb-12
Conducted by:	Thomas Chan and Lawrence Kan
Site Observation & Potentially Sources of Contamination:	Public transport interchange was in operation. Other at-grade areas were restricted from public access. No adverse contaminated land impacts are identified based on site survey observation.
Necessity for Site Investigation	No
Recommended No. of Boreholes	NA

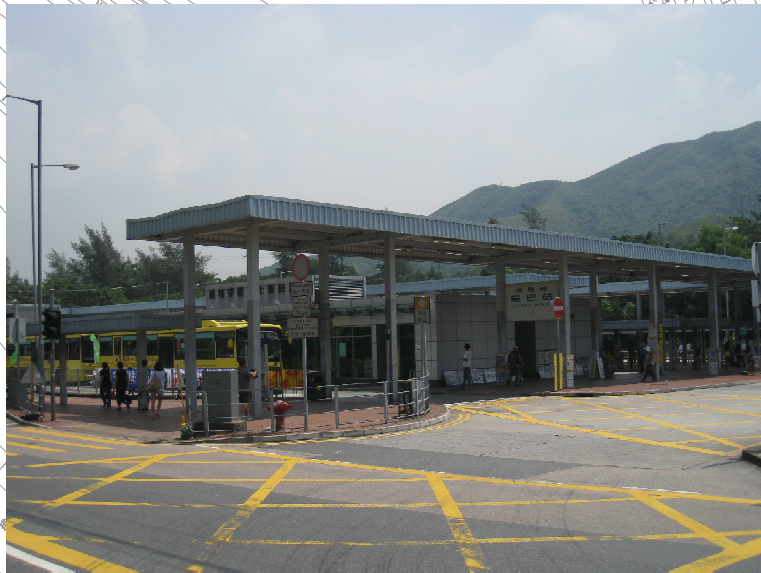
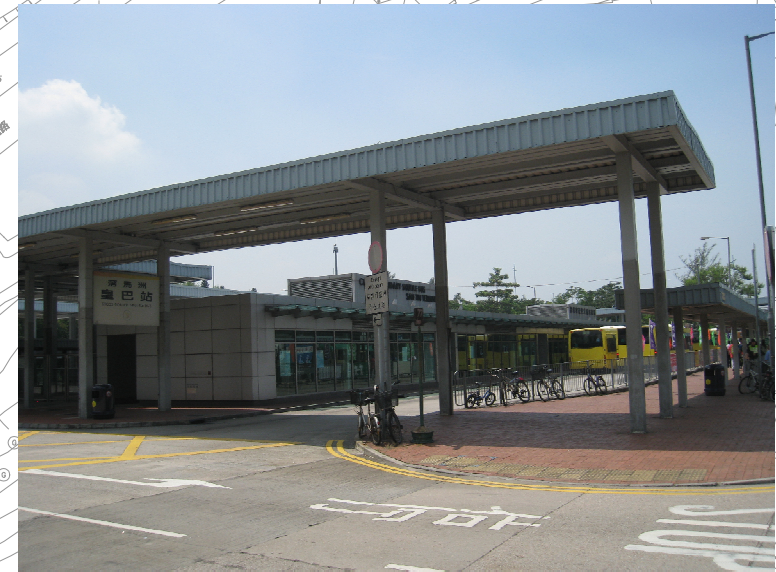
Site Survey Information and Recommendation	
Date of Survey:	Feb-12
Conducted by:	Thomas Chan and Lawrence Kan
Site Observation & Potentially Sources of Contamination:	Fully paved public transport interchange. No vehicle repairing or maintenance workshop within the interchange. No adverse contaminated land impacts are identified based on site survey observation.
Necessity for Site Investigation	No
Recommended No. of Boreholes	NA

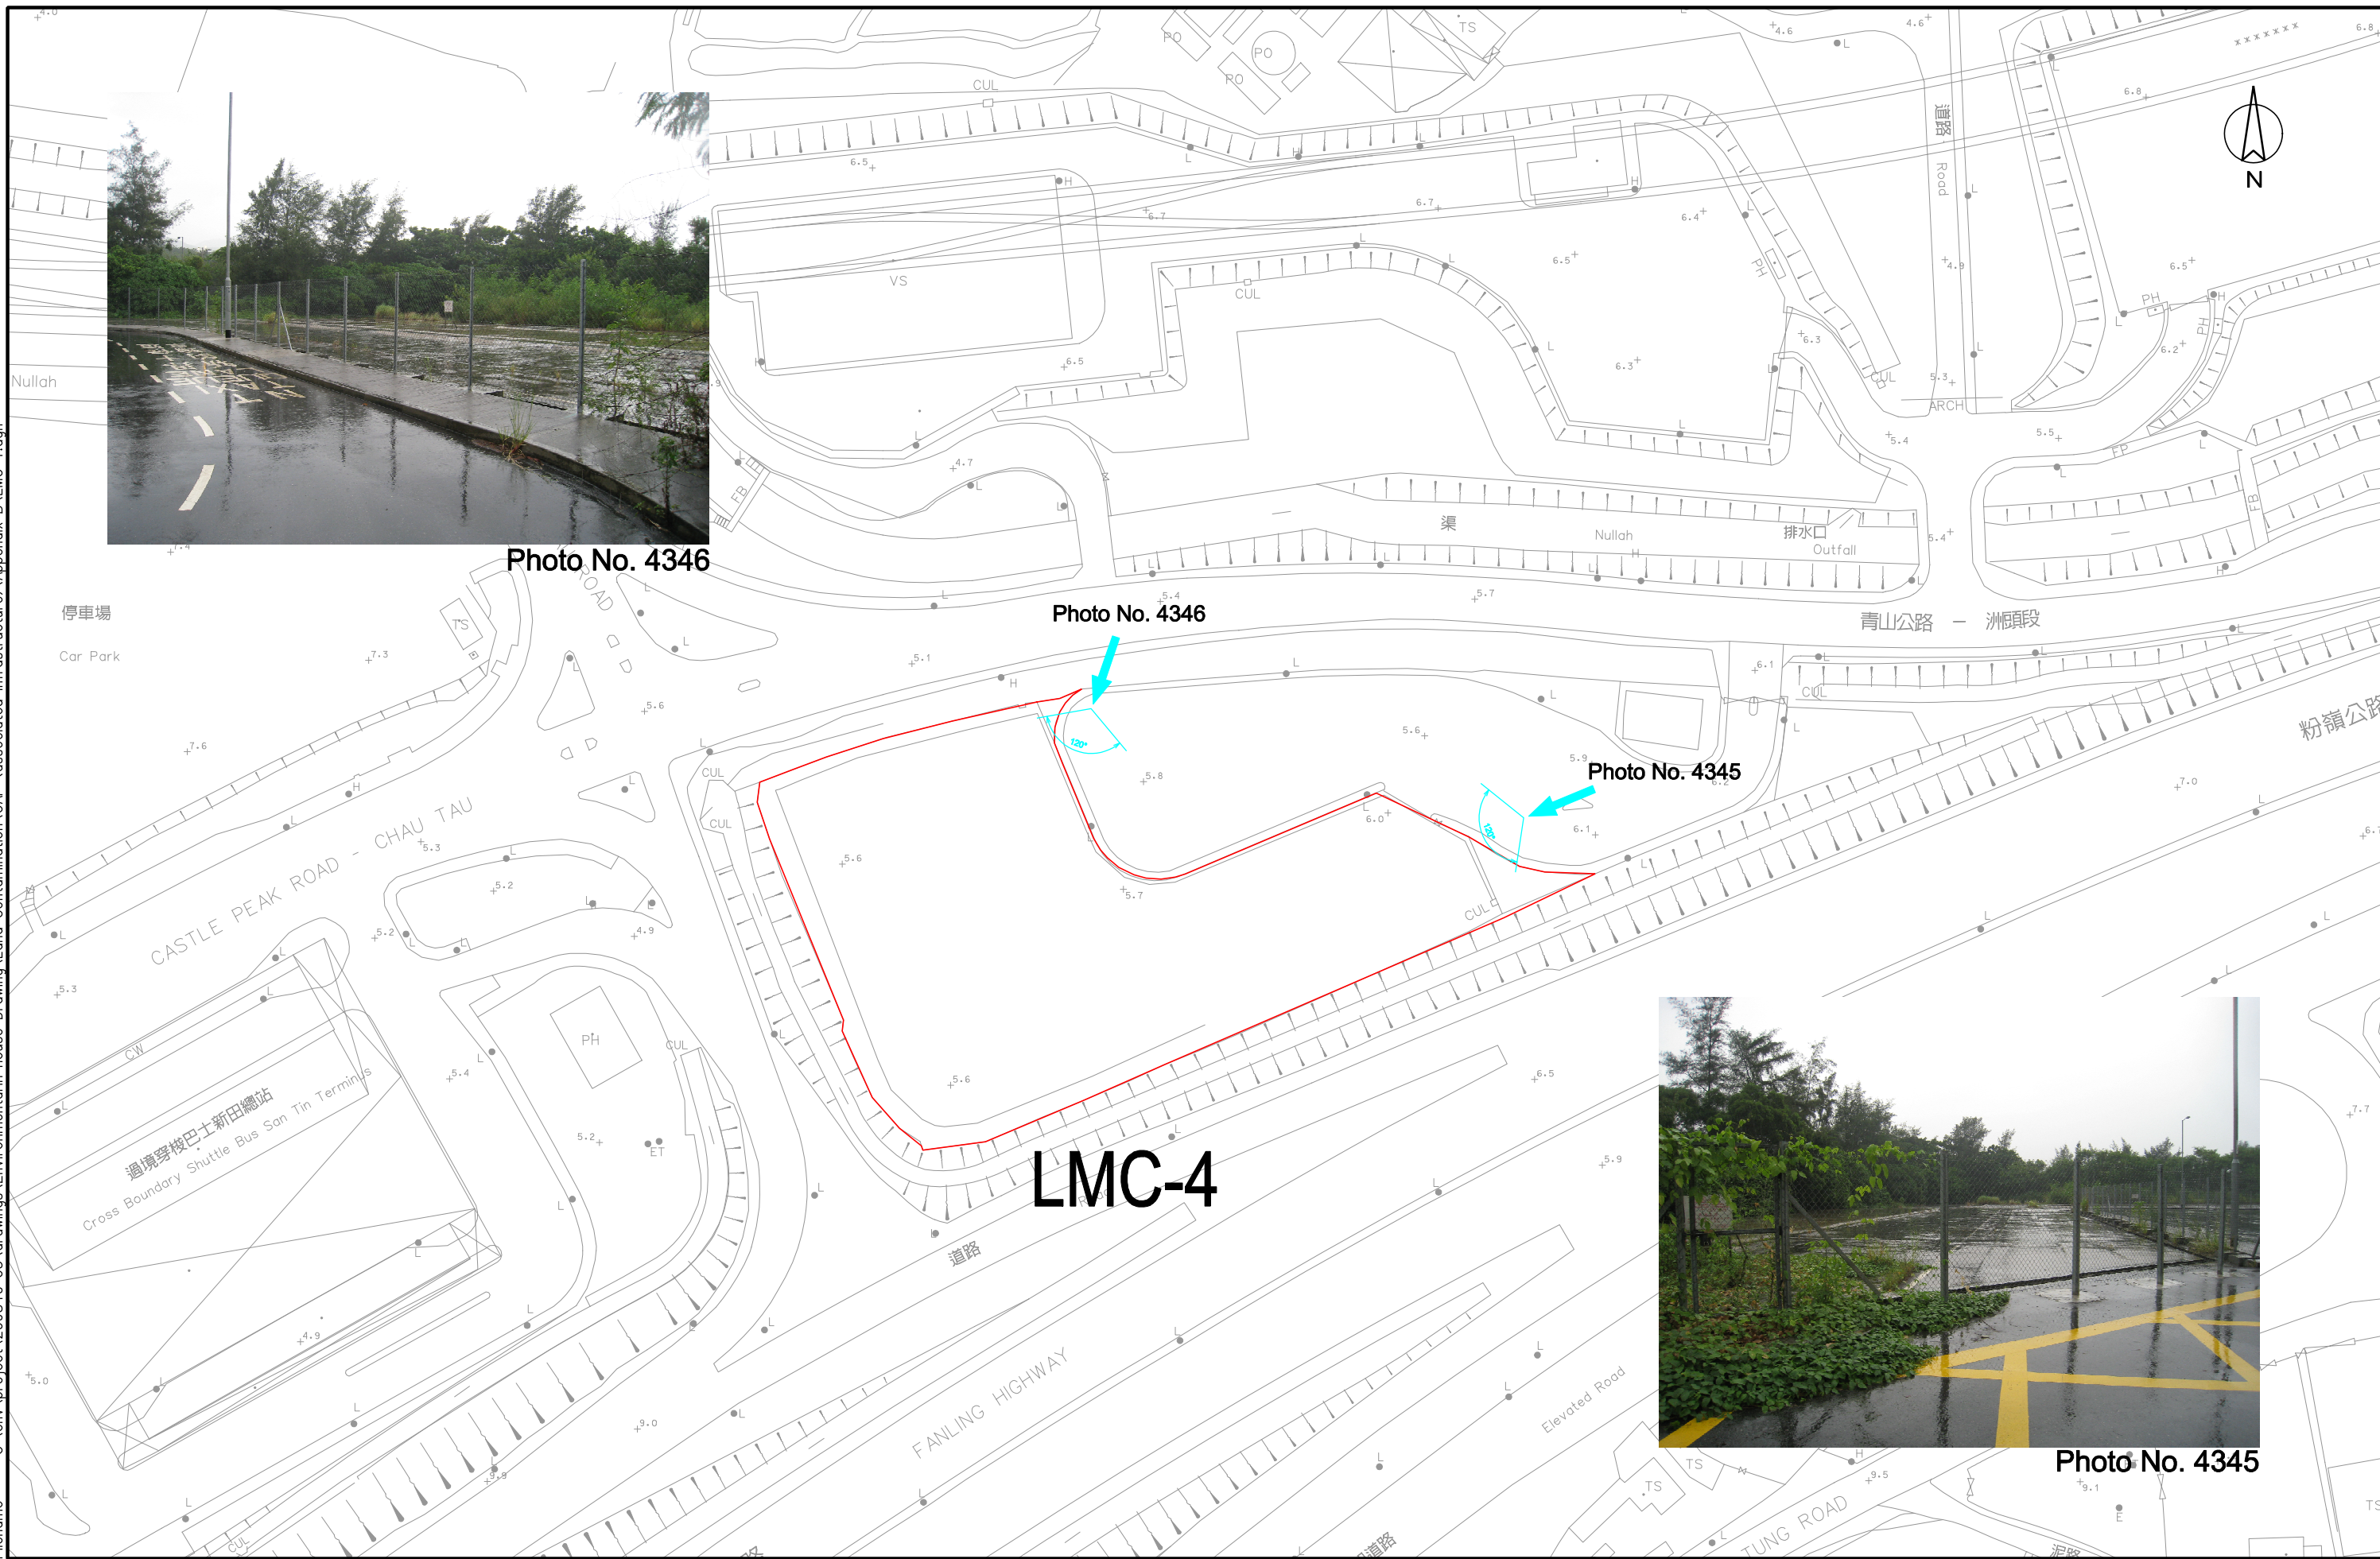
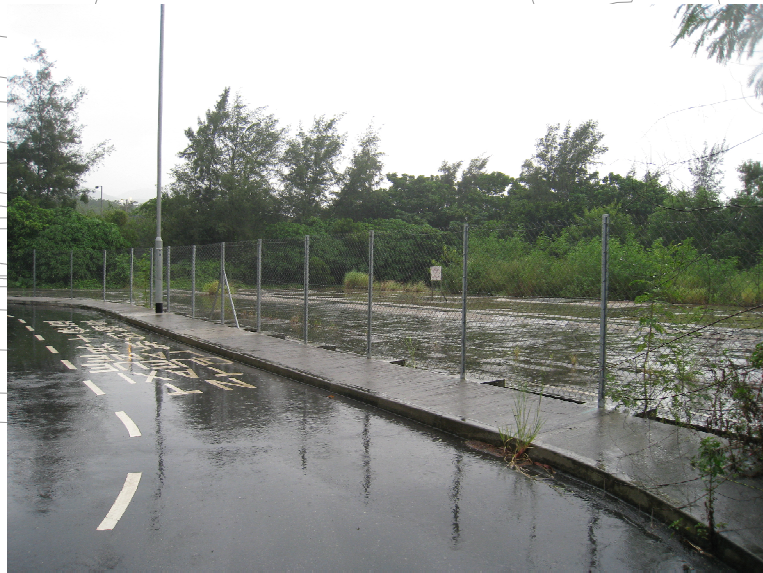
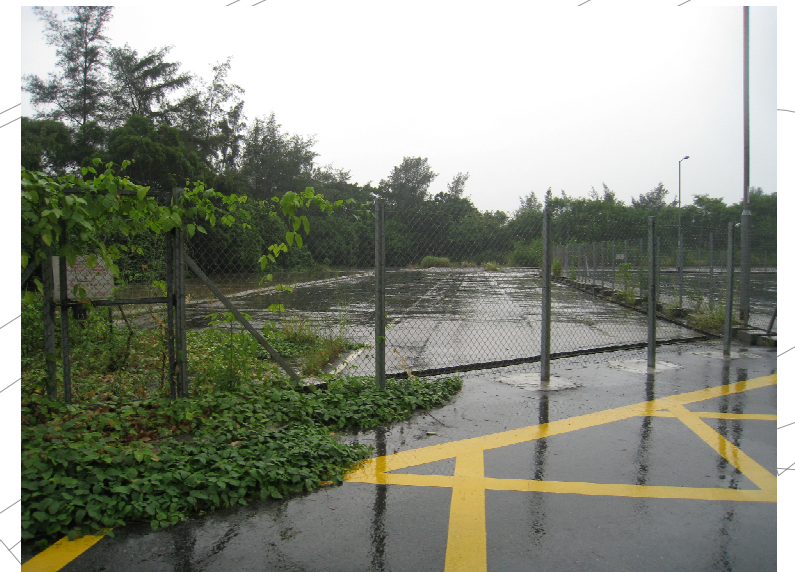
Site Survey Information and Recommendation	
Date of Survey:	Feb-12
Conducted by:	Thomas Chan and Lawrence Kan
Site Observation & Potentially Sources of Contamination:	Fenced-off paved government land. (Former LMC Spur Line site offices)
Necessity for Site Investigation	No
Recommended No. of Boreholes	NA

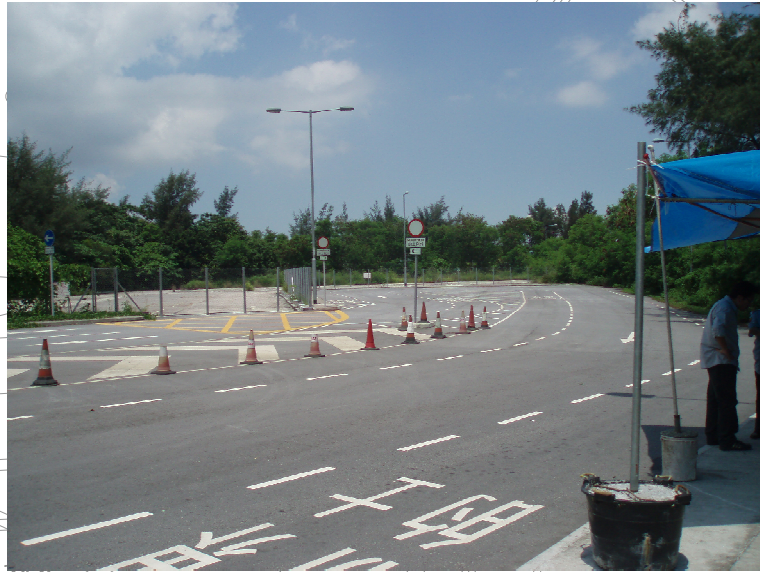
Photo No. P7080106

Site Survey Information and Recommendation	
Date of Survey:	Feb-12
Conducted by:	Thomas Chan and Lawrence Kan
Site Observation & Potentially Sources of Contamination:	Paved taxi waiting area. One-off access chit to LMC restricted area was distributed to the taxi drivers. Restricted from public access. No adverse contaminated land impacts are identified based on site survey observation.
Necessity for Site Investigation	No
Recommended No. of Boreholes	NA
