**Planning and Engineering Study on  
Development of Lok Ma Chau Loop**

**Archaeological Field Survey**

Final Report

**HONG KONG INSTITUTE OF ARCHAEOLOGY**

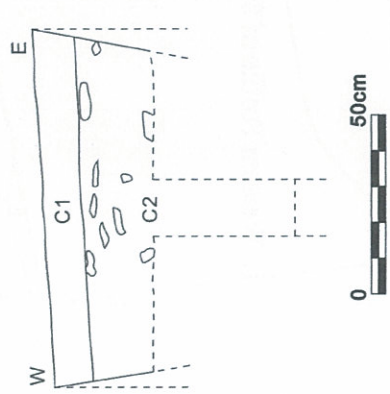
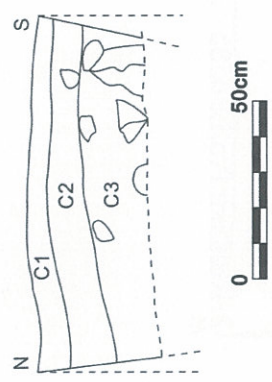
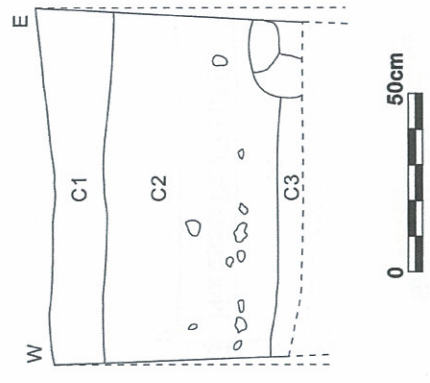
- 4.2.1 The area along Border Road comprises three sub-areas named Border Road-1 to Border Road-3. In this area, totally 12 auger holes were drilled, consisting of 5a, 5b, 5d, 5e, 6a, 6b, 6d, 7a and 7d to 7g; three test pits were excavated, consisting of 5c, 5f and 6c. The locations of the archaeological works in this area are marked in Drawings 3 to 5; the strata revealed from the test pits are displayed in Drawing 19 and Plates 1 to 2:1.

- 4.2.2 The archaeological works along the northern side of Border Road are all distributed at the edge of hill slope. The auger tests in this area all quickly reached the regolith deposit of yellowish red clay mixed with gravel. On the relatively flat terraces, where the test pits were allocated, a modern layer was found between the surface layer and the regolith deposit (TP5c did not reach the regolith deposit due to the hardness of stone slabs of modern fill). Farther to the north of the road are the low flat fields of mud with high level of water table.

1. Northern Profile of 5c

2. Eastern Profile of 5f

3. Northern Profile of 6c

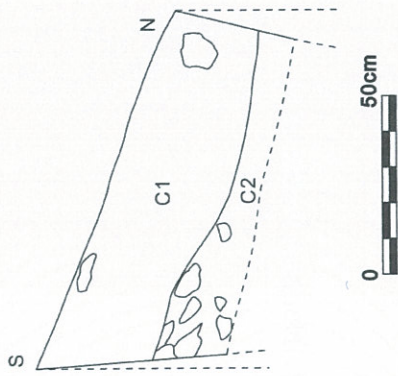
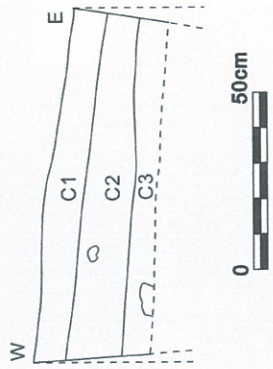
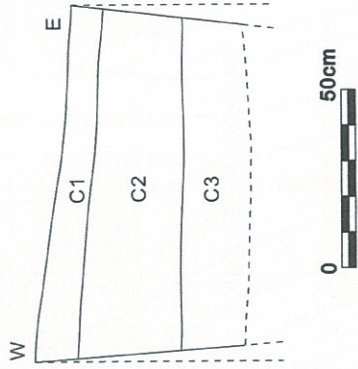
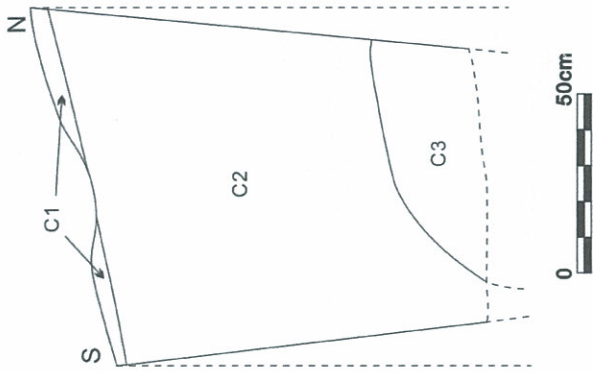
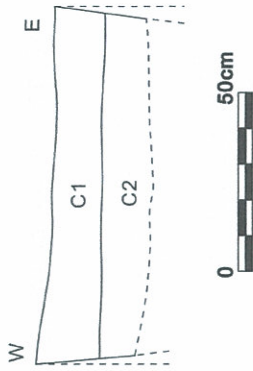
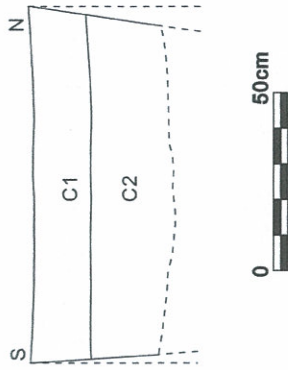
- 4.3.1 The area at Ma Tso Lung comprises four sub-areas named Ma Tso Lung-1 to Ma Tso Lung-4. In this area, totally 20 auger holes were drilled, consisting of 8c, 8e to 8j, 9a, 9c to 9e, 10b, 10f to 10g, 11a to 11d, 11f and 11g; six test pits were excavated, consisting of 8a, 8b, 9b, 10a, 10e and 11e. The locations of the archaeological works in this area are marked in Drawings 6 to 9; the strata revealed from the test pits are displayed in Drawings 20 to 21 and Plates 2:2 to 5:1.

- 4.3.2 Archaeological works in sub-areas Ma Tso Lung-1 to Ma Tso Lung-3 are allocated on the lower part of the hill slopes or the low terraces at hill foot; archaeological works in sub-area Ma Tso Lung-4 are located on flat fields or terraces of river valley. At some locations nearby ditch or water course, e.g. auger holes 10f and 10g, the tests reached water soaked sludge or sandy deposit; the other testing works all reached regolith deposit of weathered clay soon after digging through the surface layer.

1. Western Profile of 8a

2. Northern Profile of 8b

3. Northern Profile of 9b

1. Western Profile of 10a

2. Northern Profile of 10e

3. Northern Profile of 11e

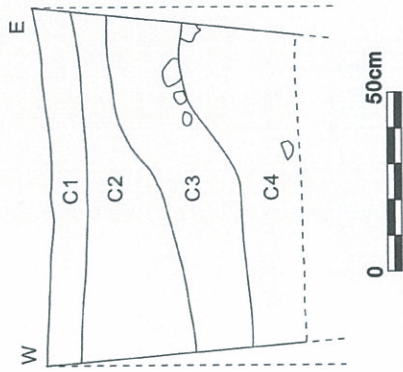
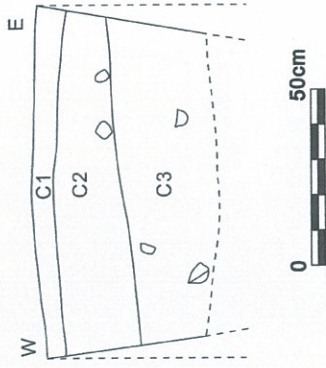
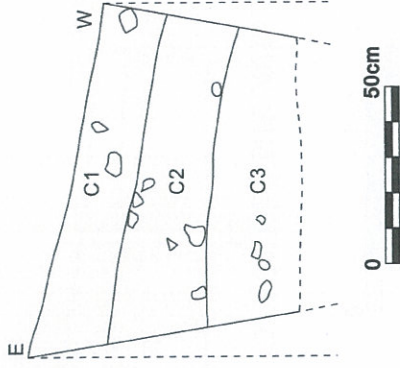
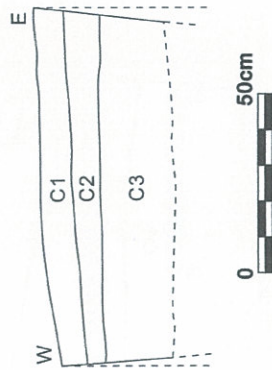
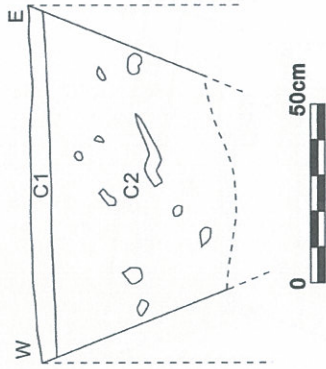
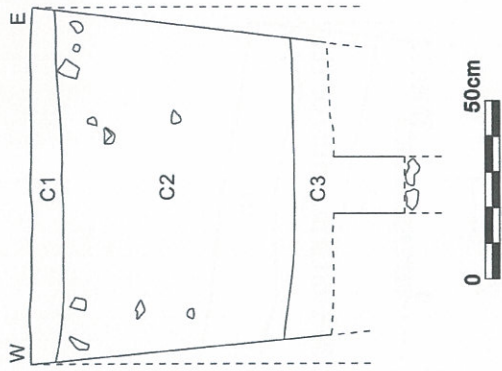
- 4.4.1 The area along Ma Tso Lung Road comprises five sub-areas named Ma Tso Lung Road-1 to Ma Tso Lung Road-5. In this area, totally 20 auger holes were drilled, consisting of 14b, 14d, 14e, 14g to 14i, 14k, 15b to 15e, 16a, 16d, 16f, 17a, 17b, 17e, 17f, 18d and 18f; nine pits were excavated, consisting of 14c, 14f, 14j, 15a, 16e, 16g, 17d, 18b and 18e. The locations of the archaeological works in this area are marked in Drawings 10 to 14; the strata revealed from the test pits are displayed in Drawings 22 to 24 and Plates 5:2 to 9.

- 4.4.2 The archaeological works in this area are scattered along hill foot and on relatively flat terraces. The results of the field investigation in this area are composed of two kinds, depending on their locations: the archaeological works allocated close to current existing roads and other constructed structures usually encountered hard modern fill layer(s) formed with concrete, mortar or gravel material; the archaeological works distributed on slopes or terraces that are away from roads or other facilities usually reached regolith deposit of weathered clay.

1. Northern Profile of 14c

2. Northern Profile of 14f

3. Southern Profile of 14j

1. Northern Profile of 15a

2. Northern Profile of 16e

3. Northern Profile of 16g

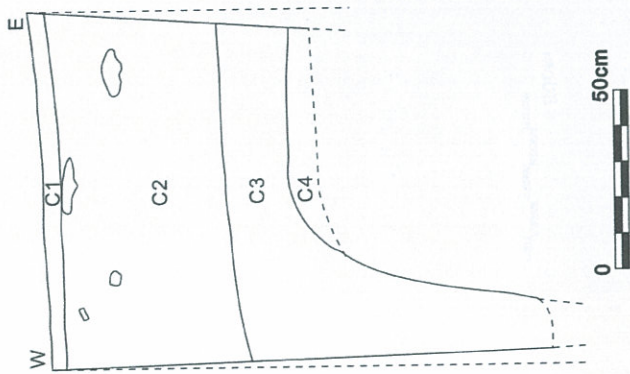
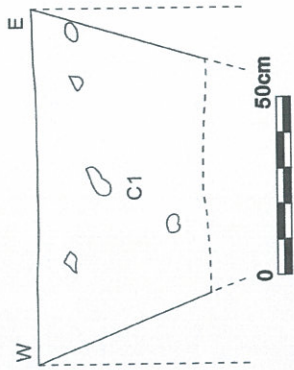
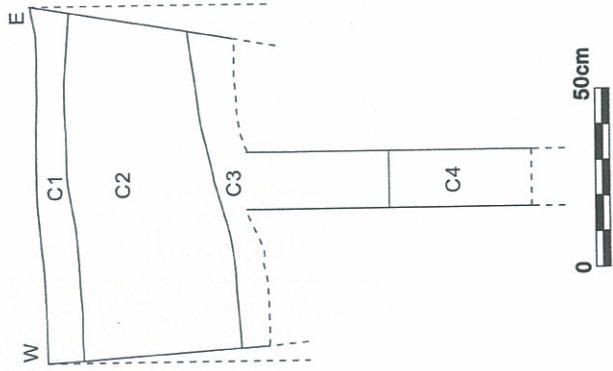
1. Northern Profile of 17d

2. Northern Profile of 18b

3. Northern Profile of 18e

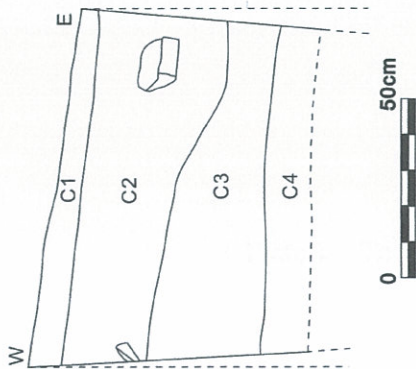
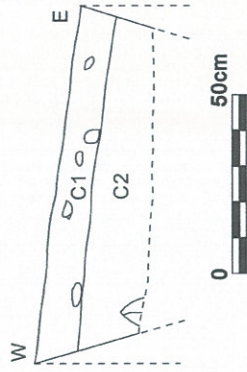
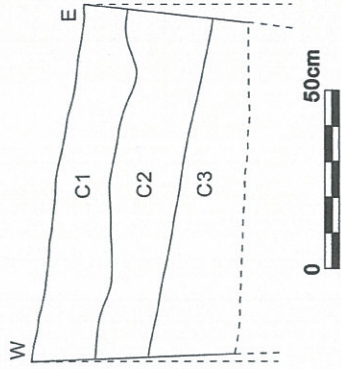
- 4.5.1 The area along Ho Sheung Heung Road comprises four sub-areas named Ho Sheung Heung-1 to Ho Sheung Heung-4. In this area, totally 14 auger holes were drilled, consisting of 20b, 21a, 21b, 21e, 21f, 21i, 22a, 22c, 22d, 22f, 23a, 23c, 23e and 23f; three pits were excavated, consisting of 21d, 22e and 23d. The locations of the archaeological works in this area are marked in Drawings 15 to 18; the strata revealed from the test pits are displayed in Drawing 25 and Plates 10 to 11.

- 4.5.2 The archaeological works in sub-areas Ho Sheung Heung Road-1 and Ho Sheung Heung Road-2 are distributed on the edge of hill slopes along both sides of the road; the archaeological works in the other two sub-areas Ho Sheung Heung Road-3 and Ho Sheung Heung Road-4 are allocated on high-elevation hill slopes. These archaeological works all reached regolith deposit of weathered clay mixed with gravel.

1. Northern Profile of 21d

2. Northern Profile of 22e

3. Northern Profile of 23d

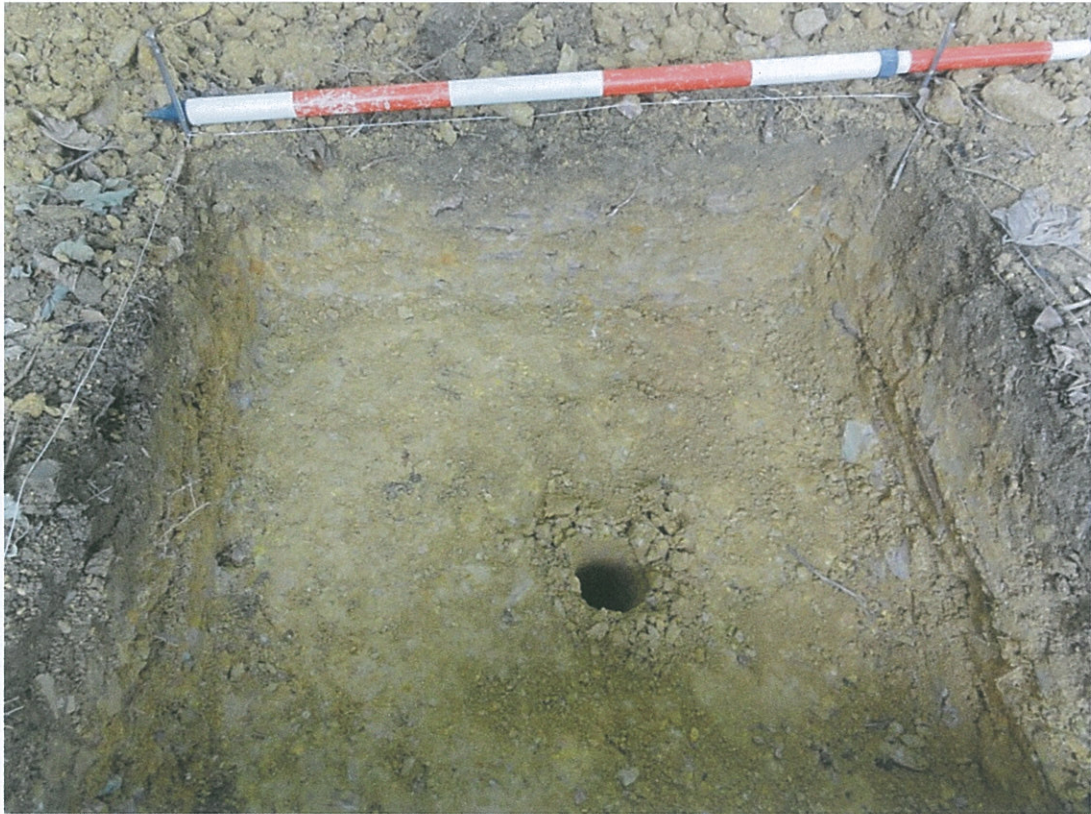
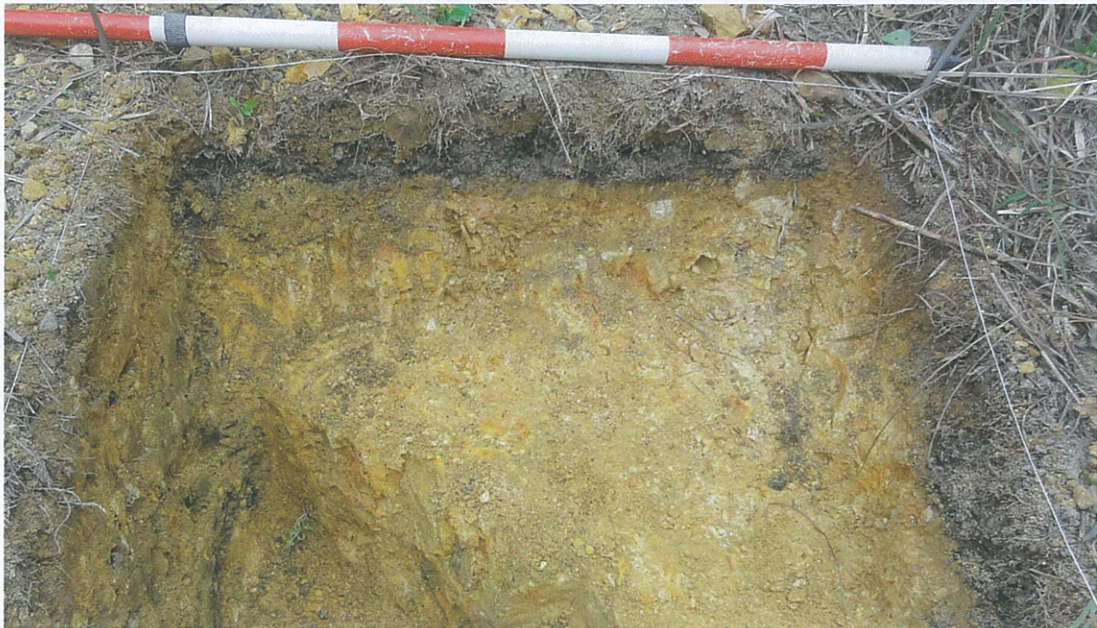
1. Northern Section of 5c

2. Eastern Section of 5f

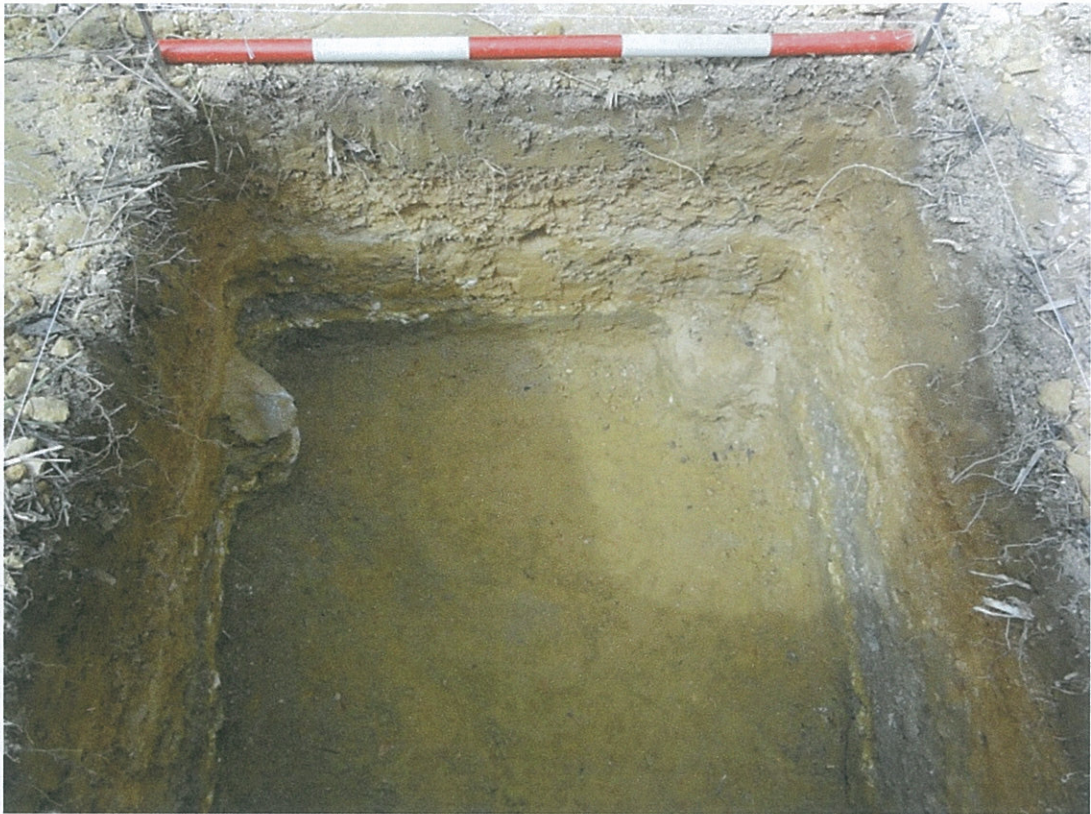
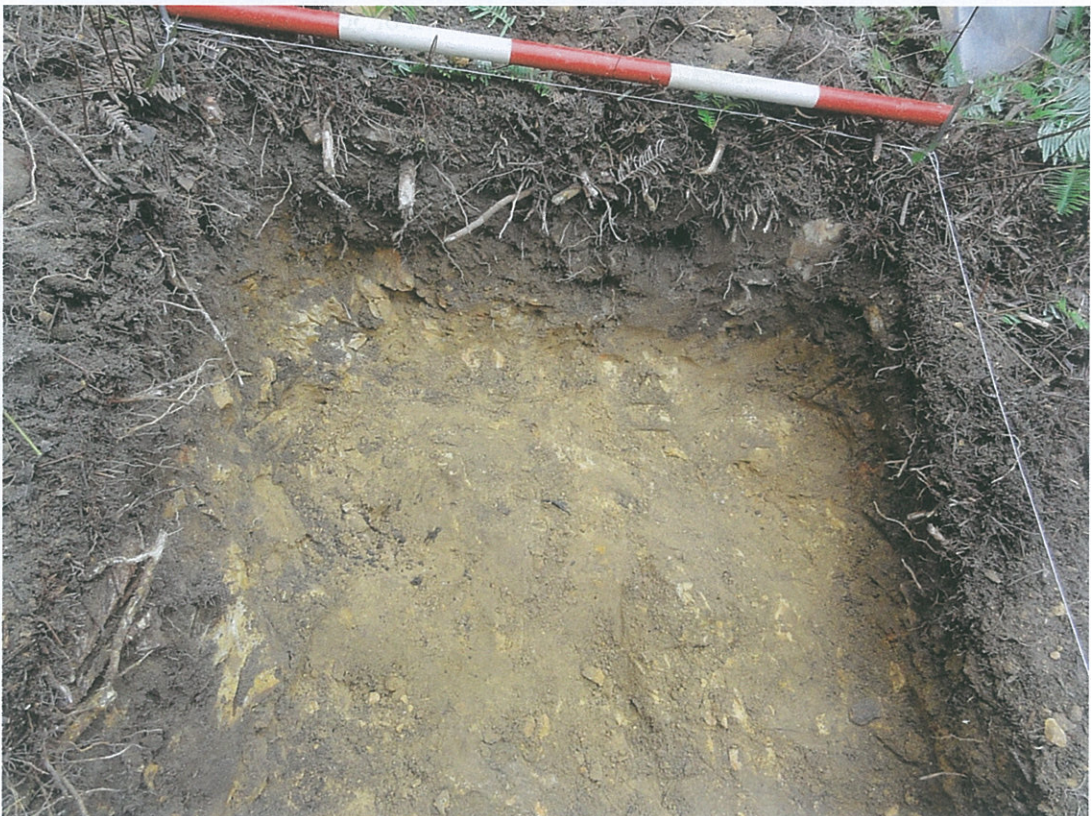
Plate 2 Test Pits 6c and 8a

1. Northern Section of 6c

2. Western Section of 8a

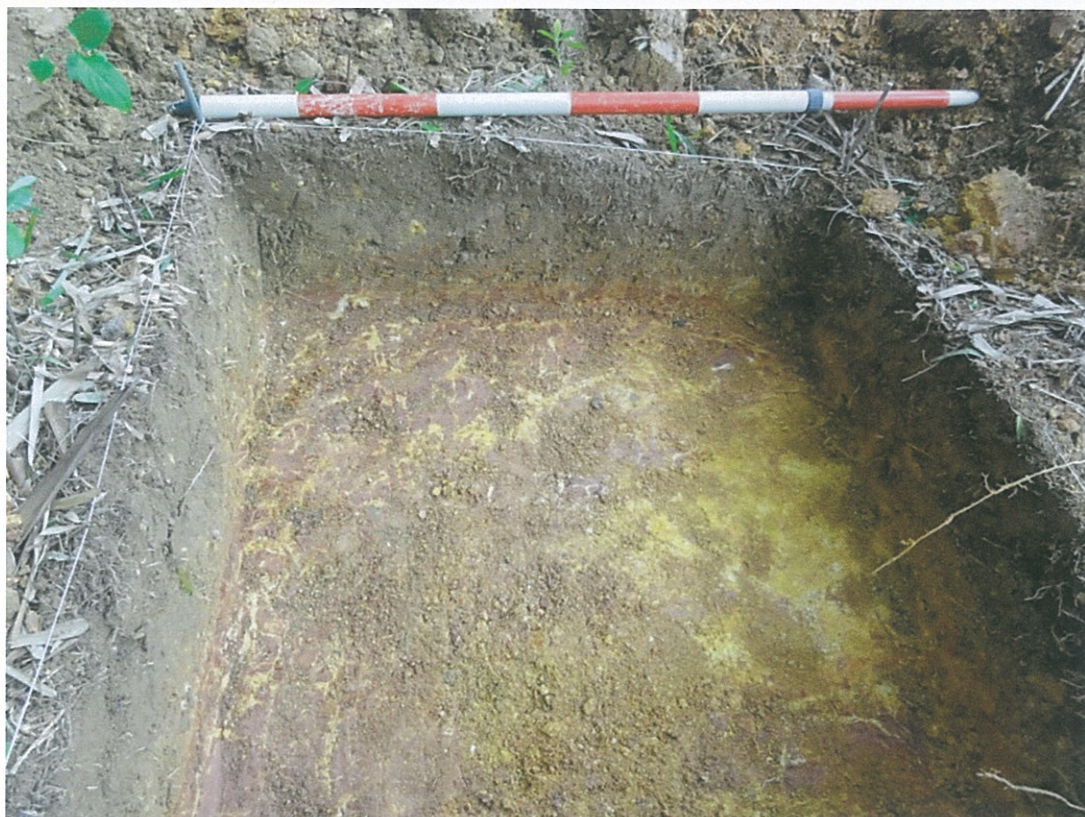
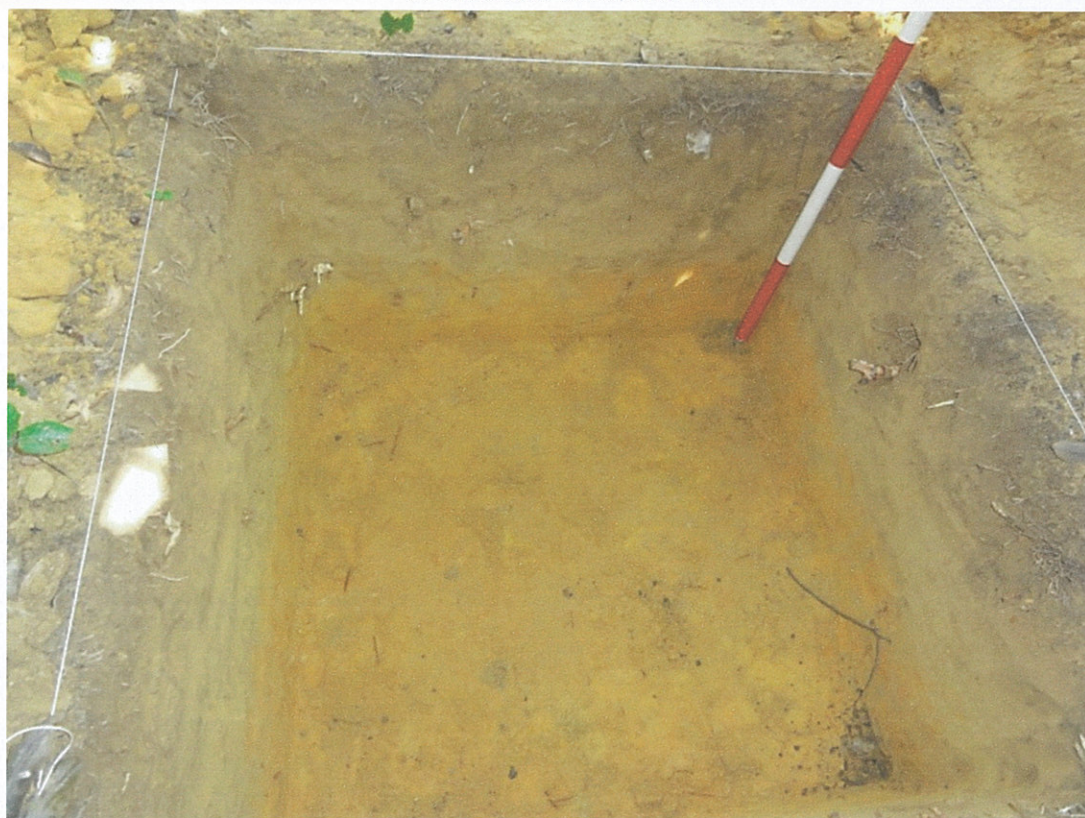
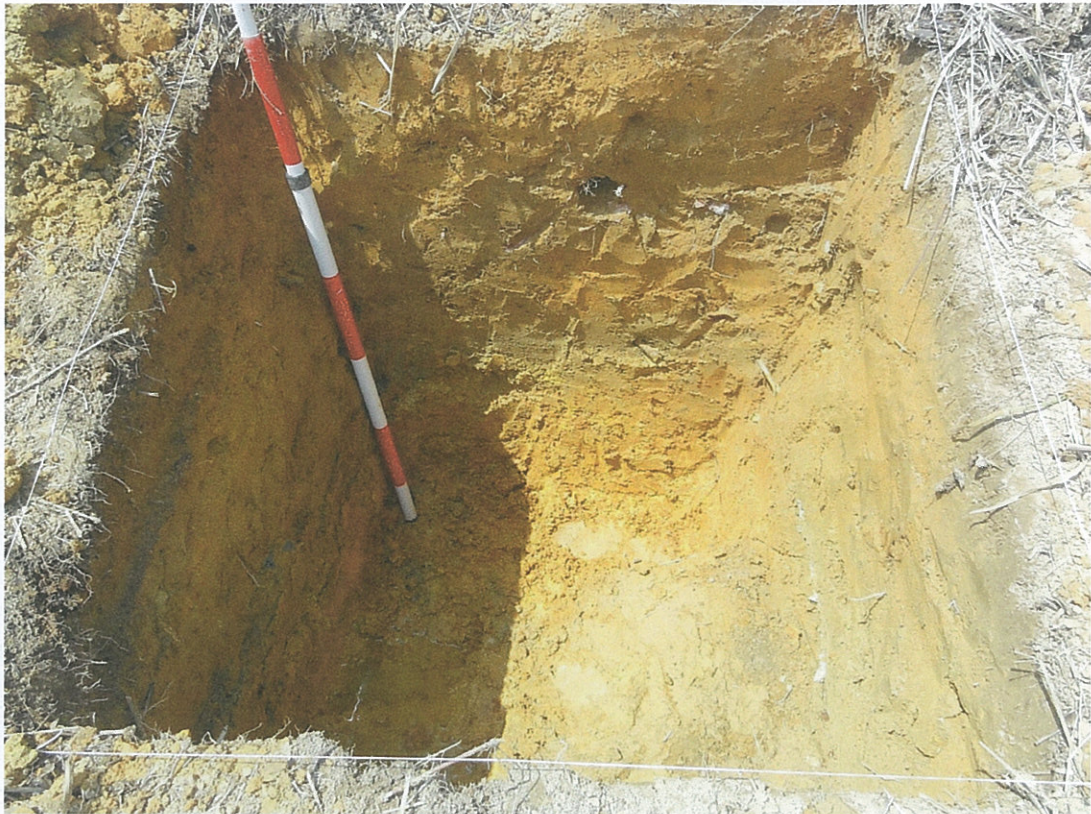
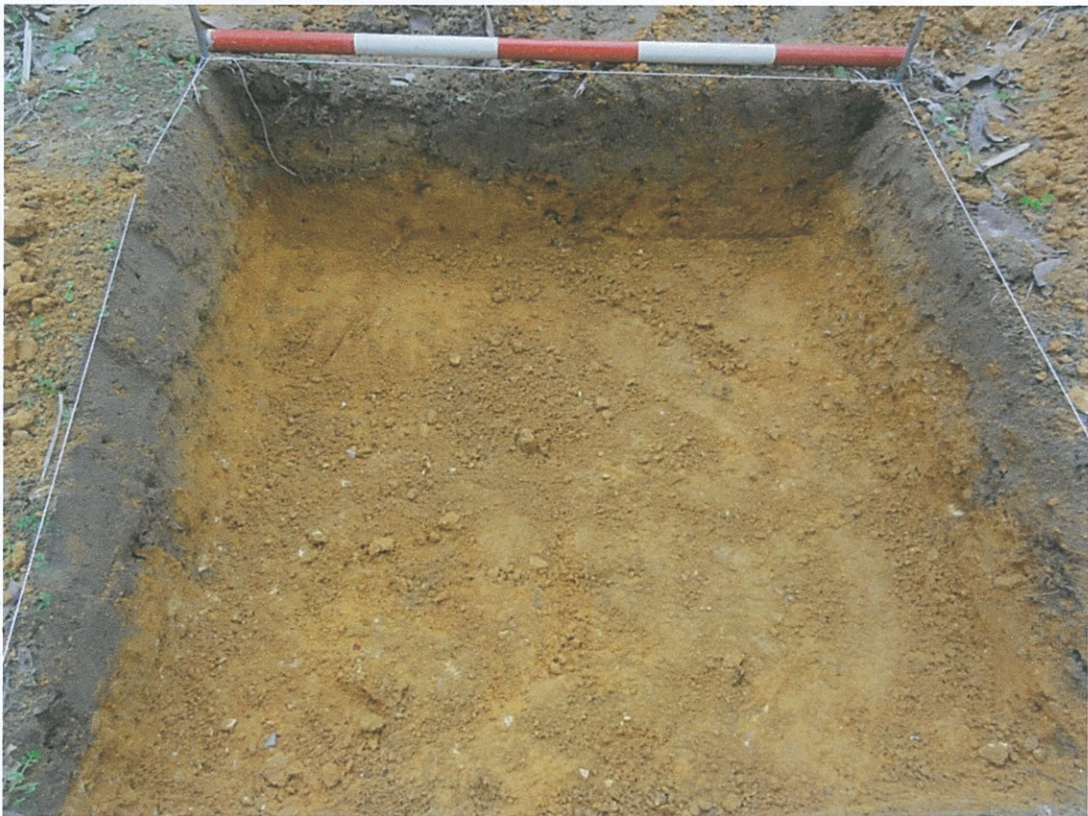
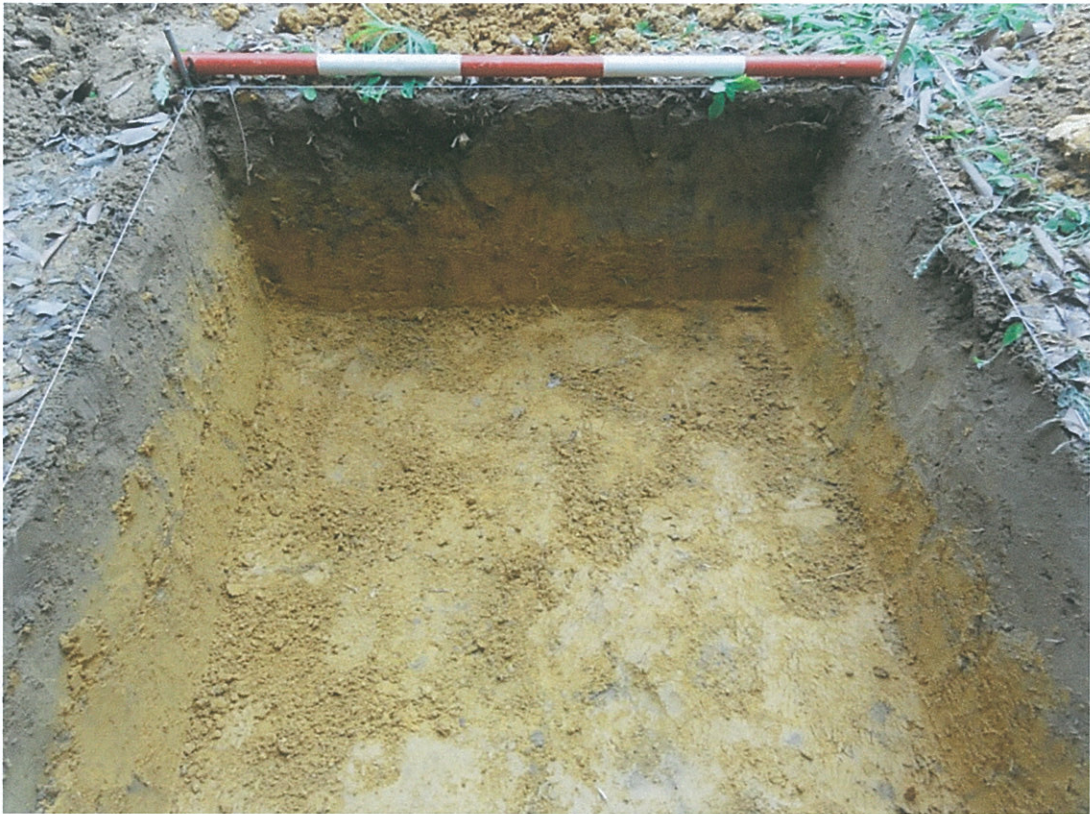
1. Northern Section of 8b

2. Northern Section of 9b

1. Western Section of 10a

2. Northern Section of 10e

1. Northern Section of 11e

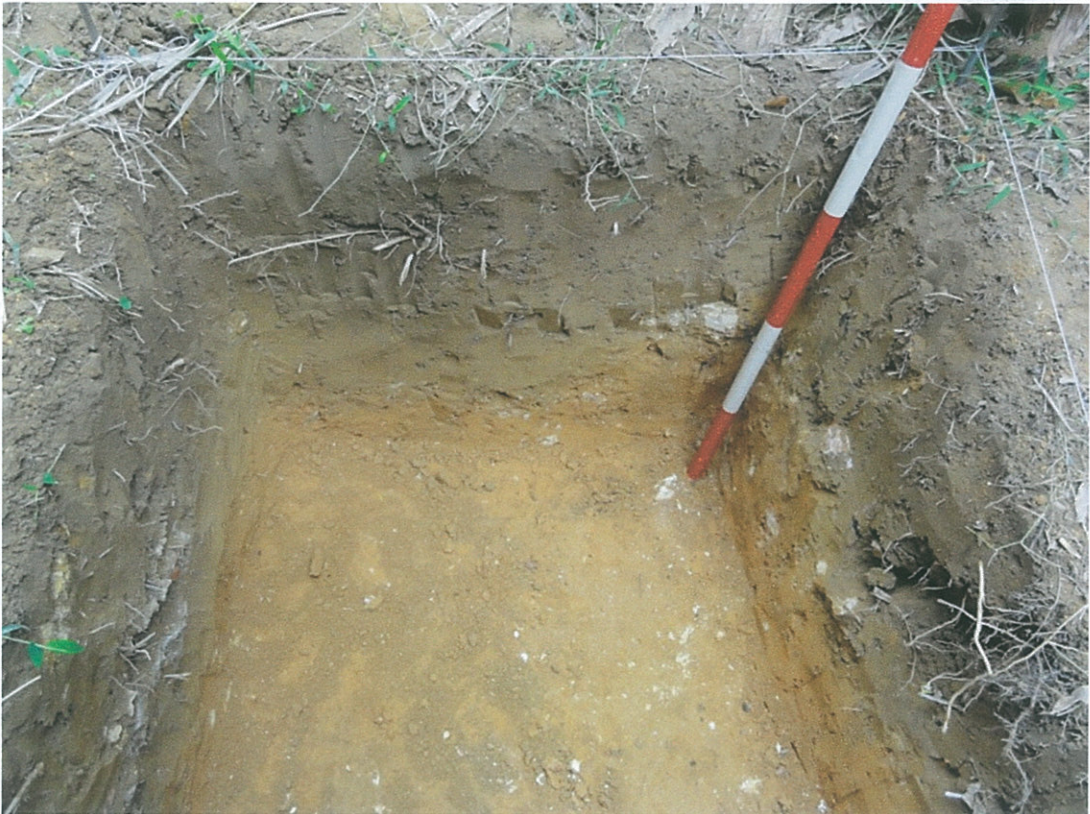
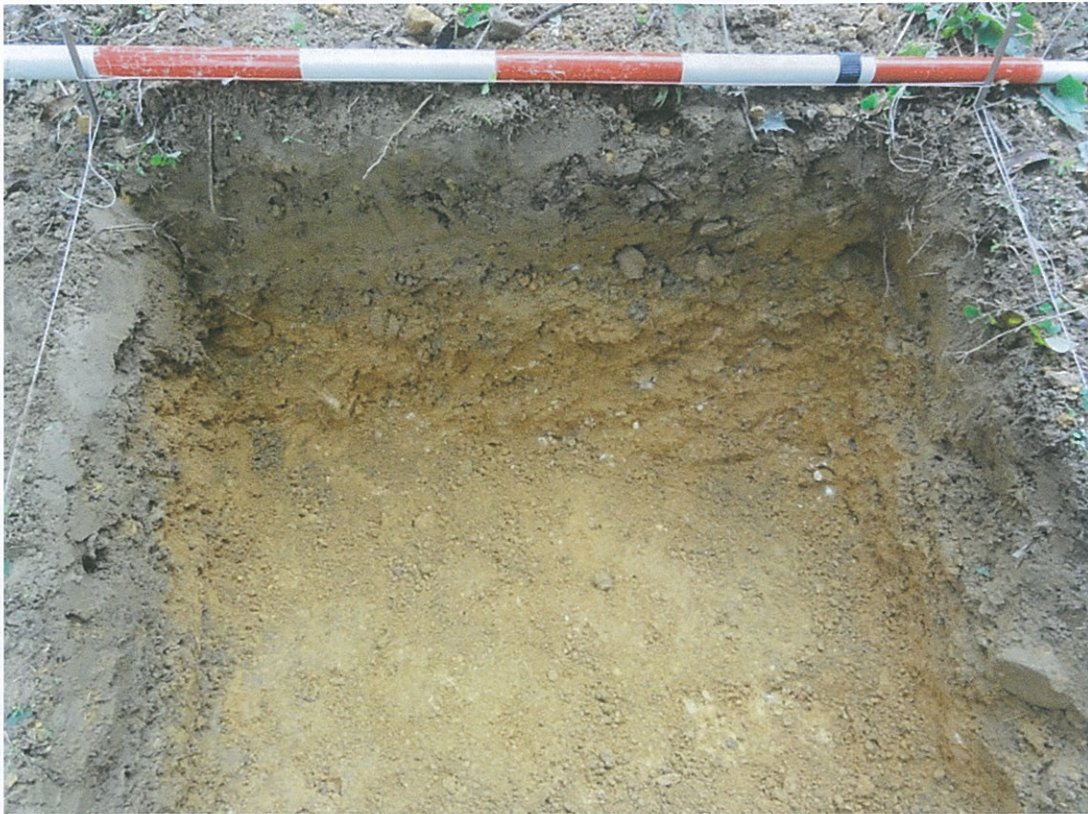
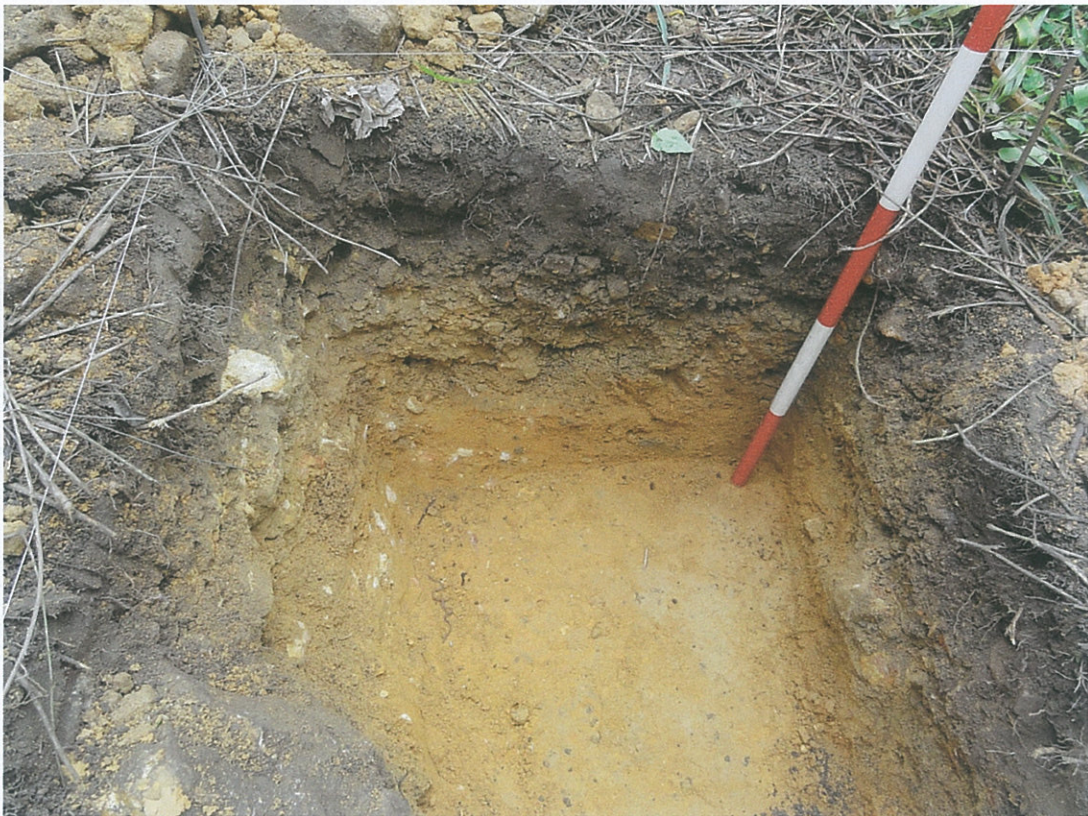
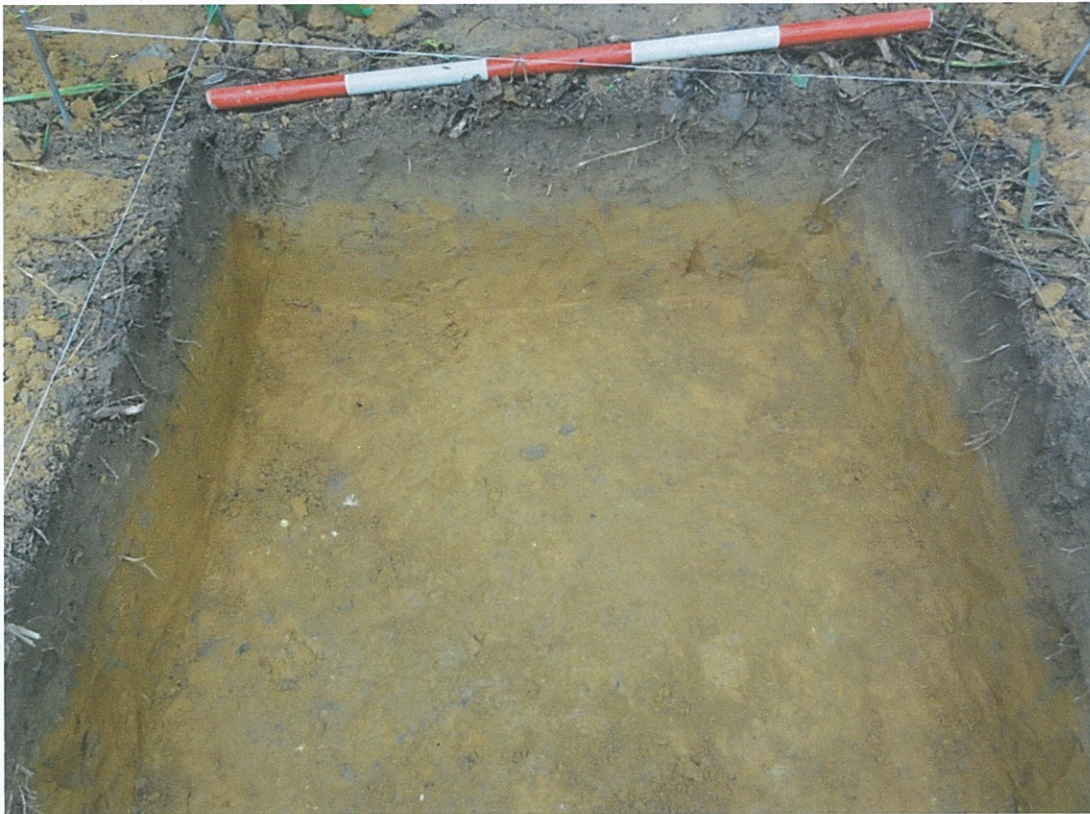
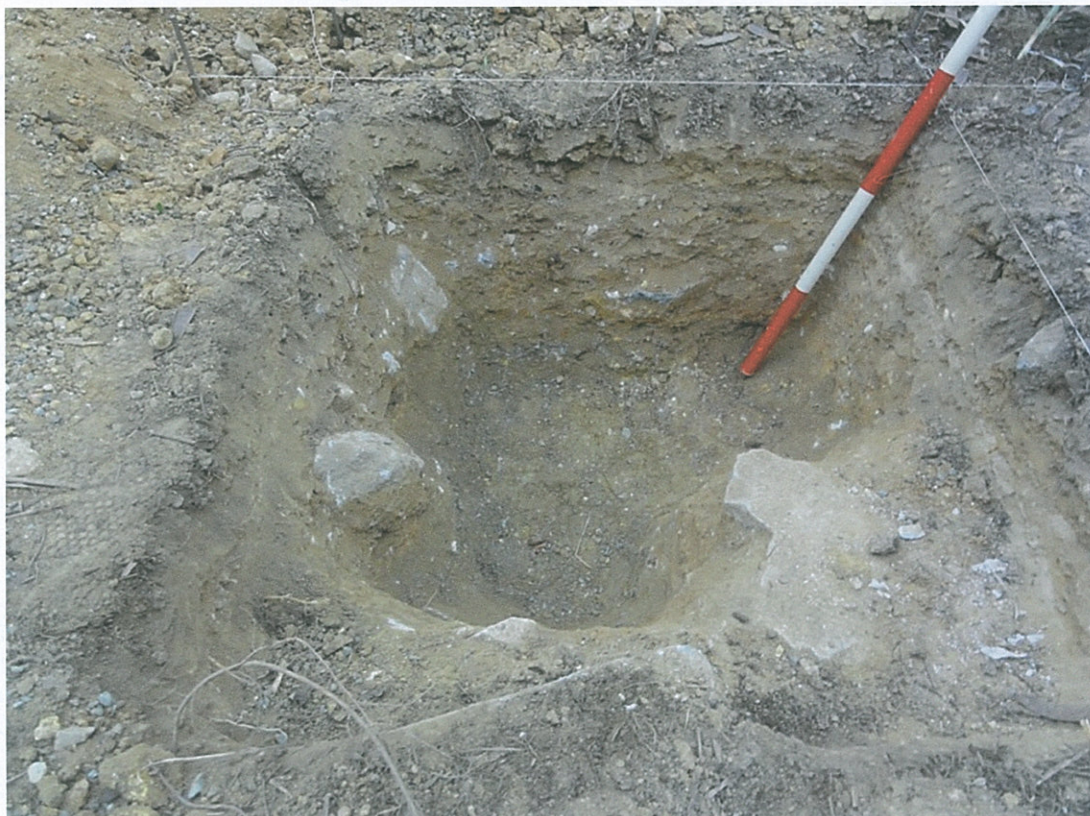
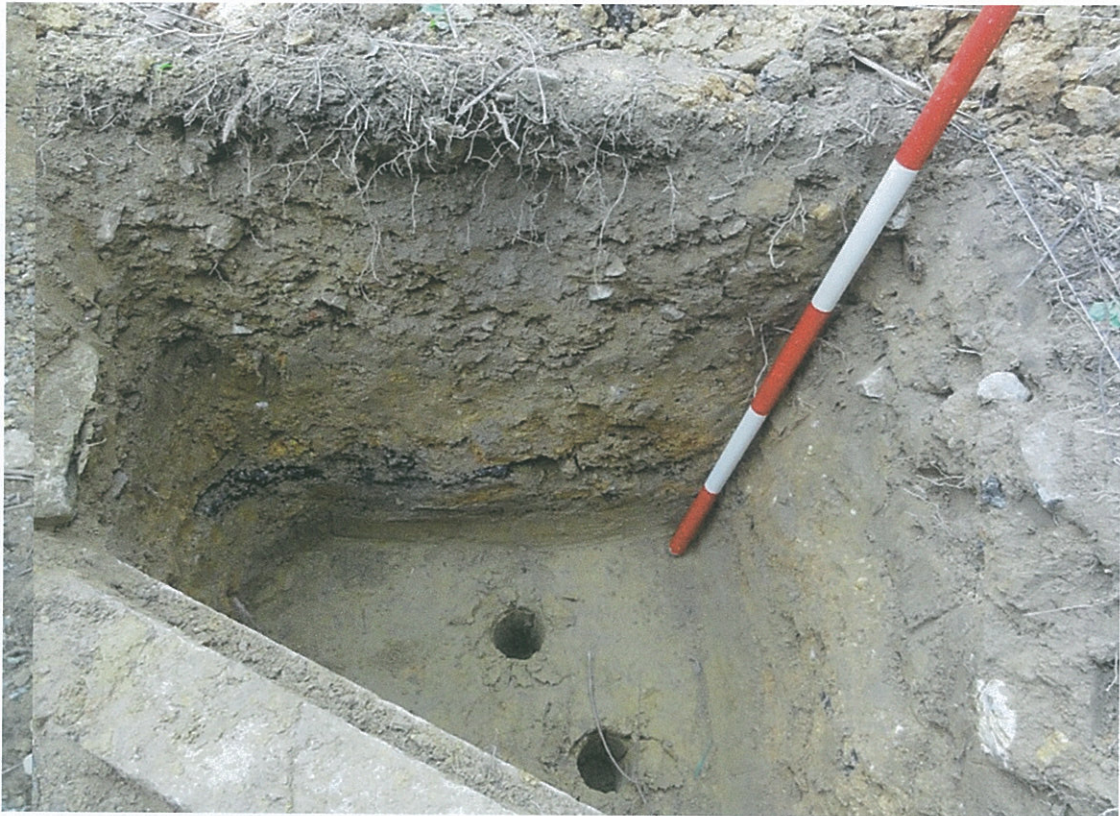
2. Northern Section of 14c

1. Northern Section of 14f

2. Southern Section of 14j

1. Northern Section of 15a

2. Northern Section of 16e

1. Northern Section of 16g

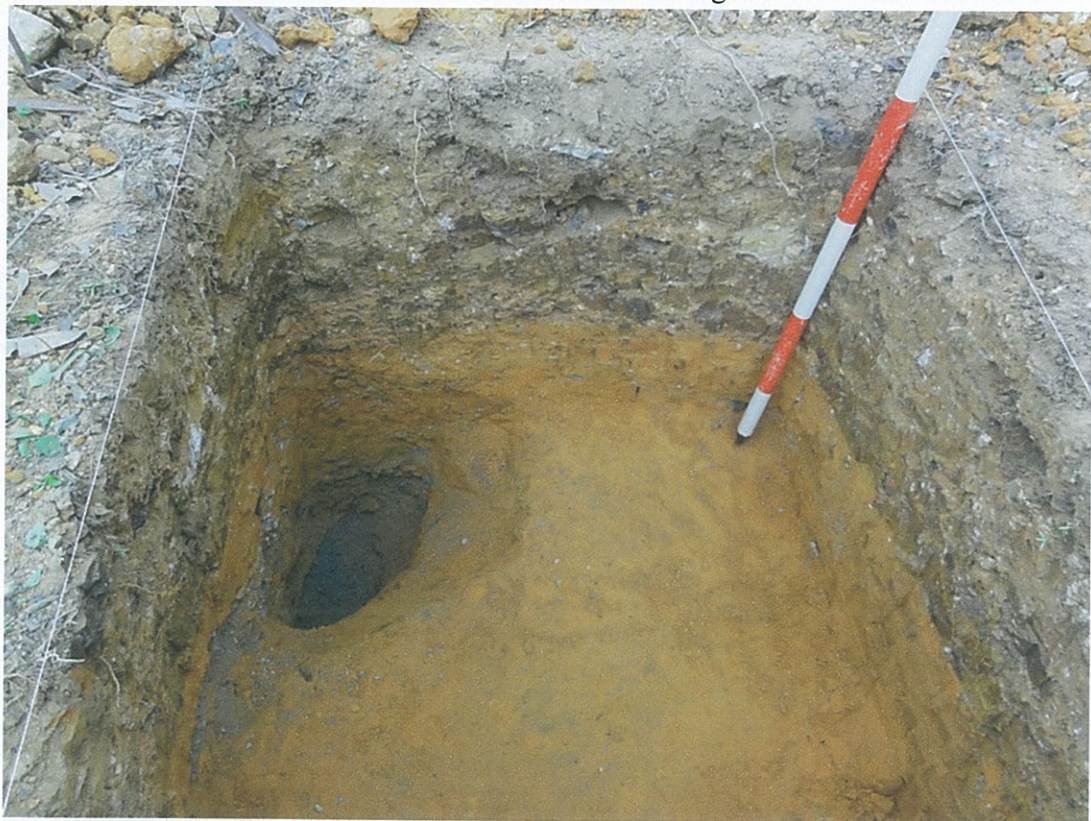
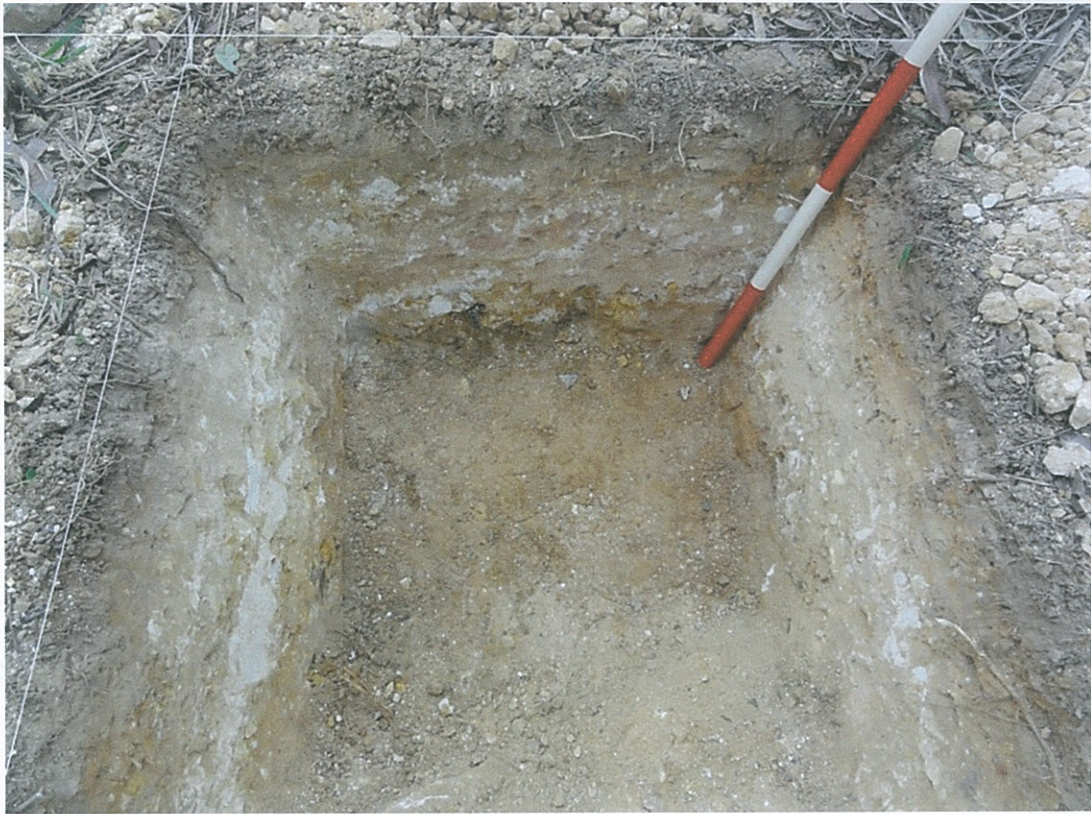
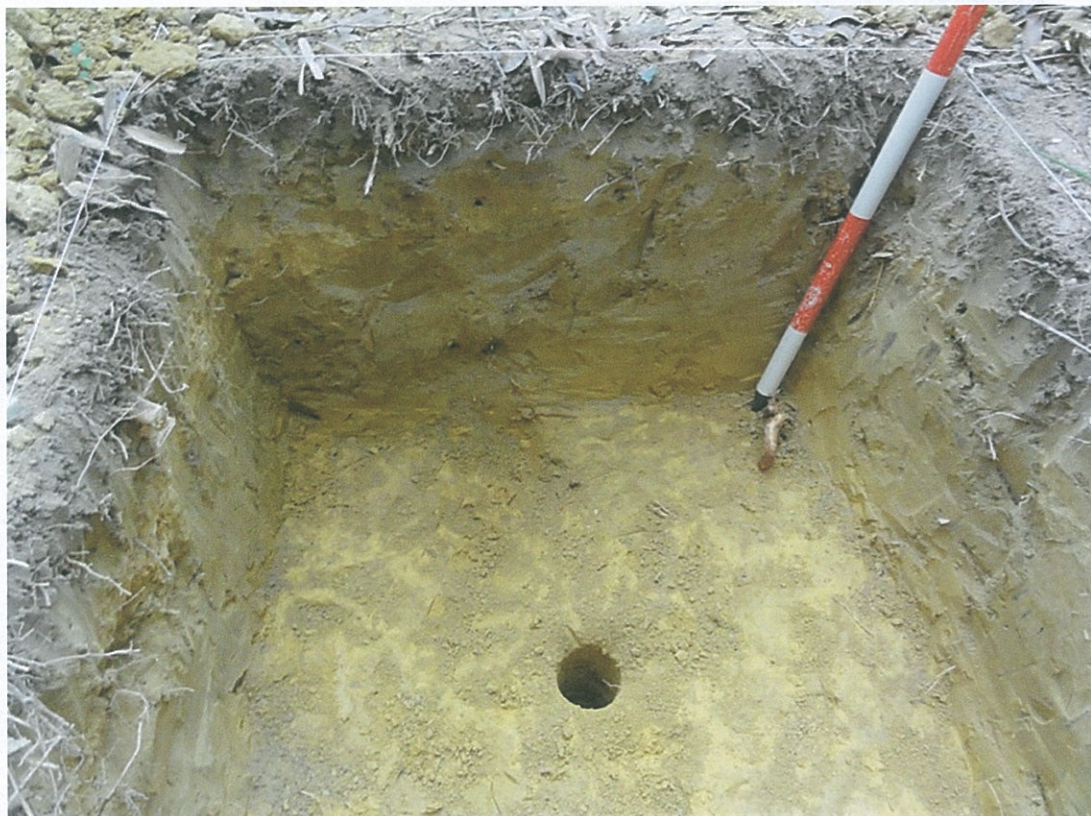
2. Northern Section of 17d

1. Northern Section of 18b

2. Northern Section of 18e

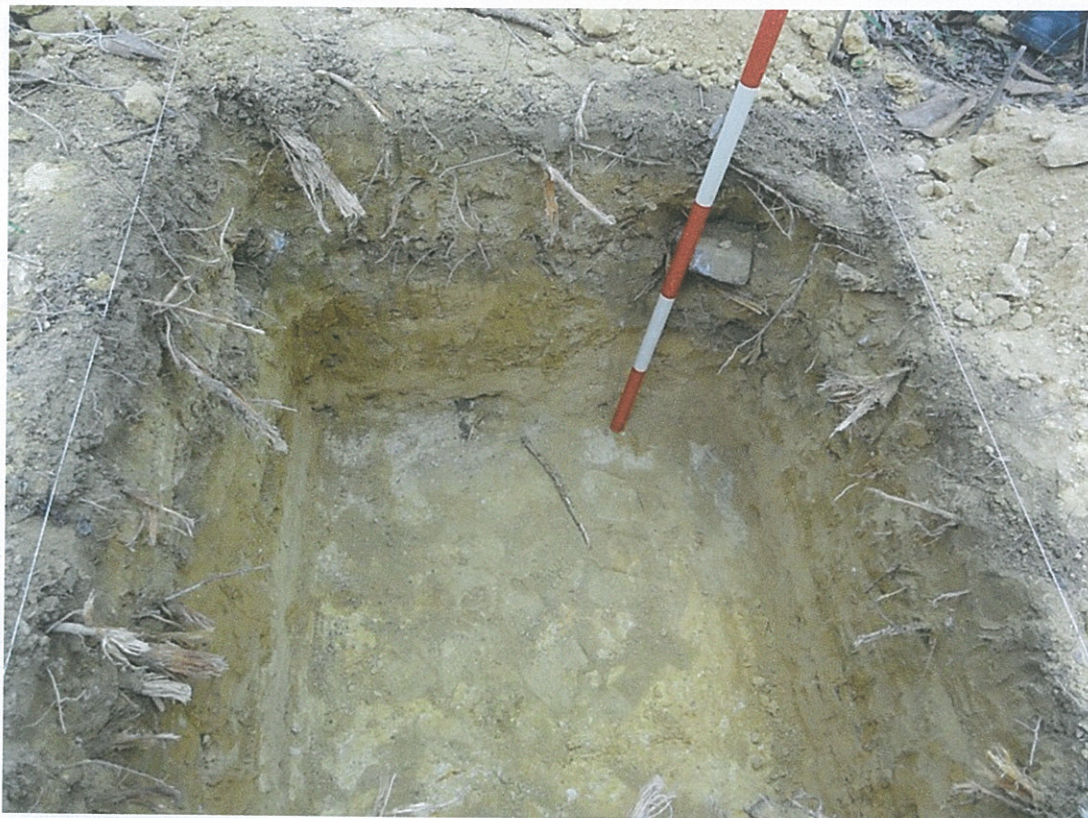
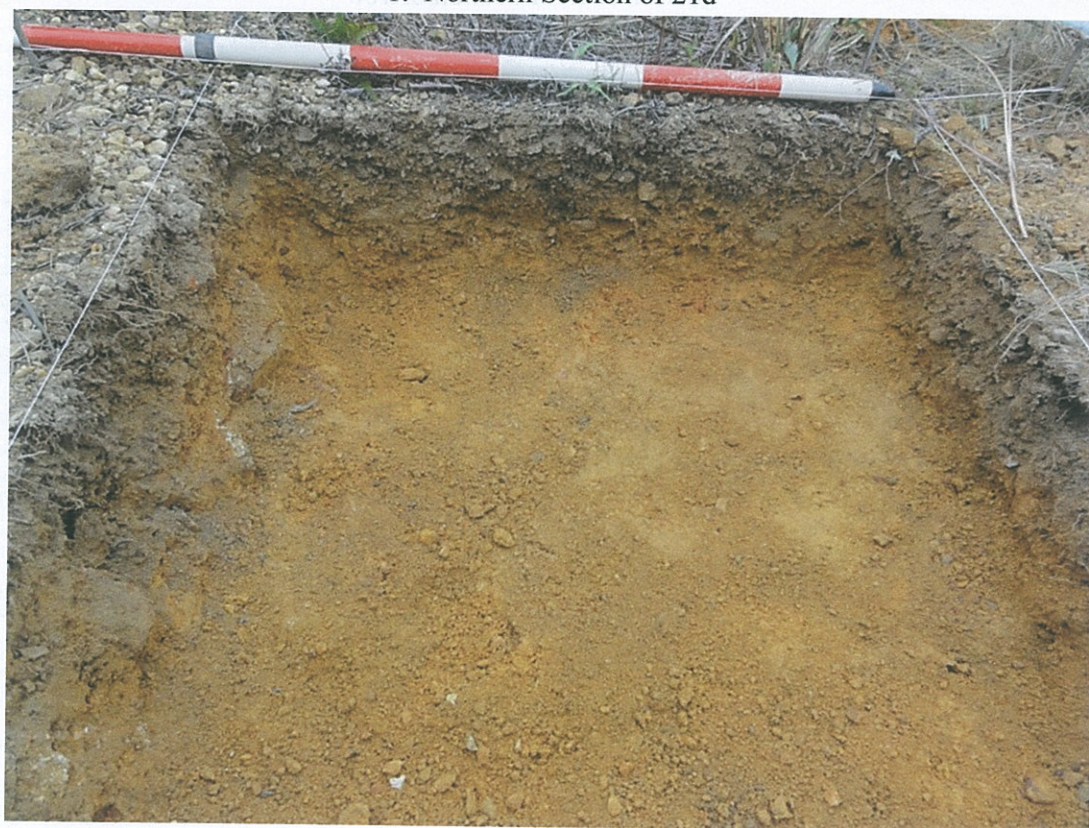
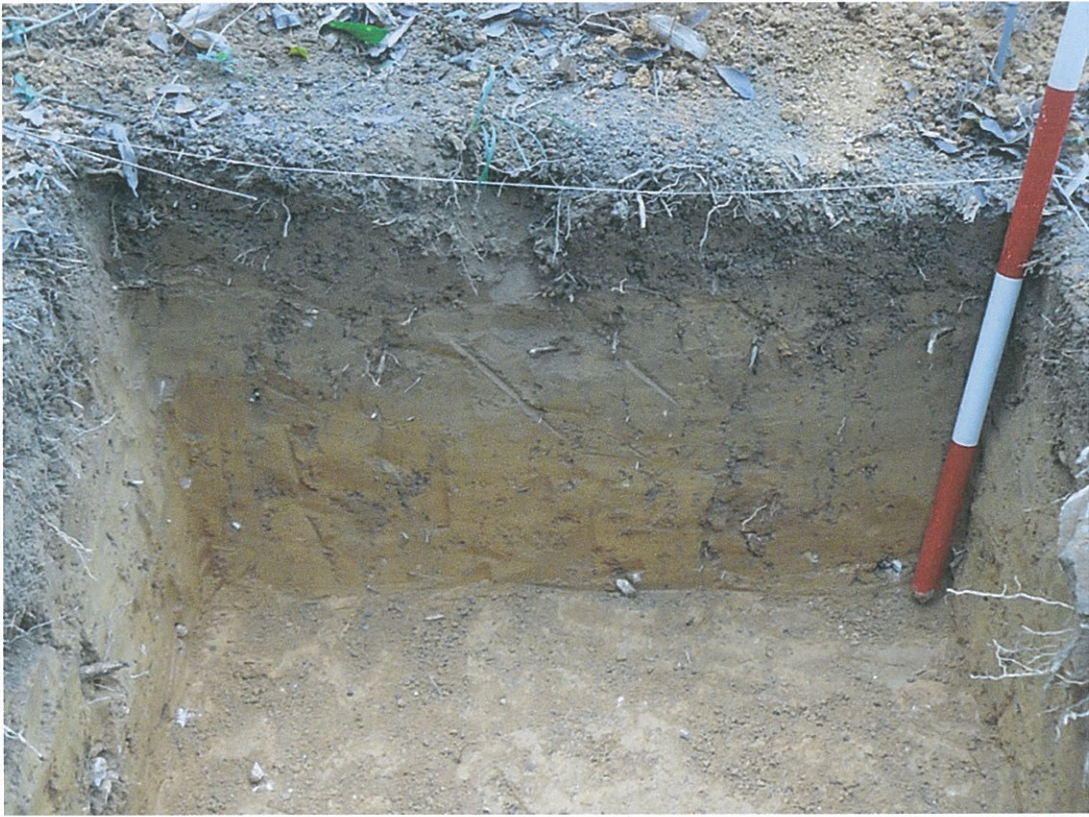
1. Northern Section of 21d

2. Northern Section of 22e

1. Northern Section of 23d
