West Kowloon Cultural District

Contamination Assessment Plan

February 2012

West Kowloon Cultural District Authority

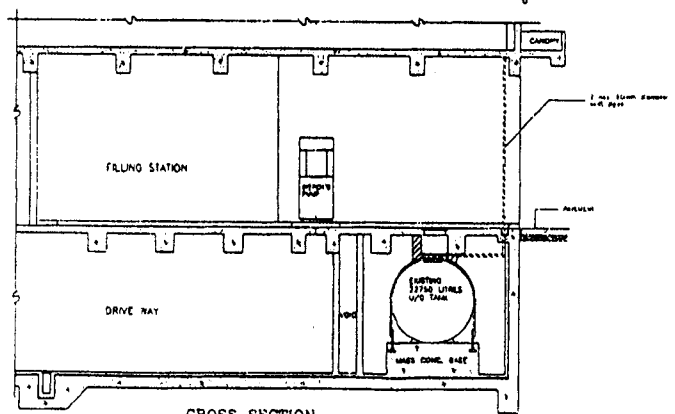
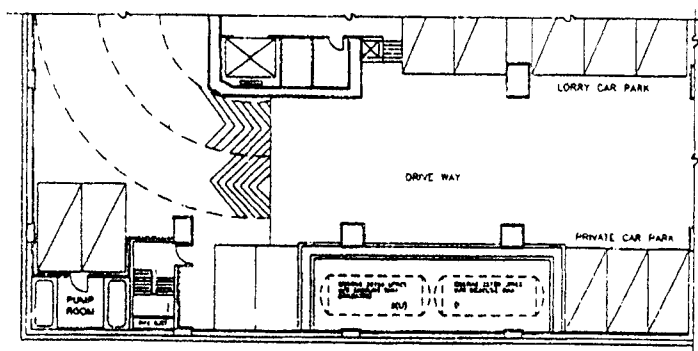
Shell Kok Cheung Street Filling Station

- LEGEND
- 0 ENCLOSURE
 - 1 REDUCER
 - 2 DATE VALVE
 - 3 ANGLE CHECK VALVE
 - 4 (U) - GASOLINE (UNLEADED)

The petrol filling station located at Skyway House is approximately 50m from the KSL alignment. According to the information provided by the filling station operator, the filling station had been operated since 1982. There are two underground tanks located at the basement level, one for storage of unleaded gasoline and the other for diesoline (Annex 1). The volume of each tank is approximately 22.75m³. The tanks are supported on a concrete base with no direct contact between the tanks and the rooms. Information on previous spillage or leakage of diesel fuel is not available.

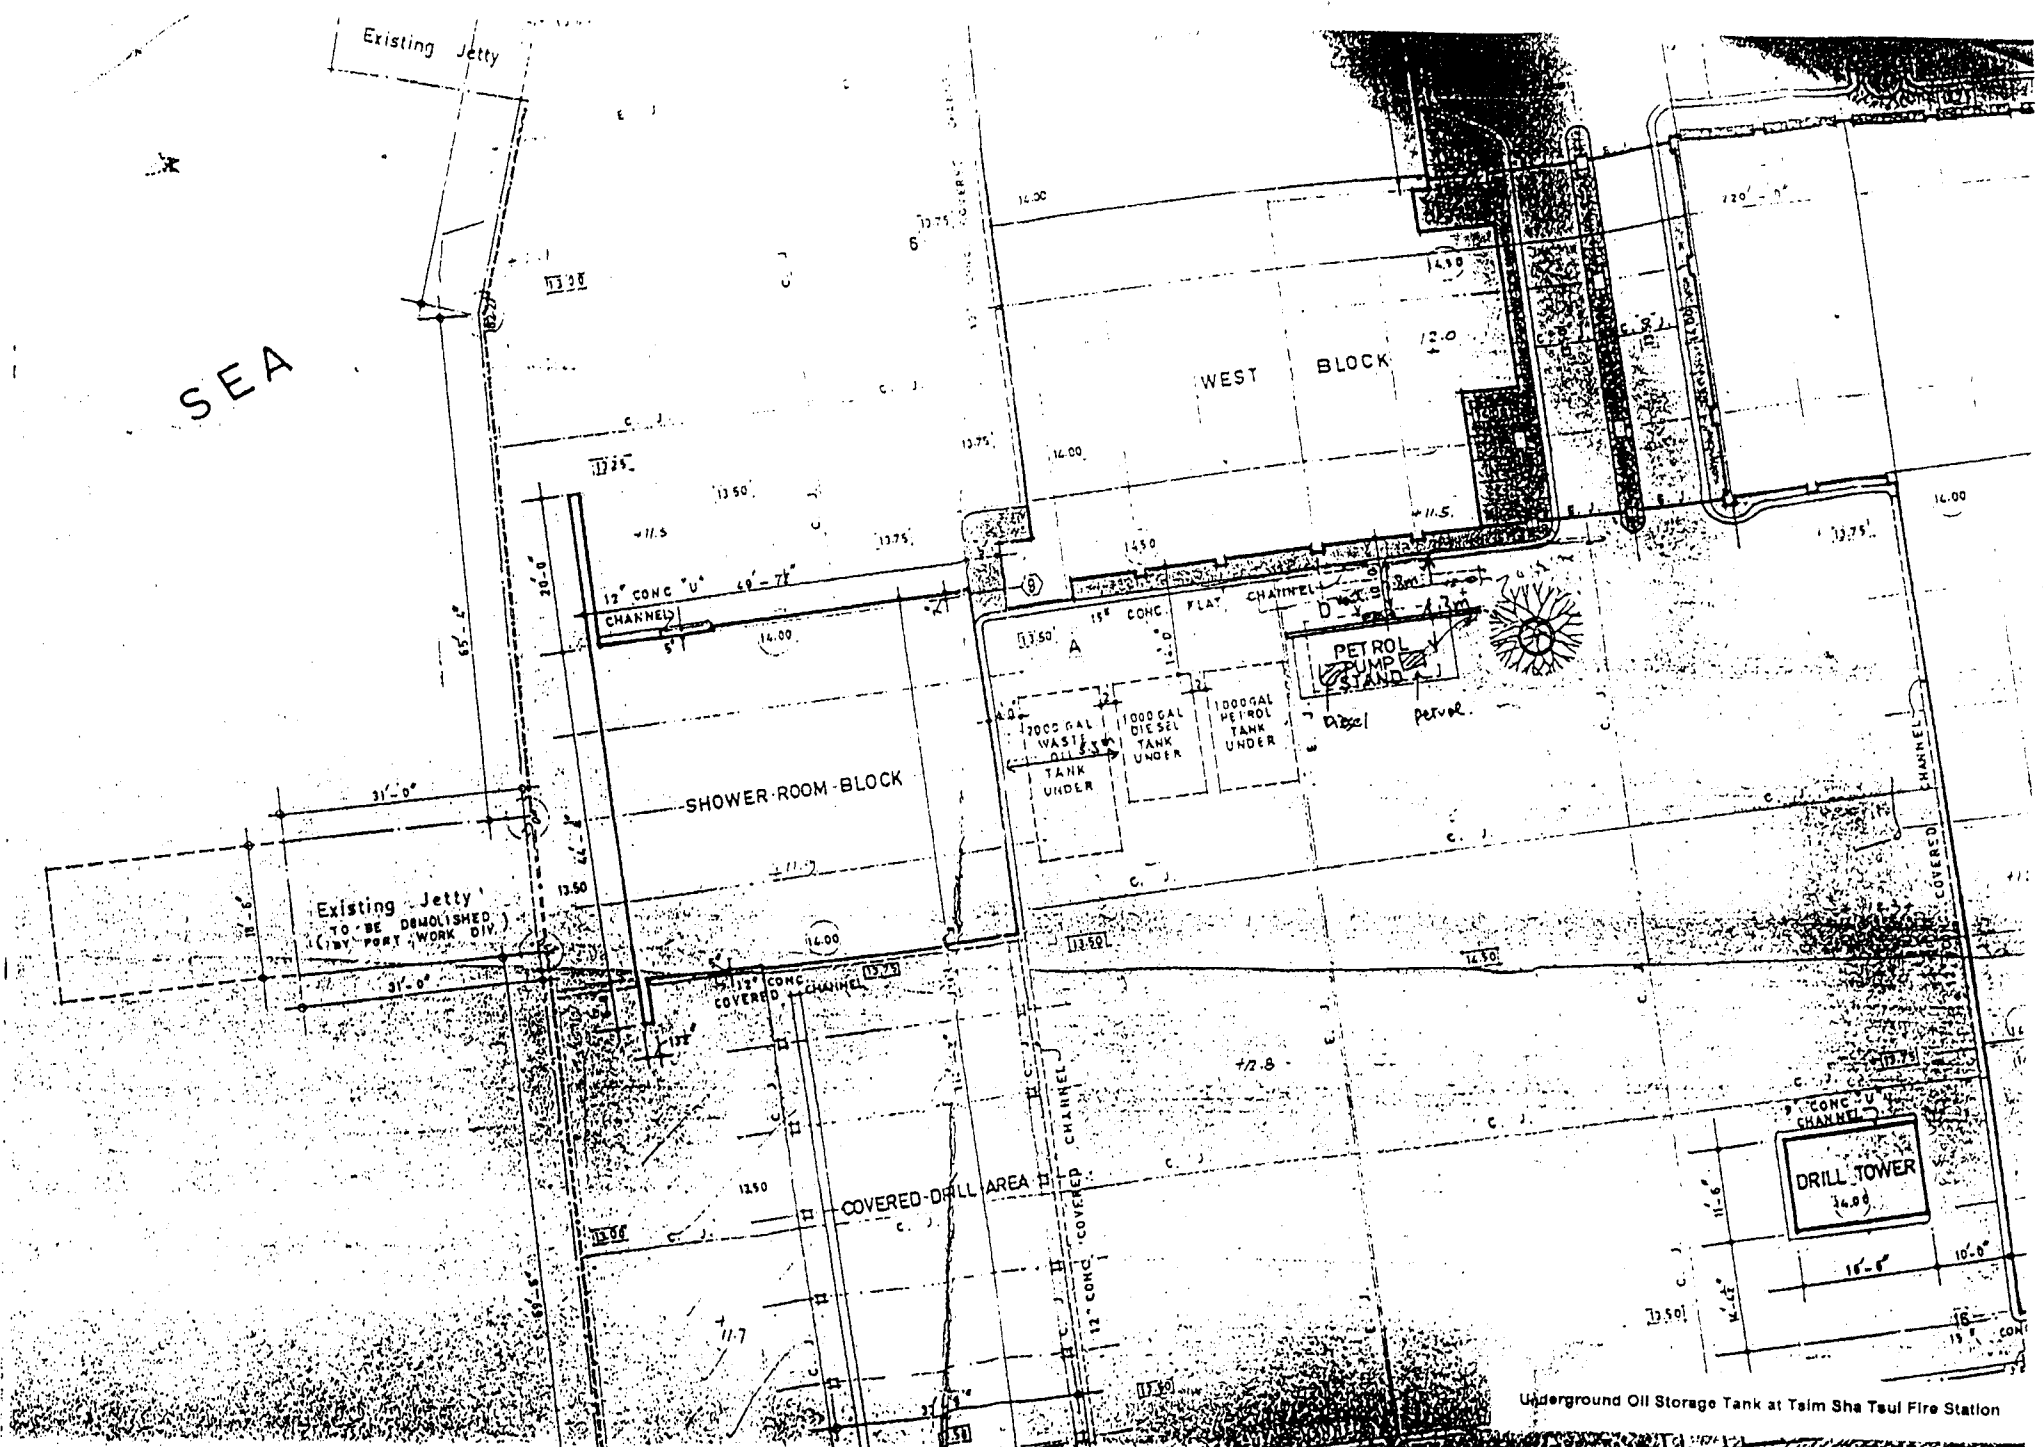
Underground Oil Storage Tank at Taim Sha Tsui Fire Station

Reply from FSD revealed that the only licensed DG stores in the proximity of WKCD Project area are the two underground fuel oil storage tanks (each with a capacity of 4,600 litres) located at the TST Fire Station, but no incident records of spillage/leakage of DG were identified.

There are two underground fuel oil storage tanks at the existing TST Fire Station within the WKCD site. Although there were no records of any accidents involving spillage/leakage of chemical waste or DG within or in the proximity of the WKCD Project area, it is proposed to carry out further site investigation for the TST Fire Station location to identify any potential sources of land contamination that may be due to, but not limited to, leakage or spillage from the fuel oil tanks, pipes, or during refilling. The reason is as follows.
