Ref: CC01	Title: Shrine	Category: Religious, Ritual and Funerary	
Address: Near the intersection of Pak Kok Tsui Road and Cheung Kwai Road		Figure Ref: 10.22	Old Ref: PC12
Orientation: West		Grading: Nil Grade

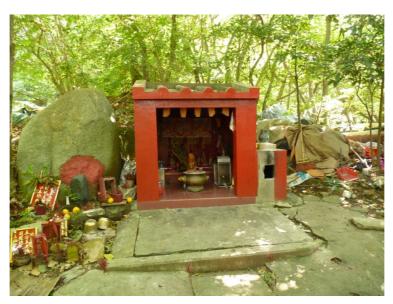
Architectural Appraisal: Small 3-sided box shaped concrete structure with exterior walls painted red. Open front with offering area inside.

Existing Condition: Good structural condition

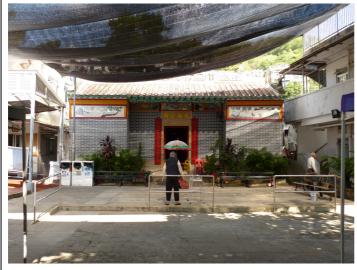
Exterior Façade of Tin Hau Temple

Layout: A temple in two	-hall-one-courtyard layout of the	ree bays	
Construction Material:			
Windows: Nil	mber rafters, purlin and clay tile astered with false brick lines	es	
Decorative Features: Th	ne main ridge is with Shiwan (石 ding ridges are a Sun God (日前 ee dragon, flowers and rocks m	神) and a Moon God (月神) o	
	o, dragon, nowers and rocks in		
Interior: See Architectur	•		
Interior: See Architectur Existing Condition: Goo	al Appraisal above		
	al Appraisal above

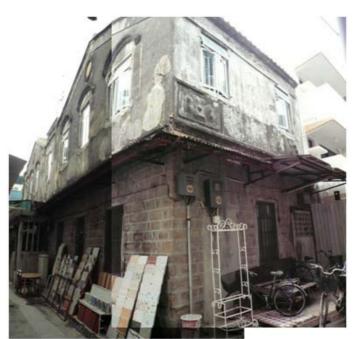
Rear and side elevation of Goon Sor

Associated Historical/ Cultu	ral Events or Individual: Nor	ne		
Inscriptions: 所	公			
Architectural Appraisal:				
Layout: A two level rectangular structure with attached temporary structures  Construction Material: Roof: Timber beams and clay tile laying pitched roof Windows: Modern Style metal frame glass windows Walls: Stone Doors: Metal gate  Decorative Features: Embossment feature on wall frieze				
Interior: Not Accessible				
Existing Condition: Fair				
Past and Present Uses: Community buildings, prison, grocery store (currently)				
Modifications: Modern windows were installed.				
Photographia Passada				
Photographic Record:

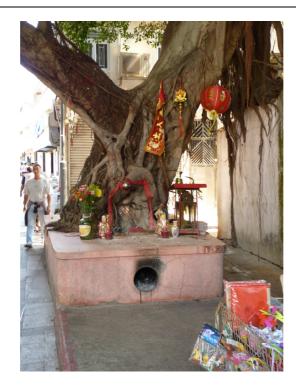
The shrine is a tree shrine and a platform was constructed around the tree. A burner is found as part of the platform.

Existing Condition: Good

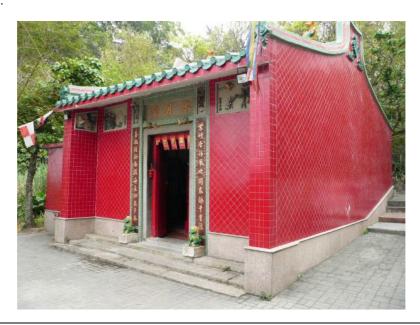
**Existing Conditions: Good**

Modifications: The temple is covered with glazed ceramic tiles internally and externally made in a renovation in 1996. It was also heavily modified by renovations in 1958.
