Figure: 11-34

ENVIRON
Title: Landscape and Visual Mitigation Measures - Photomontage (Sheet 1 of 8)	Drawn by: LW
Project: Comprehensive Development and Wetland Protection near Yau Mei San Tsuen, Yuen Long	Checked by: AM
	Rev.: -
	Date: DEC 2014

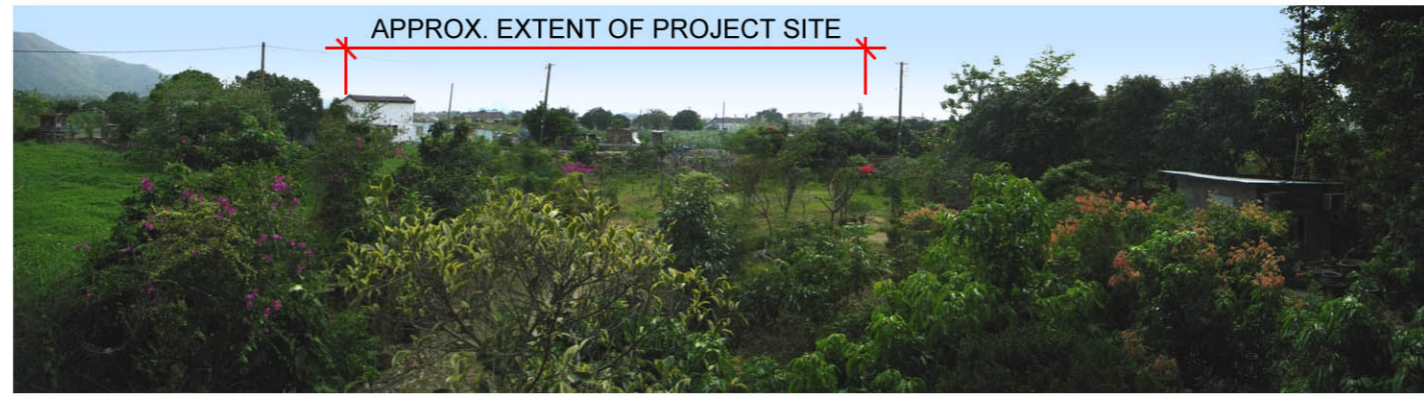
VIEW FROM VSR R3 SOUTHERN ROYAL PALMS - EXISTING SITUATION (VIEW POINT 9)

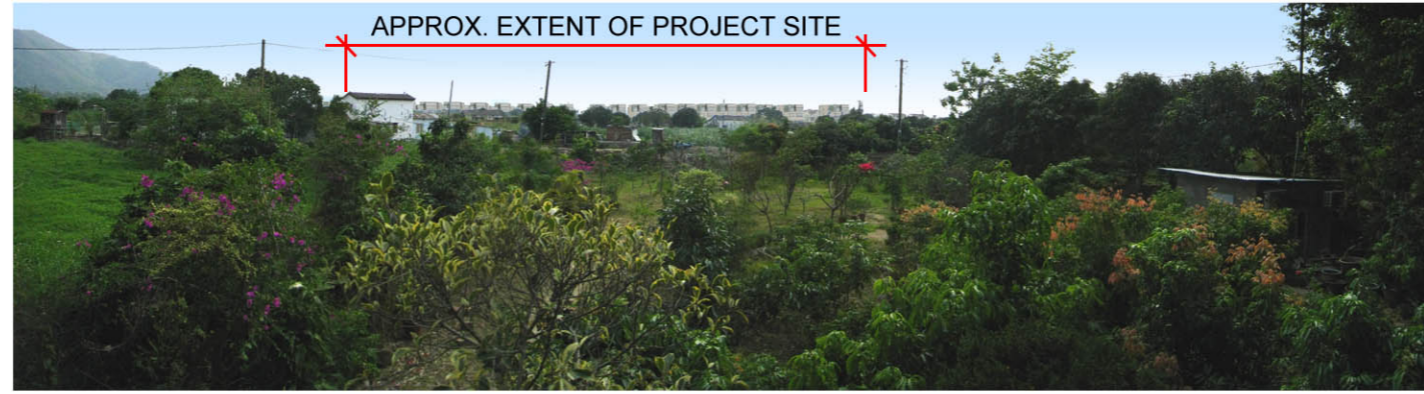
VIEW FROM VSR R3 SOUTHERN ROYAL PALMS - DAY 1 WITHOUT MITIGATION (VIEW POINT 9)

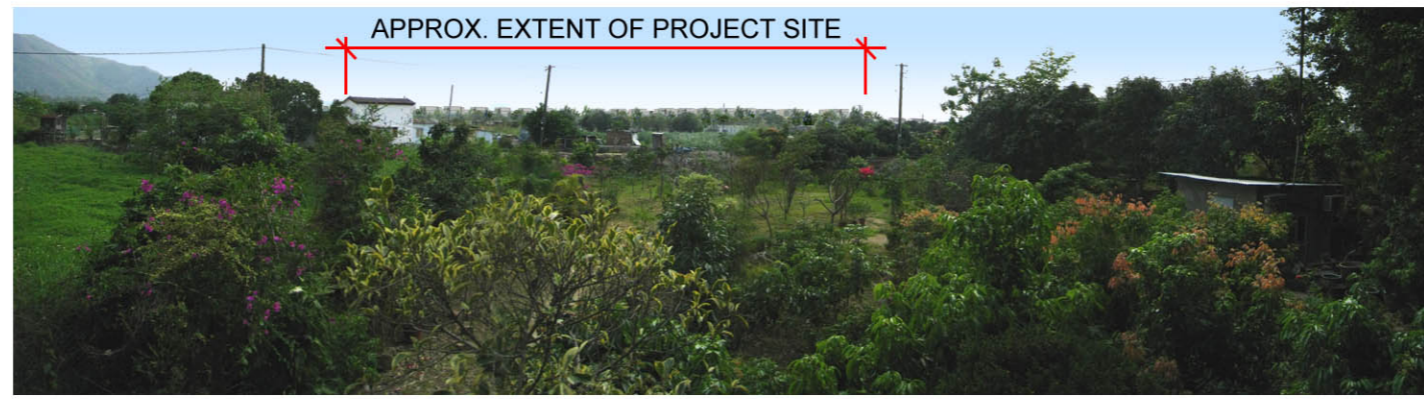
VIEW FROM VSR R3 SOUTHERN ROYAL PALMS - DAY 1 WITH MITIGATION (VIEW POINT 9)

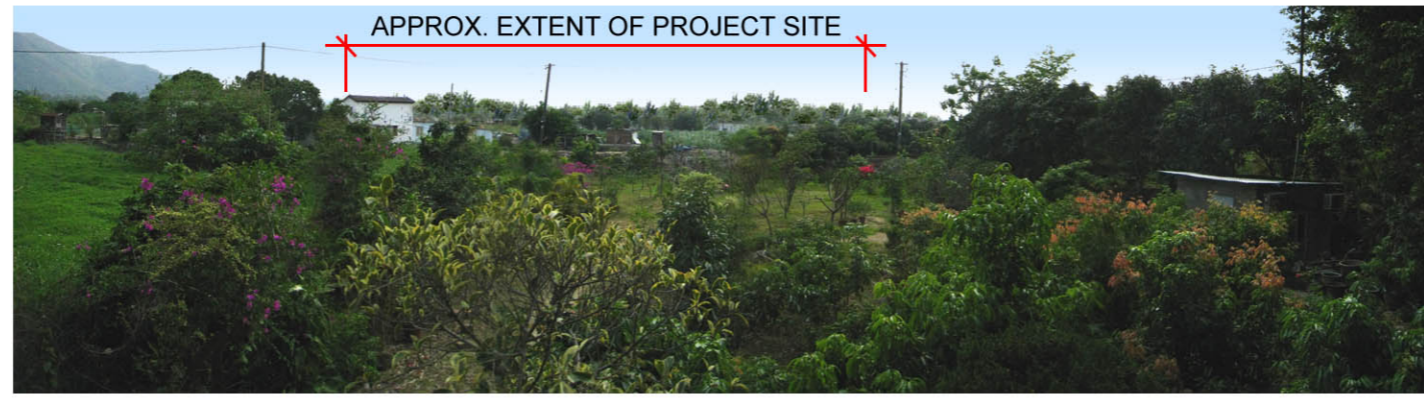
VIEW FROM VSR R3 SOUTHERN ROYAL PALMS - YEAR 10 WITH MITIGATION (VIEW POINT 9)
