Figure: 11-37

Title: Landscape and Visual Mitigation Measures - Photomontage (Sheet 4 of 8)

Project: Comprehensive Development and Wetland Protection near Yau Mei San Tsuen, Yuen Long

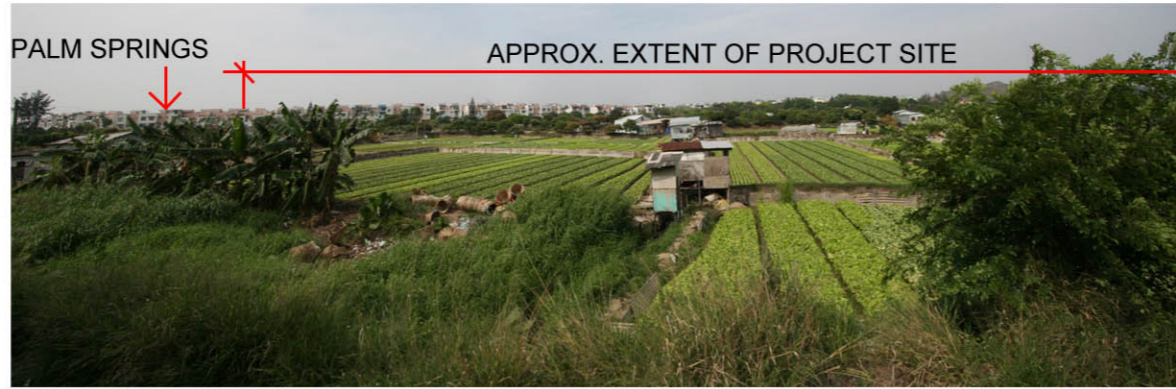
VIEW FROM VSR R1 NORTHERN FAIRVIEW PARK - EXISTING SITUATION (VIEW POINT 12)

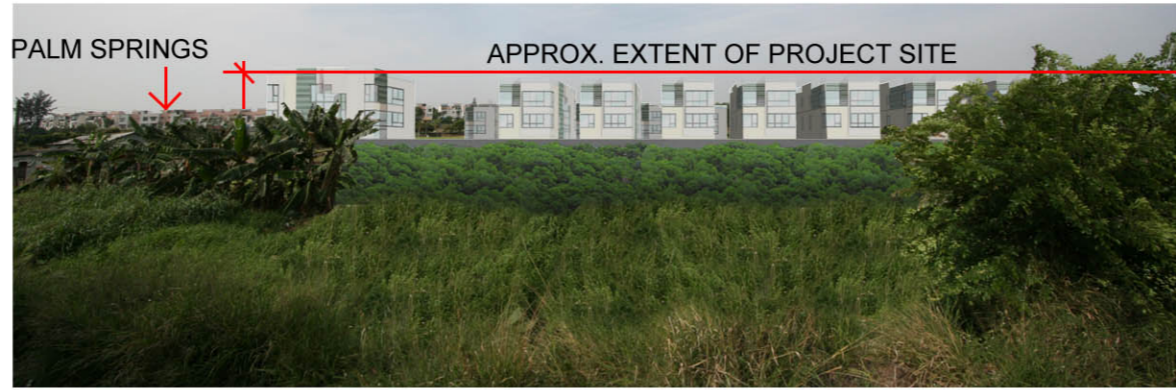
VIEW FROM VSR R1 NORTHERN FAIRVIEW PARK - DAY 1 WITHOUT MITIGATION (VIEW POINT 12)

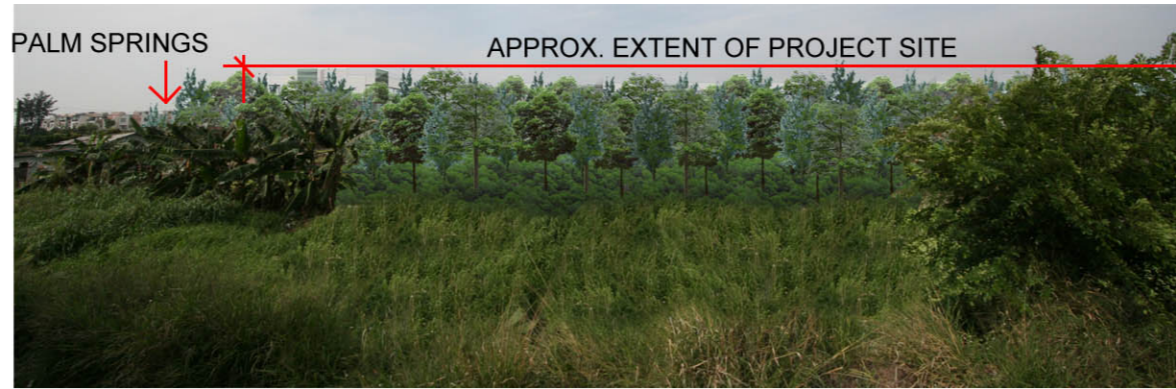
VIEW FROM VSR R1 NORTHERN FAIRVIEW PARK - DAY 1 WITH MITIGATION (VIEW POINT 12)

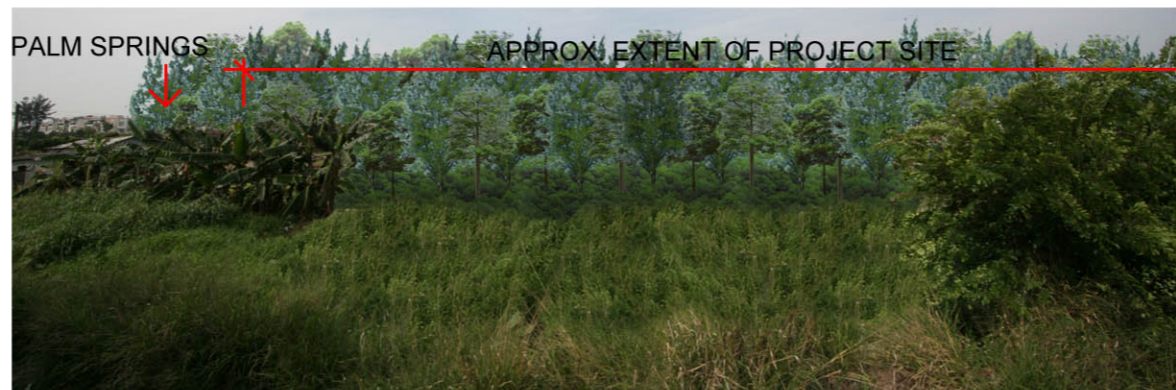
VIEW FROM VSR R1 NORTHERN FAIRVIEW PARK - YEAR 10 WITH MITIGATION (VIEW POINT 12)
