Appendix 12.2

Historic Building and Structures Catalogue

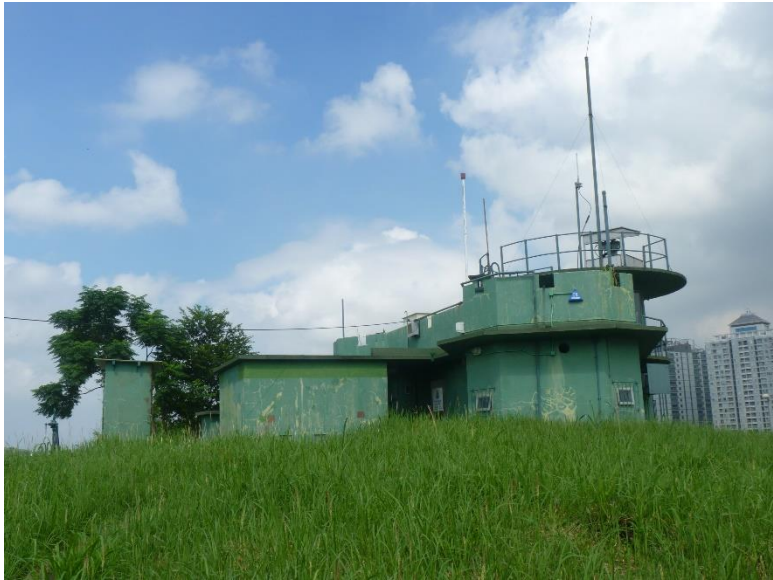
Ref: GB-01	Title: MacIntosh Fort (Nam Hang)	Category: Government
Location: Sha Ling near Lo Wu		Figure Ref: 12.3.4
Orientation: North		Grading: Grade 2
Surrounding Environment: The building is set at the top of a grassy hill overlooking the surrounding countryside and faces the Shenzhen River and the Chinese border.		
Historical Appraisal: The fort is one of seven observation posts that were built along the border during 1949 and 1953.		
Associated Historical / Cultural Events or Individual: The forts were named after Duncan William MacIntosh, the police commissioner of Hong Kong between 1946 and 1953. He was behind the scheme to build the forts which became known at the time as MacIntosh Cathedrals		
Inscriptions: None		
Architectural Appraisal: The fort is constructed of reinforced concrete and the design of all seven forts is similar. The origin of the design is not known, but it has been suggested that it may be after the bridge of a ship or hill top forts in India. The design does not correspond to a specific architectural style but has been described as Modern Utilitarian. The fort has an observation tower and two wings forming a chevron shape.

Interior: Not Accessible		
Existing Condition: Good		
Past and Present Uses: Originally as a lookout post for illegal immigrants. The building has remote controlled facilities today and is not manned.		
Modifications: No obvious modifications.		
Photographic Record:

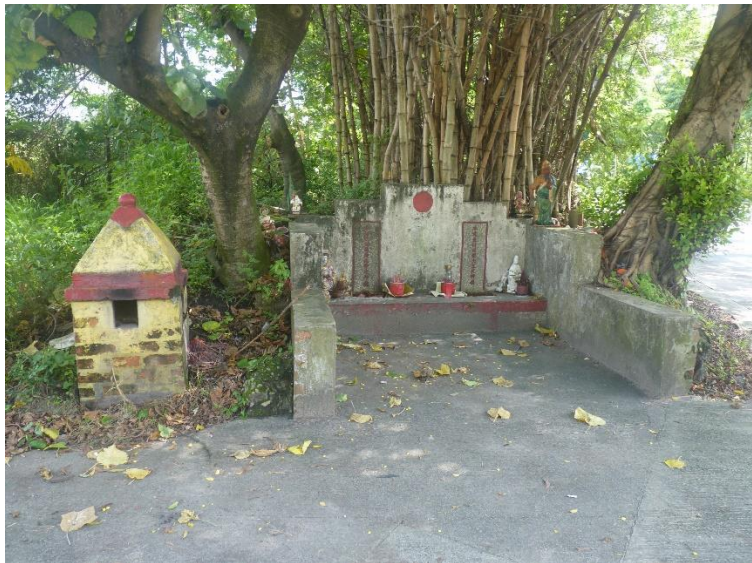
Ref: HB-01	Title: Earth God Shrine	Category: Religious, Ritual and Funerary
Location: Man Kam To Road		Figure Ref: 12.3.5
Orientation: Southwest		Grading: Nil
Surrounding Environment: The temple is set by the side of Man Kam To Road in a non-village setting on a road leading up to the Sandy Ridge Cemetery. There is a stand of bamboo behind the shrine.		
Historical Appraisal: The shrine may date to the Qing Dynasty.		
Associated Historical/ Cultural Events or Individual: None		
Inscriptions: (L) 正 本 神 坊 之 土 神 地 位 福 德		Inscriptions: (R) 大 本 王 境 之 護 神 村 位 社 稷
Architectural Appraisal: The shrine is covered with concrete and the burner beside of brick and concrete.		
Interior: Not applicable		
Existing Condition: Good		
Past and Present Uses: Religious, Ritual and Funerary		
Modifications: None		
Photographic Record:

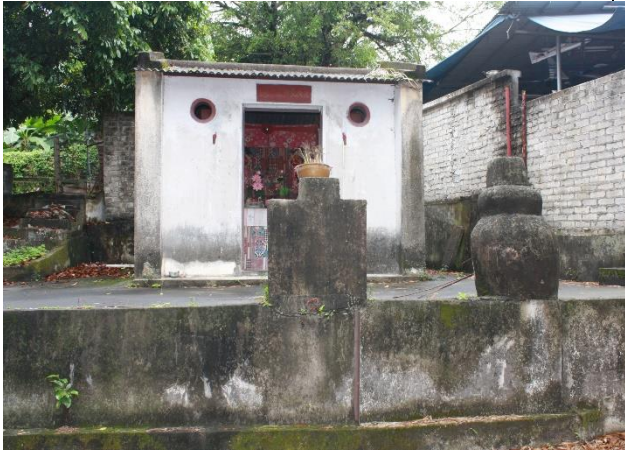
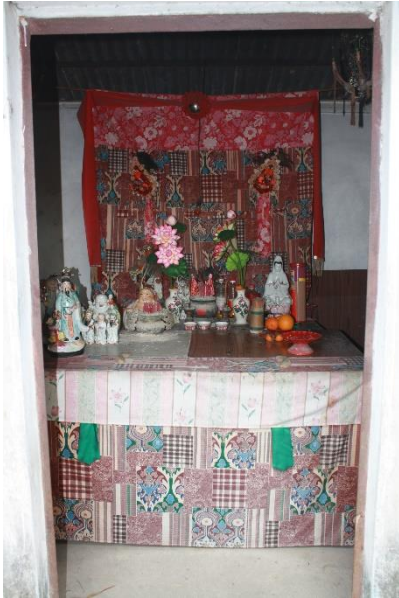
Ref: HB-02	Title: Tin Hau Temple	Category: Religious, Ritual and Funerary
Location: Man Kam To Road		Figure Ref: 12.3.6
Orientation: Southwest		Grading: Nil
Surrounding Environment: The temple is set by the side of Man Kam To Road in a non-village setting. There are housing and light industrial compounds in the area.		
Historical Appraisal: The Temple is used by the local people. The local informants did not have any detailed information on the history of the temple.		
Associated Historical/ Cultural Events or Individual: None		
Inscriptions: None		
Architectural Appraisal: Modern concrete structure single room and single storey. Corrugated metal roof. The façade has a rectangular entrance and two round air vents beside the top corner of the door. The building is set on a concrete platform and there is an offerings burner and small shrine on the platform in front of the temple.		
Interior: Single room very plain wall and floor, corrugated metal roof as ceiling.

Existing Condition: Good		
Past and Present Uses: Religious, Ritual and Funerary		
Modifications: None		
Photographic Record:

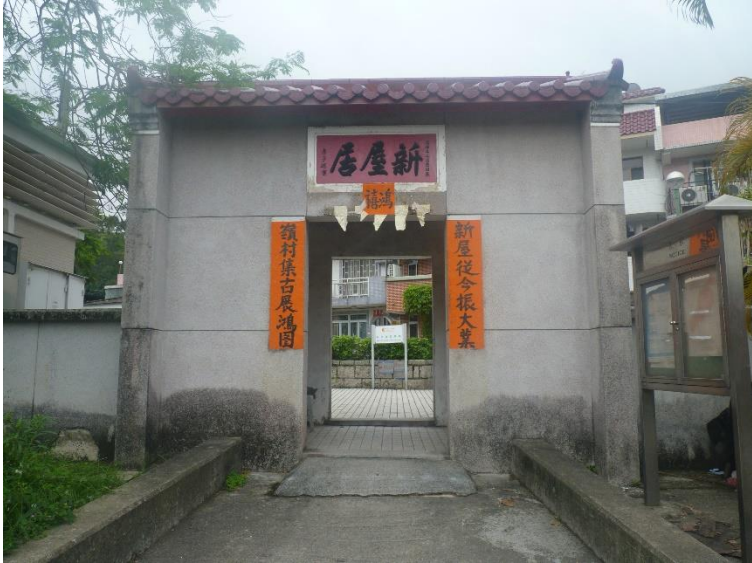
Ref: HB-03	Title: San Uk Ling Village Entrance Gate	Category: Local Community
Location: San Uk Ling Village		Figure Ref: 12.3.11
Orientation: Northwest		Grading: Nil
Surrounding Environment: The gate is situated at the front of the village just off Lin Ma Hang Road		
Historical Appraisal: The gate dates back to 1956.		
Associated Historical/ Cultural Events or Individual: None		
Inscriptions: (L) 李子遊書	Inscriptions: (Centre) 新屋居	Inscriptions: (R) 丙申年二月吉日立
Architectural Appraisal: The gate is concrete covered. It is rectangular in shape with a single storey room inside. The roof has decorative glazed ceramic tiles.		
Interior: Not Applicable		
Existing Condition: Good		
Past and Present Uses: Religious, Ritual and Funerary		
Modifications: None		
Photographic Record:

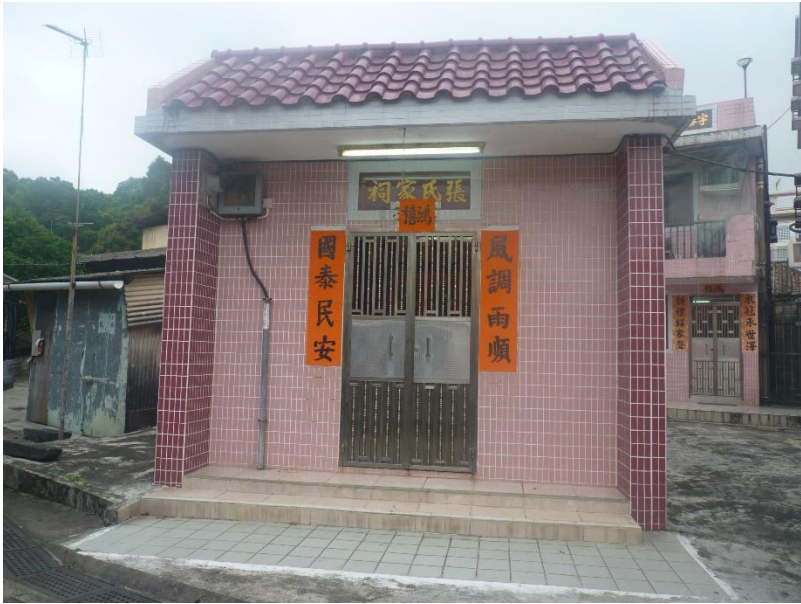
Ref: HB-04	Title: Cheung Ancestral Hall	Category: Religious, Ritual and Funerary
Location: San Uk Ling Village		Figure Ref: 12.3.11
Orientation: Northwest		Grading: Nil
Surrounding Environment: The hall is situated near the front of the village in an open area.		
Historical Appraisal: The ancestral hall is of the Cheung Clan who originally settled the village from Wong Pui Leng in Shenzhen over 200 years ago (the village was listed in 1819 villages so predates that date). Local informants think the village has an age of around 300 years.		
Associated Historical/ Cultural Events or Individual: None		
Inscriptions: (L)		Inscriptions:
年 一 十 九 月 九 七		張氏家祠
Architectural Appraisal: A rectangular detached single storey building with pink exterior tiles. There is an entrance hall and main hall behind.		
Interior: Modern materials		
Existing Condition: Good		
Past and Present Uses: Religious, Ritual and Funerary

Modifications: Renovated 1997 (basically rebuilt with modern materials)		
Photographic Record:

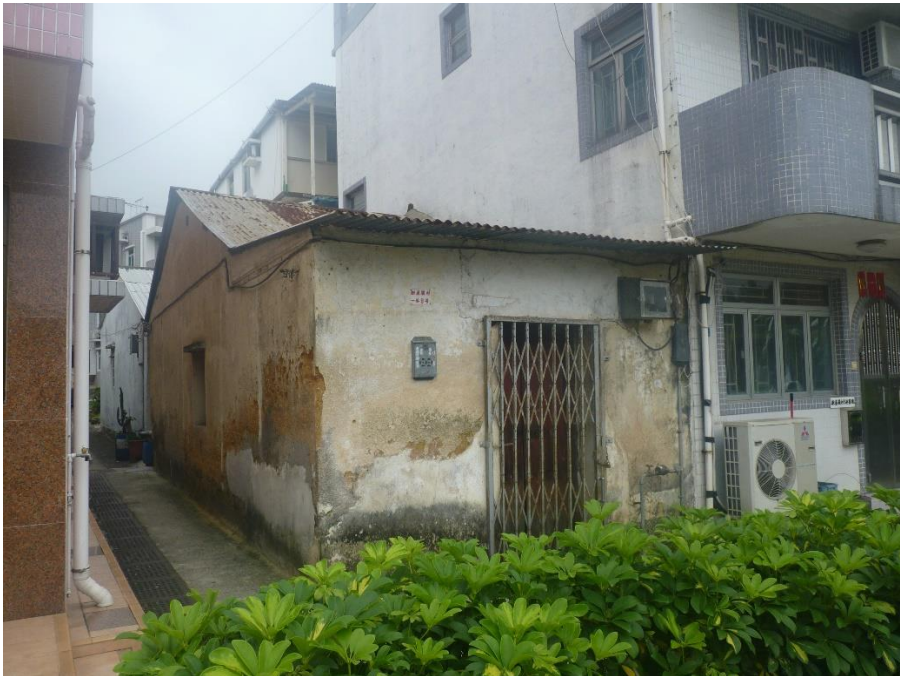
Ref: HB-05	Title: No. 9 San Uk Ling Village House	Category: Residential, Domestic
Location: No. 9 San Uk Ling Village		Figure Ref: 12.3.11
Orientation: Southwest		Grading: Nil
Surrounding Environment: In the second row of the village at the end of a terrace. It is attached to a modern building on one side.		
Historical Appraisal: The house may date back around 100 years according to local informants and as such would be one of the oldest buildings still standing in the village.		
Associated Historical/ Cultural Events or Individual: None		
Inscriptions: None		
Architectural Appraisal: Terrace row house with rammed earth walls and no decorative features.		
Interior: Not Accessible		
Existing Condition: The building appears to be structurally sound. There are some sections of render covering that has worn away and some sections of the exterior walls have been repaired with concrete.		
Past and Present Uses: Residential, Domestic

Modifications: corrugated metal roof		
Photographic Record:

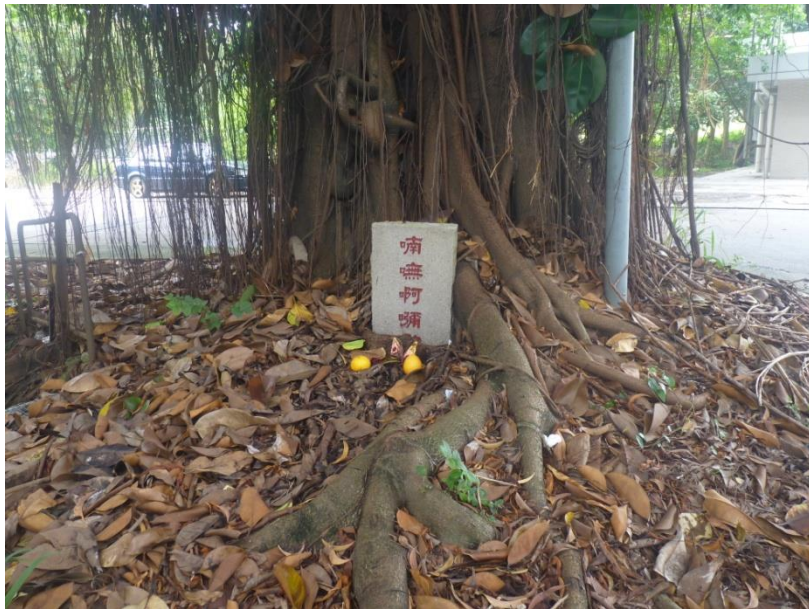
Ref: HB-06	Title: Buddhist Shrine	Category: Religious, Ritual and Funerary
Location: Man Kam To Road		Figure Ref: 12.3.5
Orientation: Southwest		Grading: Nil
Surrounding Environment: The Buddhist shrine is set by the side of Man Kam To Road in a non-village setting and near a road leading to a small settlement.		
Historical Appraisal: Date unknown.		
Associated Historical/ Cultural Events or Individual: None		
Inscriptions: 喃 無 阿 彌 陀		
Architectural Appraisal: The simple rectangular stone is set against the banyan tree. The letter are carved and painted red.		
Interior: Not applicable		
Existing Condition: Good		
Past and Present Uses: Religious, Ritual and Funerary		
Modifications: None		
Photographic Record:
