Job Title AGREEMENT NO. CE 14/2014(HY) NEW WANG TONG RIVER BRIDGE, MUI MO					
Drawing Title TREE RECOMMENDATION PLAN					
Drawn by	AC	Checked by	PW	Approved by	TO
Date	FEB2015

Tree Assessment Schedule

Project Title: Agreement No. CE 14/2-14 (HY) New Wang Tong River Bridge, Mui Wo

**AGREEMENT NO. CE 14/2-14 (HY) NEW WANG TONG RIVER BRIDGE, MUI WO
TREE SURVEY PHOTOGRAPHS**

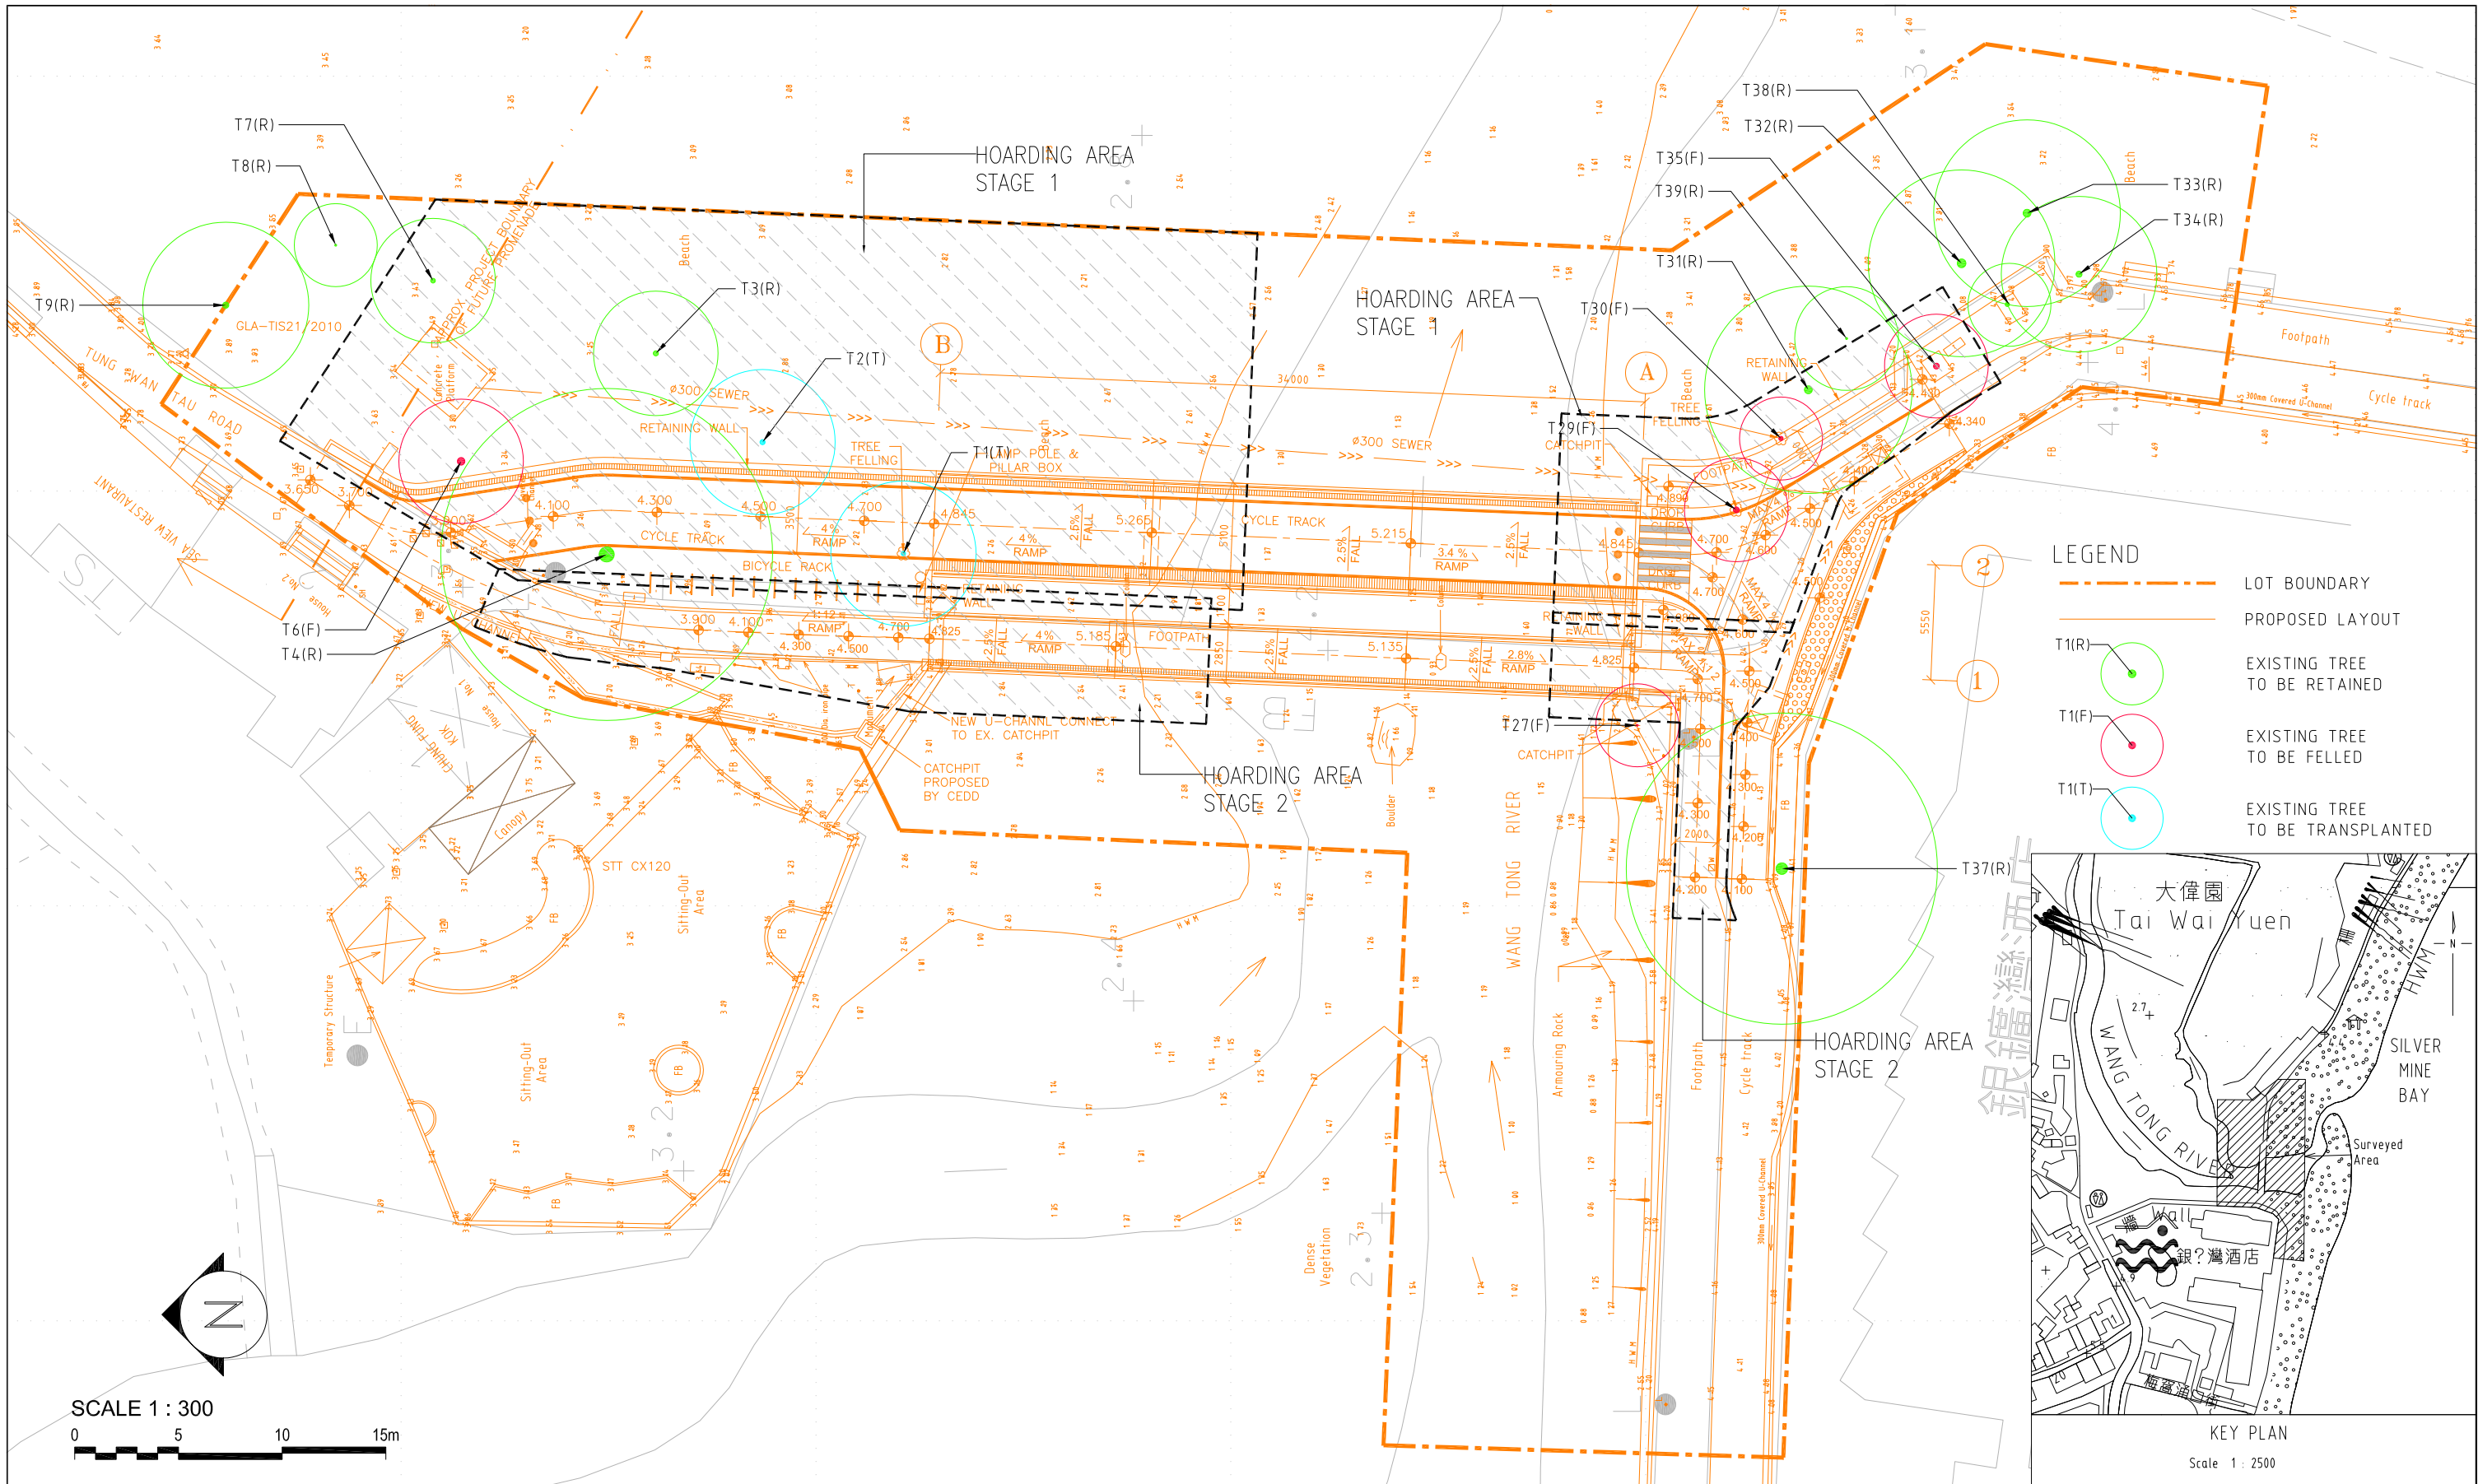
Drawing No.	MLAL1-TS02
Scale	1:300
Job No.	MLAL1

Amendment No.	Date	Description	Drawn by	Checked by	Approved by
B	DEC 2015	RECOMMENDATION REVISED FOR TREE NO. T4	AC	TO	TO
A	DEC 2015	HOARDING AREAS ADDED	AC	TO	TO

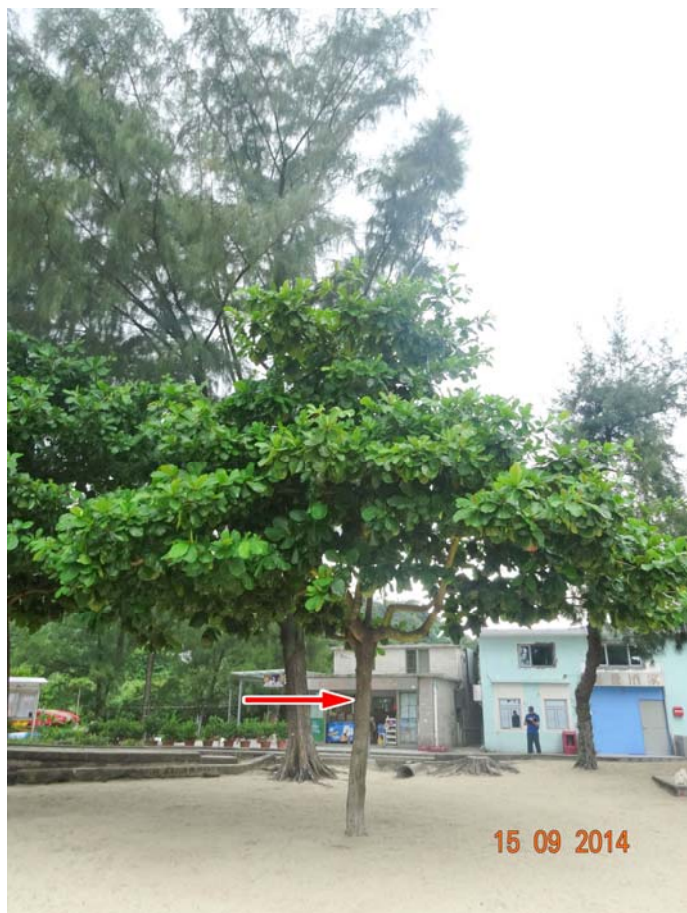
Photo No. 5 | T3 (Retain)

T3	<i>Terminalia catappa</i>	欖仁樹	9.0	248.3	6.0	Fair	Fair	Good	Fair	Medium	Located in sand limiting rootball formation; only bare root transplanting feasible	None	Retain		LCS D	Form not typical due to previous failure.
T4	<i>Casuarina equisetifolia</i>	木麻黃	14.0	732.1	16.0	Good	Good	Fair	Good	Low	Mature specimen	None	Retain		LCS D	Quality specimen with a strong central leader. Good basal flare.
T6	<i>Casuarina equisetifolia</i>	木麻黃	11.0	366.1	6.0	Fair	Fair	Fair	Fair	Low	Evidence of stress	None	Fell	Impacted by northern bridge ramp footing excavations; only Fair Form, Health & Amenity Value and Low transplanting suitability	LCS D	Minor cavity, epicormic developments from burls.
T7	<i>Terminalia catappa</i>	欖仁樹	9.0	229.2	7.0	Fair	Fair	Good	Fair	Medium	Located in sand limiting rootball formation; only bare root transplanting feasible	None	Retain		LCS D	Trunk wound.
T8	<i>Terminalia catappa</i>	欖仁樹	5.0	95.5	4.0	Poor	Fair	Fair	Fair	Medium	Juvenile specimen	None	Retain		LCS D	No basal flare due to guying to the tree surround.

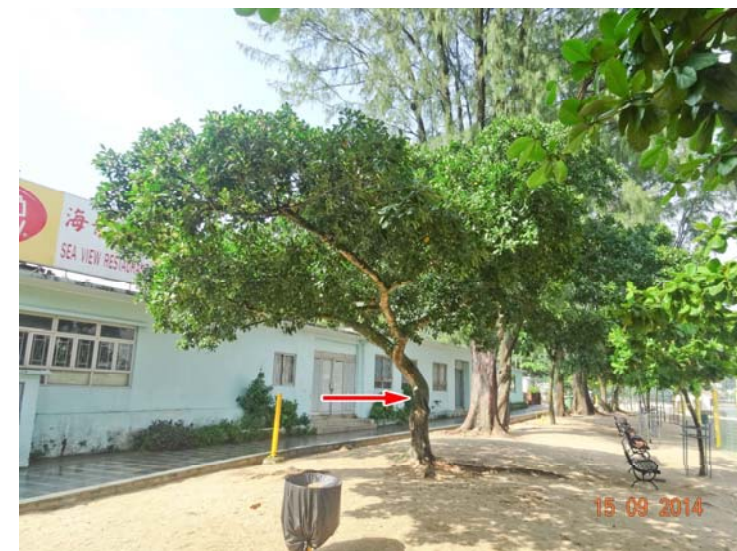
Photo No. 20 | T9 (Retain)

T9	<i>Ficus microcarpa</i>	榕樹	5.0	299.2	8.0	Fair	Fair	Good	Poor	Medium	Located in sand. Limitation	None	Retain		LCS D	Very broad specimen. Over-extended laterals. Medium sized cavity on lower main trunk with internal decay with wound wood development.
T27	<i>Macaranga tanarius var. tomentosa</i>	血桐	2.0	95.5	4.0	Poor	Poor	Good	Poor	Low	Growing on granite revetment	None	Fell	Impacted by existing bridge demolition and reconstruction works; impractical to transplant due to root environment in granite revetment	LCS D	Juvenile specimen.
T29	<i>Macaranga tanarius var. tomentosa</i>	血桐	5.0	283.3	5.0	Poor	Fair	Good	Poor	Low	Trunk leaning	None	Fell	Impacted by southern bridge ramp construction; trunk wounds and leaning form plus Low transplanting suitability.	LCS D	Significant trunk wound and basal damage.
T30	<i>Macaranga tanarius var. tomentosa</i>	血桐	4.5	213.3	4.0	Poor	Poor	Fair	Fair	Low	Numerous wounds	None	Fell	Impacted by southern bridge ramp construction; Poor Amenity Value & Form plus Low transplanting suitability.	LCS D	Asymmetrical tree: Incomplete union.

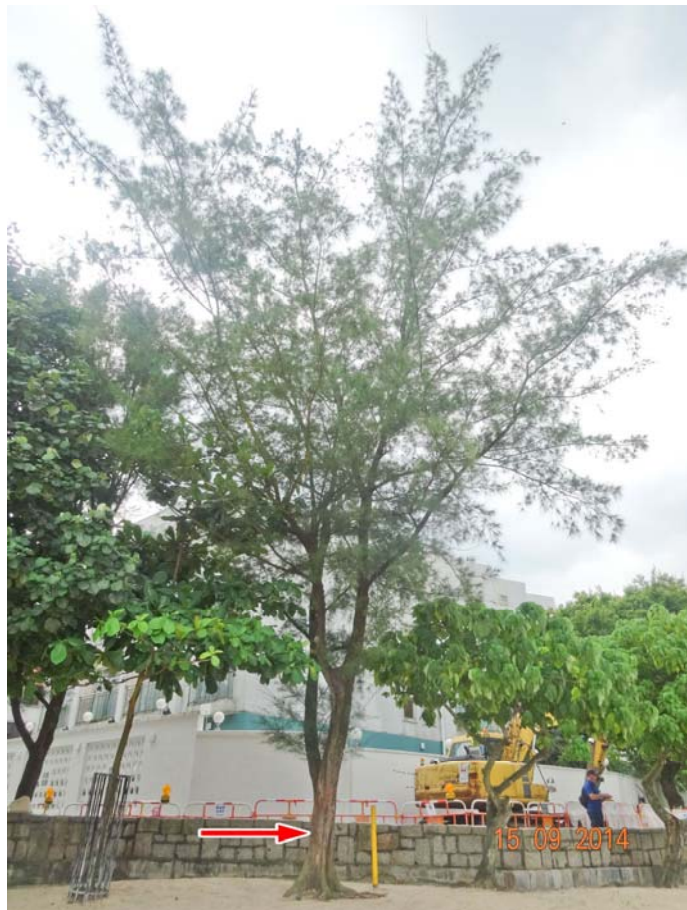
Photo No. 35 | T31 (Retain)

T31	<i>Casuarina equisetifolia</i>	木麻黃	12.0	382.0	10.0	Fair	Fair	Fair	Fair	Low	Low crown vitality	None	Retain		LCS D	Some cracks, wounds and pruning cuts observed although these are not considered threatening to the viability of the tree.
T32	<i>Hibiscus tiliaceus</i>	黃槿	8.0	423.4	9.0	Fair	Fair	Good	Fair	Low	Irregular specimen	None	Retain		LCS D	Poor previous pruning.
T33	<i>Hibiscus tiliaceus</i>	黃槿	8.0	375.6	9.0	Fair	Fair	Good	Fair	Low	Irregular specimen	None	Retain		LCS D	Poor previous pruning.
T34	<i>Casuarina equisetifolia</i>	木麻黃	12.0	292.8	7.5	Fair	Fair	Poor	Poor	Low	Wall impediment	None	Retain		LCS D	Numerous wounds created by pruning and previous failures.
T35	<i>Casuarina equisetifolia</i>	木麻黃	12.0	283.3	5.0	Fair	Fair	Poor	Poor	Low	Located in a paved tree surround	None	Fell	Impacted by southern bridge ramp construction; Poor Health & Structure plus Low transplanting suitability.	LCS D	Poor previous pruning, low foliage density.

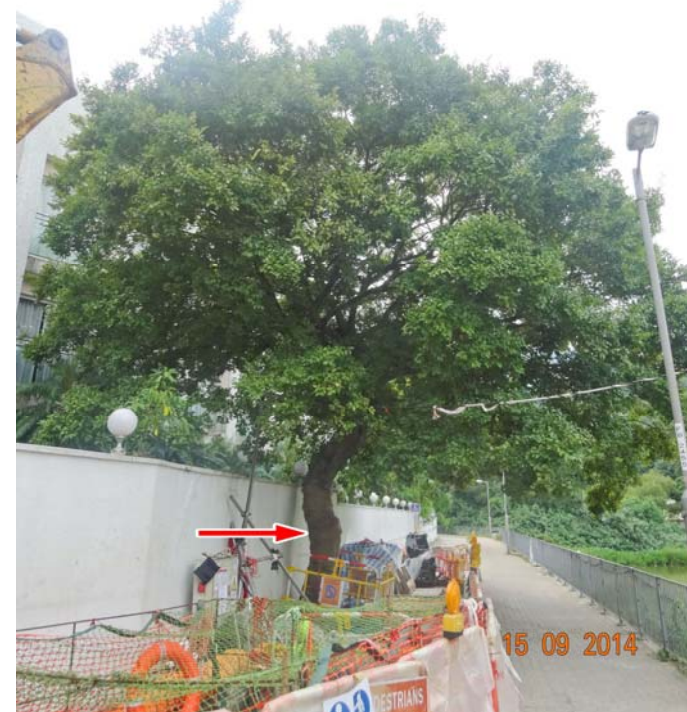
Photo No. 58 | T37 (Retain)

T37	<i>Celtis sinensis</i>	朴樹	12.0	557.0	15.0	Fair	Good	Good	Good	Low	Growing location confined by wall & paving	None	Retain		LCS D	Quality specimen tree.
T38	<i>Ficus microcarpa</i>	榕樹	4.0	203.7	4.0	Poor	Poor	Poor	Poor	Low	Wall tree	None	Retain		LCS D	Rooting environment is shared between the planting pit and the beach wall. Severely asymmetrical.
T39	<i>Terminalia catappa</i>	欖仁樹	6.5	101.9	5.0	Poor	Fair	Good	Fair	Medium	Juvenile specimen	None	Retain		LCS D	Insect nest present. Trunk wounds observed.
