# **New Wang Tong River Bridge**

## **Environmental Impact Assessment Report**

**(Final)**

**Agreement No. CE 14/2014 (HY) – New Wang Tong River Bridge, Mui Wo Environmental Impact Assessment and Drainage Impact Assessment  
Environmental Impact Assessment Report (Final)**

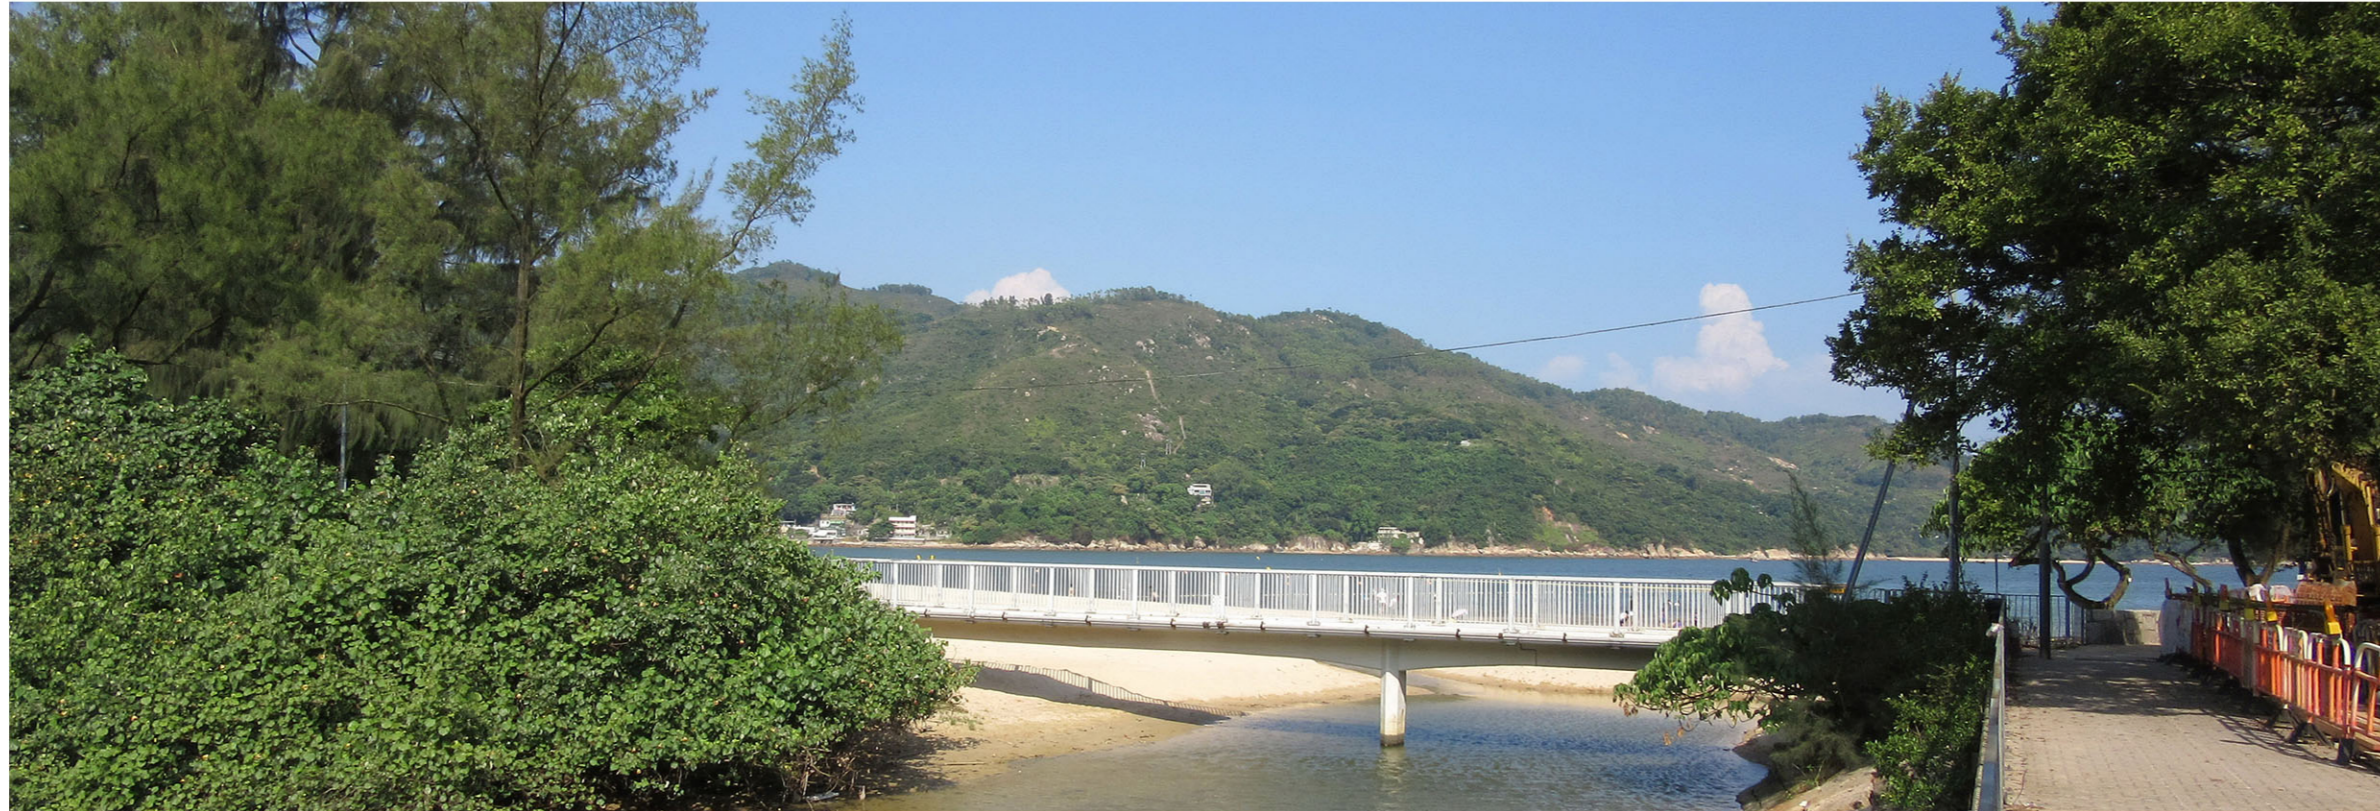
EXISTING CONDITIONS

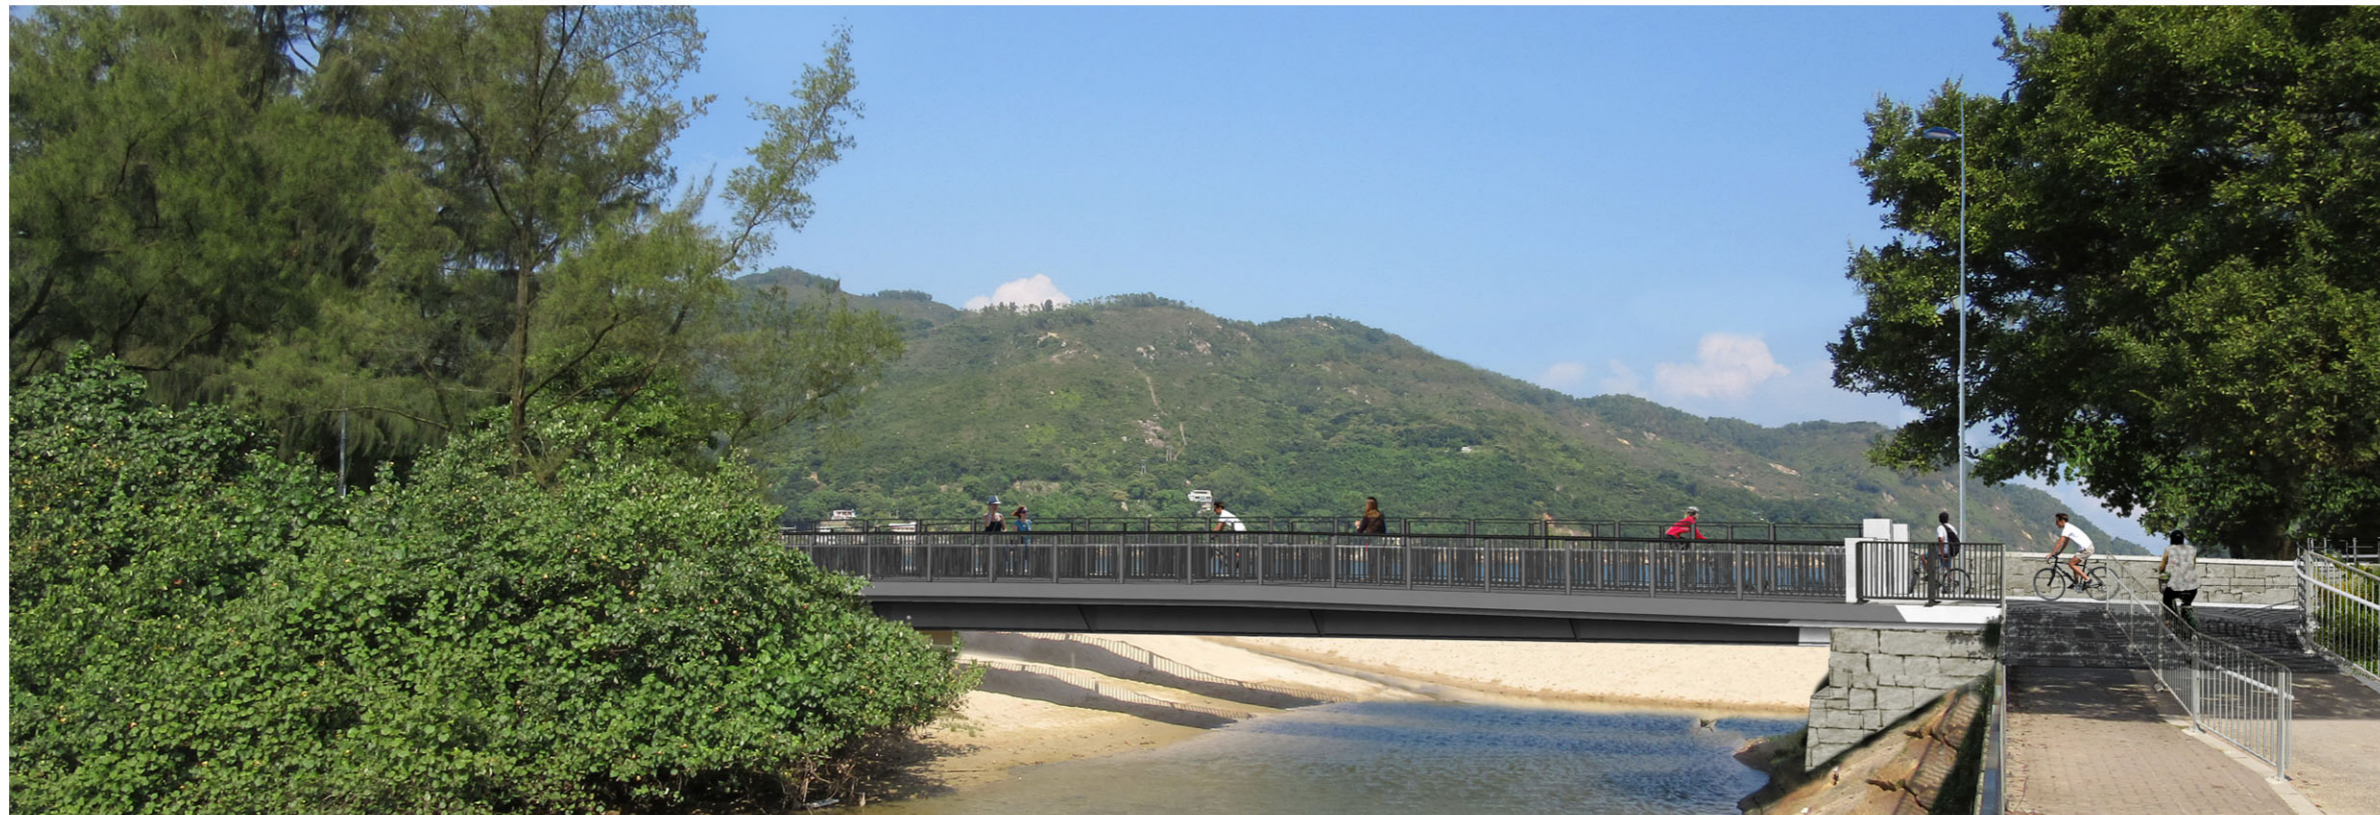
DAY 1 WITHOUT MITIGATION MEASURES

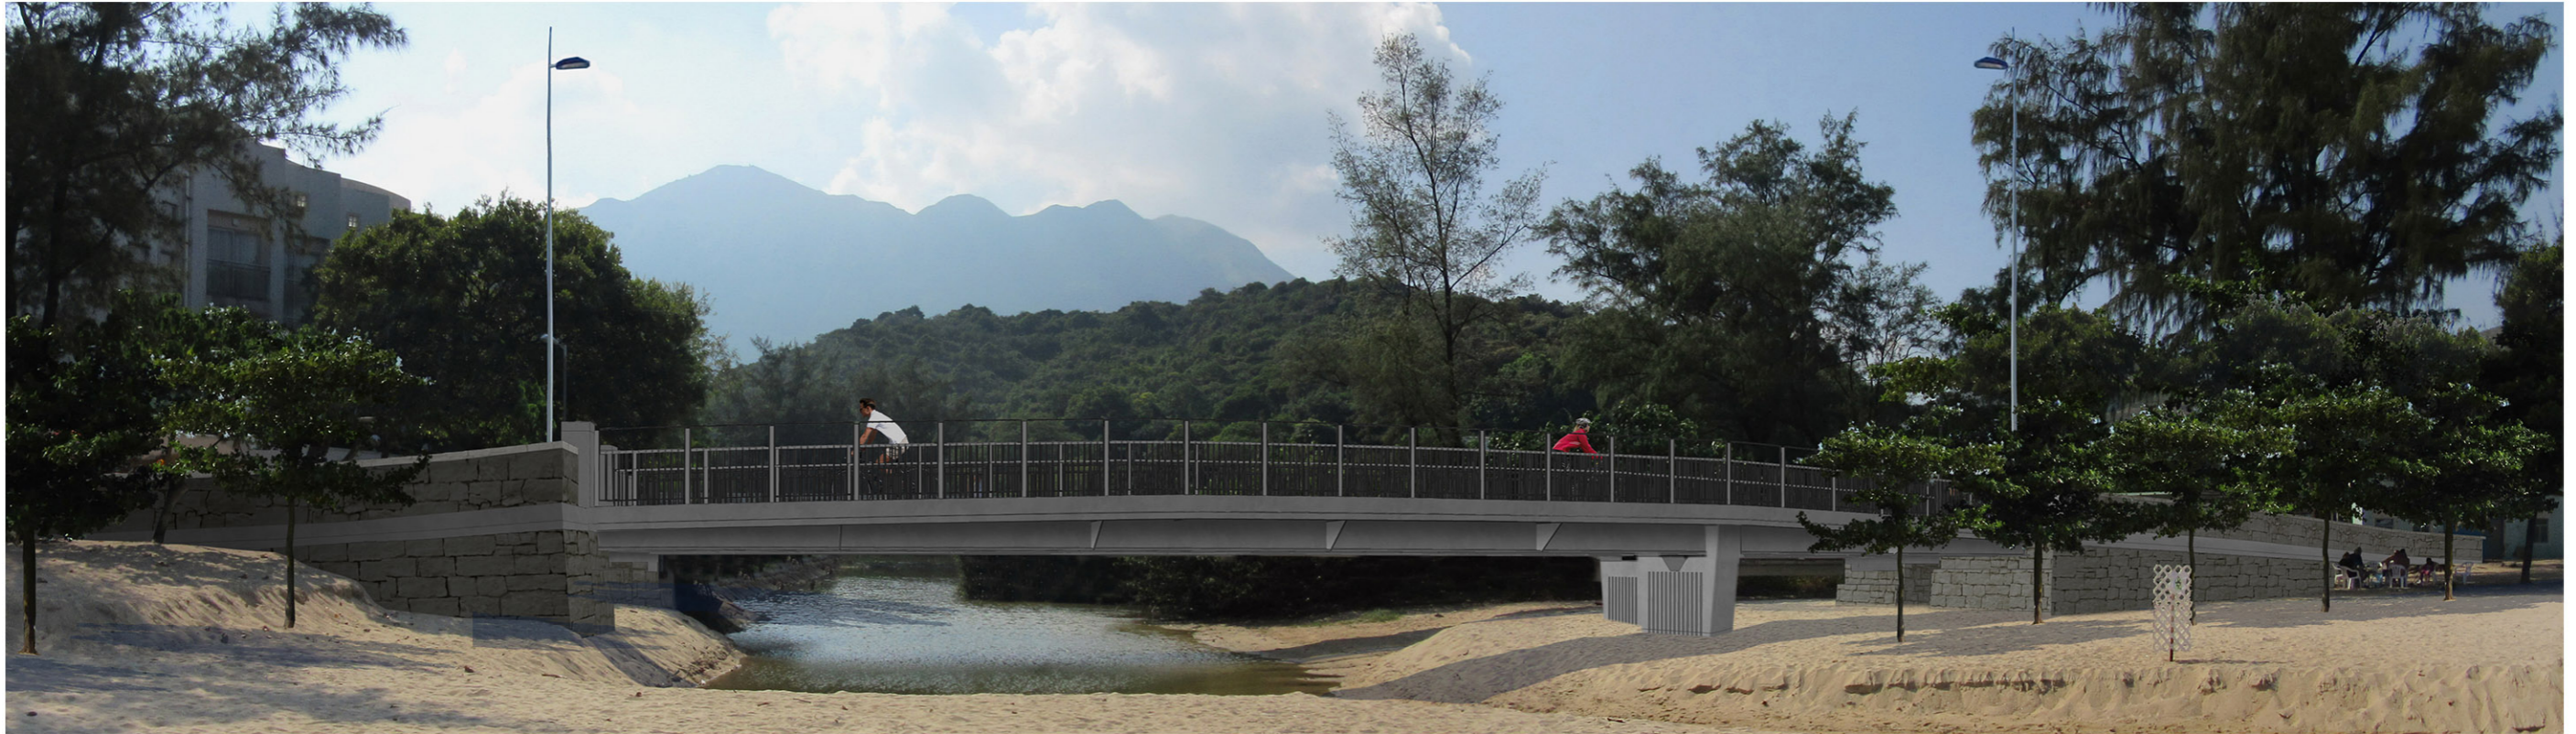
DAY 1 WITH MITIGATION MEASURES

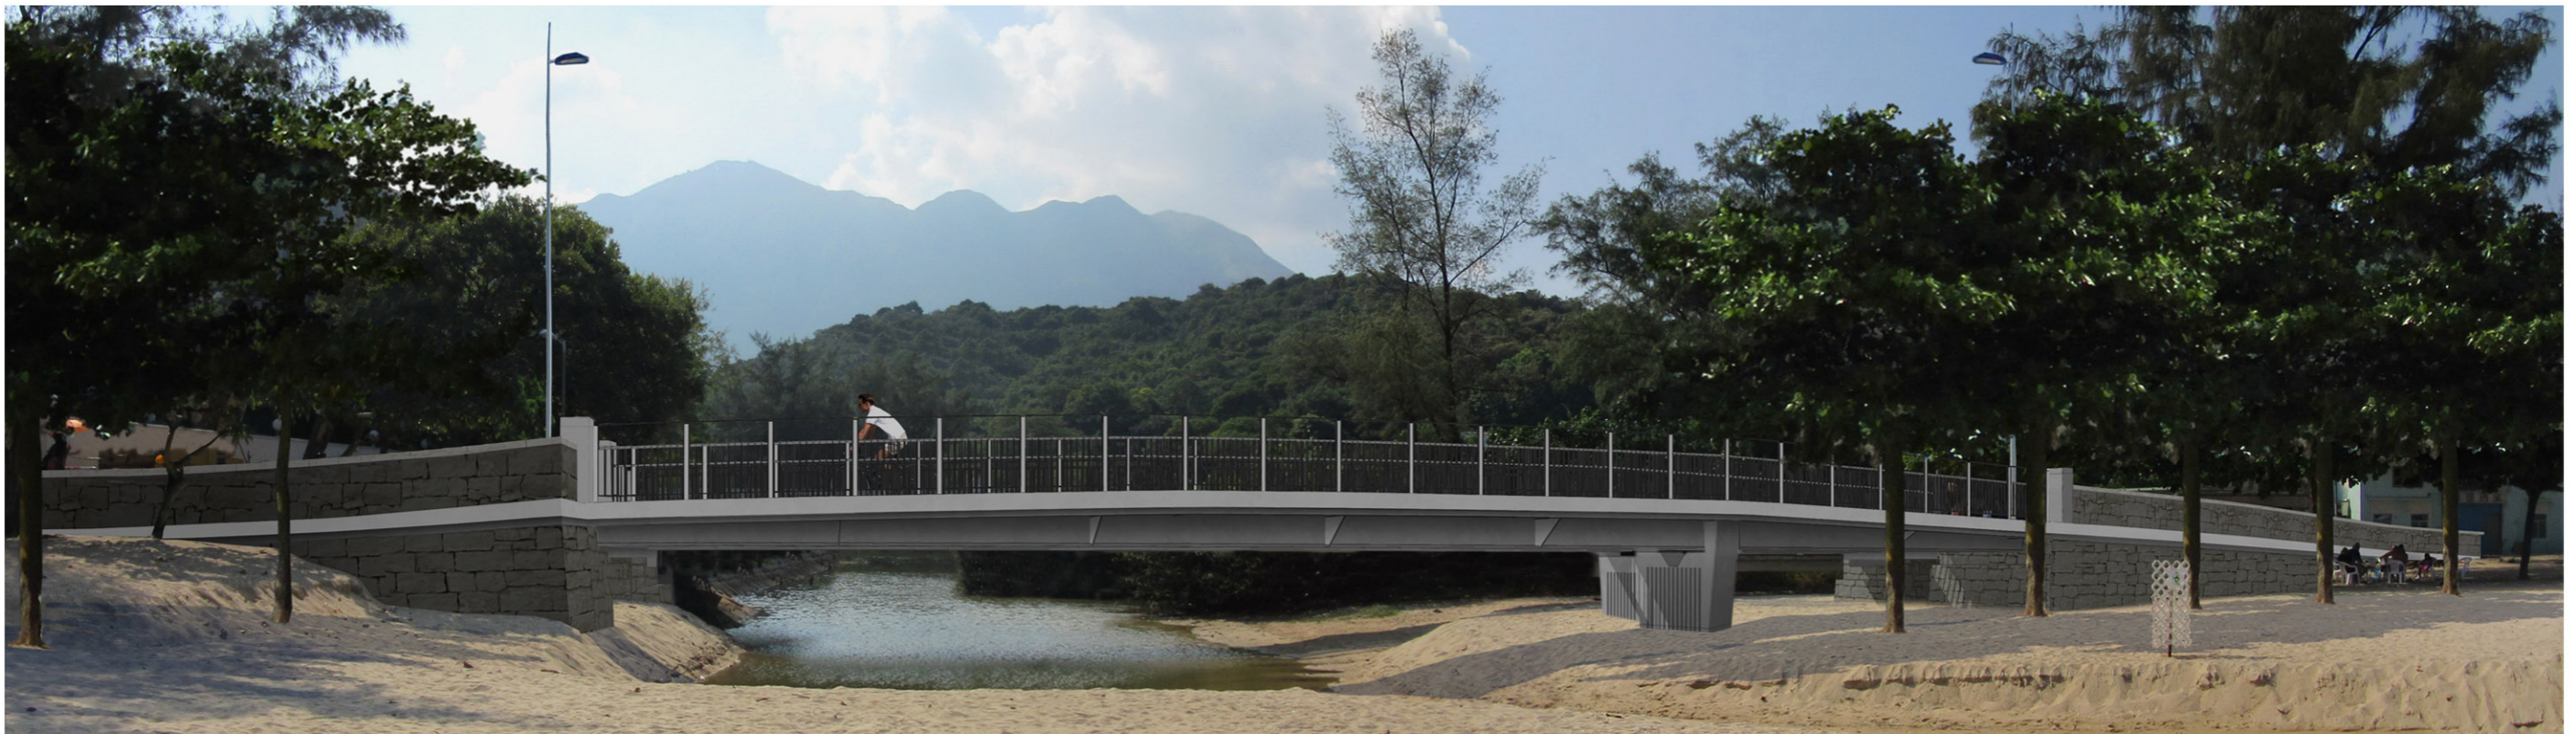
YEAR 10 WITH MITIGATION MEASURES

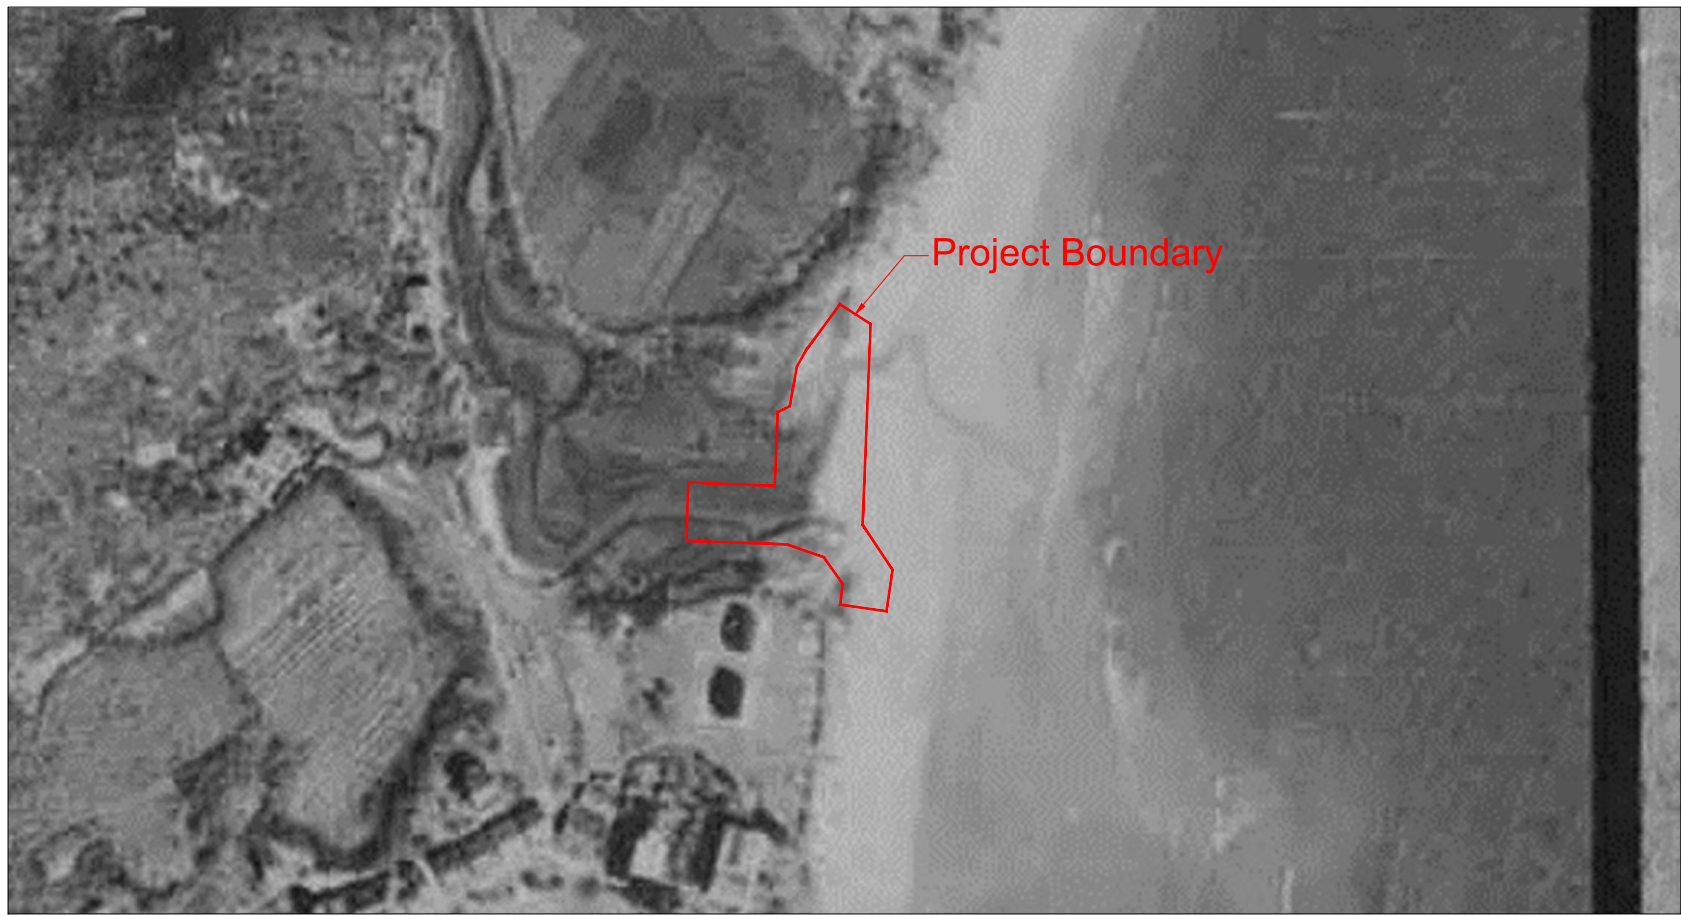
**Year: 1945**

- Very extensive agricultural land in Tai Wai Yuen and at the foot of Butterfly Hill
- Old bridges at mouth of Wang Tong River
- Wang Tong River was untrained and had large mudflat at river mouth

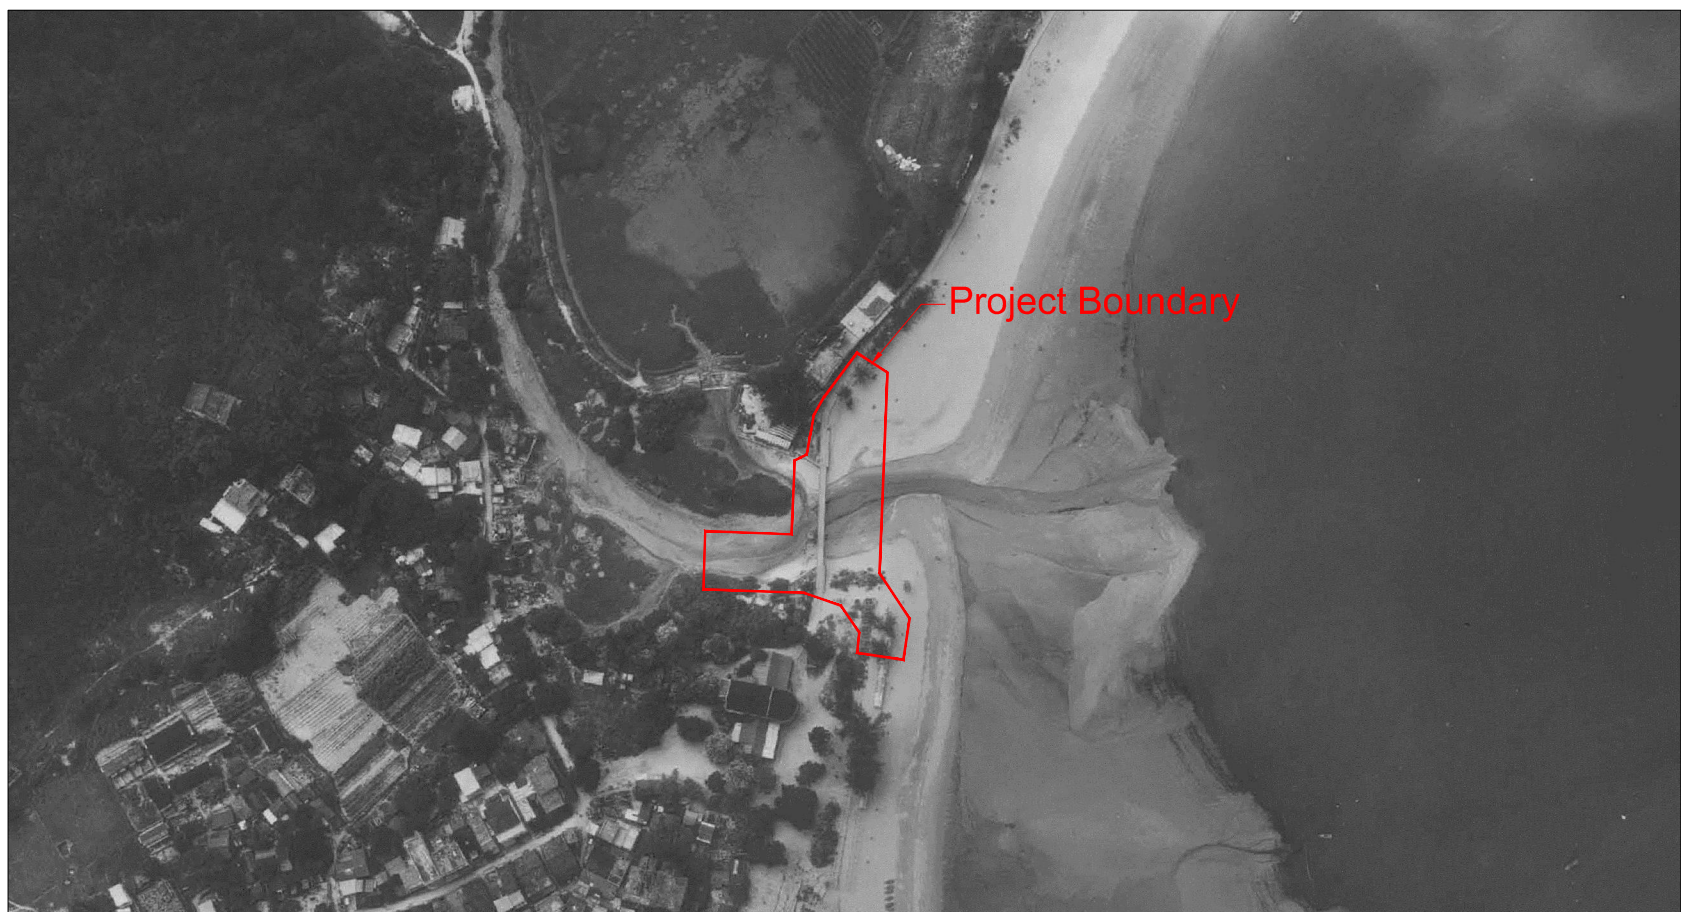
**Year: 1973**

- The now Wang Tong River Bridge was constructed.
- Shape of Wang Tong River as now
- Houses built at Tung Wan Tau Road and along Wang Tong River at the foot of Butterfly Hill

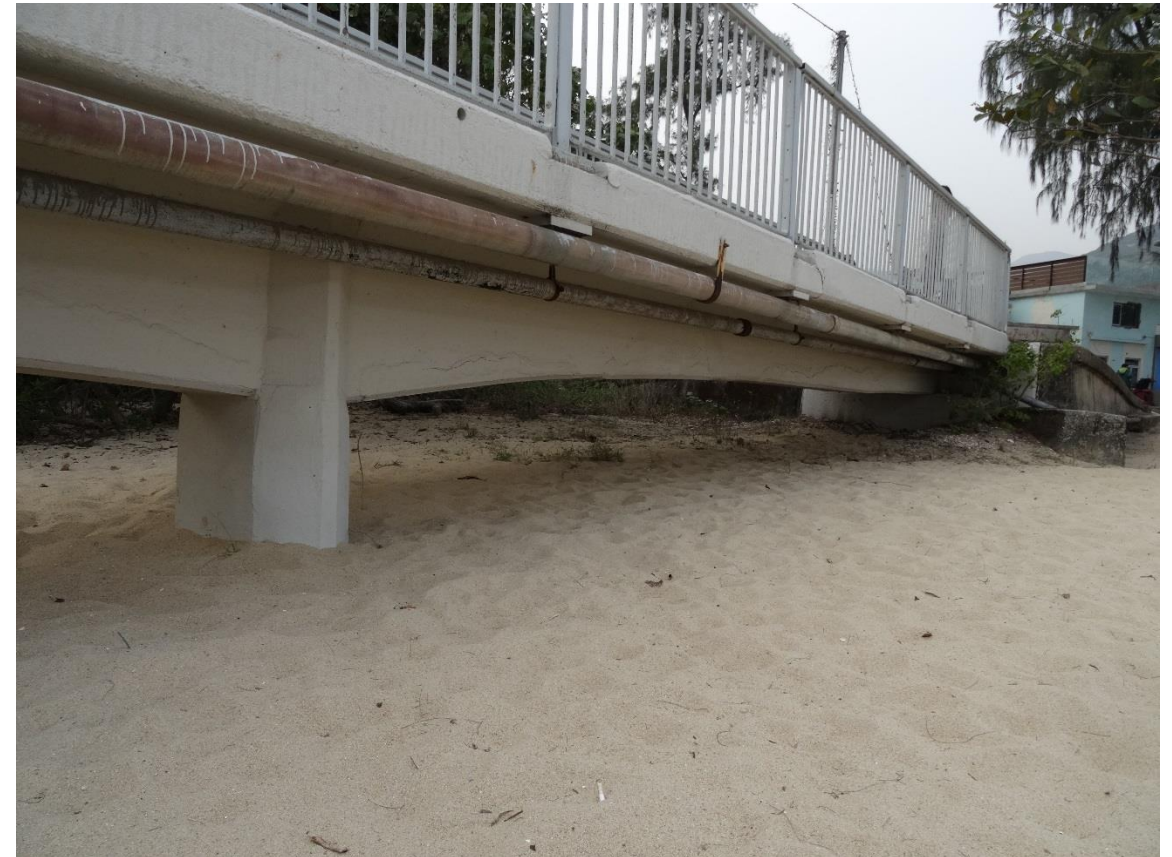
P2: Northern pier of Wang Tong Bridge
