List of Figures

1 INTRODUCTION

PROJECT
 項目
RELOCATION OF SHA TIN SEWAGE TREATMENT WORKS TO CAVERNS: CAVERNS AND SEWAGE TREATMENT WORKS - INVESTIGATION, DESIGN AND CONSTRUCTION

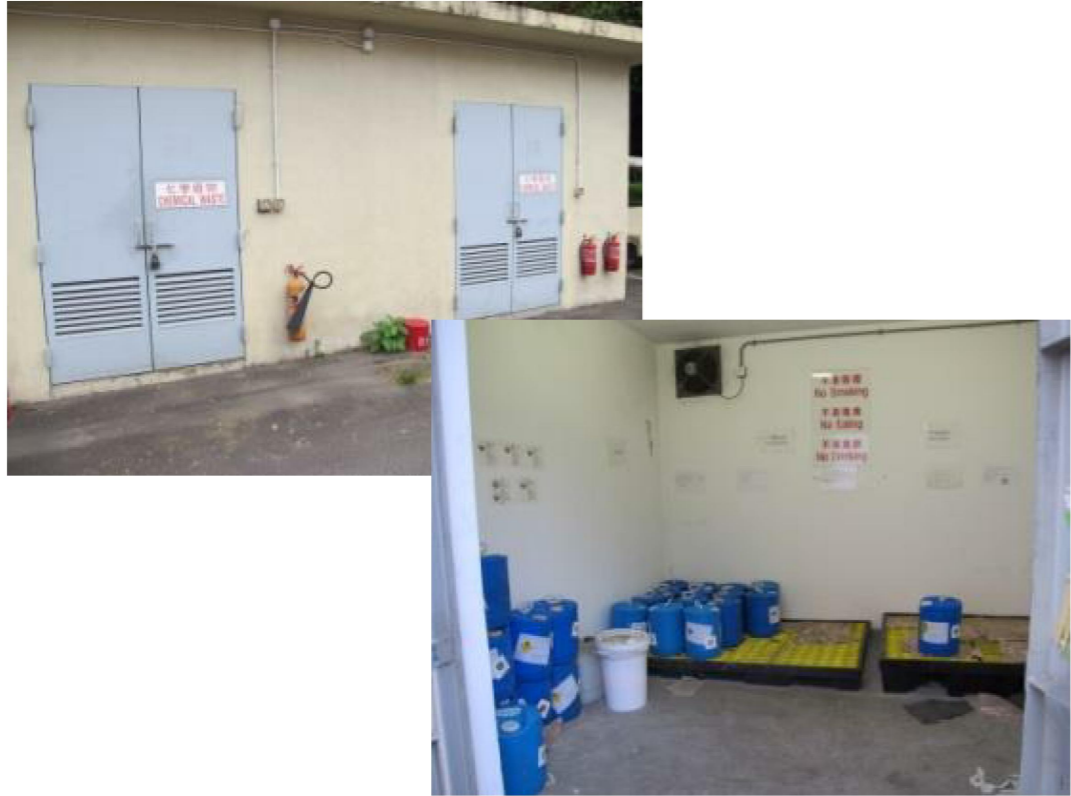
No.: **A2**
Date taken: 07/11/14

Description:
Room A: Spent Sulfuric Acid, Nitric Acid in liquid form
Room B: Spent Alkali
The chemical wastes in the store are protected from weather. The floor of the store is concreted paved and ventilation in the store is good.

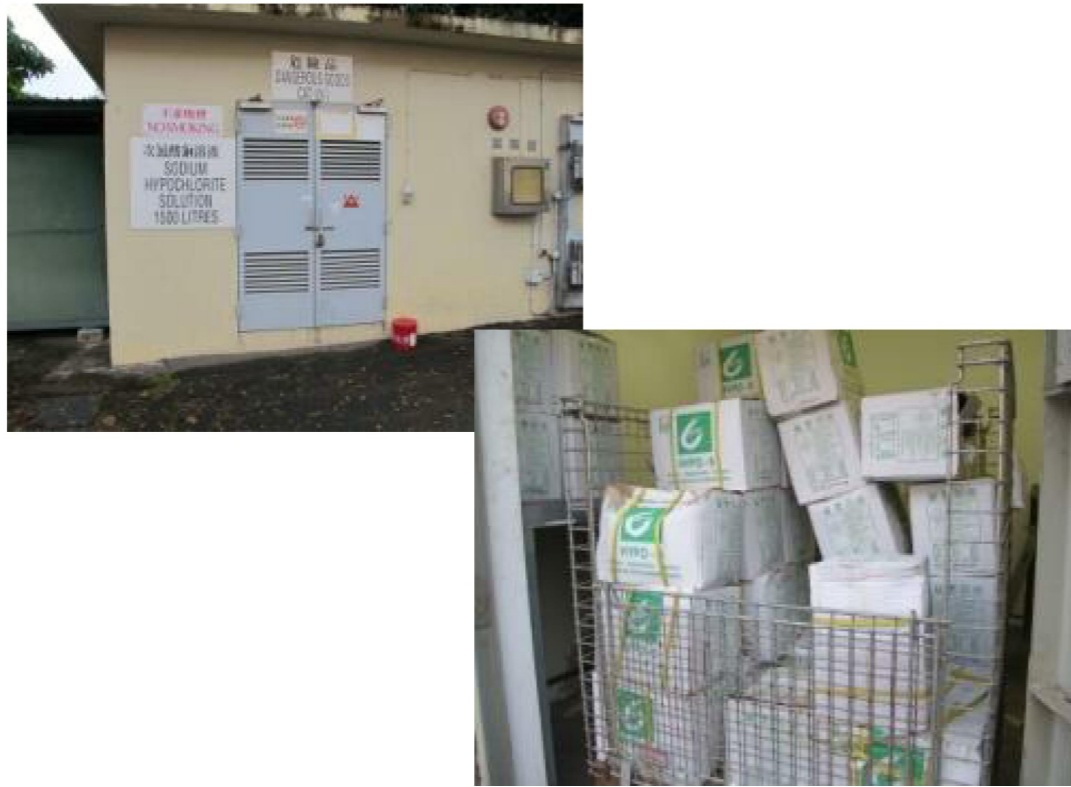
No.: **A3**
Date taken: 07/11/14

Description:
Room A: The bagged sodium hypochlorite (in powder form) is stored in the DG store and is protected from weather. The floor of the DG store is concreted paved and was observed in good condition.

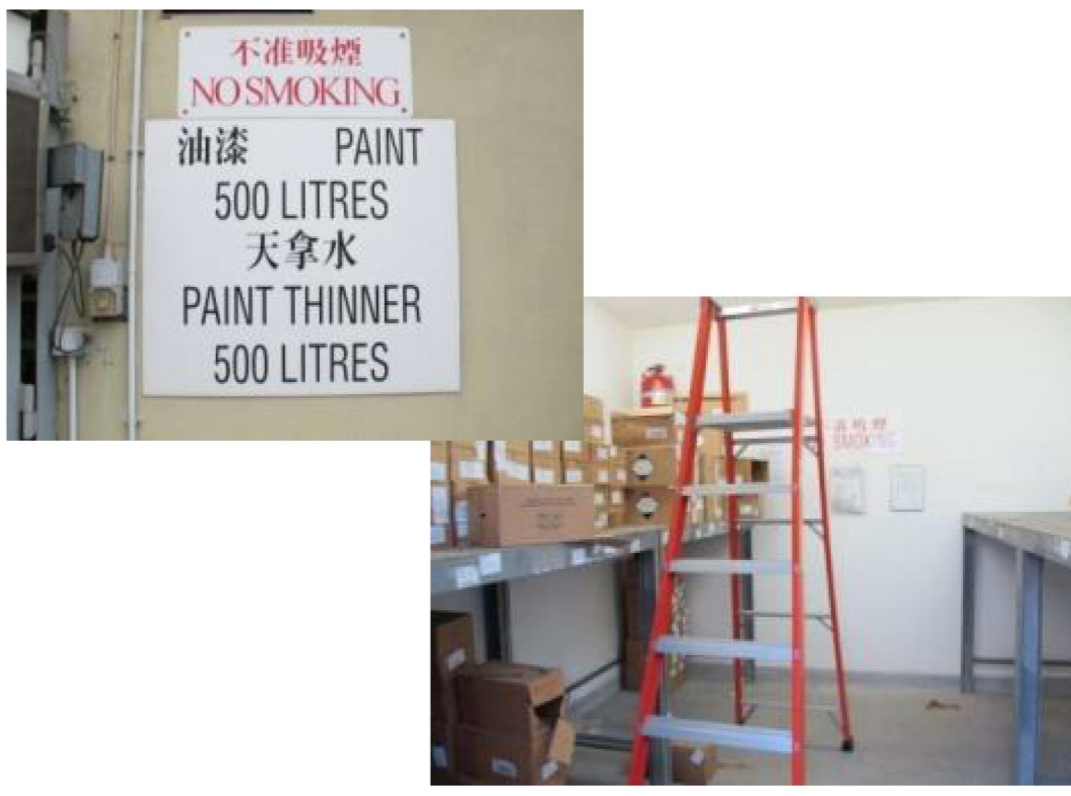
No.: **A4**
Date taken: 07/11/14

Description:
Room B: Paint and paint thinner are stored in the room.
The paint and thinner are protected from weather. The floor of the DG store is concreted paved and was observed in good condition.

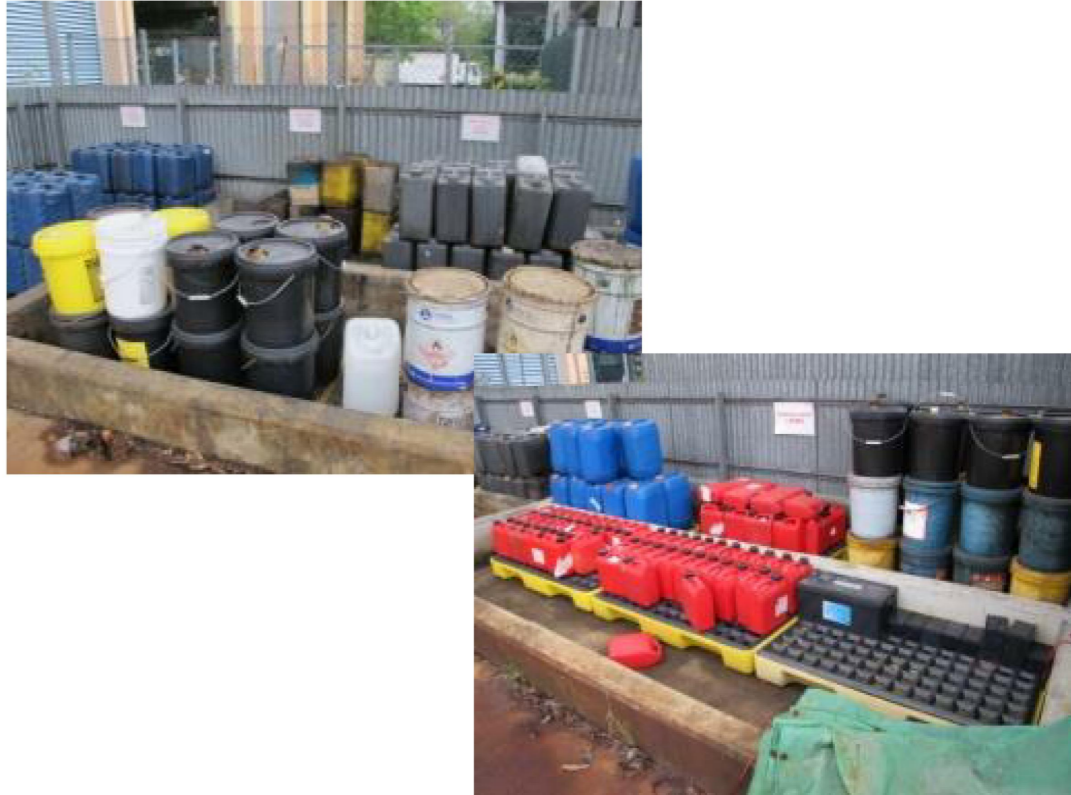
Description:
Empty lubrication oil containers, grease containers, bleach drums and waste batteries
The chemical waste area has a metal roof and the floor of the area is concreted paved with bundings and was observed in good condition.

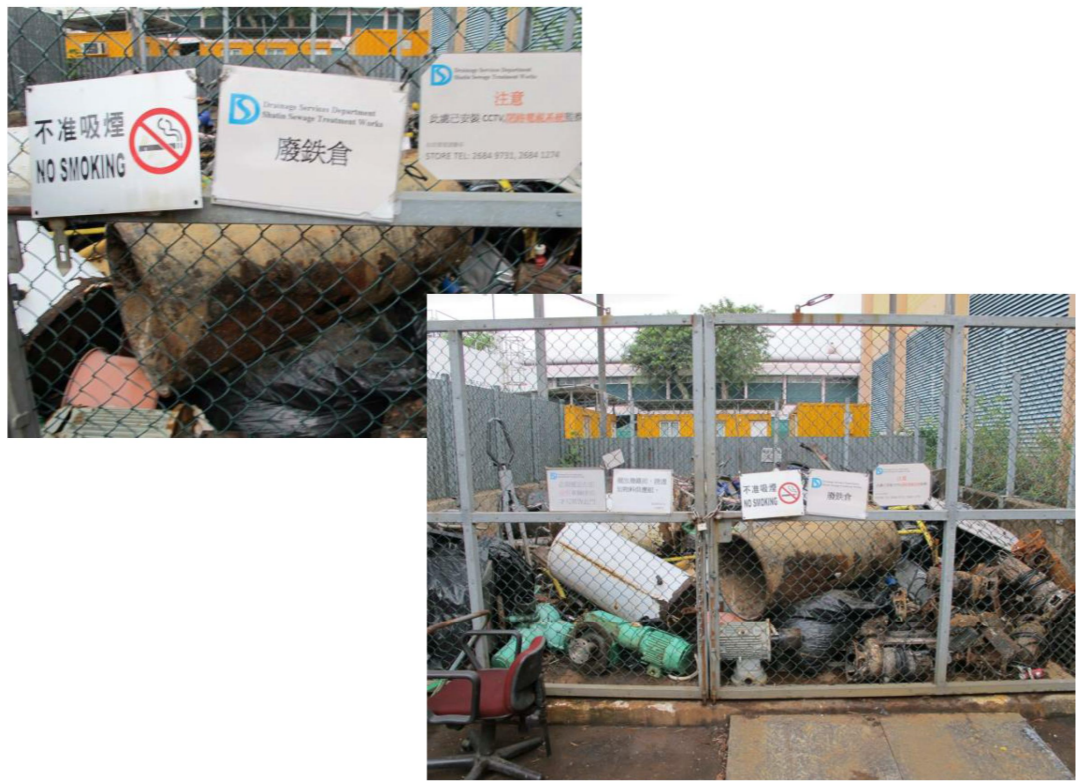
No.: A5	Date taken: 07/11/14
Location: Scrap Iron Storage Area (Area: ~21m ²)	
Description: Metal scrap generated within STSTW were temporary stored in this concrete paved storage area with fences surrounding the locked area.

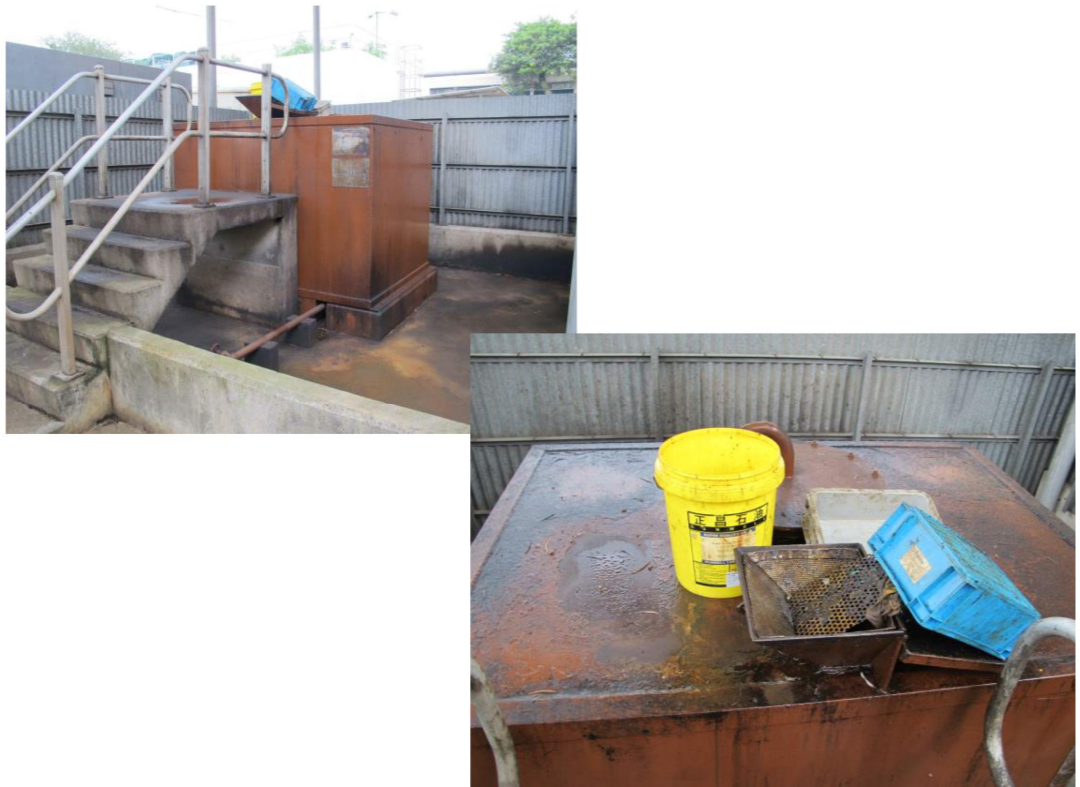
No.: A6	Date taken: 07/11/14
Location: Chemical Waste Collecting Tank (Area: ~34m ²)	
Description: The chemical waste collecting tank is situated on top of a concrete paved area with concrete bunding to prevent spilling and leakage.

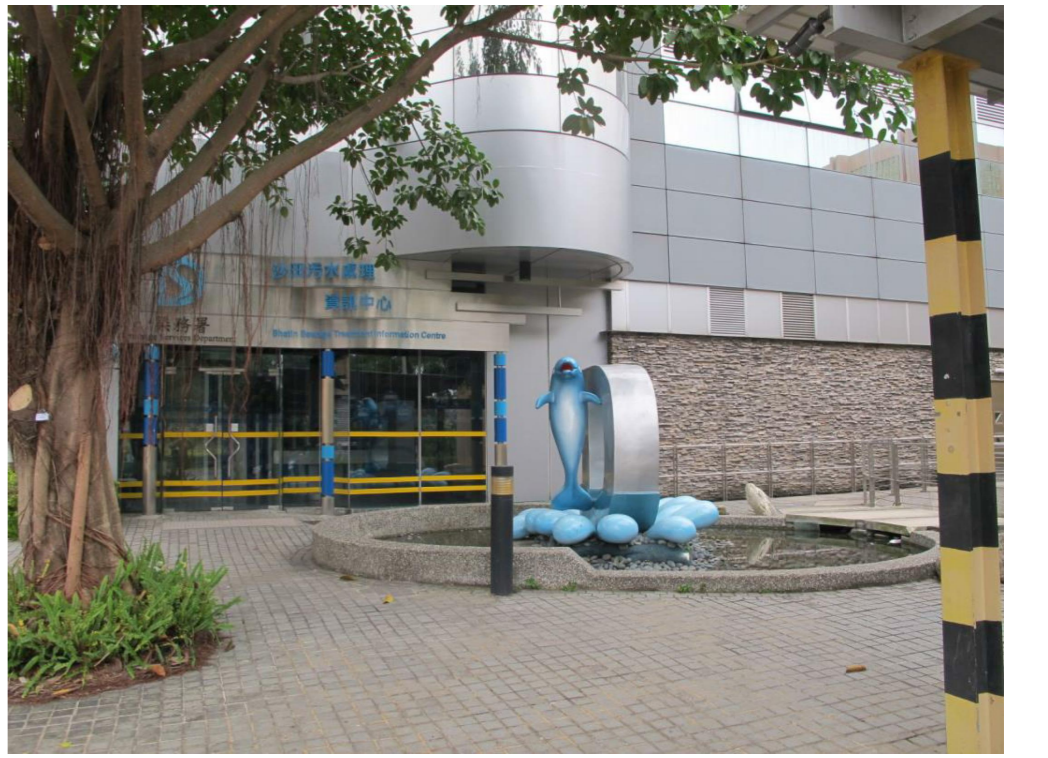
No.: A8	Date taken: 28/01/15
Location: Administration and Laboratory Buildings (Area: 1470m ²)	
Description: Laboratory is on the first floor of the building. Ground floor is used only as exhibition center and storeroom. No chemicals were found stored on the ground floor.

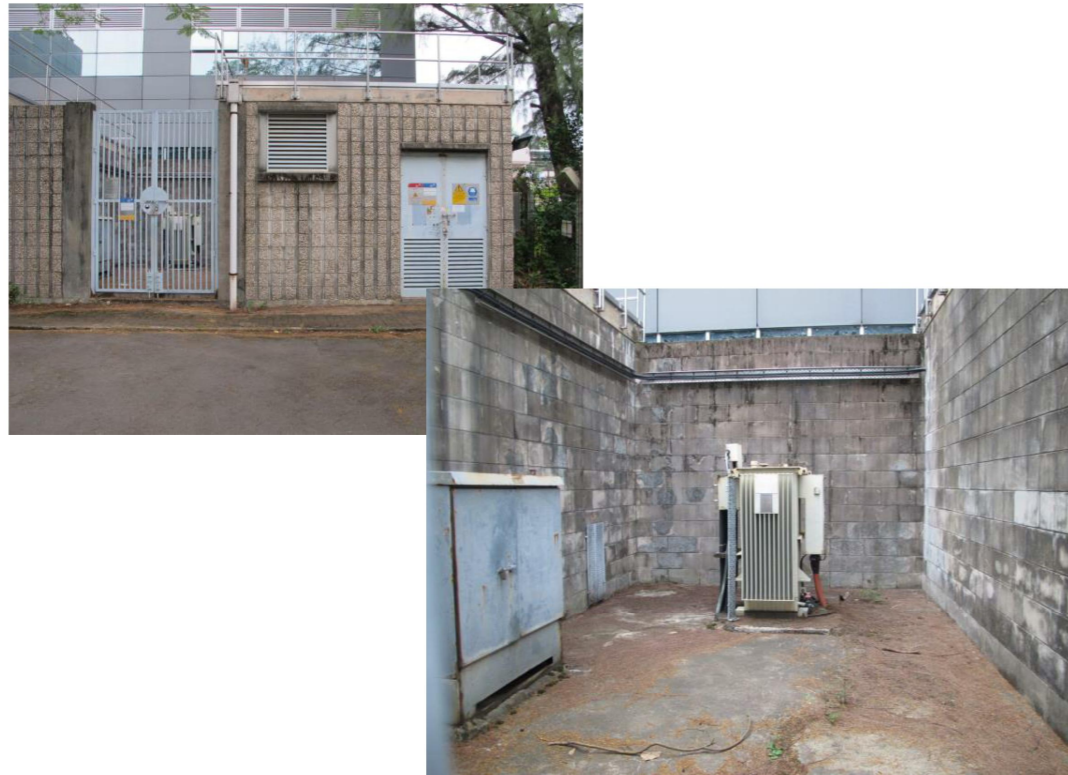
No.:
A10 **Date taken:**
03/11/14

Description:
CLP Transformer No. 1 is operated by CLP and located within the substation. Ground are concrete paved and without stains.

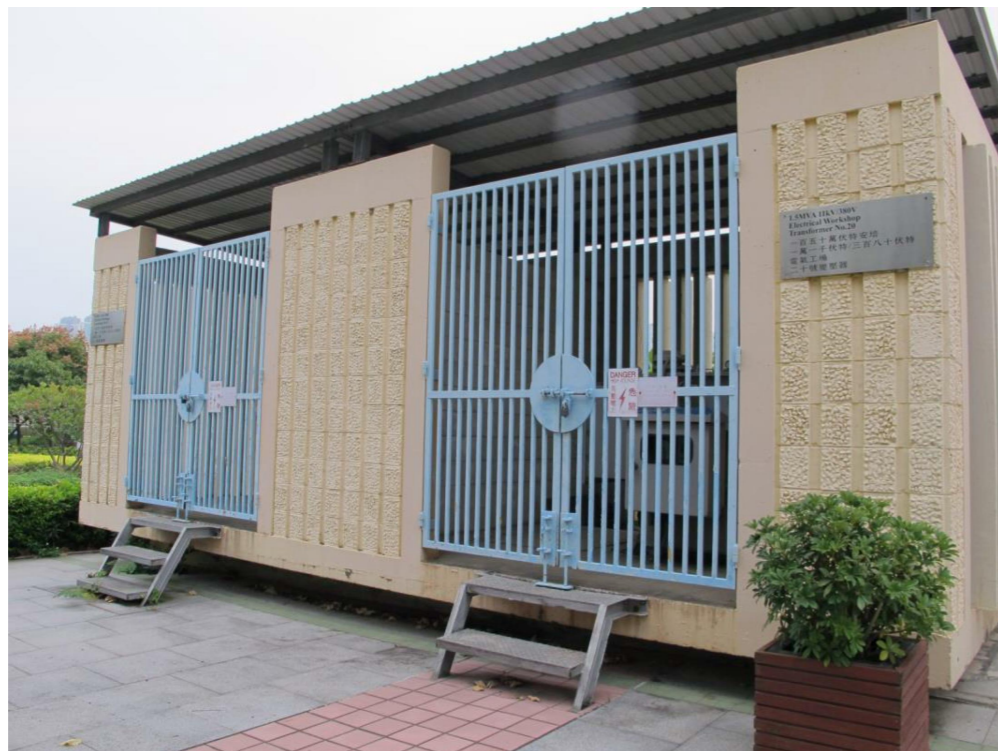
No.:
A11 **Date taken:**
07/11/14

Description:
Transformer No. 19 and No. 20 are housed within the transformer rooms. The transformer rooms are elevated on an approximately 0.5m concrete platform.

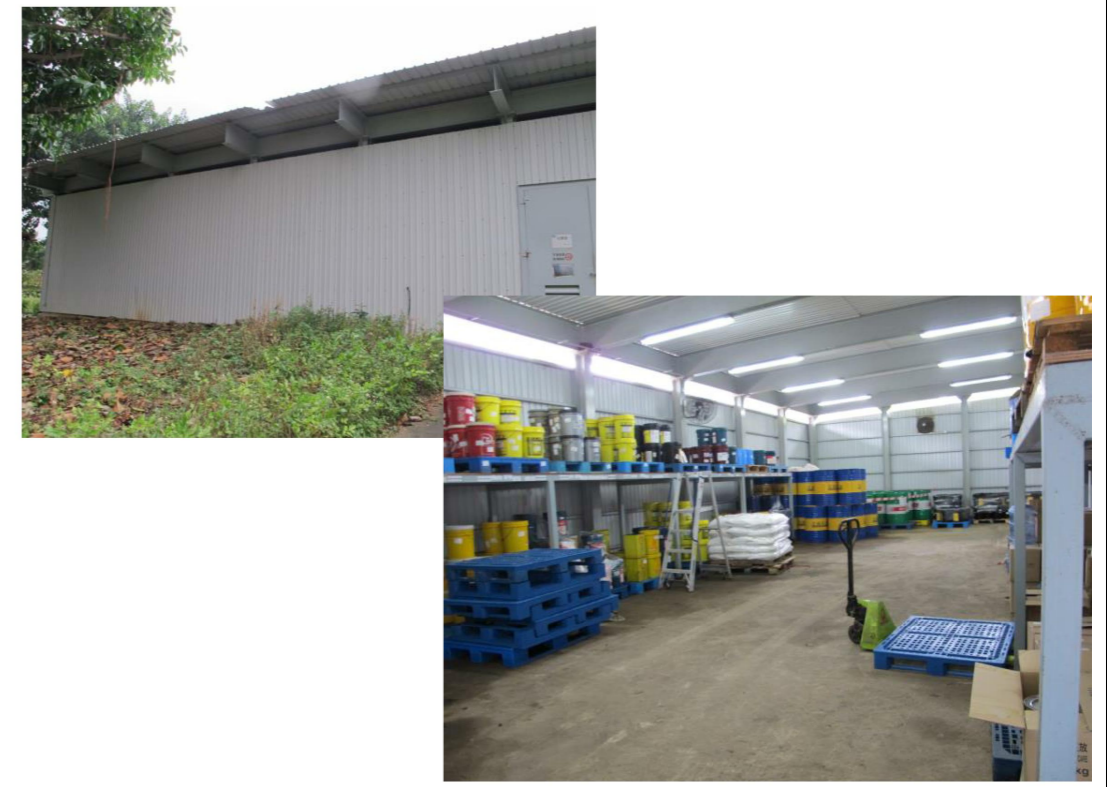
No.:
A12 **Date taken:**
07/11/14

The chemical store has a metal roof and the floor of the store is concreted paved with good ventilation. No sign of spillage or stain was observed.

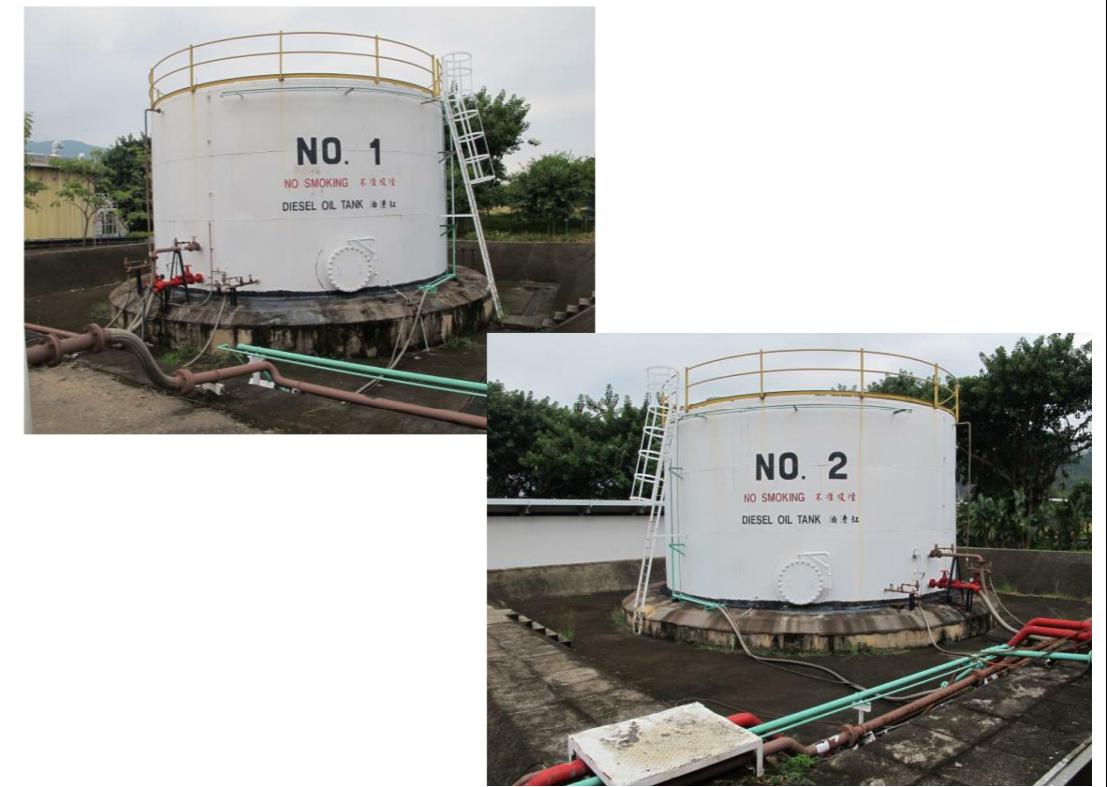
Description:
Two ~1000L aboveground diesel oil tanks used by STSTW power house's generator.

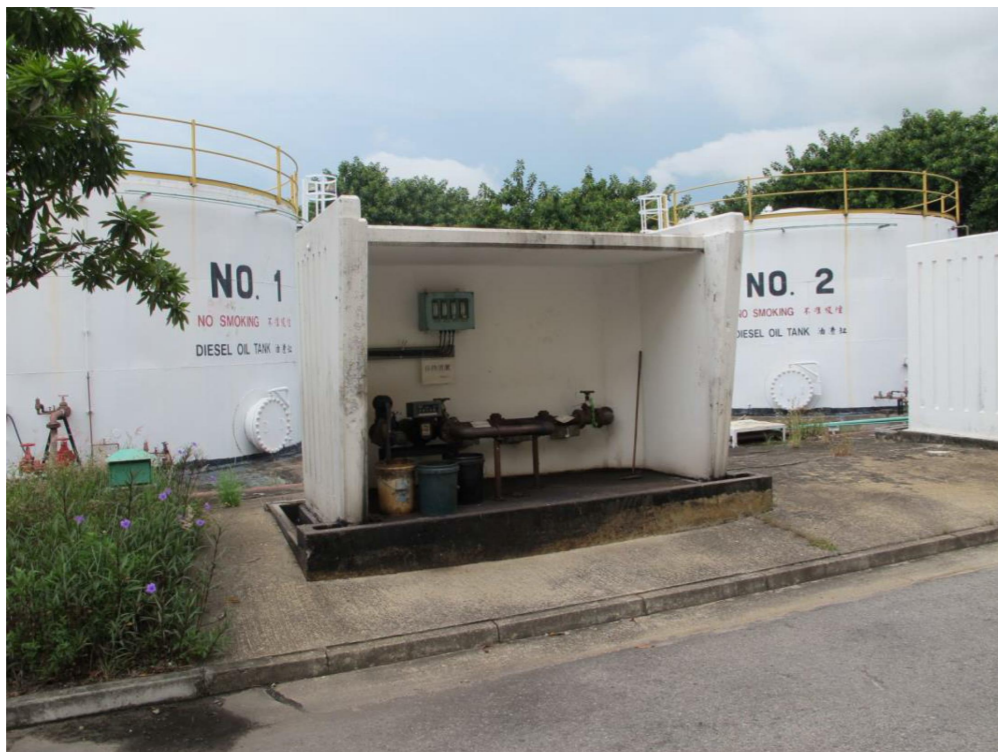
No.: A13	Date taken: 17/07/15
Location: Diesel Filling Point	
Description: A diesel filling point was observed near the diesel storage tank.

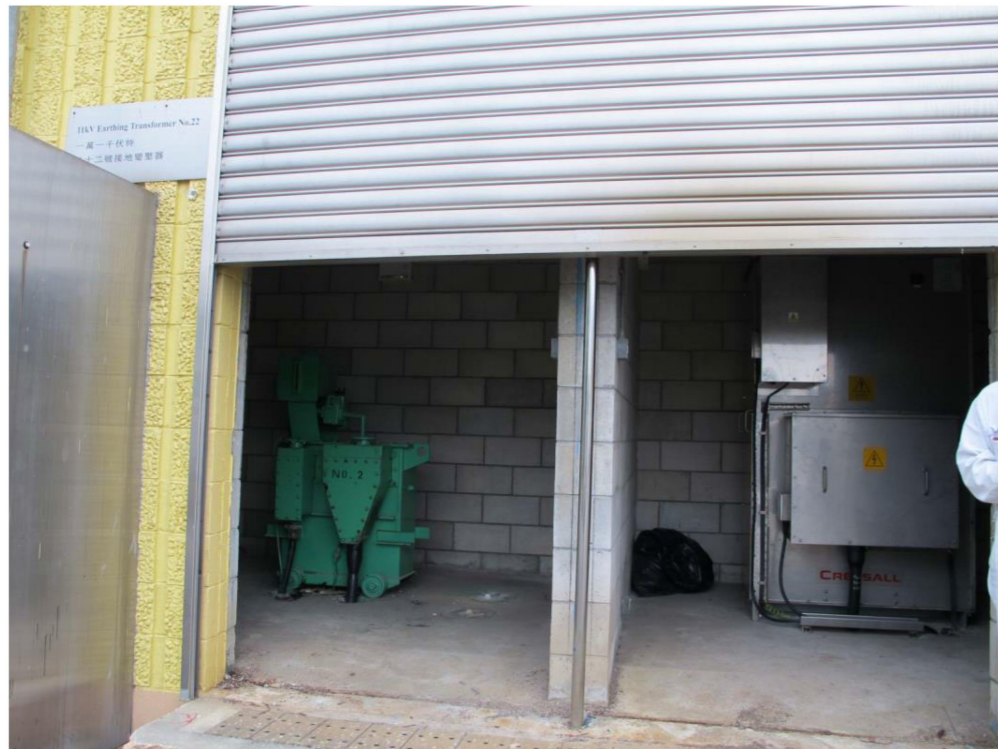
No.: A14	Date taken: 07/11/14
Location: Transformer No.21 & 22	
Description: Two transformers (labeled as 'Transformer No. 21' and '22') were located at the western side of the Power House.

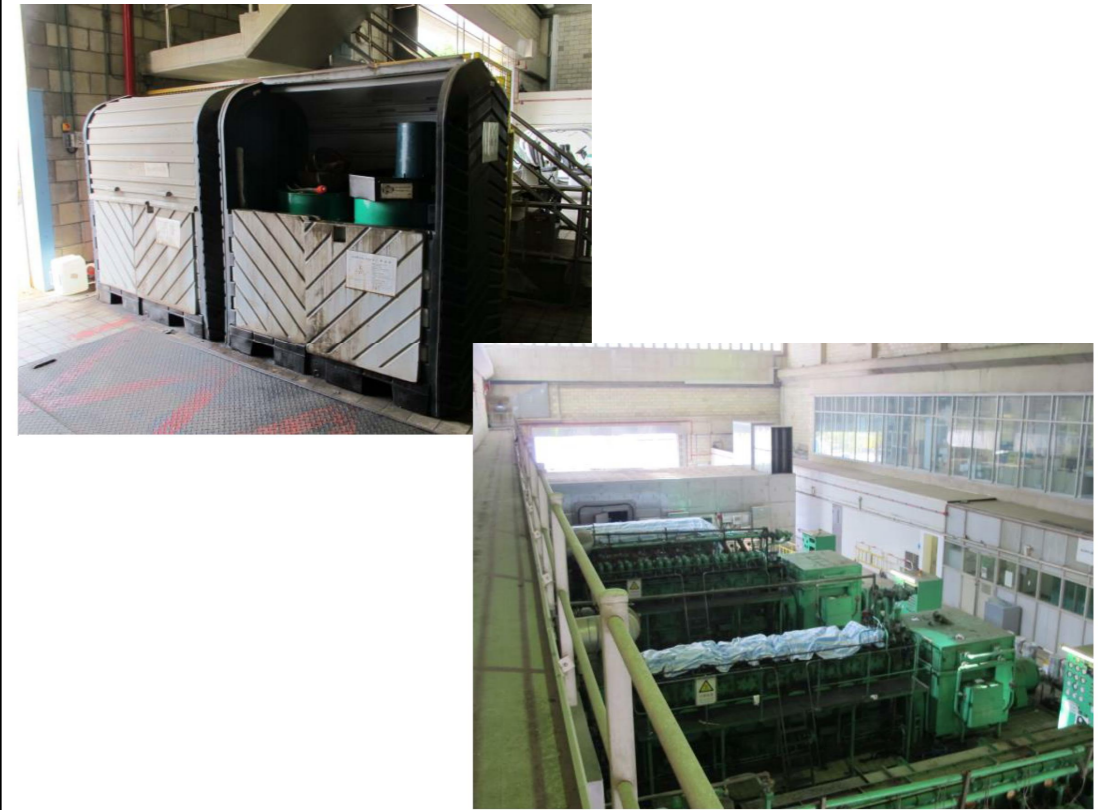
No.: A15	Date taken: 7/11/14 & 28/01/15
Location: Power House (Area: ~2470m ²)	
Description: Six set of power generators and five set of air blowers supply energy for the treatment plant. Fuel and lubrication oil were being used in daily operation. A temporary chemical waste collecting point for lubrication oil bottles and oil drums was observed at entrance of the building.

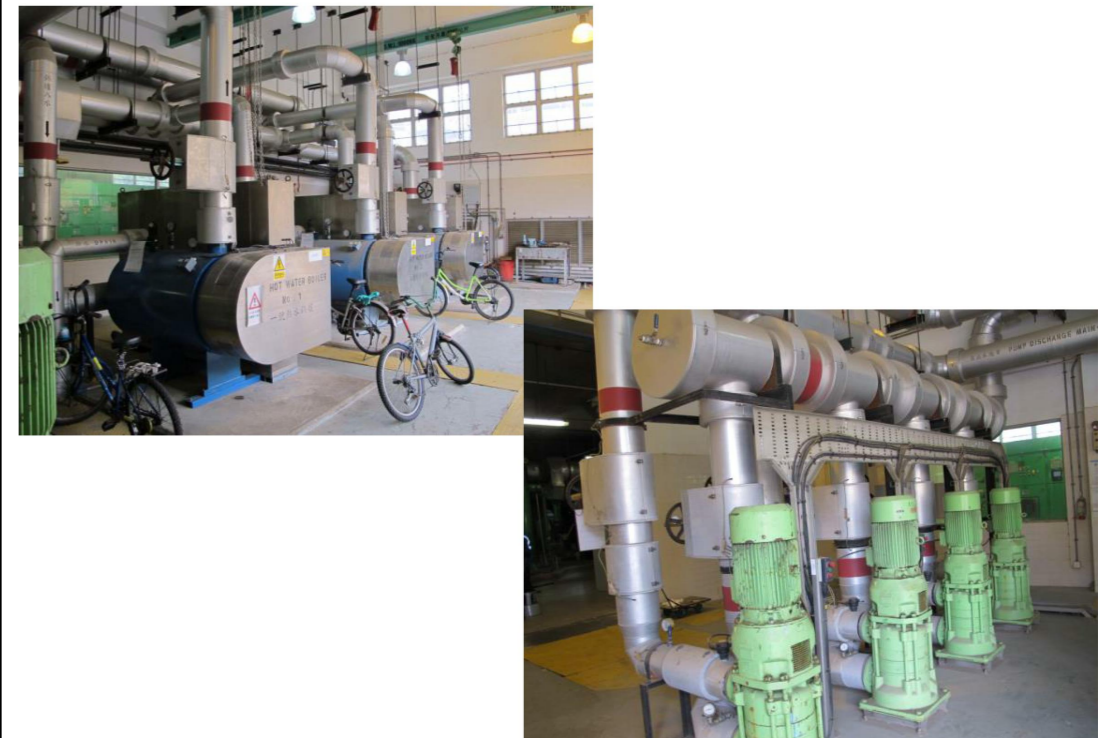
No.: A16	Date taken: 28/01/15
Location: Boiler House (Area: ~231m ²)	
Description: Four set of hot water boiler located within the building, no fuel or lubricant is needed for the boiler to operate. No oil stain was observed inside the building.

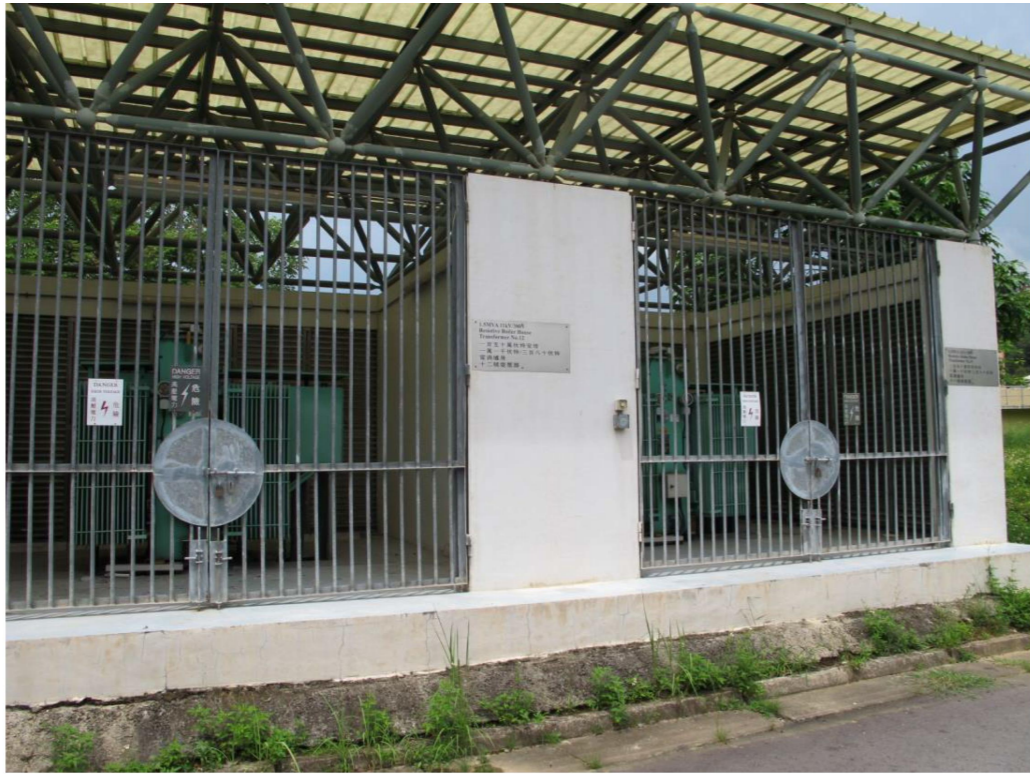
No.:
A18 **Date taken:**
17/07/15

There are 2 transformers (labeled as Transformer No. 11 to 12) near the Power House for the operation of the Boiler House. The transformers are housed within the transformer rooms. The transformer rooms are elevated on an approximately 1.0m concrete platform. No stains were observed on the floor.

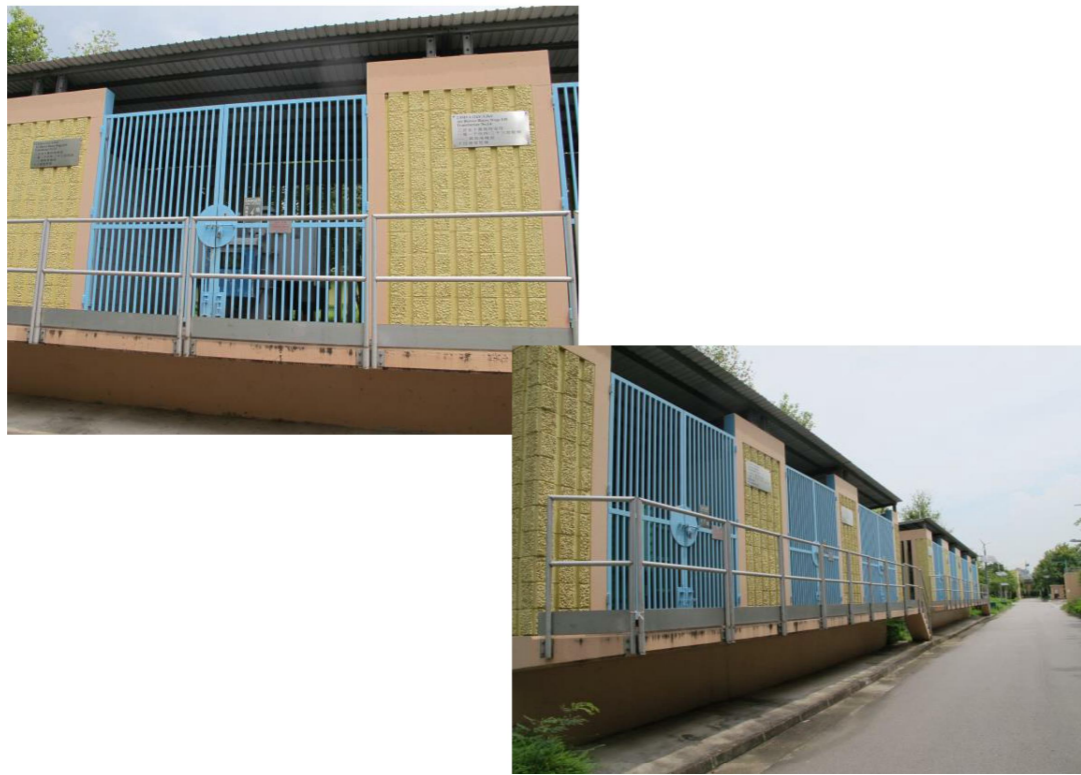
No.:
A19 **Date taken:**
28/01/15

There are 6 transformers (labeled as Transformer No. 13 to 18) near the Power House for the operation of the Power House. The transformers are housed within the transformer rooms. The transformer rooms are elevated on an approximately 1.0m concrete platform. No stains were observed on the floor.

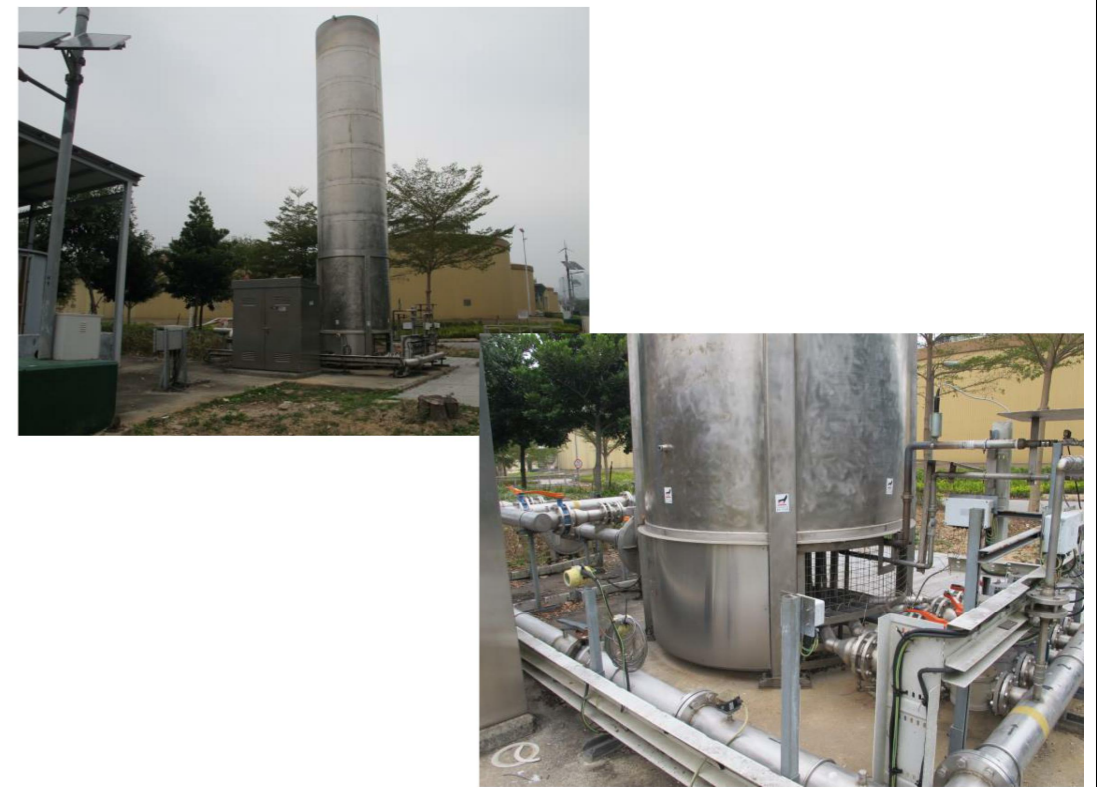
Waste Gas Burners
(Area: ~36m²)

Two set of waste gas burners are located within the treatment plant, to remove methane gas produced from digestion/sludge holding tanks.

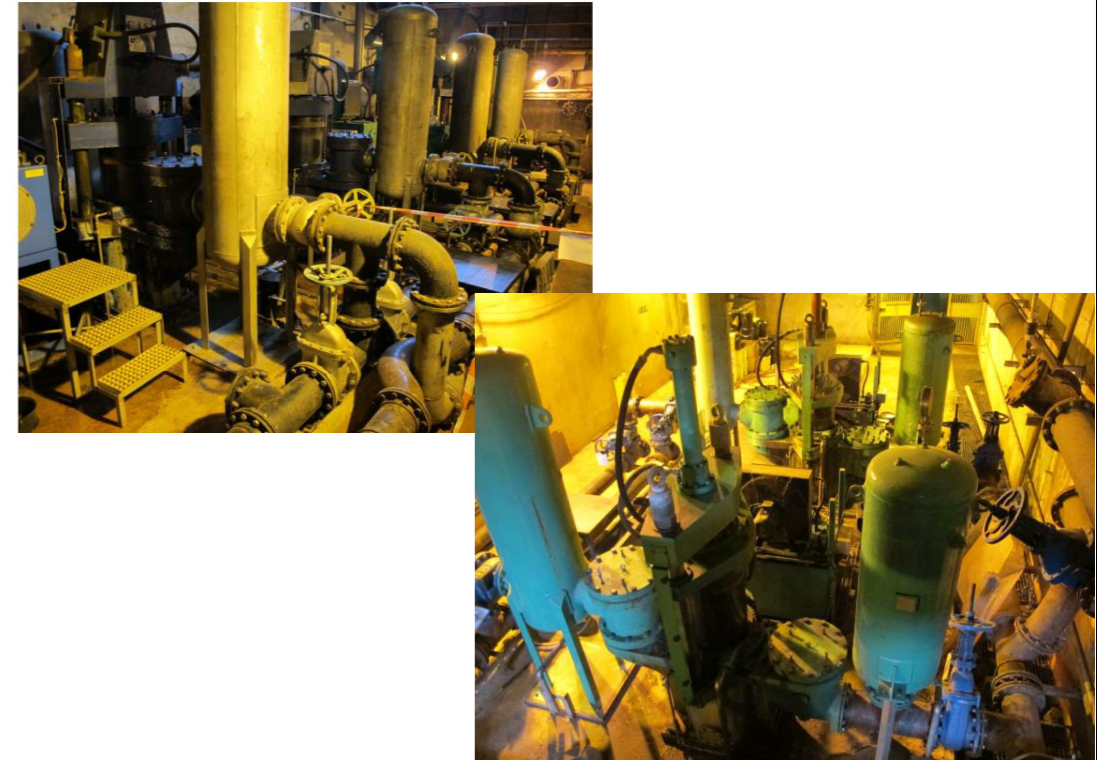
No.:
A20 **Date taken:**
28/01/15

Sludge thickening receiving tanks and cold water receiving tanks were observed in the building.

Concrete paved ground is in good condition and no sign of spillage or stain was observed.

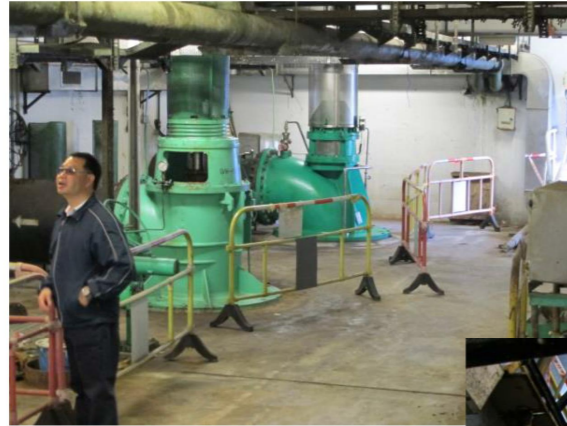
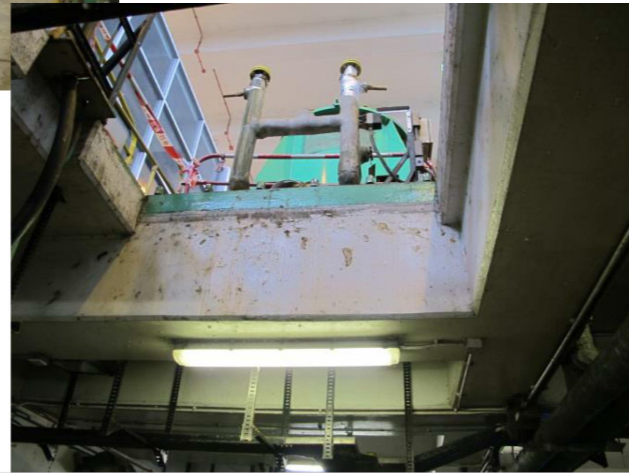
Location:
Effluent Pumping Station
(Area: 619m²)

Description:
Four set of effluent pumps are located within the building. Turbine of the pump that required use of lubricant is located on the first floor.

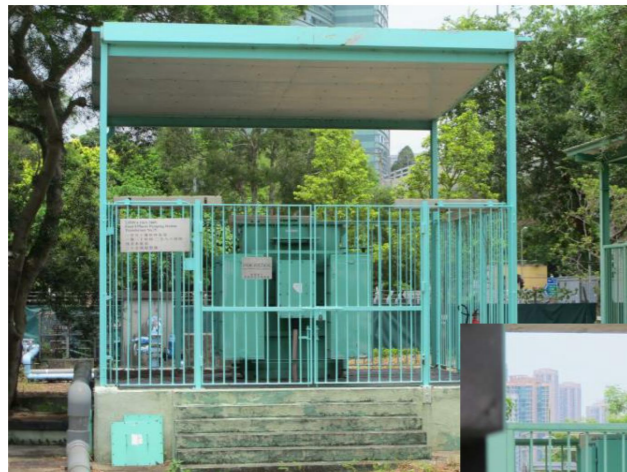
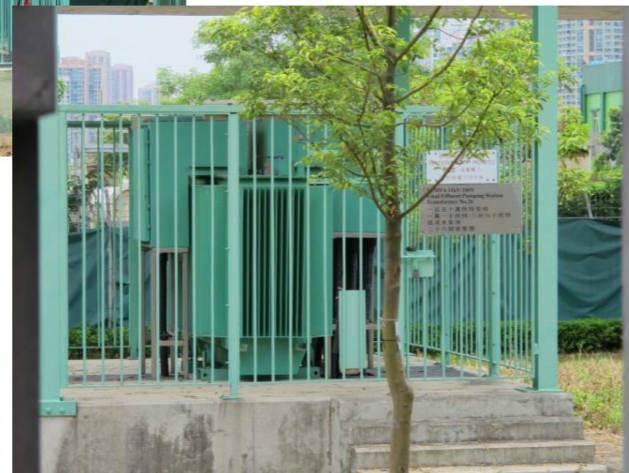
No.: **A26** Date taken: 17/07/15

Description:
There are 2 transformers (labeled as Transformer No. 25 to No. 26) near the Effluent Pumping Station. The transformers are on an elevated concrete platform of approximately 0.5m thick. No stains were observed on the floor.

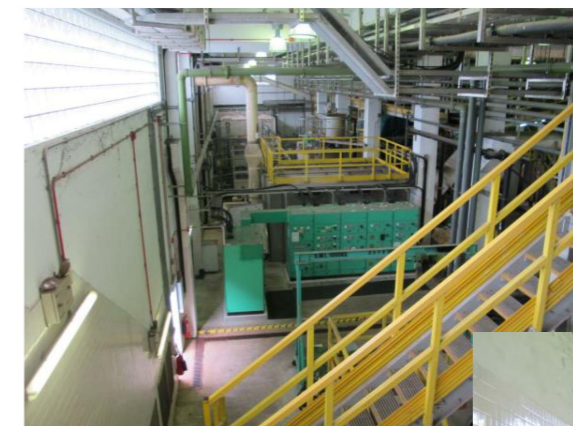
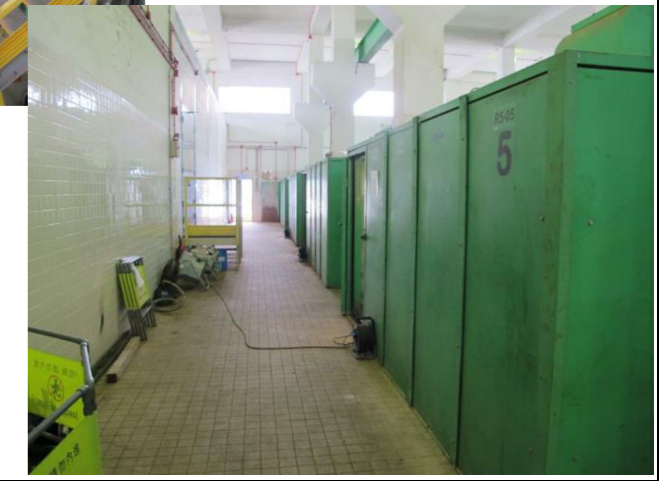
No.: **A27** Date taken: 28/01/15

Description:
Eight centrifuges are located on the first floor of the building and their control panels are based on the ground floor.

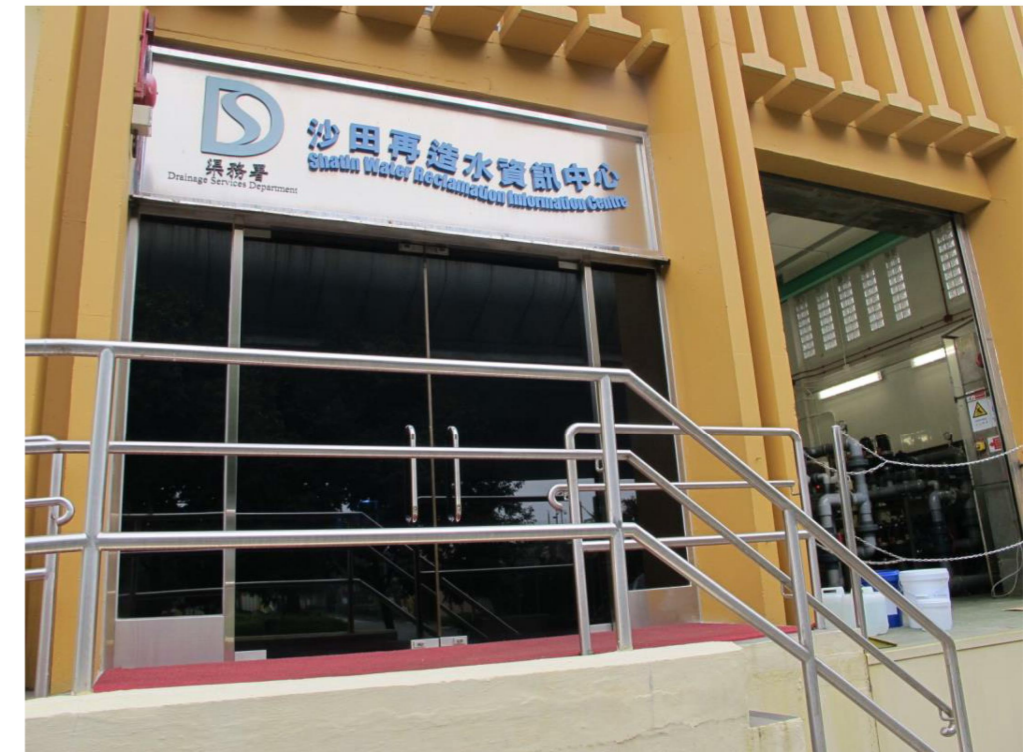
No.: **A28** Date taken: 28/01/15

Description:
Major part of the building is used as information center for visitor.

The remaining portions are used for water reclamation (e.g. ultrafiltration and reverse osmosis system).

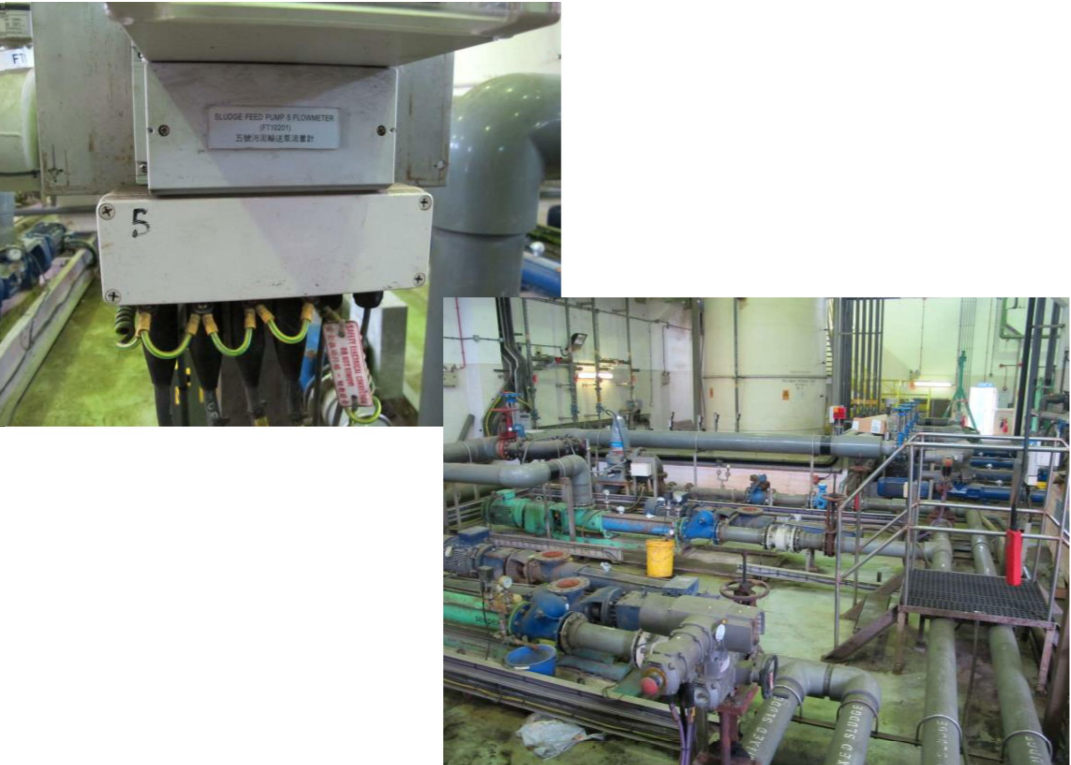
No.: A30	Date taken: 28/01/15

Location: Sludge Transfer Pumping Station (Area: 475m ²)		
Description: Sludge pumps are located on the first floor of the building and for the ground floor, only transfer pipes were observed, no lubricant is needed for pipe line.

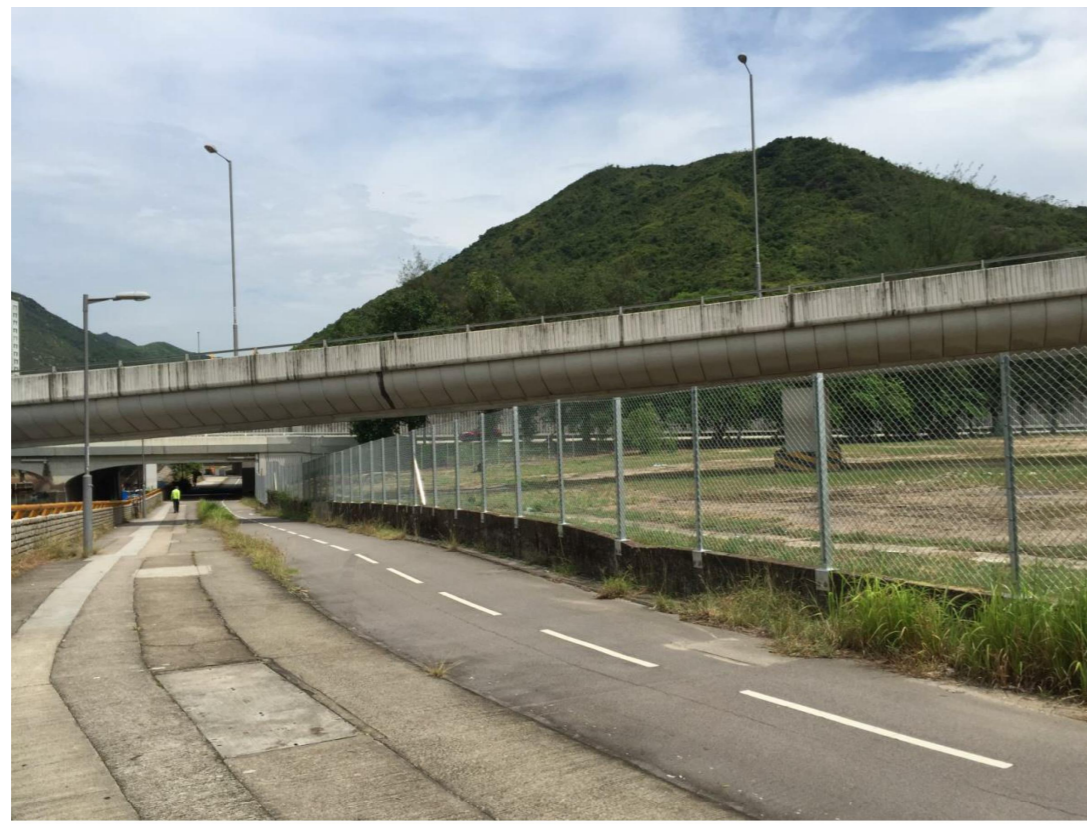
No.: B7	Date taken: 17/07/15
Location: Cycling track and footpath outside the vehicle detention centre (VDC) of the Northeastern part of Area A	
Description: The area is consisted of concrete paved bicycle track, foot path and fenced vacant area.

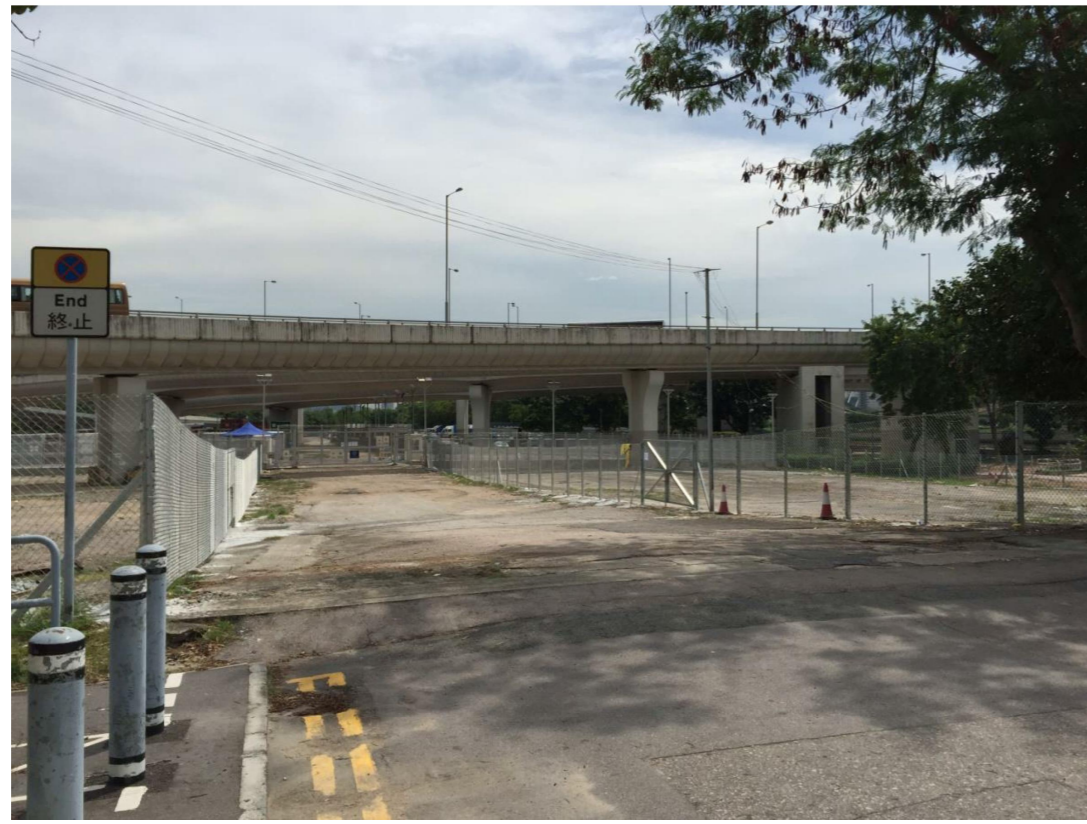
No.: B8	Date taken: 17/07/15
Location: End of Hang Tai Road at the main entrance of VDC in Area A	
Description: Photo showing the concreted paved road and fenced VDC area.
