**Project Title: Port Shelter Sewerage, Stage 3 – Sewerage Works at Po Toi O
(Application No. EIA-244/2016)**

Submission of information pursuant to Section 8(1) of the EIAO

Updated photomontage showing the facade treatment of the sewage treatment plant and the conceptual geotechnical design for the slope (Please see enclosed Fig 10.14a & 10.14b)

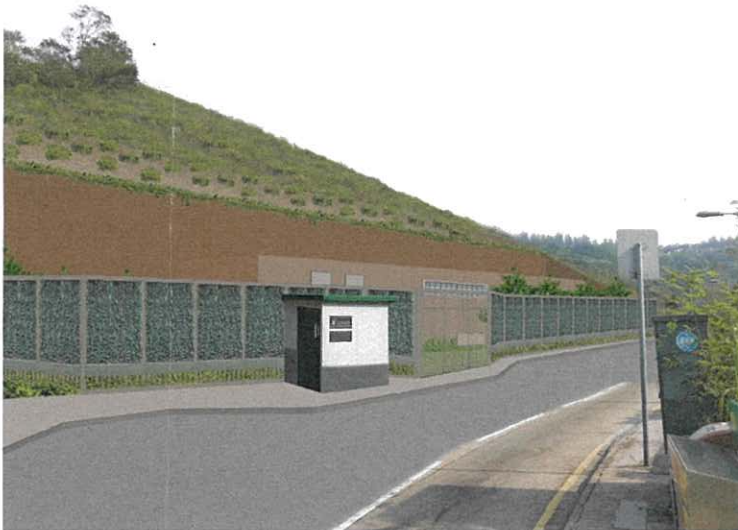
DAY 1 WITH MITIGATION MEASURES

The visual mitigation of the building and retaining wall behind is addressed by the use of chromatic treatment, vertical greening, shrub and tree planting:

- The retaining wall and STP are to be painted with a non-reflective paint in recessive earth tones similar to the natural geology and soil colour of the area so that they blend into the hillside behind.

- Self-clinging climbers are proposed to be planted at the base of the retaining wall and STP in order to green the elevations over time. Climbers and trailing plants will also be planted at the top of the retaining wall to speed the green coverage of the wall. Climbers are also proposed at the base of the site perimeter fence to provide additional screening to the STP and retaining wall elevations. Planters will be irrigated with simple dripline tubing which will ensure that healthy growth is maintained during the winter dry season. It is anticipated that climber planting can provide some effective visual mitigation after the first season and coverage will thicken with each growing season thereafter. In order to provide initial greening of the perimeter fence at Day 1, temporary planters and frames with pre-grown climbers will be attached to the fence as a temporary greening solution. These will be removed once the permanent climber planting at grade has established sufficiently to provide a greening effect.

- Tree planting is also proposed although this will take longer to establish and provide a screening effect. Once mature however, the tree planting will provide an effective visual screen and reduce the apparent scale of the STP.

- Shrub planting is proposed in ground level planters along the fence line and around the STP to strengthen visual screening and amenity. Native shrub and ground cover planting will also be provided on the disturbed ground above the top of the retaining wall in order to re-establish vegetation cover on the existing

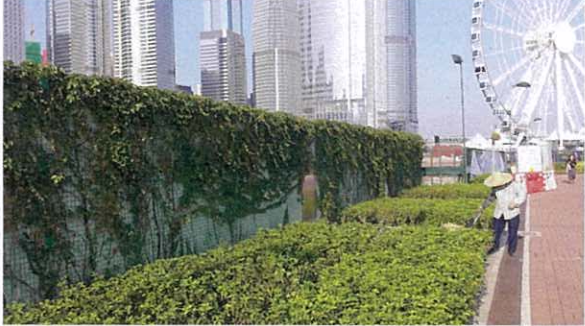
Parthenocissus quinquefolia - Central Waterfront (one season's growth)

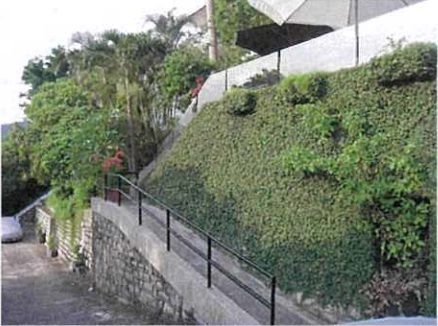
Ficus pumila - Fairway Vista, Po Toi O

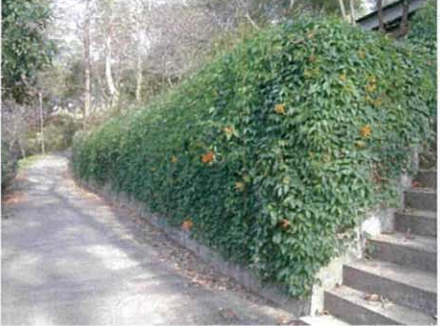
Pyrostegia ignea - planted at top of wall

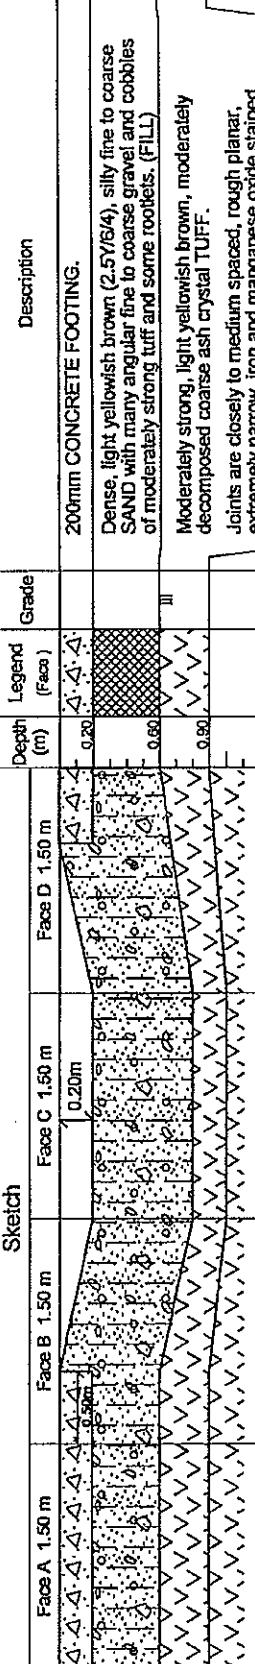
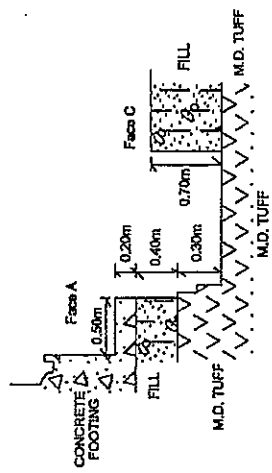
TRIAL PIT RECORD

Project: Agreement No. CE 65/2006 (DS), Port Shelter Sewerage Stage 2 and Stage 3 - Design and Construction, Ground Investigation and Laboratory Testing (Batch 1) WORKS ORDER No.: GE/2007/13.14	Trial Pit No.: TP1	Excavation Dates: 22/01/2010 to 23/01/2010 Backfill Date: 29/01/2010
Contract No.: GE/2007/13	Logged by: P. Zhang Date logged: 25/01/2010 Checked by: S.M. Style Date checked: 27/01/2010	Co-ordinates: E 848492.73 m N 815054.71 m Ground Level: +5.70 mPD	Description: 200mm CONCRETE FOOTING. Dense, light yellowish brown (2.5Y/6.4), silty fine to coarse SAND with many angular fine to coarse gravel and cobbles of moderately strong tuff and some rootlets. (FILL) Moderately strong, light yellowish brown, moderately decomposed coarse ash crystal TUFF. Joints are closely to medium spaced, rough planar, extremely narrow, iron and manganese oxide stained, dipping at 1. 280°/74°, 2. 040°/54°, 3. 280°/80° and 4. 100°/74°.

Legend (Face) Grade III	End of Trial Pit at 0.90m.
PLAN
