Contract Title  
**CONTRACT NO. PM 10/2014  
DRAINAGE IMPROVEMENT WORKS  
IN YUEN LONG, STAGE 1**

Drawing Title  
**Residual Visual Impact  
During Construction and Operation  
- Lin Fa Tei**

Drawing Number	<b>Figure 9.80</b>	Revision	-
----------------	--------------------	----------	---

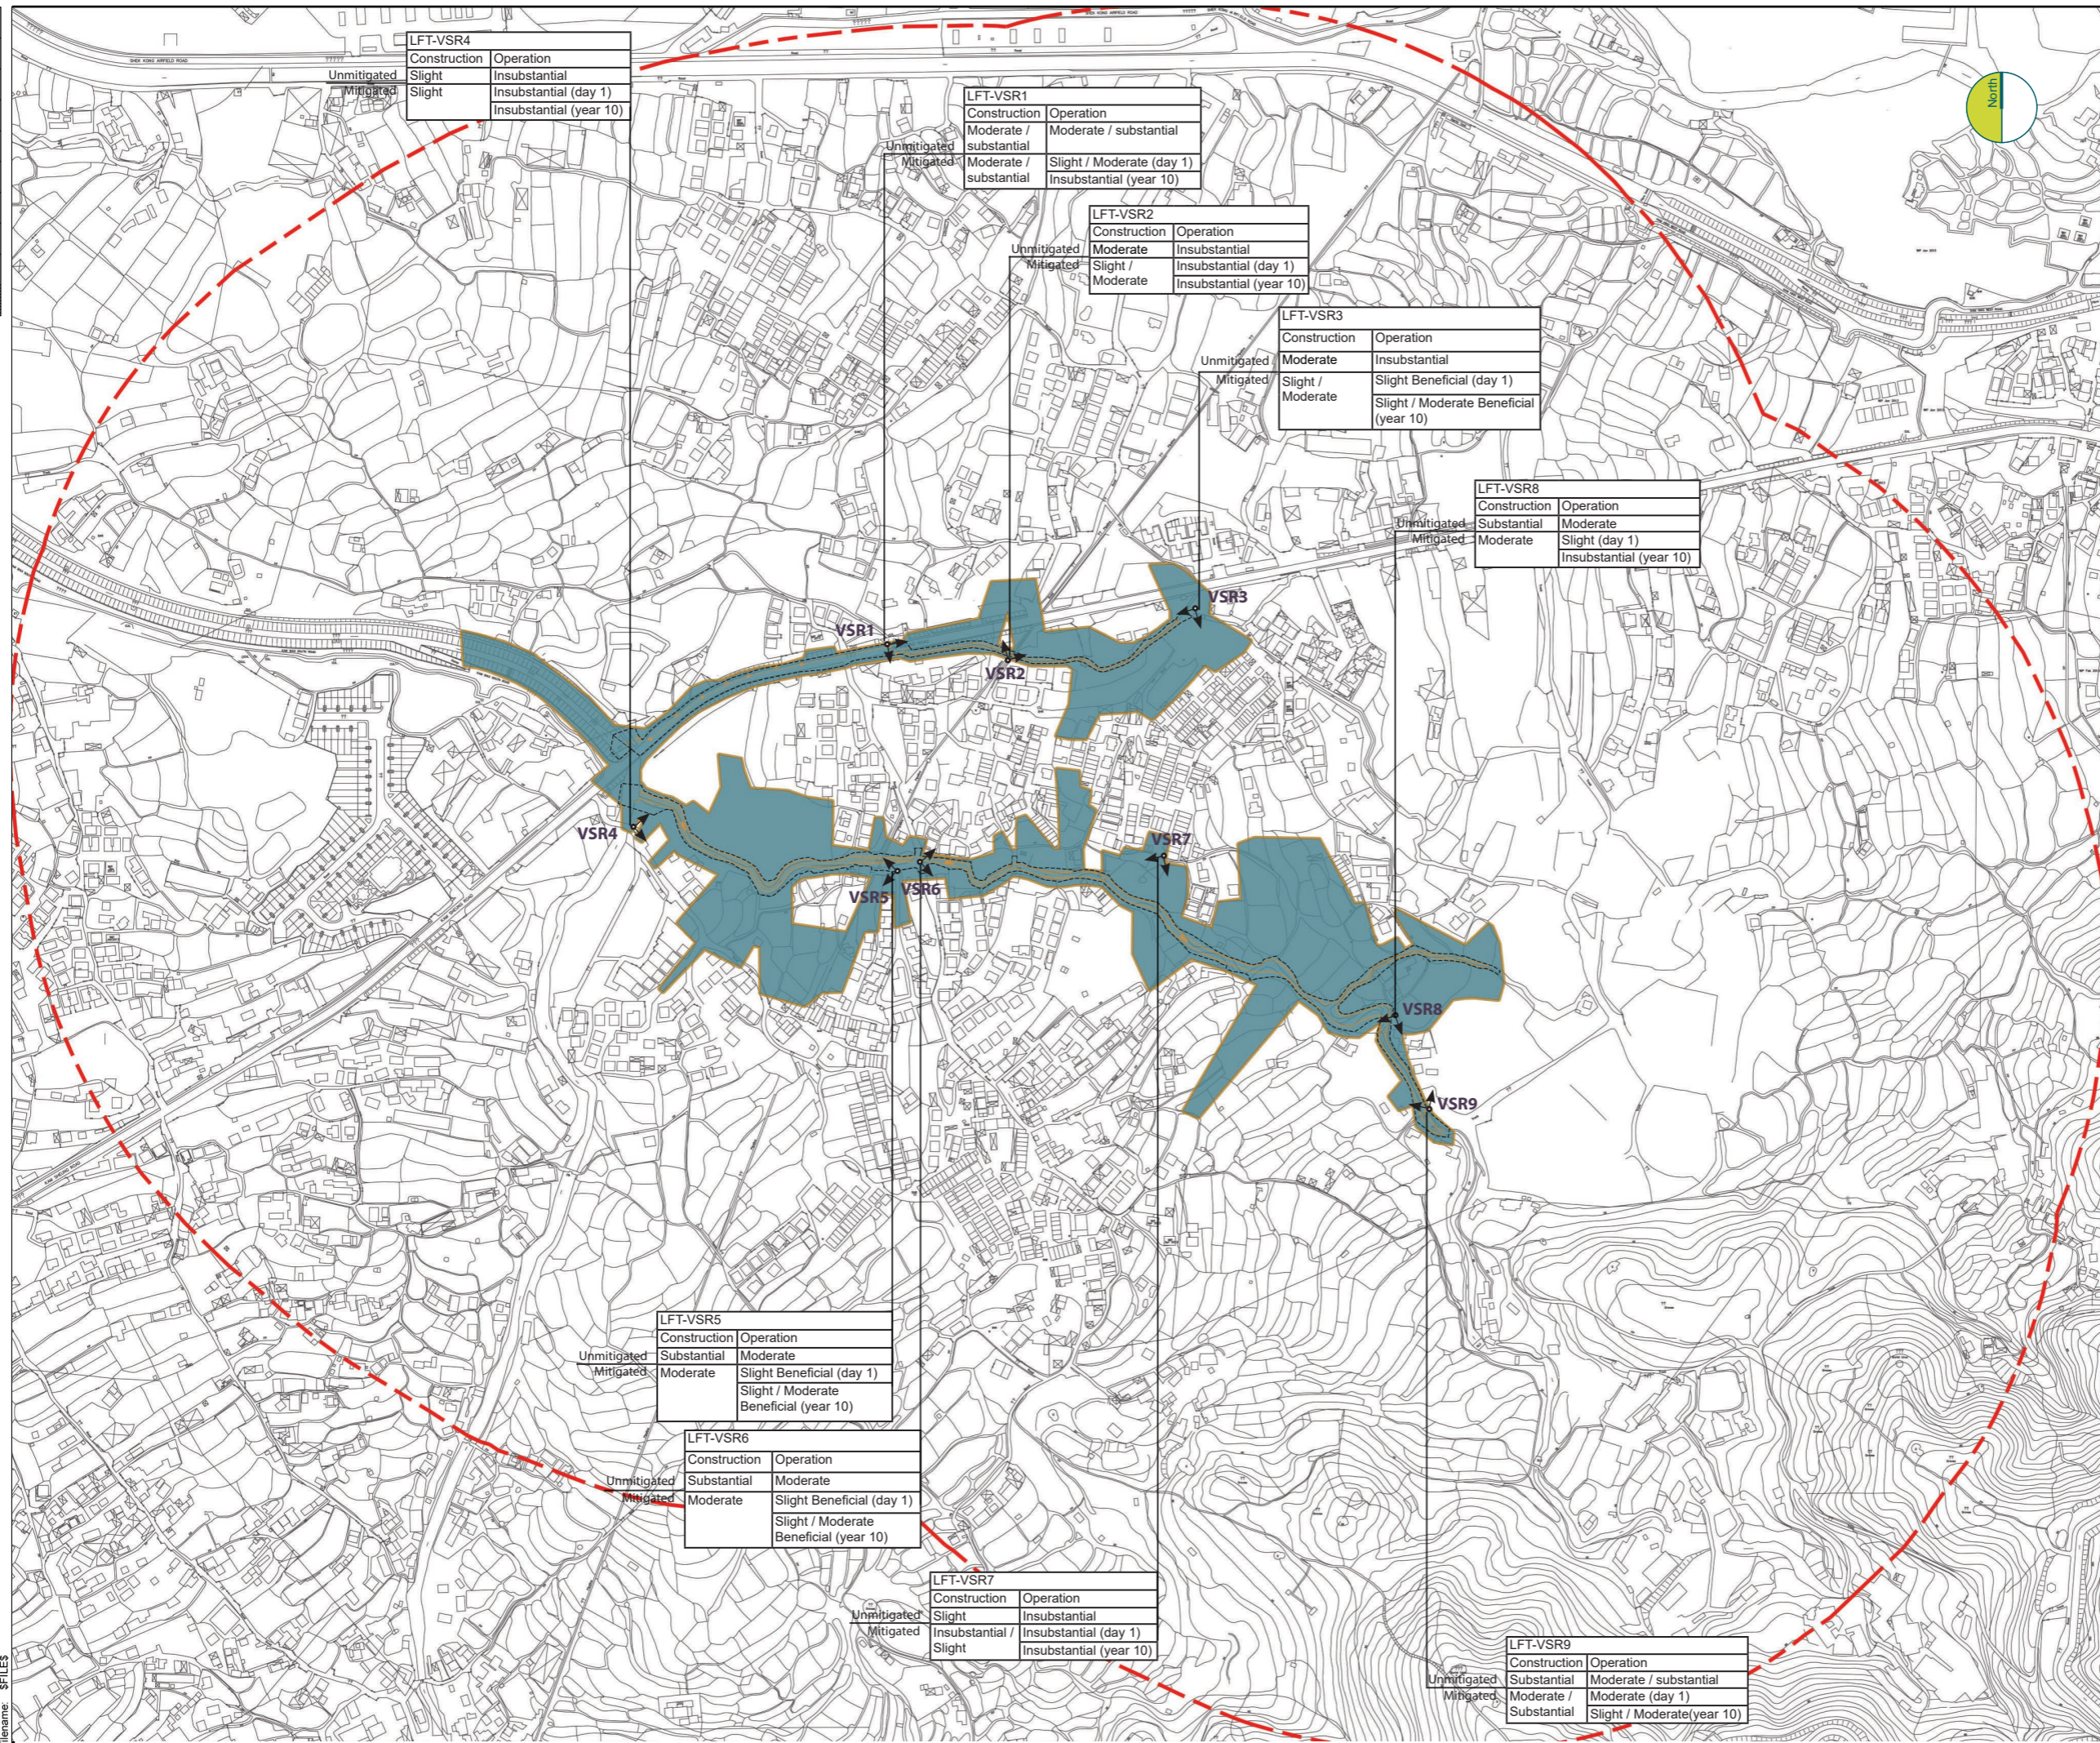
- Work Limit Boundary
- 500M Study Area
- Visual Envelope
- Location of Visually Sensitive Receiver (VSR) and direction of main views

Visual Impacts		
	Construction	Operation
Unmitigated	No Impact	Slight
Mitigated	Substantial	Moderate (day 1) Moderate (year 10)
