7. LAND CONTAMINATION

PROJECT:
Re-provision of Open Cycle Gas Turbines at Lamma Power Station

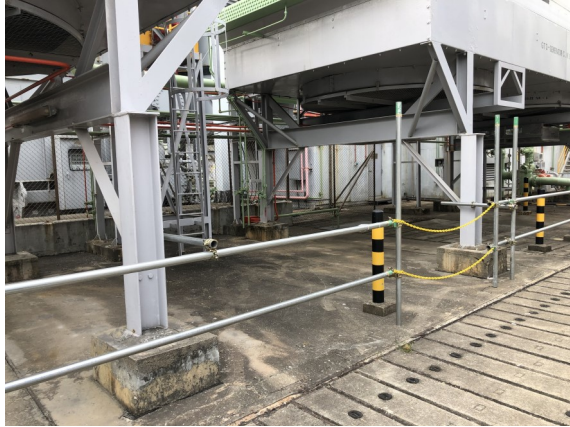
Photo 7: Footings of Generator Coolers

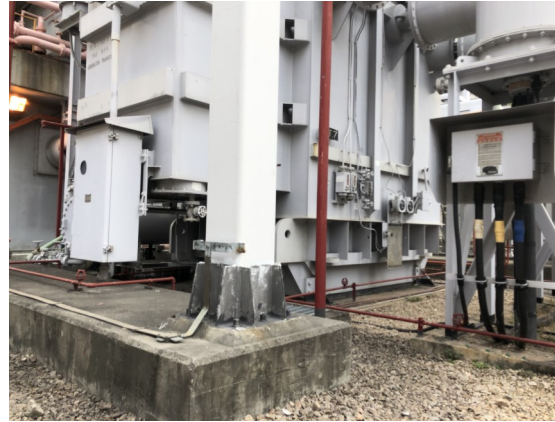
Each GT was mounted on a concrete made foundation pile which provided a barrier to prevent any potential fuel leakage from entering the soil. Each transformer was constructed within a concrete containment bund filled with pebbles inside an isolated area, which prevents contamination from entering the ground beneath of the transformer. No signs of oil stains were observed. The composition of transformer oil used was reportedly free of PCBs. The generator coolers for GT did not require use of fuel and chemicals. Based on the site walkover and interview with site management, no historical fuel / or chemical spillage or leakage were occurred at the six (6) GTs and its auxiliaries.

Photo 8: GT's transformer concrete bund filled with pebbles

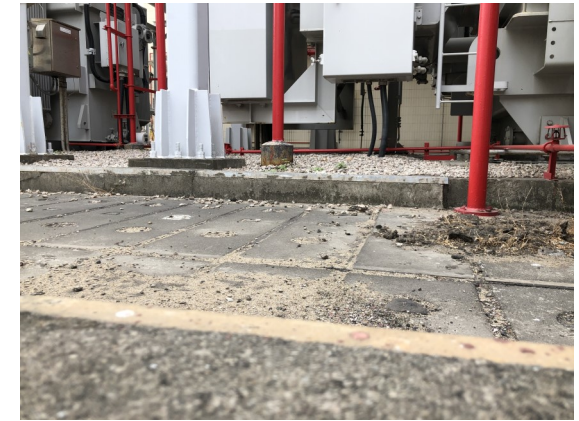
Photo 9: GT's transformer concrete paved ground

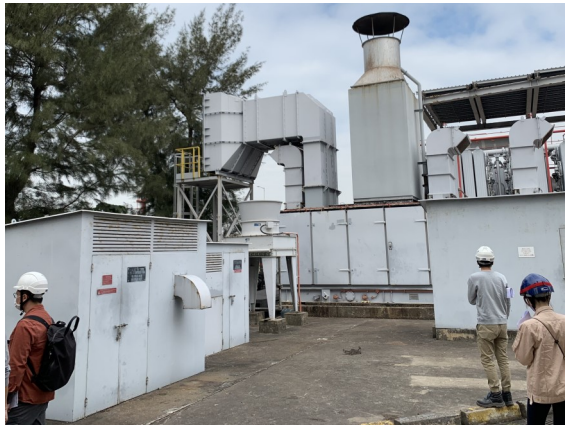
Minor fuel seepage was noted from the diesel supply pipes. Minor oil stains was also observed in one of the air compressor units. The diesel supply pipes are also exposed to ambient environment, thus it could be damaged under extreme weather conditions over the years. Due to its long operation history and its direct exposure without physical protection, potential land contamination caused by the fuel leakage could not be ruled out. Since no significant oil stains were noted on the ground of the BSGT, the extent of potential contamination is likely localised.

Photo 10: Black Start Generator set (one (1) diesel generator and three (3) air compressor units).

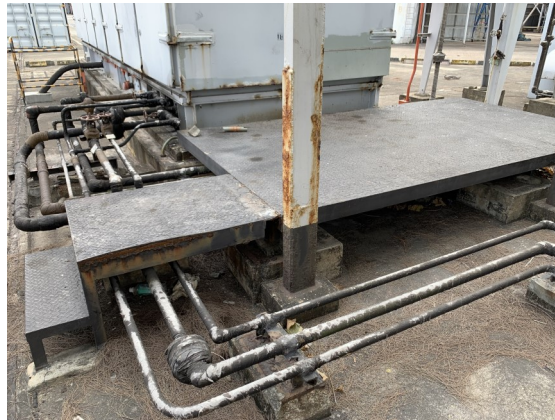
Photo 11: Diesel supply pipes

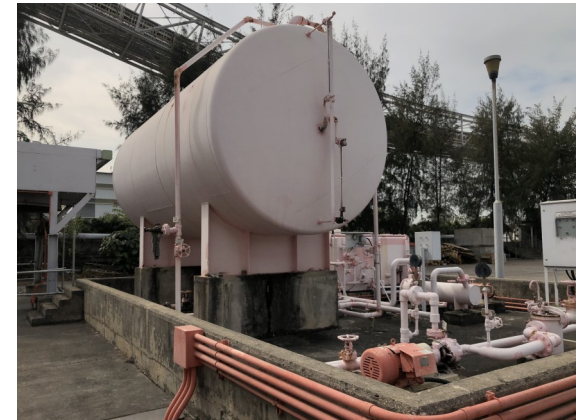
Based on the site observation and operation history of the lube oil tank, the black deposits were likely caused by erosion of screws / steel bars in the concrete footings of the lube oil tank and at the several pipe joints. The lube oil tank structure and its piping are also exposed to ambient environment, thus it could be damaged under extreme weather conditions over the years. Although no significant signs of potential land contamination were noted in the lube oil tank area, the potential land contamination risks as a result of long term usage and extreme weather impacts could not be ruled out. Considering the lube oil tank was installed within a concrete bund to contain any potential oil leakage or spillage, the extent of potential contamination is likely localised.

Photo 12: Lube oil tank

Therefore, one (1) sampling location is proposed at the centre of Lube Oil Tank area based on hotspot sampling approach to represent the overall land condition.

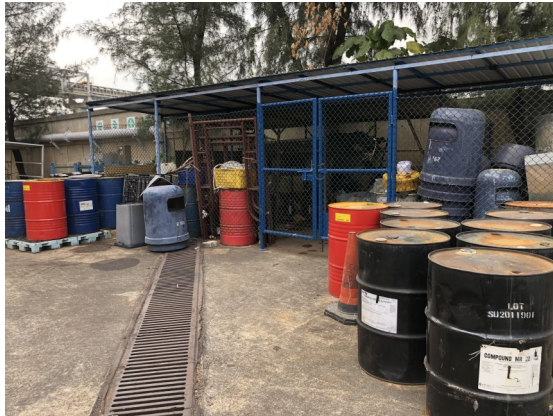
Miscellaneous Storage Shed	<p>Approximately 20 empty chemical containers without secondary containers were placed in the vicinity of the Miscellaneous Storage Shed. Several black stains of about 1m² were observed on the ground of the shed's entrance.</p>

Based on the observation during the site walkover, approximately 20 empty chemical containers without secondary containers were placed in the vicinity of the Miscellaneous Storage Shed. The area of Miscellaneous Storage Shed is about 40 m². In addition, two black stains of about 1m² in total were observed on the ground of the shed's entrance. The potential land contamination from fuel or chemical leakage is likely. Considering the small footprint of black stains observed onsite, the extent of potential contamination is likely localised.

Photo 13: Miscellaneous Storage Shed

Therefore, one (1) sampling location is proposed at the shed entrance based on hotspot sampling approach to investigate the potential contamination at the black stains.

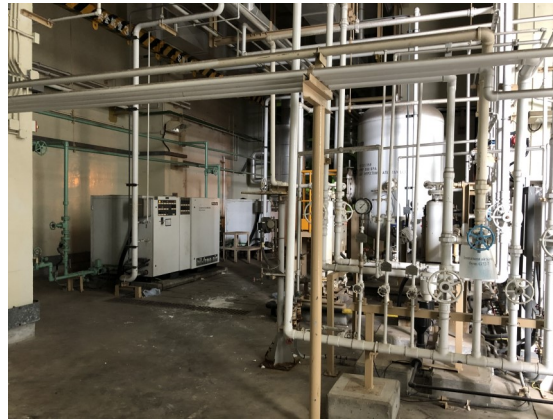
No signs of potential land contamination, including oil stain or colour stain, and no chemical storage were observed at the Turbo Block structure, miscellaneous gas tanks and cooling water pumps on G/F during the site walkover. No potential land contamination impacts were observed at the generator, generator coolers and lube oil coolers that were installed on 1/F and above floors.

Photo 14: Gas tanks installed at the ground floor of GT57 Auxiliary Building

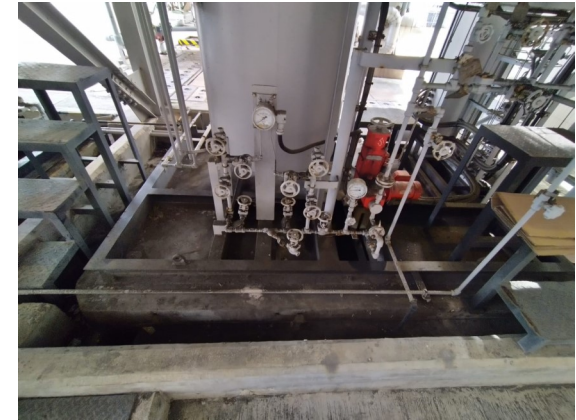
Based on site walkover observation and interview with site management, the Chemical Dosing Pit (Hydrazine Hydrate Tank) appeared to be well maintained. No signs of chemical leakage or spillage were observed. Moreover, the concrete containment bund surrounding the Chemical Dosing Pit (Hydrazine Hydrate Tank) prevents contamination from entering the ground beneath. Reportedly by site management, no historical chemical spillage or leakage incidents were occurred. The risk of hydrazine hydrate being released into the soil is very low. However, potential mechanical pump oil leakage as a result of long term usage of the mechanical pump of the dosing pit could not be ruled out. Due to the small footprint of mechanical pump, the extent of potential contamination is likely localised.

Photo 15: Chemical Dosing Pit (Hydrazine Hydrate Tank) at the ground floor of GT57 Auxiliary Building

Therefore, one (1) sampling location is proposed at the bottom of the mechanical pump of Chemical Dosing Pit (Hydrazine Hydrate Tank) based on hotspot sampling approach to investigate the potential land contamination. Due to shallow excavation depth required for the new cable trenches, trial pit is recommended as site investigation (SI) method.

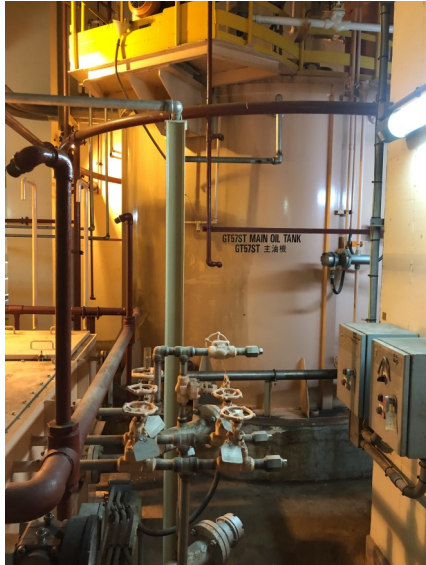
No signs of potential land contamination, including oil stain or colour stain, were observed at the main oil tank area during the site walkover. According to the information provided by HK Electric, the Main Oil Tank was fabricated in 2001 and put into operation in 2003. The Main Oil Tank and its oil pipes have been maintained in good condition as they are located in an indoor environment. In addition, the concrete bund that contains the Main Oil Tank and its oil pipes prevents contamination from entering the ground beneath. No signs of corrosion or damages were noted at the tank structure and its oil pipes during the site walkover.

Photo 16: Main oil tank installed at the ground floor of GT57 Auxiliary Building

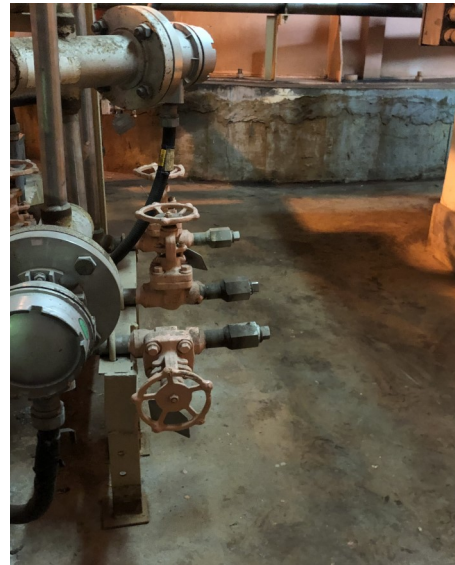
Therefore, the good condition of tank structure and oil pipes and the concrete bund indicated that there's a remote chance of historical oil leakage or spillage at the Main Oil Tank area. In addition, no excavation works will be required during demolition of main oil tank.

Photo 17: Main oil tank paved surface in good condition

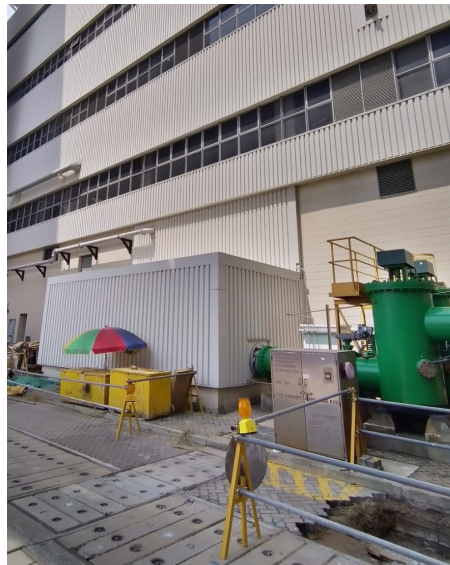
The Circulating Water Pipe Room only served to enclose the emerging section of two (2) circulating water pipes connected to the Condenser inside the GTAB. No current and historical land contamination activities were noted. Although deep excavation works down to 5m bgl will be

Photo 18: Circulating Water Pipe Room at the immediate east of GT57 Auxiliary Building

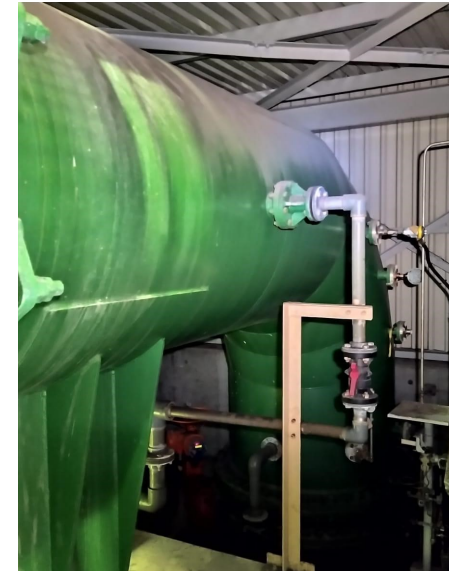
Photo 19: Circulating Water Pipe emerging from underground
