Appendix 11.1 Photos of non-graded buildings and structures and additional historic buildings

Additional historic buildings

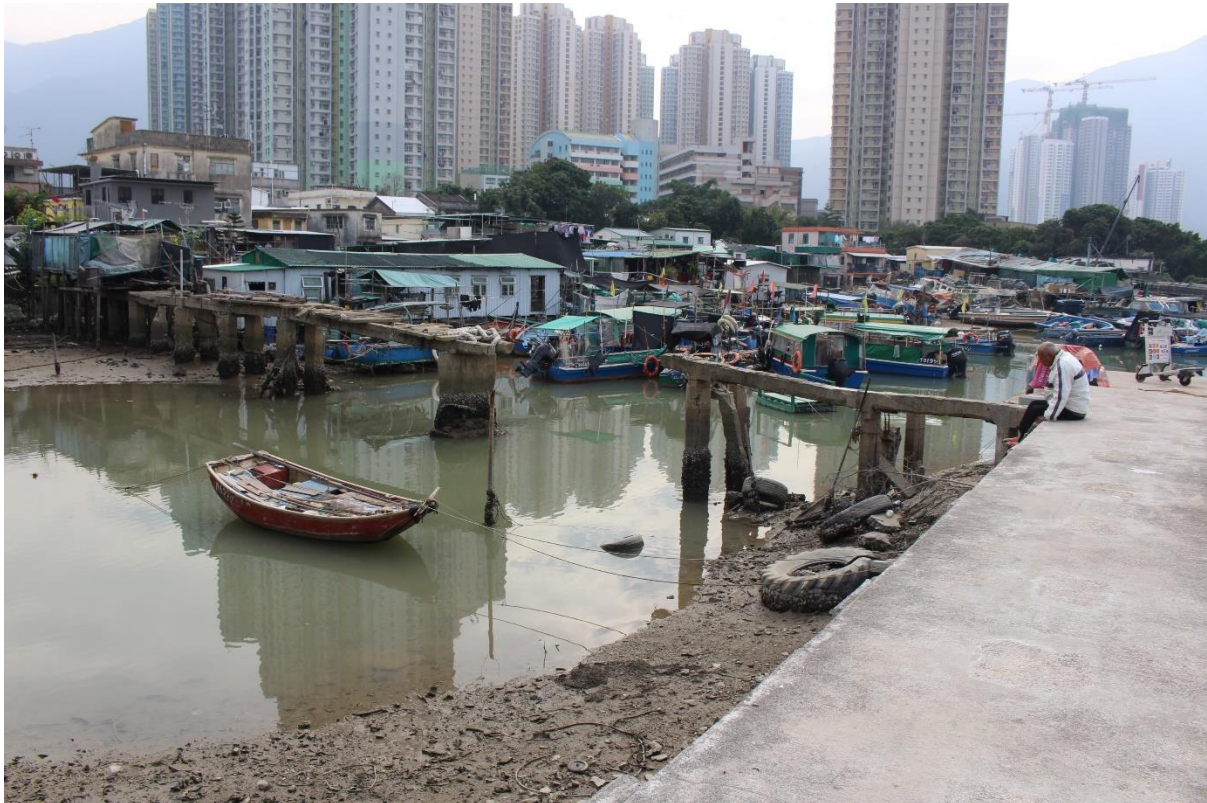
Plate 1

Broken bridge in Ma Wan Chung

The concrete bridge is undated but construction was built by 1973 (see Figure A aerial photo below).

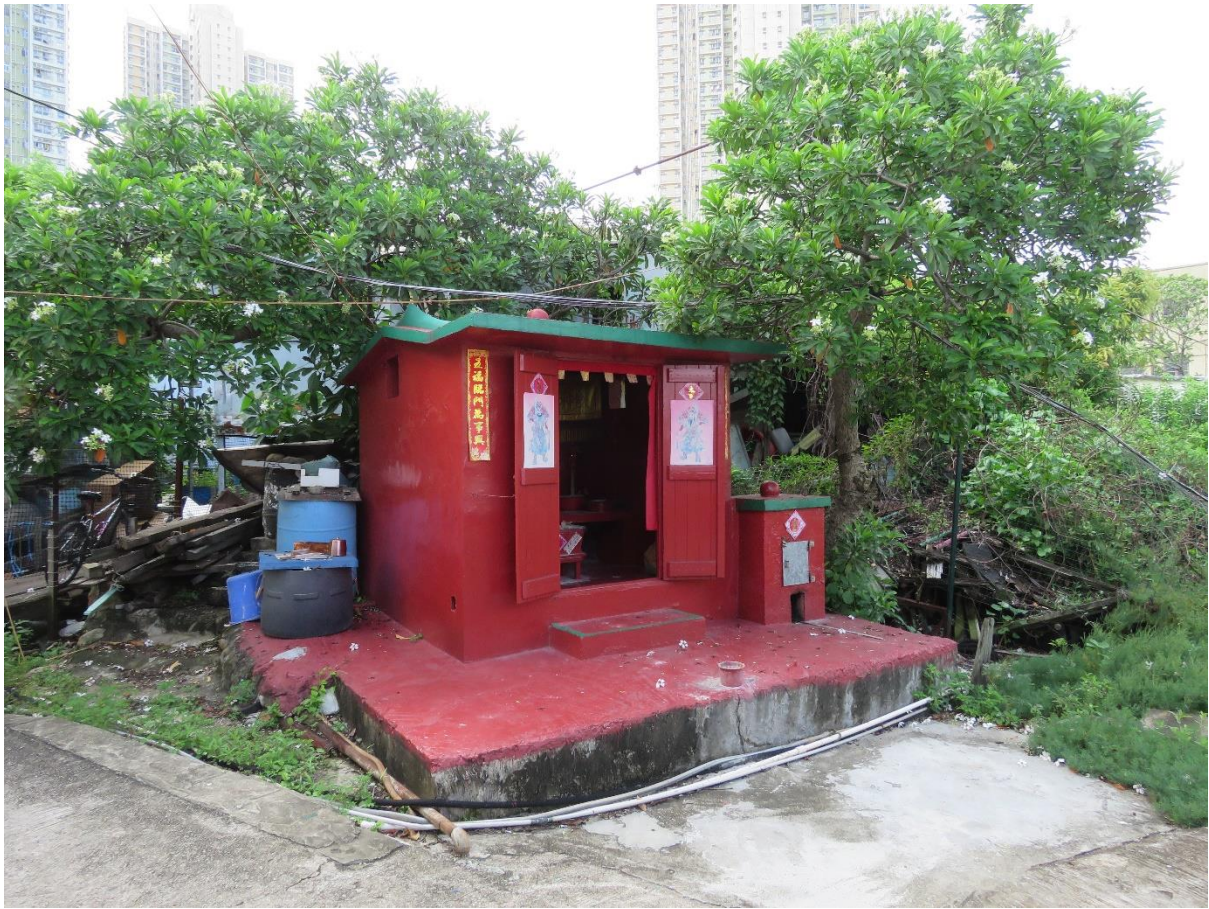
Plate 2

Earth shrine in Ma Wan Chung of unknown date but (re)constructed in modern materials.

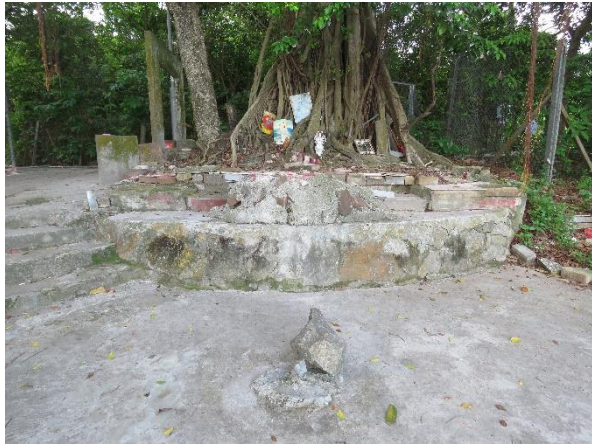
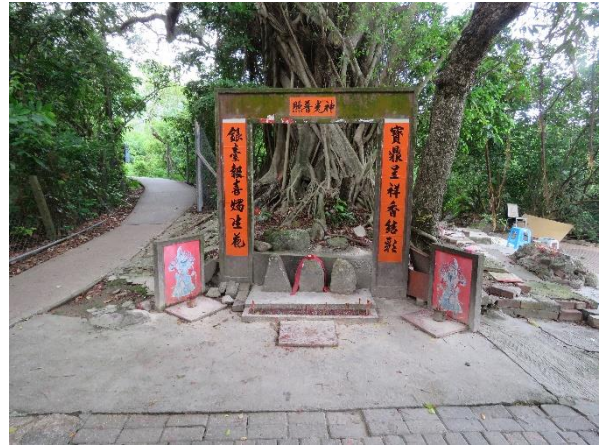
Plates 3-4

Shrine and Earth Shrine in Sha Tsui Tau of unknown date but (re)constructed in modern materials.

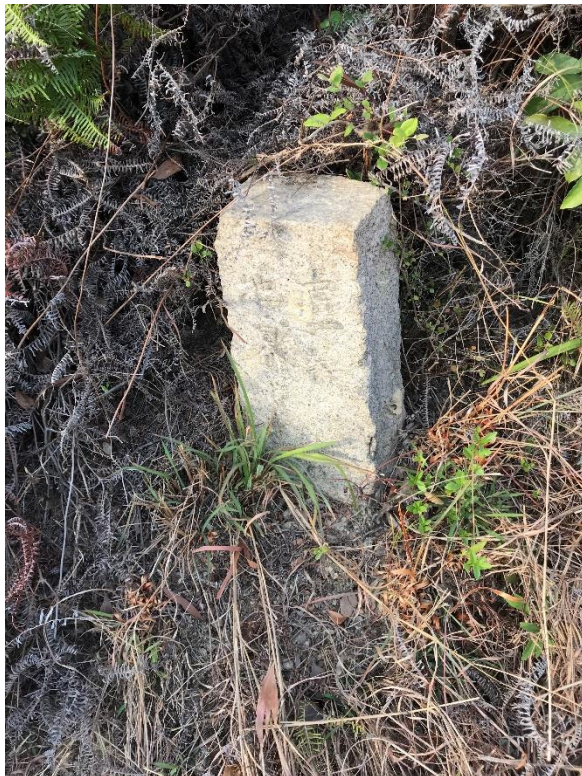
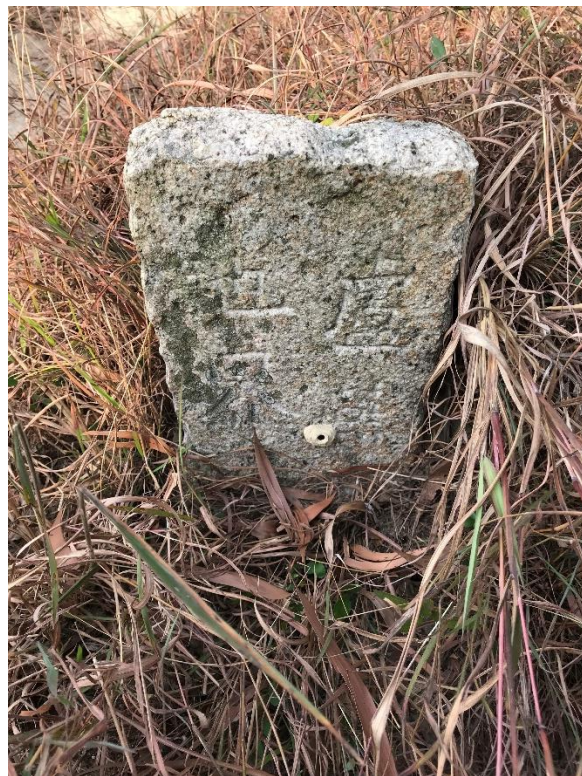
Plate 5

Two boundary stones which are located on the hillock north of Ma Wan Chung Village. Undated but likely to be associated with settlement of Ma Wan Chung in the late 20th century.

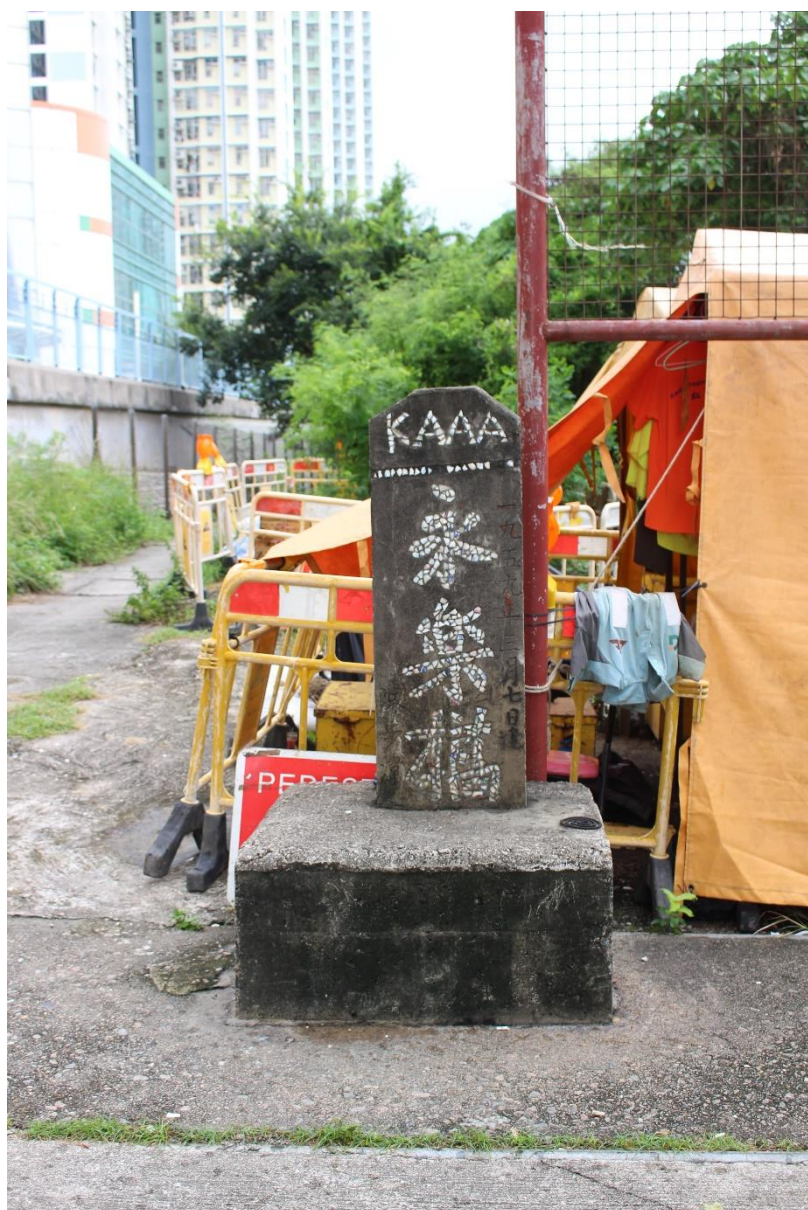
Plate 6

The concrete stele is dated to 1959 and associated with the construction of Wing Lok Bridge (永樂橋) which connected Ma Wan Chung with Sha Tsui Tau communities.

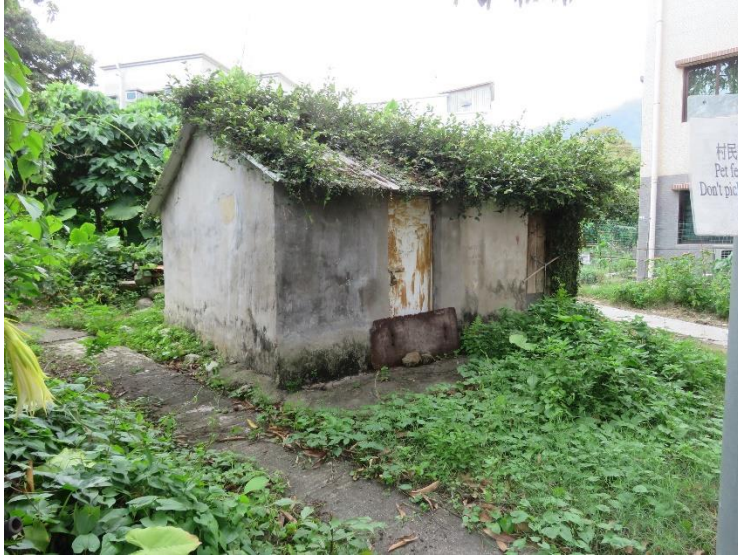
Plate 7

It is a shed made of red brick and has pitched roof once covered by tiles (Highways Department 2002). A review of old survey maps suggests its erection date falls between 1906 and 1968 (SMO 1906a; Ordnance Survey 1968). Small rectangular windows open at rear wall. Walls have been surfaced with cement. The roofing material has been replaced by congregated sheet. One door keeps wooden shutters while the other has been replaced with metal door.

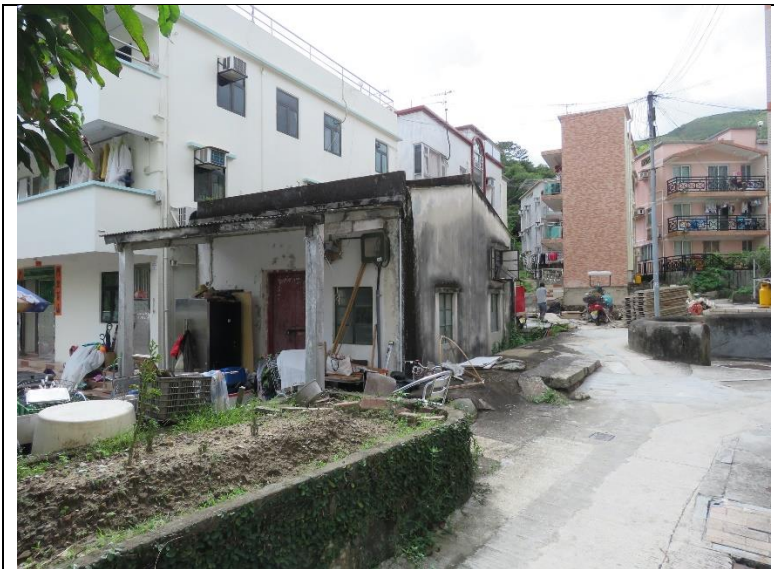
Plate 8

It is single hall residential house with pitched roof. A review of aerial photo and surveyed map suggests its erection date falls between 1963 and 1968 and it has low heritage value (Lands Department 1963; Ordnance Survey 1968).

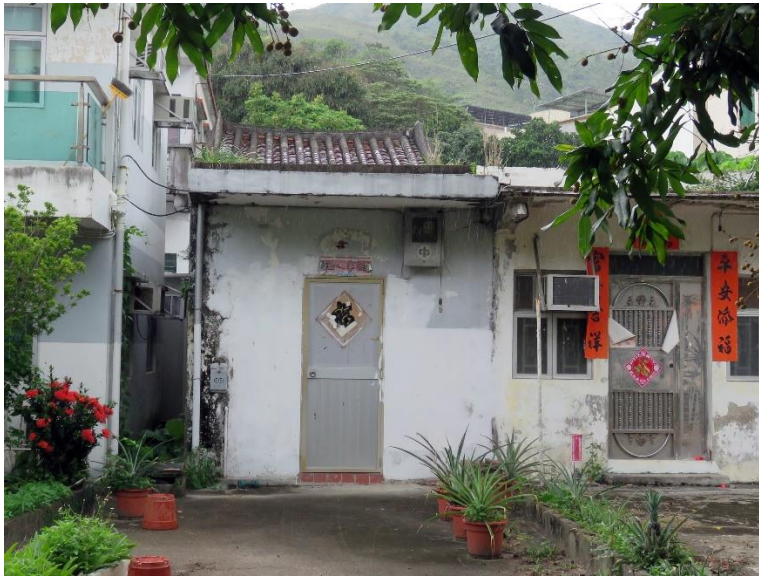
Plate 9

It is a courtyard style residential house. It is with a pitched roof covered by tiles. Wall surface is paved with concrete. A review of aerial photo and surveyed map suggest the house came into existence between 1906 to 1945 (Lands Department 1945; SMO 1906a). Façade is with modern metal gate. Glass windows at two levels are installed on rear wall, suggesting a cockloft level inside.

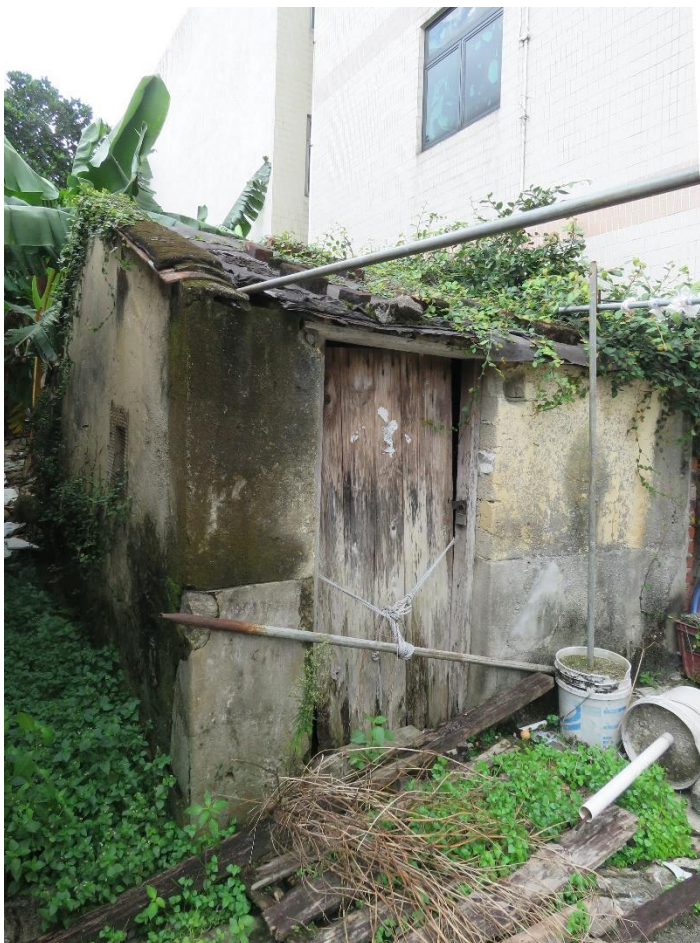
Plate 10

It is a single hall building with pitched roof. A review of aerial photo and surveyed map suggest the building was erected between 1906 and 1963 (Lands Department 1963; SMO 1906a). It is made of mud brick, stone, timber and tile. Roof tiles have been largely replaced by metal sheets and tarpaulin. A small window opens at side wall. Walls are surfaced by mortar and concrete.

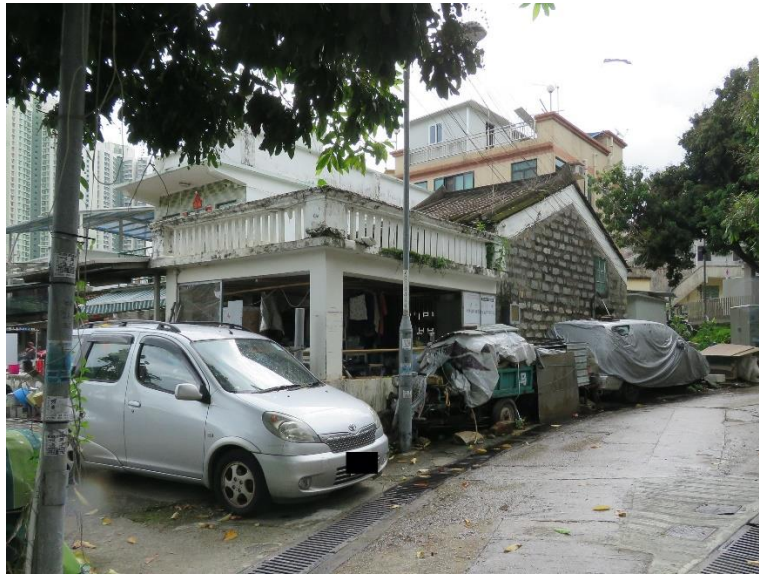
Plate 11

It is two-storey residential house with pitched tile roof and a porch under balcony. A review of aerial photos suggests the building was constructed between 1924 to 1956 (Lands Department 1924 & 1956). The house is constructed of stone blocks and concrete. Wall frieze and porch is painted in white. Glass windows are opened at side wall.

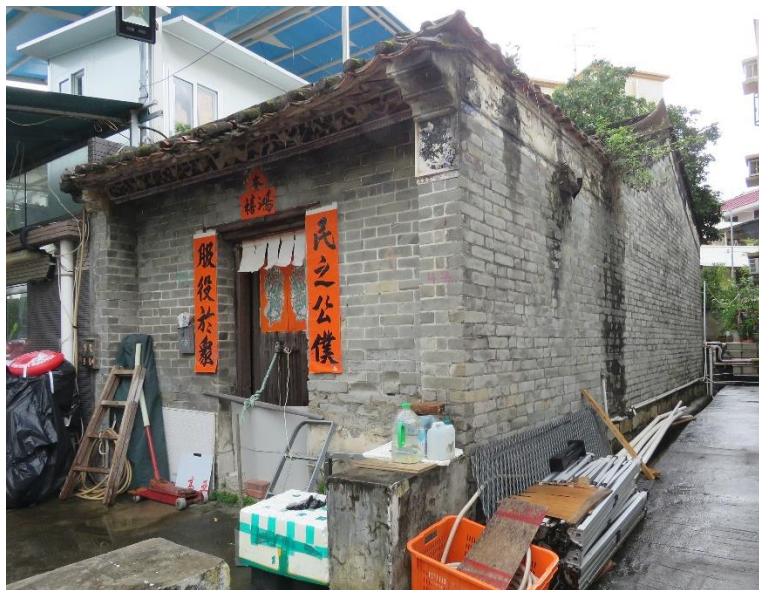
Plate 12

It is a courtyard style residential house. A review of aerial photo and survey map suggests the house was constructed between 1906 and 1956. Walls and roof are covered by tiles. Wooden fascia and frieze boards are decorated.

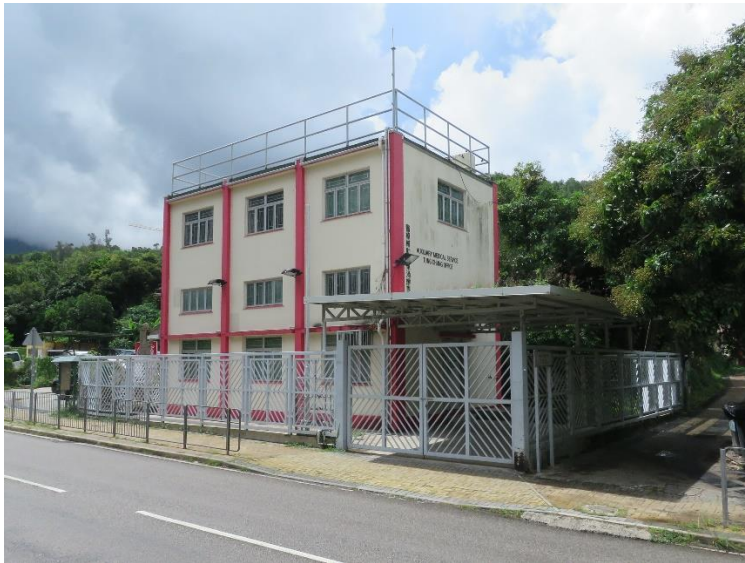
Plate 13

AMS Tung Chung Office

The Auxiliary Medical Service (AMS) is established in 1950 under the Auxiliary Medical Service Ordinance. The organization provides voluntary medical and health services to people in Hong Kong and plays an important role in times of natural disasters or calamities. A review of surveyed topographic maps shows its office building in Tung Chung appeared in between 1974 and 1976, and has low heritage value. (Ordnance Survey 1974 & 1976).

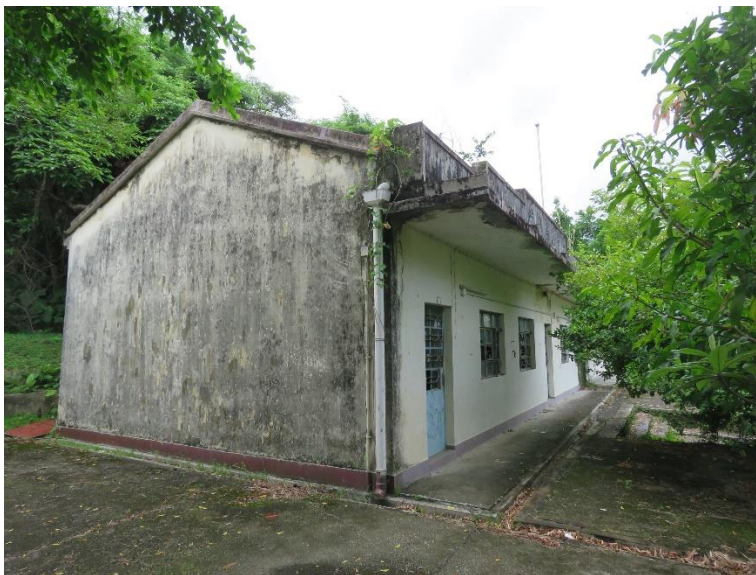
Plate 14

The school building is completed in 1957. It is a single-storey concrete building housing a row of classrooms. A pediment bearing the school title and year of construction is built in front of pitched roof but positioned to one side of the building facing a flight of staircase. Walls are painted in pale yellow and highlighted with red lines. Windows and doors are made of metal and glass. The school once provide primary education to local children. It ceased operation in 2003.

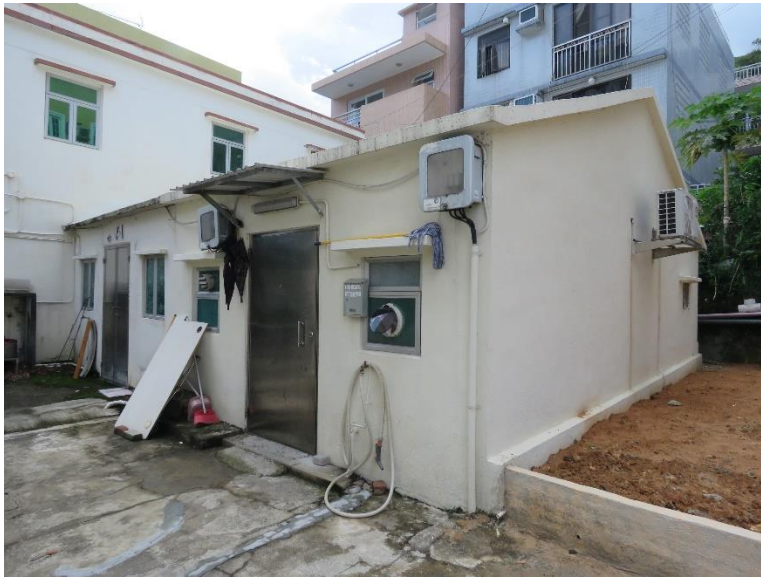
Plate 15

The houses are single-storey residential houses with concrete made pitched roof. A review of aerial photo and surveyed map suggests the site was occupied by houses since 1906 (Lands department 1945; SMO 1906). But the current houses have been largely modified: the roof is covered by concrete; modern metal gates and windows are added; walls and the roof are painted in white.

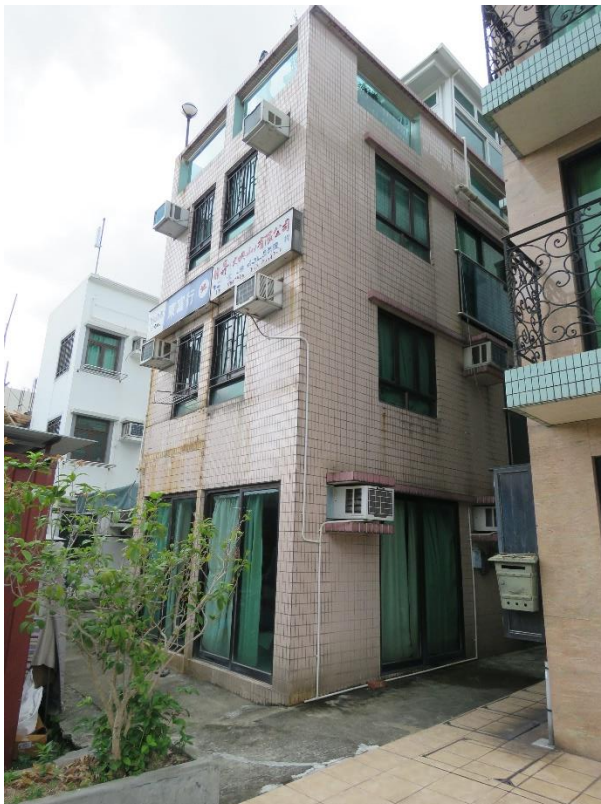
Plate 16

Building between 7B and 7D Sheung Ling Pei

The old building at this site has been replaced by a new building.

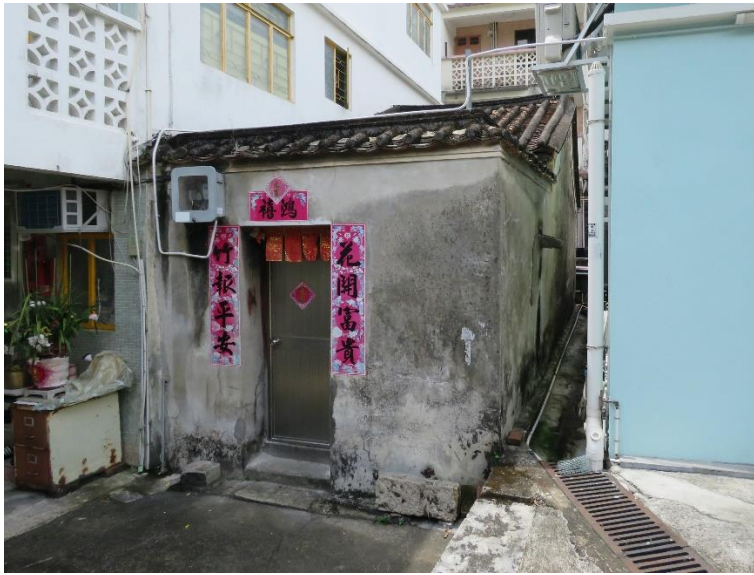
Plate 17

The building is a courtyard style residential house. A review of old survey map and aerial photos suggests the house was constructed before 1945 (SMO 1906; Lands Department 1924, 1945, 1956, 1963). Walls and roof are covered by tiles. The walls have a yellow mortar finish with concrete repair at places. Timber framework can be observed at rear wall. Frieze band is painted in white under pitched roof on side wall. Modifications include metal gate in façade and glass window added to rear wall.

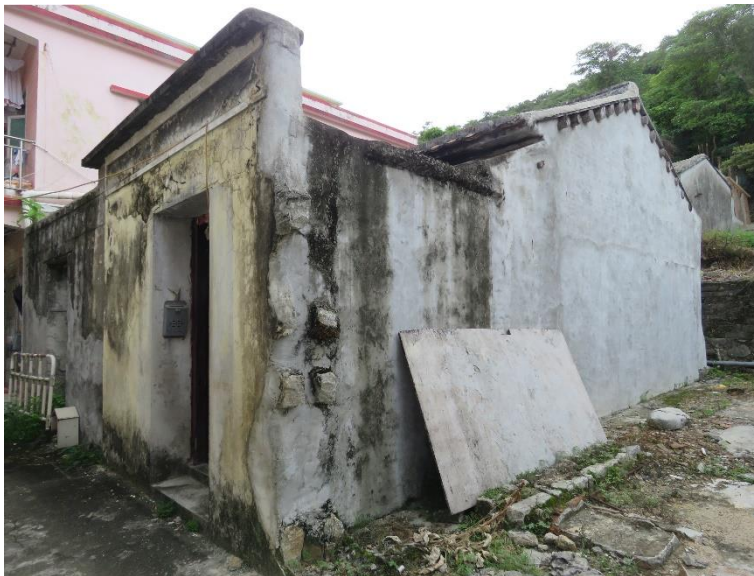
Plate 18

It is a courtyard style residential house. A review of old surveyed map and aerial photos suggest the footprint of the house existed before 1945 (SMO 1906; Lands Department 1924 & 1945). Façade wall raised higher than courtyard wall and is decorated with a plastered frieze. Entrance consists of wooden shutters painted in red. Side wall originally attached to another building shows stone component and timber framework. Wall surface is with yellow mortar finish. Modern glass windows are seen at two levels on the rear wall, suggesting a cockloft level inside.

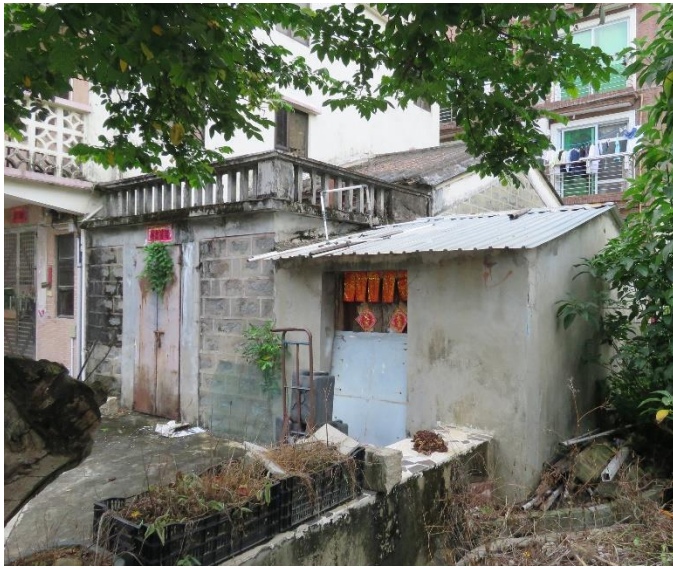
Plate 19

No.66 is a residential house made of stone blocks and concrete with a balcony built above entrance and a tiled pitch-roof above main hall. The structure beside No.66 is shed with pitched roof and wooden shutters. A review of old surveyed maps and arial photos suggest the structures were in existence in 1963; alteration in roofing material is spotted between 1956 and 1963, which might suggest renovation or rebuilt (SMO 1906; Lands Department 1956, 1963; Ordnance Survey 1968). The balcony of No.66 is made of concrete, possibly a later add-on to an open courtyard. Its façade is with metal shutters. Glass windows open at side and rear walls. The shed has metal sheet as roofing material, possibly a replacement to tiles.

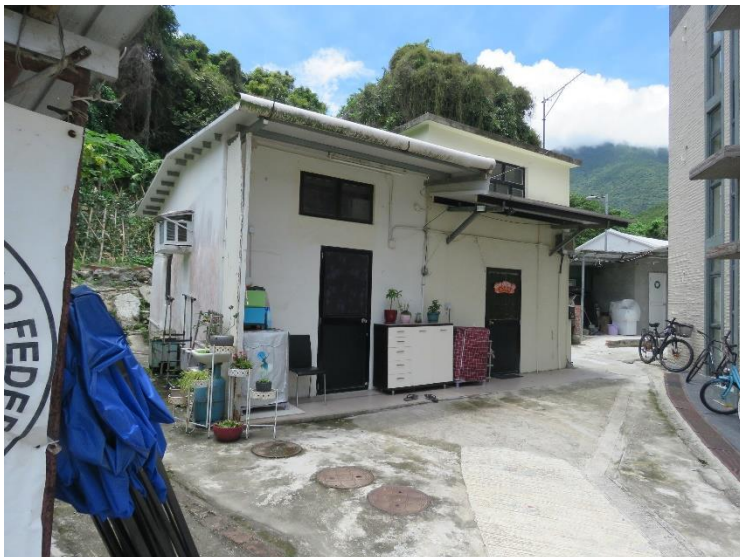
Plate 20

Nos 6-7 Shan Ha

The buildings are two residential houses. A review of satellite images suggests the current houses were constructed between 2003 to 2004 (Google Earth 2003 & 2004). The buildings have low heritage value.

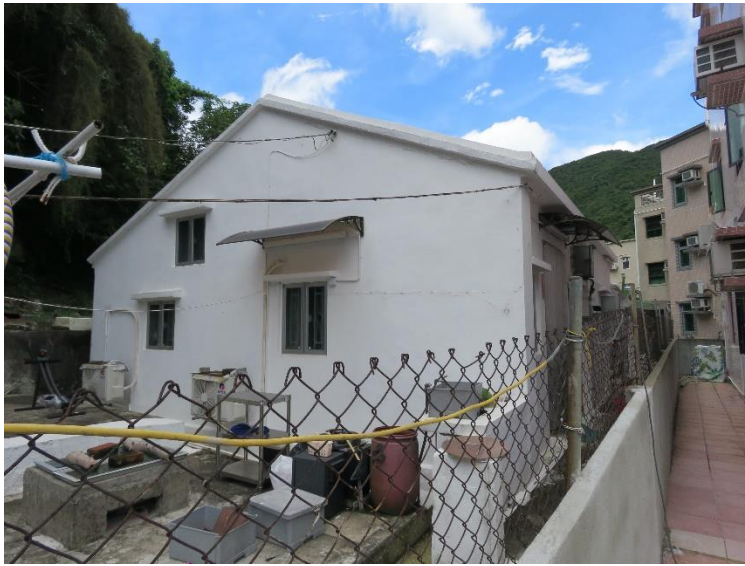
Plate 21

The building is a residential house. A review of old surveyed map and aerial photos suggests the site were occupied by a house between 1906 to 1945, and the extension in the south was added after 1968 (SMO 1906; Lands Department 1945; Ordnance Survey 1968 & 1972). The house is with a pitched roof. Façade is with modern style iron gate. Windows are opened on façade and side walls. Window levels suggest a cockloft level inside. The house has been largely modified, not much traditional element apart from the pitched roof is left. It has low heritage value.

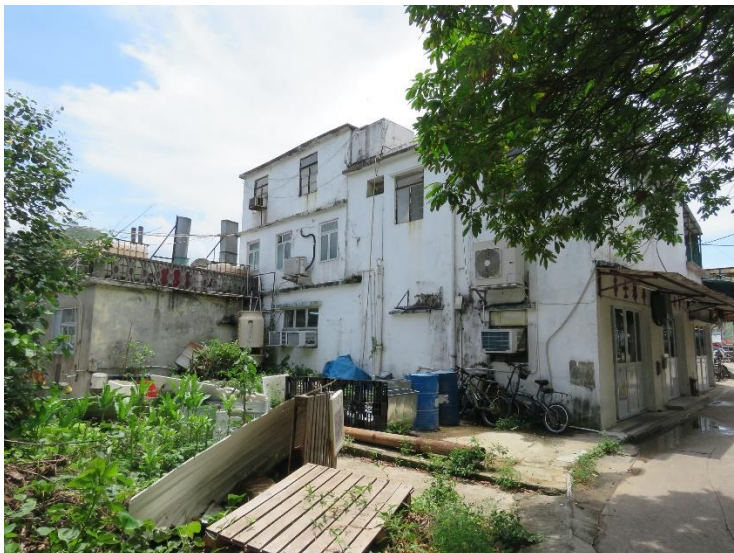
Plate 22

The building houses a seafood restaurant near the old pier. It is a three-storey concrete structure with balcony and a southeast extension. A review of past topographical maps shows there was a building at the site around 1949; however, building layout was changed over time, which suggests high degree of modification or rebuilt (War Office 1949; Ordnance Survey 1968b, 1972b; SMO 1990). It has low heritage value.

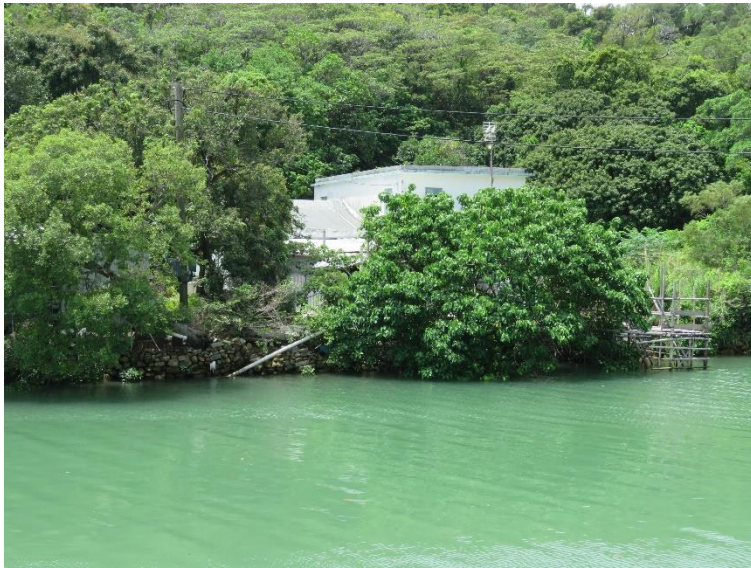
Plate 23

Access to No.16 is blocked by fence, no access was possible. The northeast half of the building was once a traditional village house which was recorded in a 1990 built heritage survey conducted by the AMO (AMO 1990). But the recorded part has seemingly been rebuilt into a two-storey flat roof concrete building.

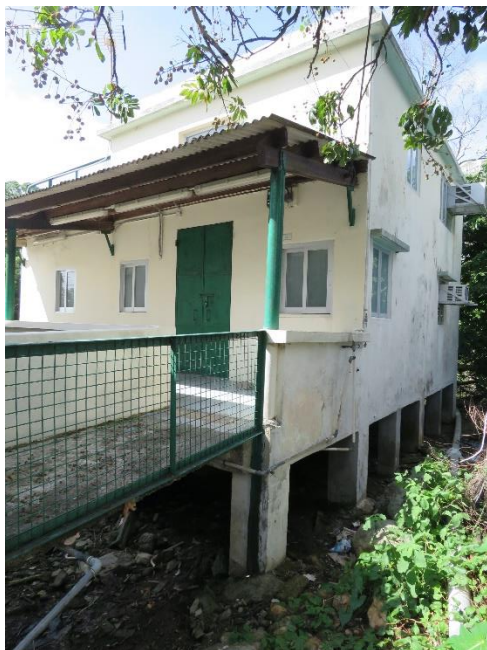
Plate 24

The structure is a concrete made stilt-house by the estuary of steam. A review of topographical maps shows it was constructed between 1968 to 1972 (Ordnance Survey 1968b & 1972b). It has low heritage value.

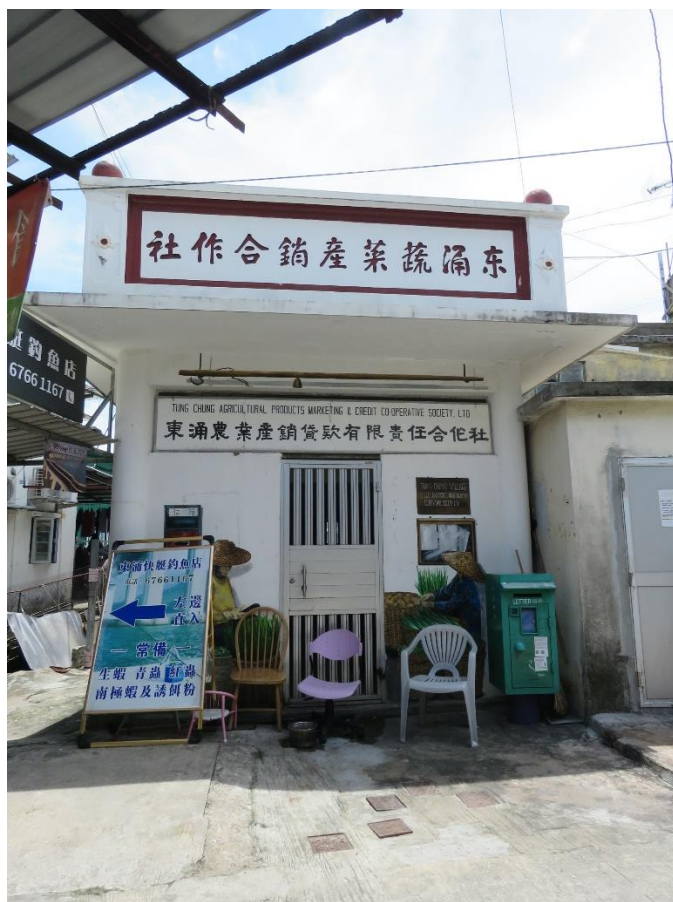
Plate 25

A review of aerial photo shows the building in Tung Chung was erected in between 1956 to 1963. It is two-storey concrete building with painted façade and unpainted building behind. The parapet carries the site name and the façade further carries the bilingual title of the Society, iron gate and paintings. Glass windows open at side and rear wall.

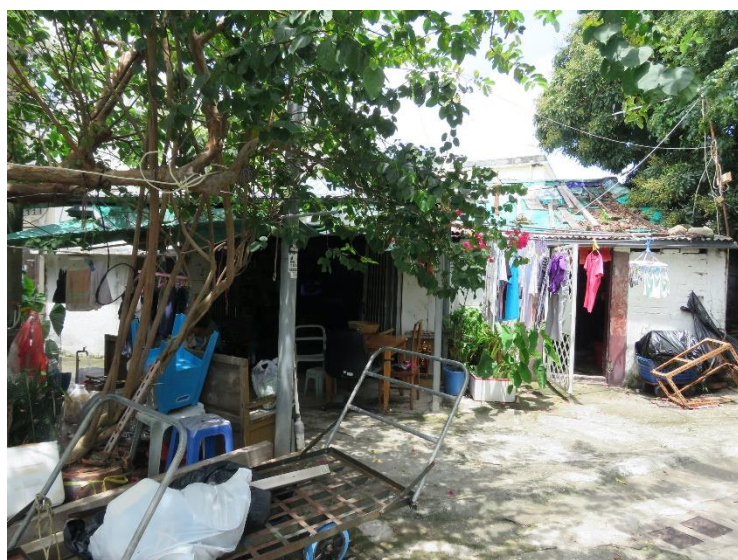
Plate 26

It is a three-bay structure with a store-shop in the middle and residence by the sides. A review of aerial photos shows the building was constructed between 1956 to 1963 (Lands Department 1956 & 1963). It has low heritage value.

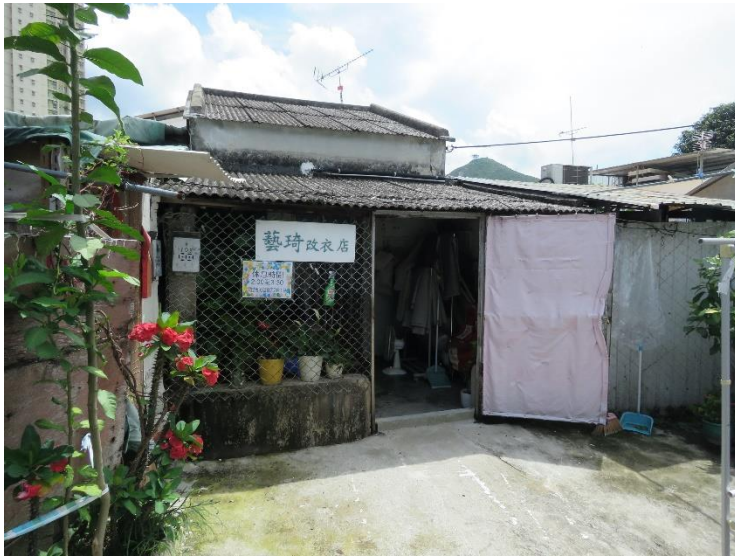
Plate 27

No. 108 Ma Wan Chung

The structure is currently a shop. A review of old surveyed map and aerial photo shows the structure was not in existence between 1906 to 1956 (SMO 1906; Lands Department 1956). It has low heritage value.

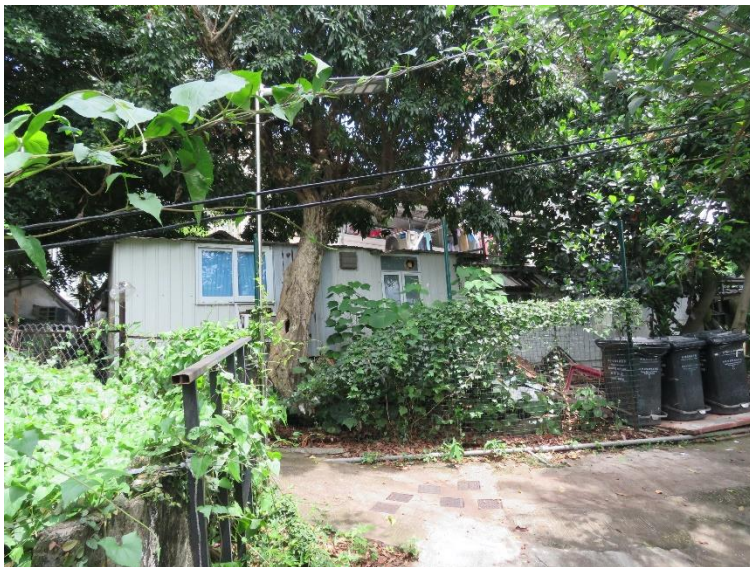
Plate 28

The structure is a residential house made of concrete and temporary structures. A review of old surveyed map and aerial photo shows the structure was not in existence between 1906 to 1956 (SMO 1906; Lands Department 1956). It has low heritage value.

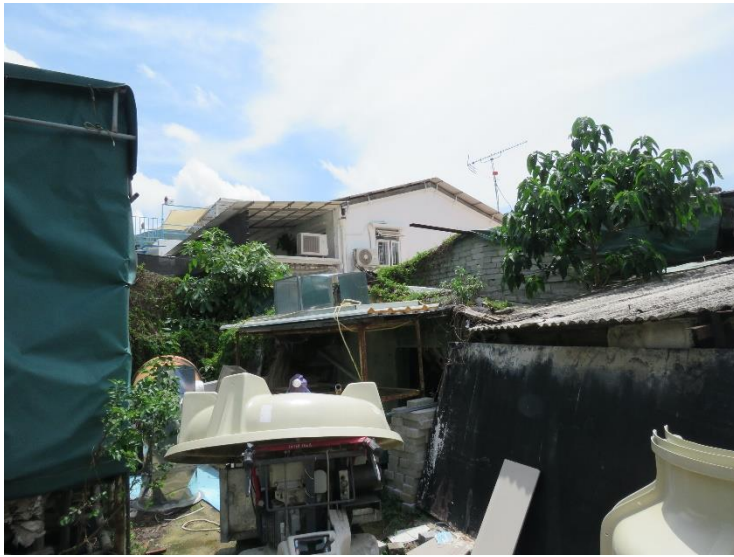
Plate 29

No. 110 Ma Wan Chung

The building is a residential house with the foreyard used as a bicycle rental shop. A review of old surveyed map and aerial photo shows the structure was not in existence between 1906 to 1956 (SMO 1906; Lands Department 1956). It has low heritage value.

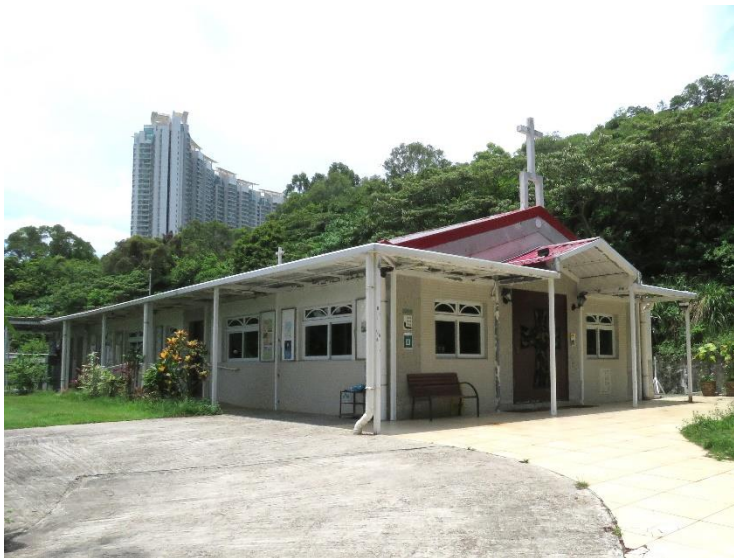
Plate 30

Tung Chung Tao Yan Youth Camp The Evangelical Lutheran Church of Hong Kong

The church was completed in 1960 as an inscribed stone plaque install on facade wall states.
