MTR Corporation Limited

Consultancy Agreement No. C1502

**Environmental Impact Assessment  
Study for Tuen Mun South Extension****Contamination Assessment Plan**

April 2022

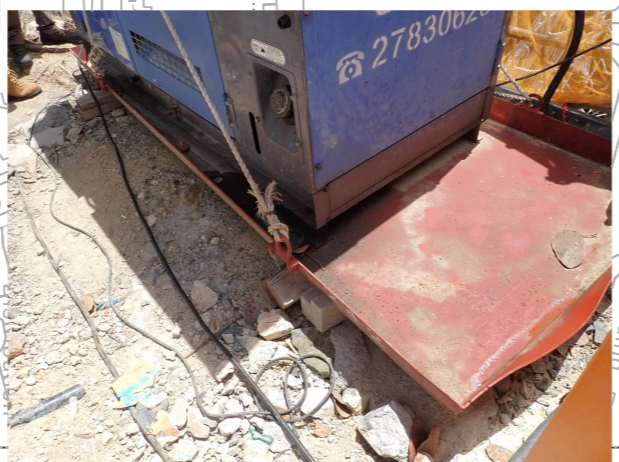
PHOTO 2624: GENERATOR (SITE TME-S4) AND GROUND CONDITION AROUND WORKS AREA OF CONTRACT NO. DC/2018/09 (DATE TAKEN: 21 MAY 2021)

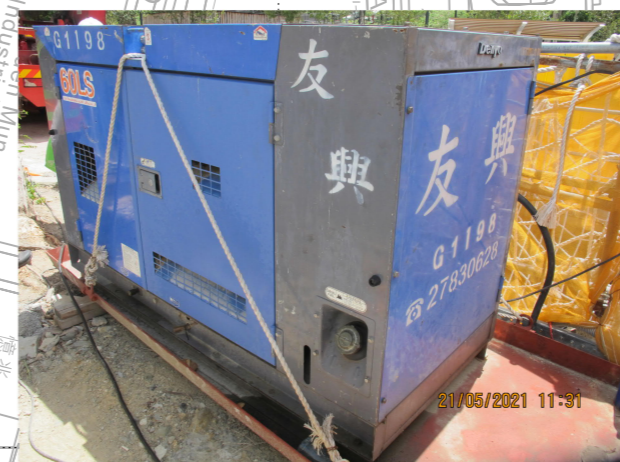
PHOTO 7461: GENERATOR AT WORKS SITE OF CONTRACT NO. DC/2018/09 (SITE TME-S4) (DATE TAKEN: 21 MAY 2021)

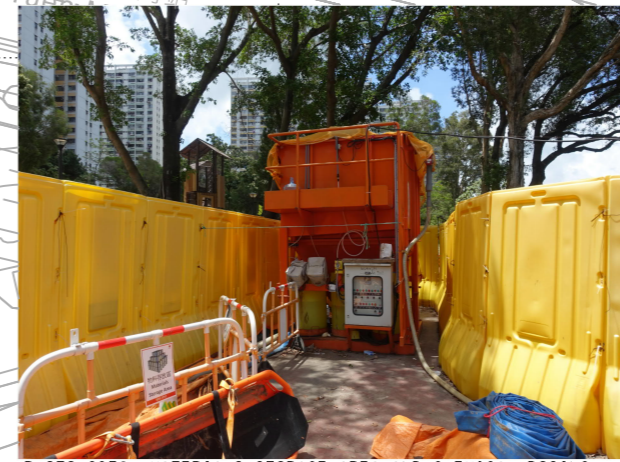
PHOTO 6970: MATERIALS STORAGE AREA AND CHEMICAL DOSING UNIT AT WORKS SITE OF CONTRACT NO. DC/2018/09 (DATE TAKEN: 21 MAY 2021)

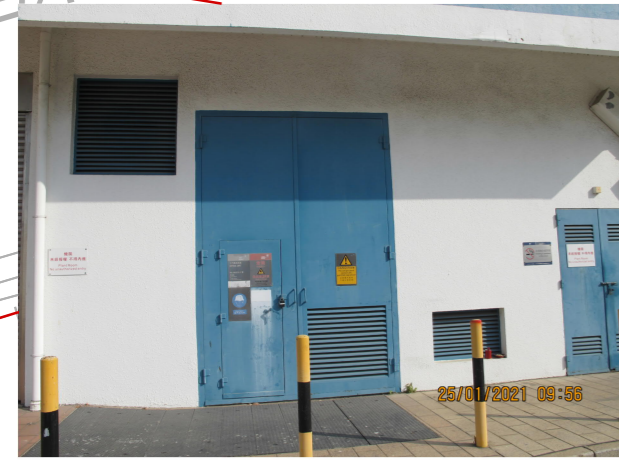
PHOTO 0858: ELECTRICAL SUBSTATION IN TUEN MUN SWIMMING POOL (SITE TME-S3)  
 (DATE TAKEN: 25 JANUARY 2021)

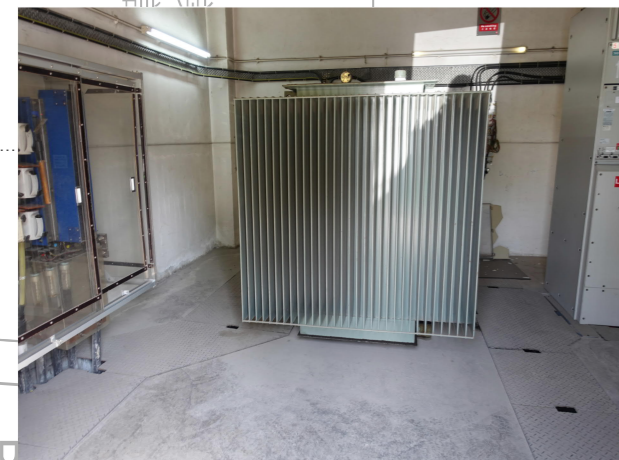
PHOTO 5894: TRANSFORMER IN ELECTRICAL SUBSTATION IN TUEN MUN SWIMMING POOL (SITE TME-S3)  
 (DATE TAKEN: 4 FEBRUARY 2021)

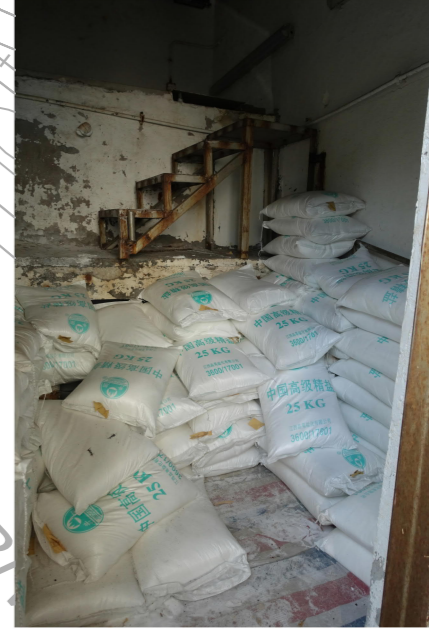
PHOTO 4676: STORAGE ROOM OF SODIUM CHLORIDE (SALT)  
 (DATE TAKEN: 25 JANUARY 2021)

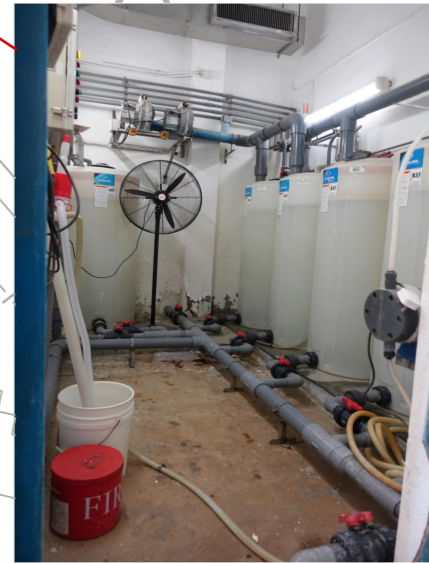
PHOTO 4705: STORAGE ROOM OF SODIUM HYPOCHLORITE (BLEACH)  
 (DATE TAKEN: 25 JANUARY 2021)

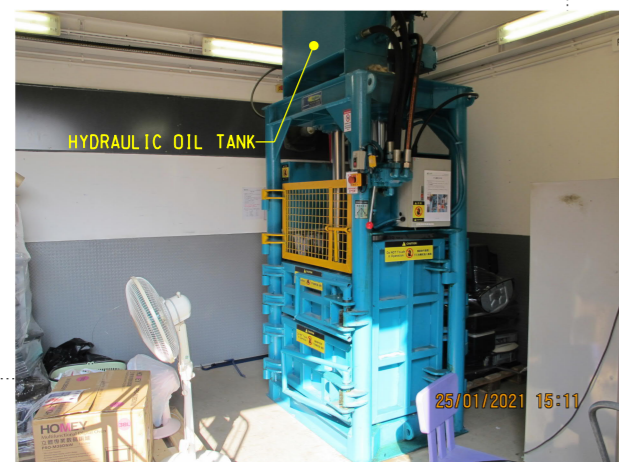
PHOTO 1022: HYDRAULIC WASTE BALER IN TUEN MUN COMMUNITY GREEN STATION (SITE TME-S1)  
(DATE TAKEN: 25 JANUARY 2021)

- 2.5.4 CWP ID 2 (Yan Oi Tong Limited) is the operator of the existing Tuen Mun Community Green Station (Site TME-S1). Given the Community Green Station has occupied the site for 3 years only since 2018, and the storage of chemical wastes (spent batteries and fluorescent lamps) on-site was only temporary as the spent batteries and fluorescent lamps are reportedly delivered off-site regularly for recycling, and the entire storage area was concrete paved with no signs of stains / spillages observed (refer to **Annex B-1** and Photo 1023 in **Figure No. C1502/C/TME/ACM/M55/020**), the storage of chemical wastes is unlikely to have caused any land contamination issues to the Project Area.

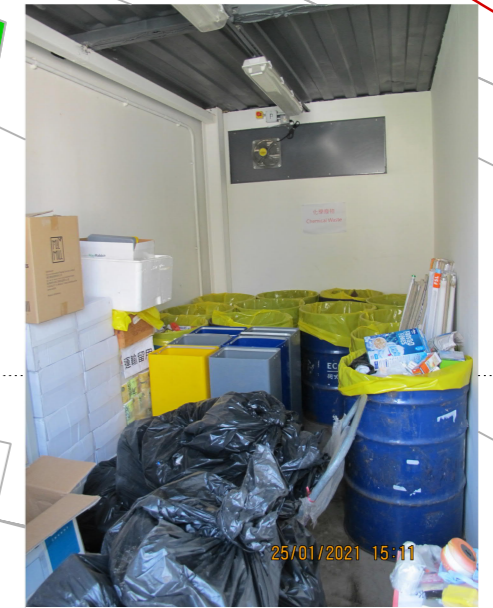
PHOTO 1023: TEMPORARY CHEMICAL WASTE STORAGE ROOM IN TUEN MUN COMMUNITY GREEN STATION (SITE TME-S1)  
(DATE TAKEN: 25 JANUARY 2021)

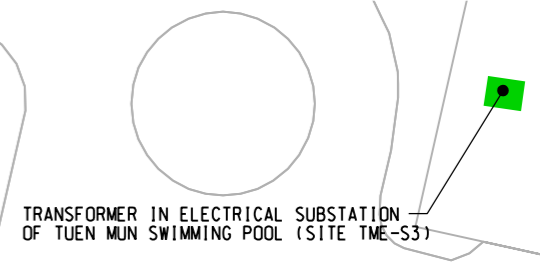
TRANSFORMER IN ELECTRICAL SUBSTATION OF TUEN MUN SWIMMING POOL (SITE TME-S3)

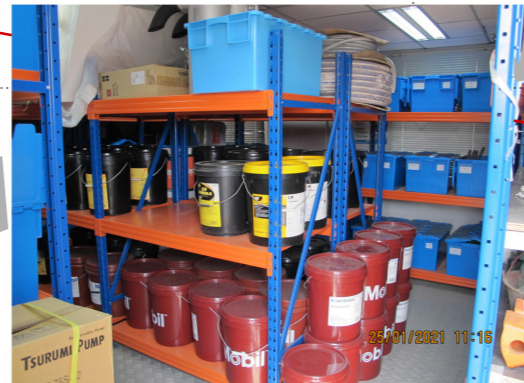
PHOTO 0926: CHEMICAL STORAGE AREA IN CIC TUEN MUN TRAINING GROUND (DATE TAKEN: 25 JANUARY 2021)

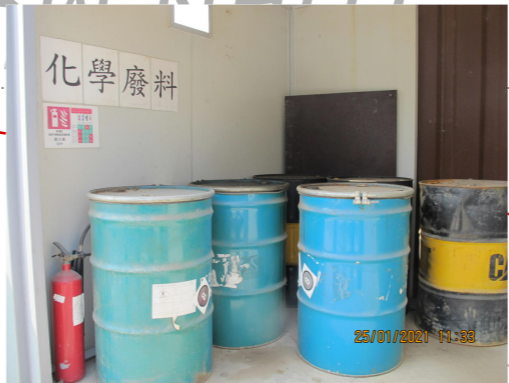
PHOTO 5763: CHEMICAL WASTE STORAGE AREA IN CIC TUEN MUN TRAINING GROUND (DATE TAKEN: 25 JANUARY 2021)

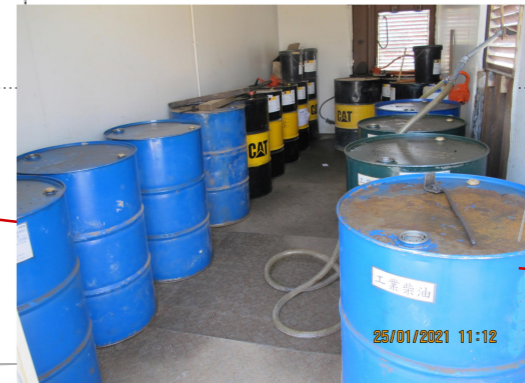
PHOTO 0916: CHEMICAL STORAGE AREA IN CIC TUEN MUN TRAINING GROUND (DATE TAKEN: 25 JANUARY 2021)

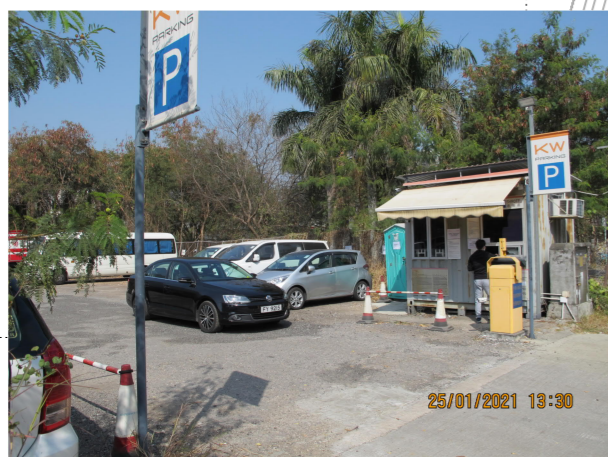
PHOTO 0966: WU SHAN ROAD CAR PARK (STT NO. MX16007) (SITE TME-S2) (DATE TAKEN: 25 JANUARY 2021)

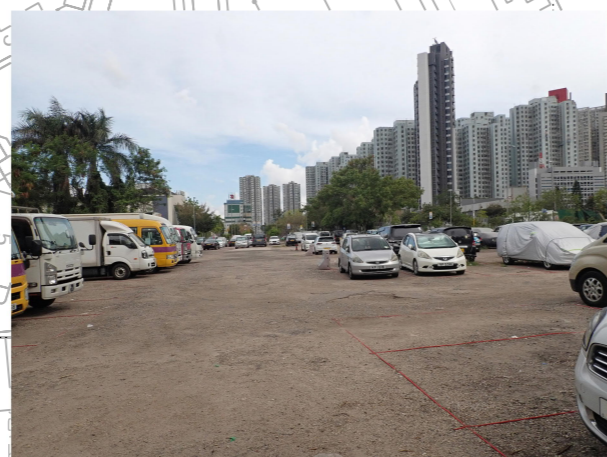
PHOTO 2506: WU SHAN ROAD CAR PARK (STT NO. MX16007) (SITE TME-S2) (DATE TAKEN: 17 MAY 2021)

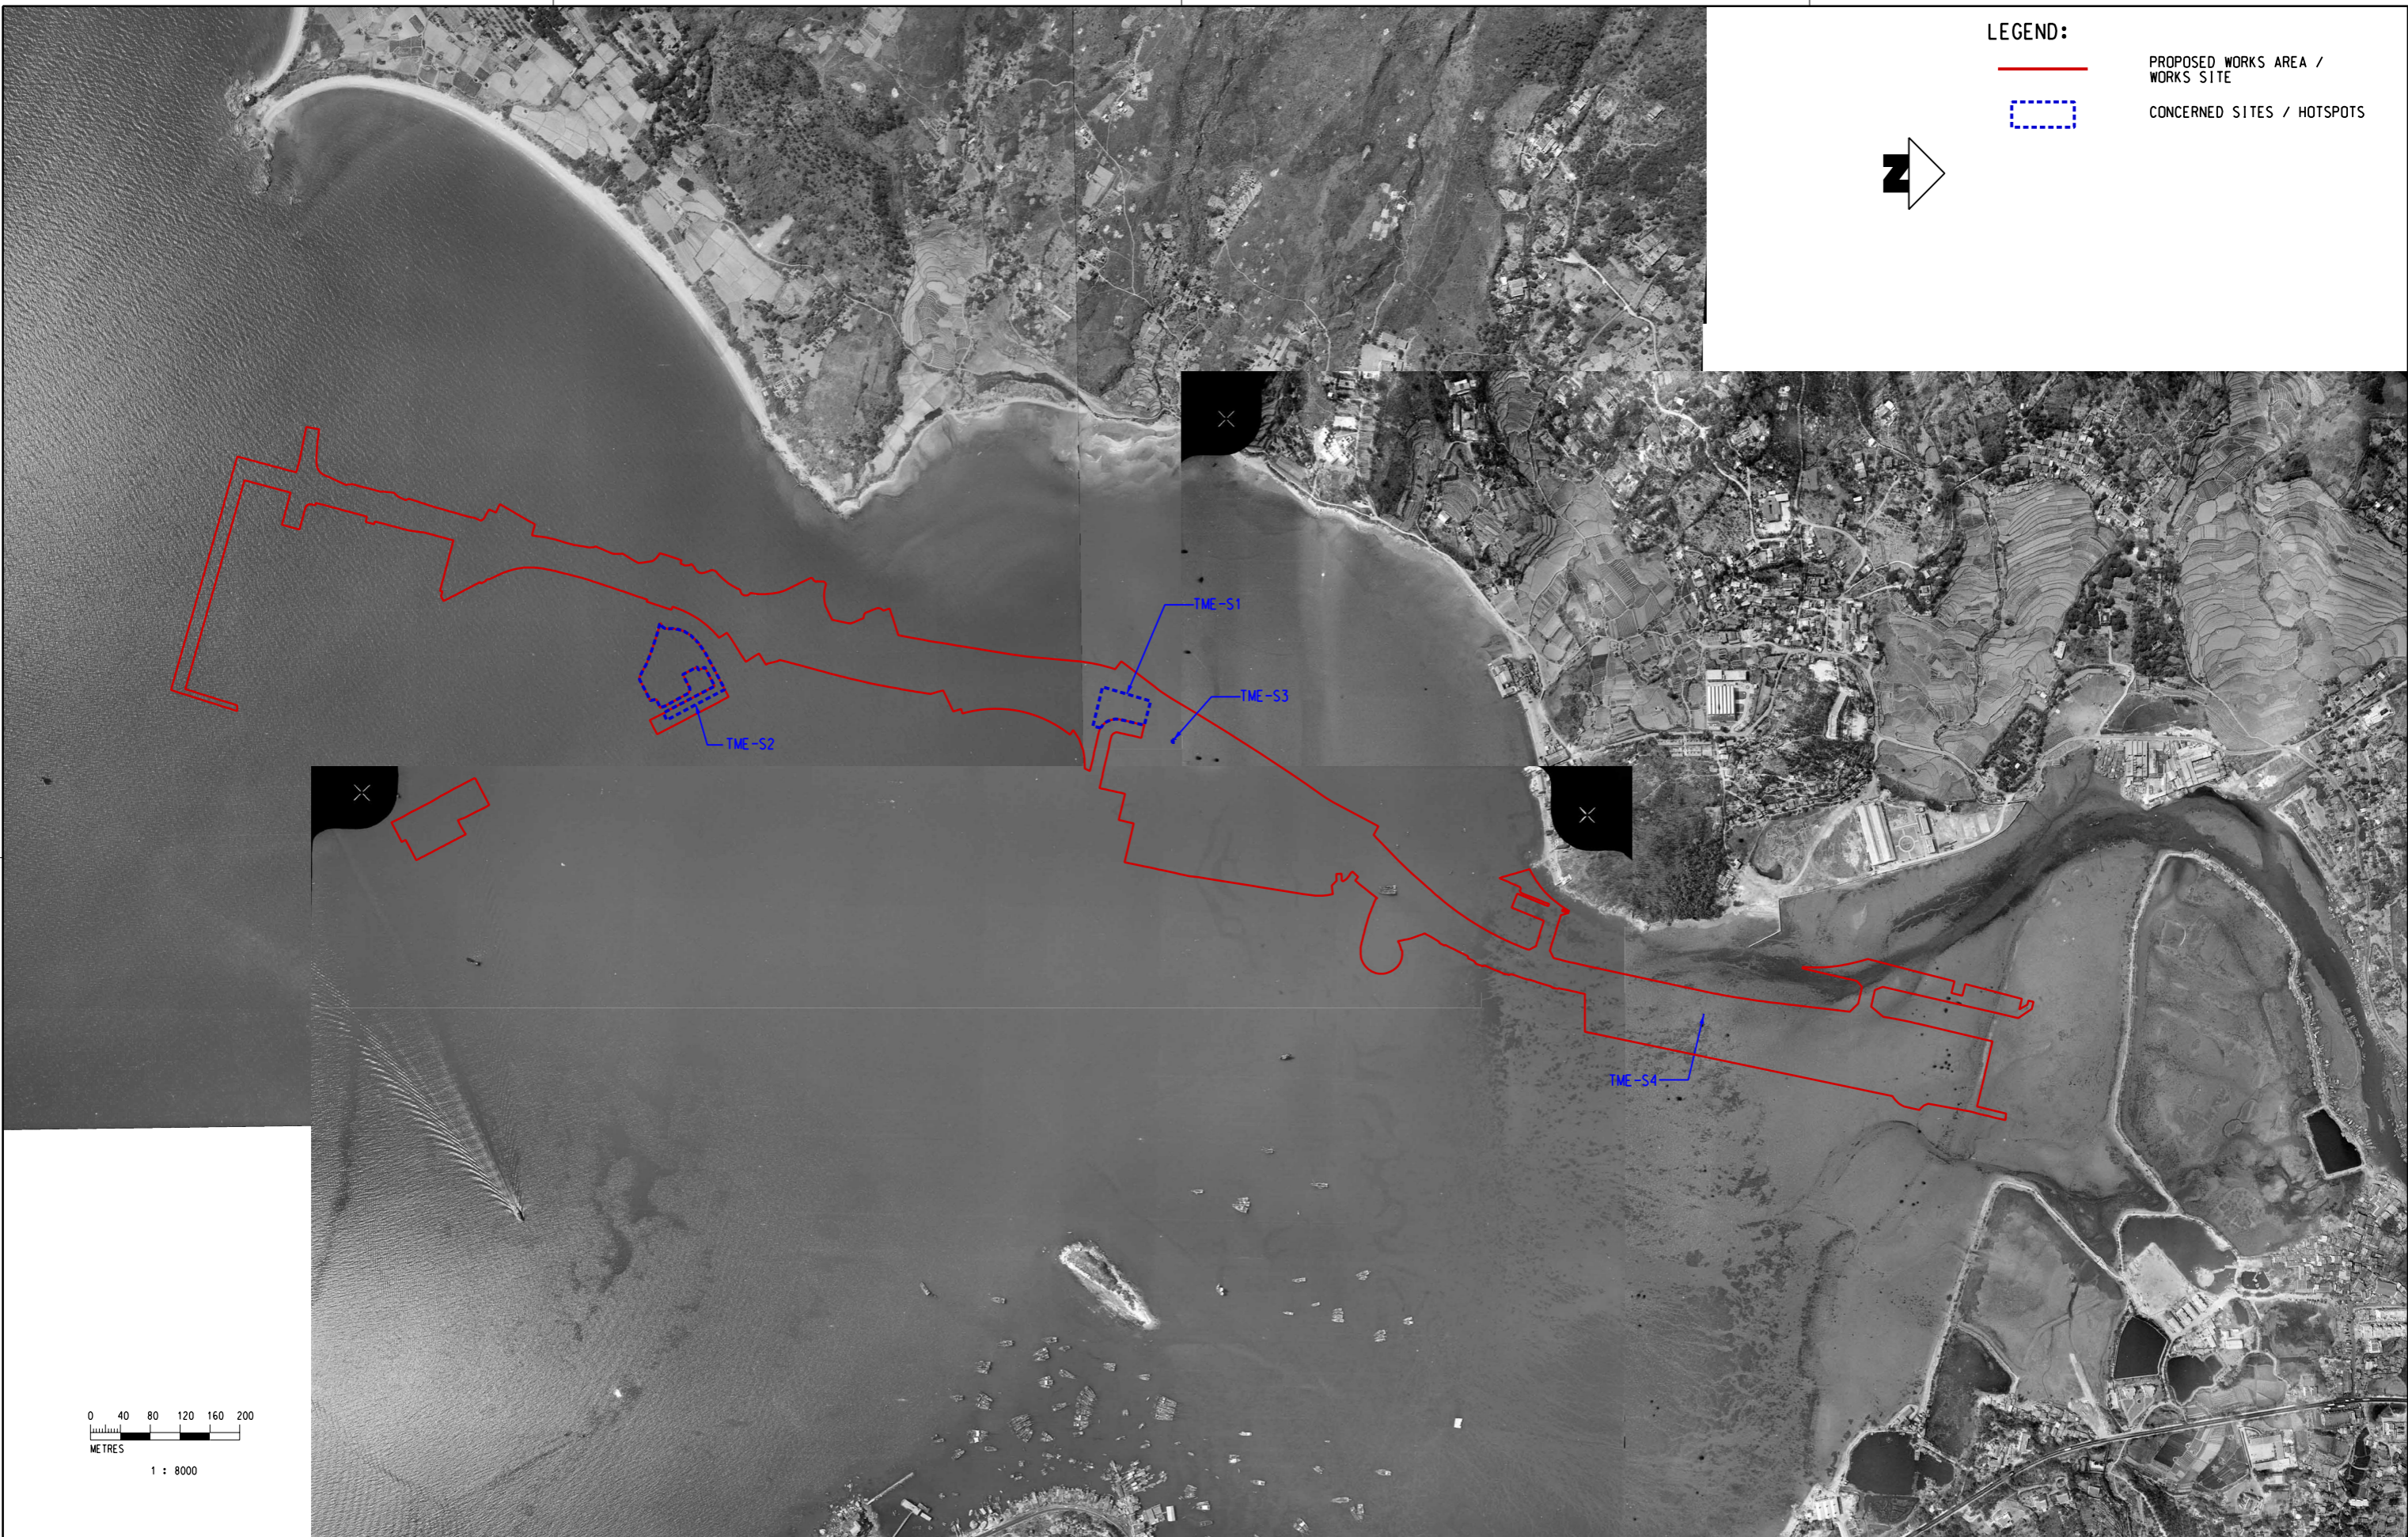
TITLE		C1502	
TUEN MUN SOUTH EXTENSION		AERIAL PHOTOGRAPH 1963	
SCALE	FIGURE NO.	REV.	
1 : 8000 (A3)	C1502/C/TME/ACM/M55/010	A

Year	Reference of Aerial Photos in Annex A	Description of Land-Uses and Site Operation / Activities
1963	<b>C1502/C/TME/ACM/M55/010</b> (#1963-6113, #1963-6115, #1963-6390, #1963-8237)	<ul style="list-style-type: none"> <li>The Project Area was occupied by open waters.</li> </ul>
1973	<b>C1502/C/TME/ACM/M55/011</b> (#03348, #04221, #04229)	<ul style="list-style-type: none"> <li>Reclamation works and reclaimed land were observed in the north and the east of the Project Area.</li> <li>The nullah was modified to the existing configuration in the north of the Project Area.</li> <li>No significant land use change was observed in the remaining portions of the Project Area.</li> </ul>
1983	<b>C1502/C/TME/ACM/M55/012</b> (#47923, #47925)	<ul style="list-style-type: none"> <li>Reclaimed land was observed in the centre and south of the Project Area. Tuen Mun Park and Tuen Mun 3<sup>rd</sup> Village Temporary Housing Area were observed.</li> </ul>

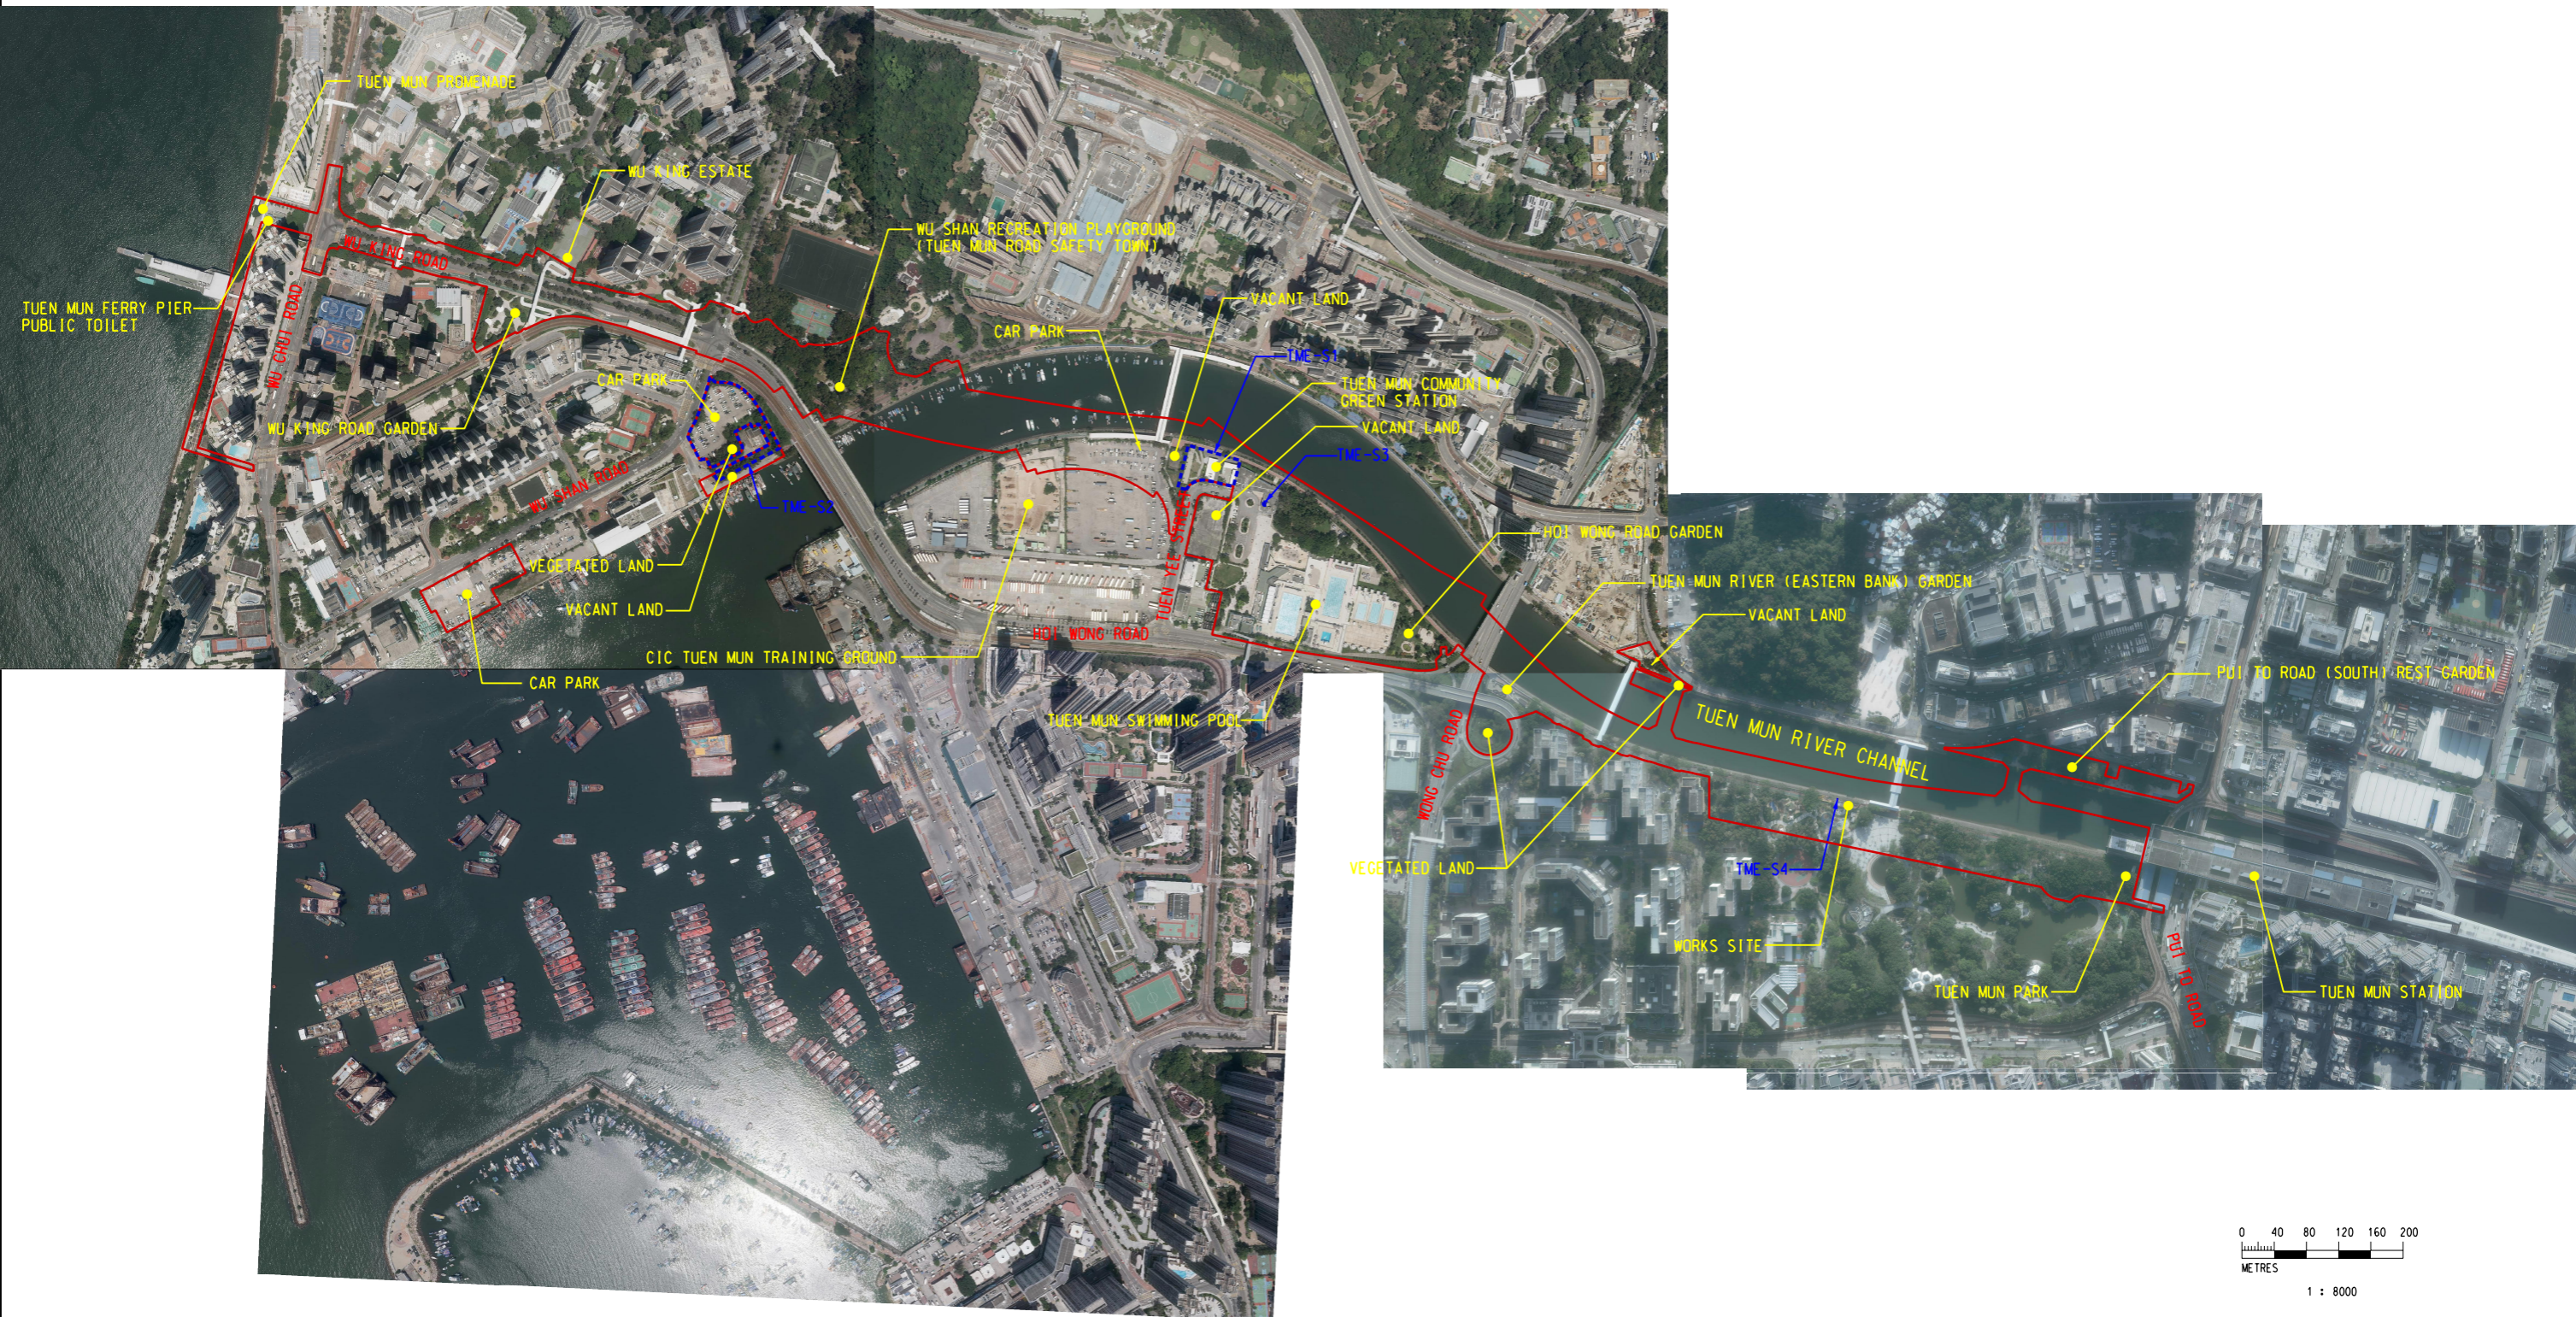
Year	Reference of Aerial Photos in Annex A	Description of Land-Uses and Site Operation / Activities
2020	<b>C1502/C/TME/ACM/M55/016</b> (#E096497C, #E096996C, #E100267C, #E100289C, #E100319C)	<ul style="list-style-type: none"> <li>• The open storage (Site TME-S1) was turned into the existing Tuen Mun Community Green Station.</li> <li>• The site office was vacated. Tuen Mun River (Eastern Bank) Garden was observed.</li> <li>• An existing works site was observed within Tuen Mun Park.</li> <li>• No significant land use change was observed in the remaining portions of the Project Area.</li> </ul>
