AEC Limited

Coral Survey Report
for
Upgrading of Tai Po Sewage Treatment Works -
Investigation

October 2020

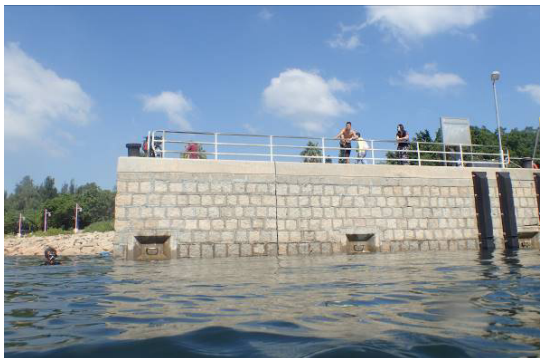
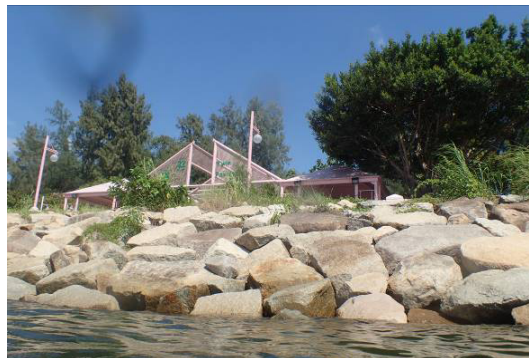
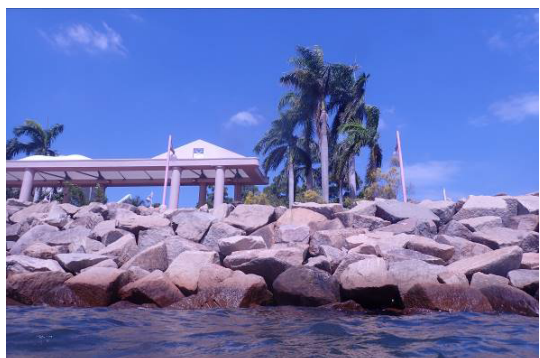
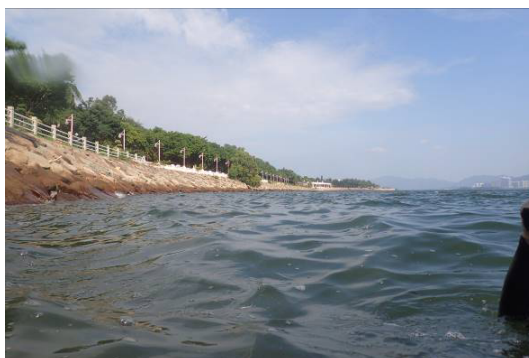
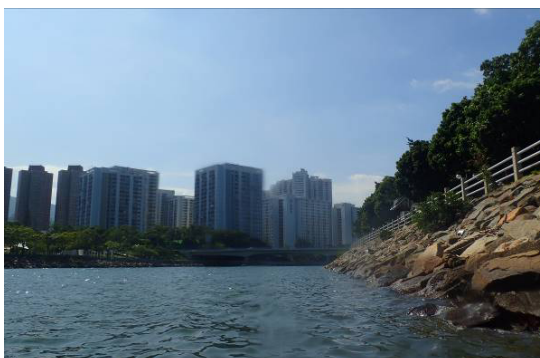
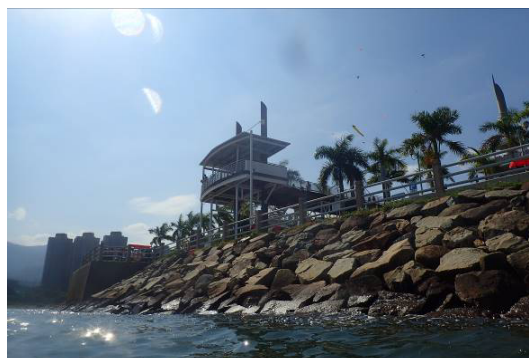
Figure 3.1 Photographic record of the environment of the survey areas

The water visibility was unsatisfactory (< 1 m) due to high water turbidity at the western side of coastline. It was due to the sediment runoff from Lam Tsuen River. The vision of dive surveyors was limited while any corals of farer distance (e.g. > 1 m from the dive surveyor), if present, might be omitted easily. At the eastern side of coastline, the water visibility was

Eastern coastline

Middle coastline

Western coastline

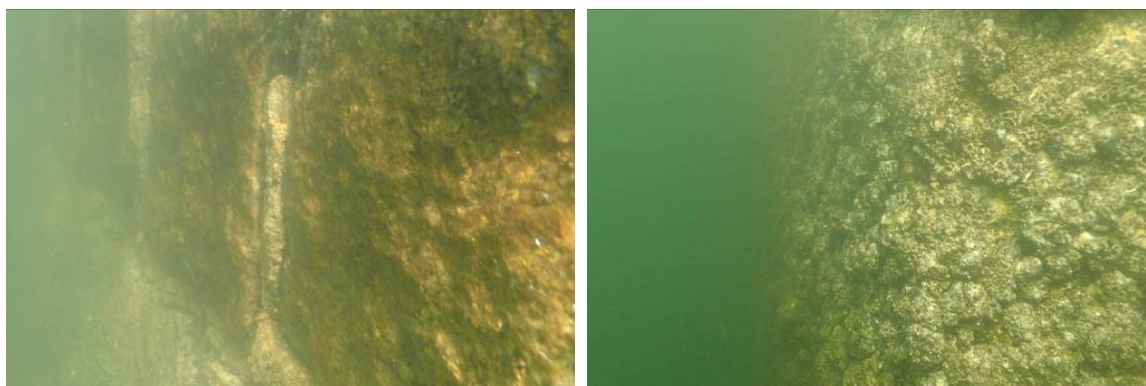
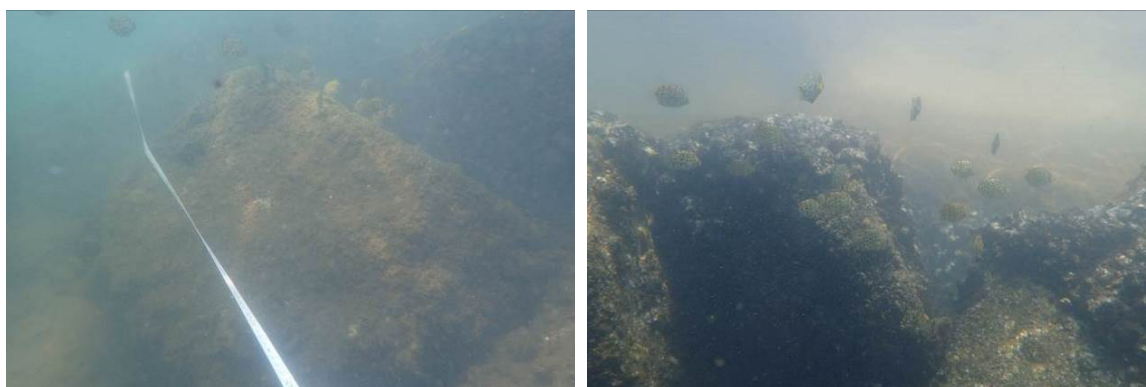
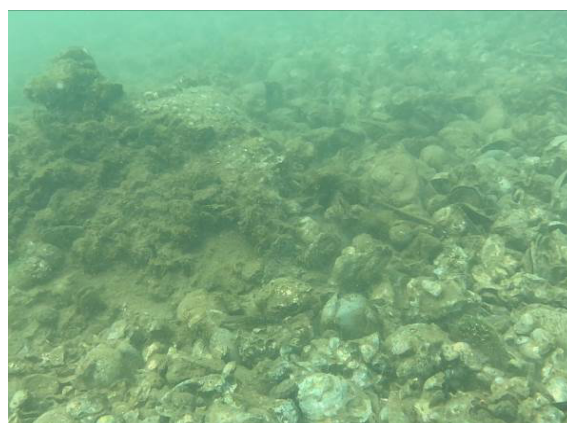
Figure 4.1 Photographic record of sub-tidal environment along the survey route

Along the whole survey route, the water depth ranged 1.5-2.0 m at the eastern end and was shallower (~1.0 m) at the western end. Starting from the east, the sub-tidal environment was a short section of vertical seawall (length ~50 m) while the rest of shoreline was large boulder blocks (diameter > 50 cm, length ~1750 m) (Fig. 4.1). Both the seawall surface and boulder blocks were colonized with biofouling fauna such as barnacle *Megabalanus tintinnabulum*, green lipped mussel *Perna viridis*, rock oyster *Saccostrea cucullata* and tunicate *Styela plicata* (Fig. 4.2). Other motile fauna such as crabs and gastropods were found inhabiting between the boulders. The adjacent sea floor was soft mud covered with broken shells detached from the hard surface. Large garbage (e.g. dumped bicycle) with biofouling organisms was found occasionally on sea floor (Fig. 4.3).

Vertical seawall (~50 m)

Large boulder blocks (~1750 m)

Soft mud seafloor covered with broken shells

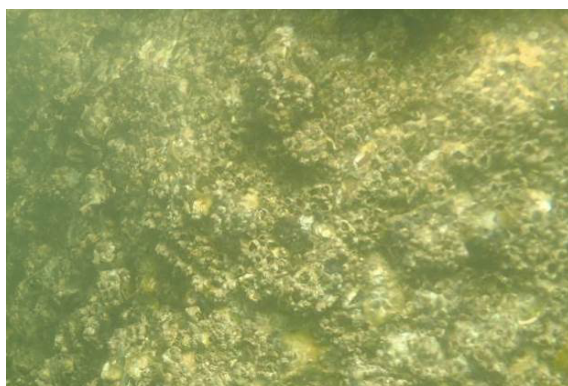
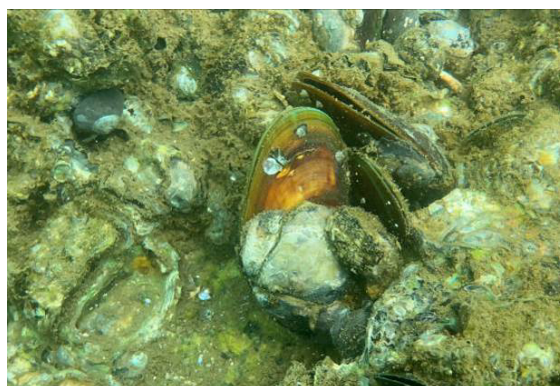
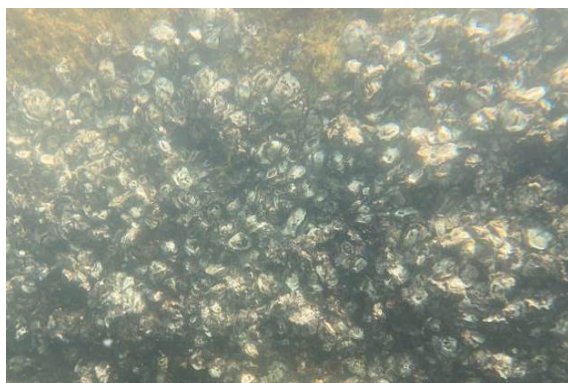
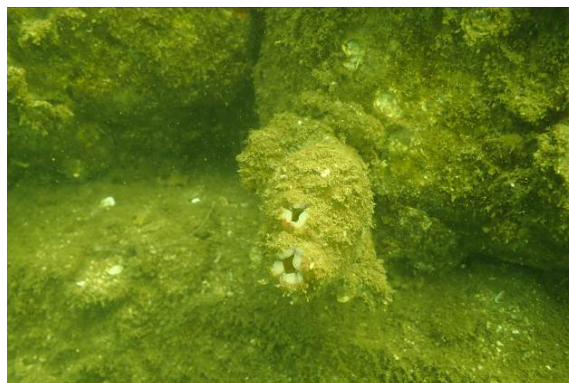
Figure 4.2 Photographic record of common biofouling fauna on the hard surface along the survey route

barnacle *Megabalanus tintinnabulum*

green lipped mussel *Perna viridis*

rock oyster *Saccostrea cucullata*

tunicate *Styela plicata*

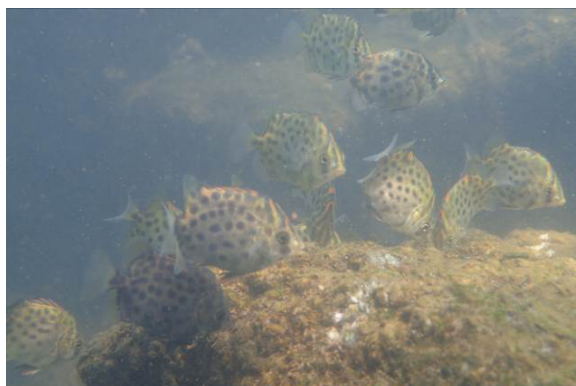
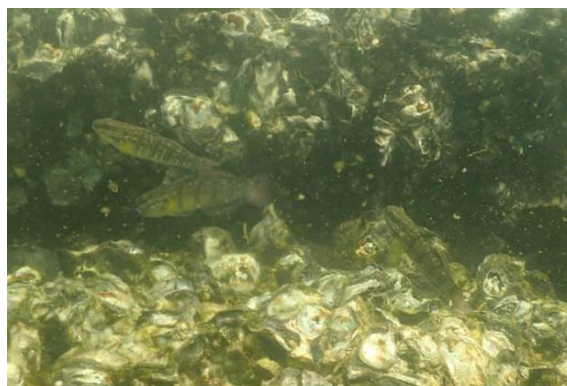
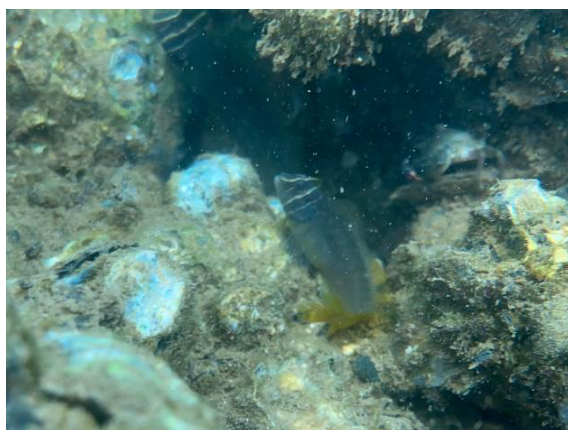
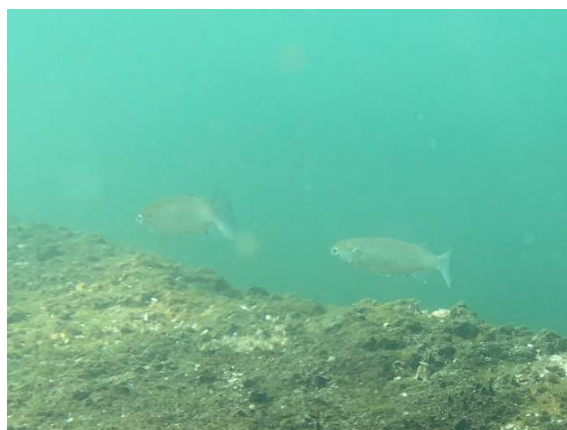
Figure 4.4 Photographic record of common and abundant fish species along the survey route

Besides, a fish community of moderate species richness and high abundance was found along the shoreline composed of large boulder blocks. The common and abundant fish species were spotted scat *Scatophagus argus*, banded goby *Amblygobius phalaena*, blenny *Omobranchus fasciolatoceps* and planiliza mullet *Planiliza* spp. (Fig. 4.4).

Spotted scat *Scatophagus argus*

Banded goby *Amblygobius phalaena*

Blenny *Omobranchus fasciolatoceps*

Planiliza mullet *Planiliza* spp.

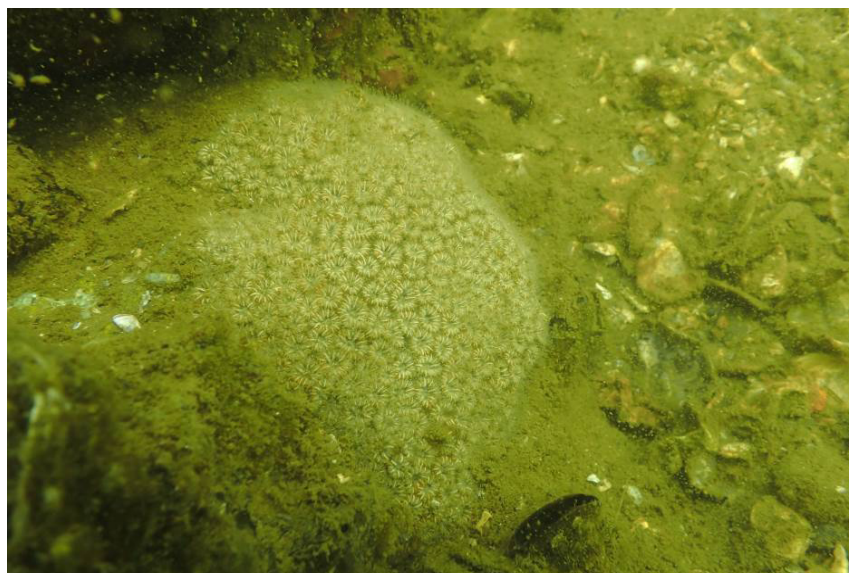
Figure 4.5 Photographic record of zebra coral *Oulastrea crispata* and spotted seahorse *Hippocampus kuda* found along the REA transect T1

Along the whole REA transect T1, the substratum was all large boulders (diameter > 50 cm) (100%) with adjacent soft mud seafloor. As mentioned, the boulders were colonized by biofouling organisms such as barnacle, mussel and rock oysters. Table 4.1 list the REA ecological attribute and coral taxa of the T1. There was one small colony of zebra coral *Oulastrea crispata* (Fig. 4.5) recorded only that contributed less than 1% cover of the transect (rank 0.5). Its abundance was ranked '1 Rare'. The colony width was about 5 cm in healthy condition. The exact location of the zebra coral was at the start-point of T1 (GPS coordinate N 22° 27.073' E 114° 11.491').

Transect	Ecological attribute	Rank	Percentage cover	Genus / Species	No. of colony	Size (w: width, h: height)	Taxon abundance rank	Abundance	Health condition
T1	Hard Corals	0.5	< 1	<i>Oulastrea crispata</i>	1	d: 5 cm	1	Rare	Healthy

Zebra coral *Oulastrea crispata*

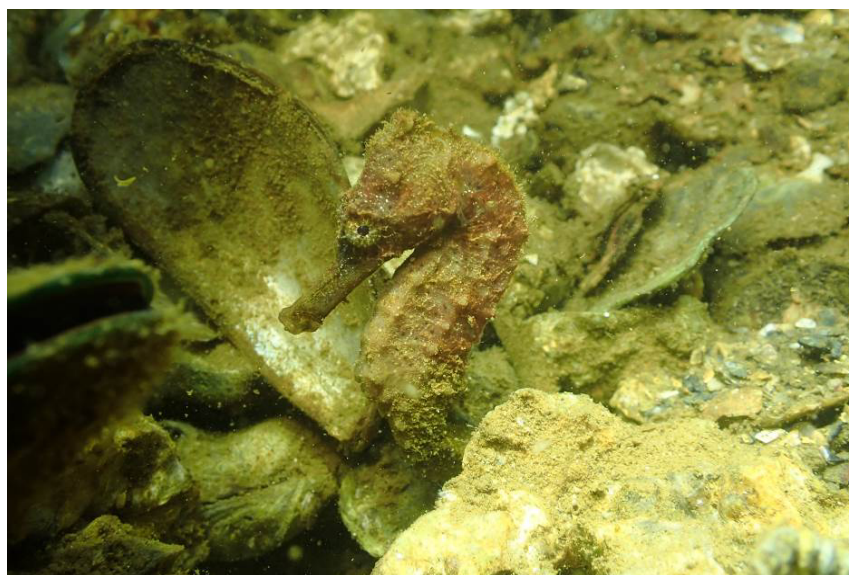
In addition, two individuals of spotted seahorse *Hippocampus kuda* (Fig. 4.5) were found at the middle of REA transect (50-55 m). No other seahorse was recorded in the rest of the survey route.

Spotted seahorse *Hippocampus kuda*

Besides coral, there was another species of conservation importance, spotted seahorse (or yellow seahorse) *Hippocampus kuda* found along the REA transect T1. It is categorized as ‘Vulnerable - VU’ in IUCN Red List of Threatened Species. The wild populations are considered to be facing a high risk of extinction in the wild. Moreover it is listed in ‘Appendix II’ of CITES while the international trade and procession are under control. In Hong Kong, the local populations face the threat of overfishing for traditional medicine and aquarium as well as trawling by-catch.

For other species of conservation importance, two individuals of spotted seahorse *Hippocampus kuda* were found. In order to avoid and reduce any developmental impacts on the seahorses, proper mitigation measures should be adopted especially adjacent to the REA transect T1.
