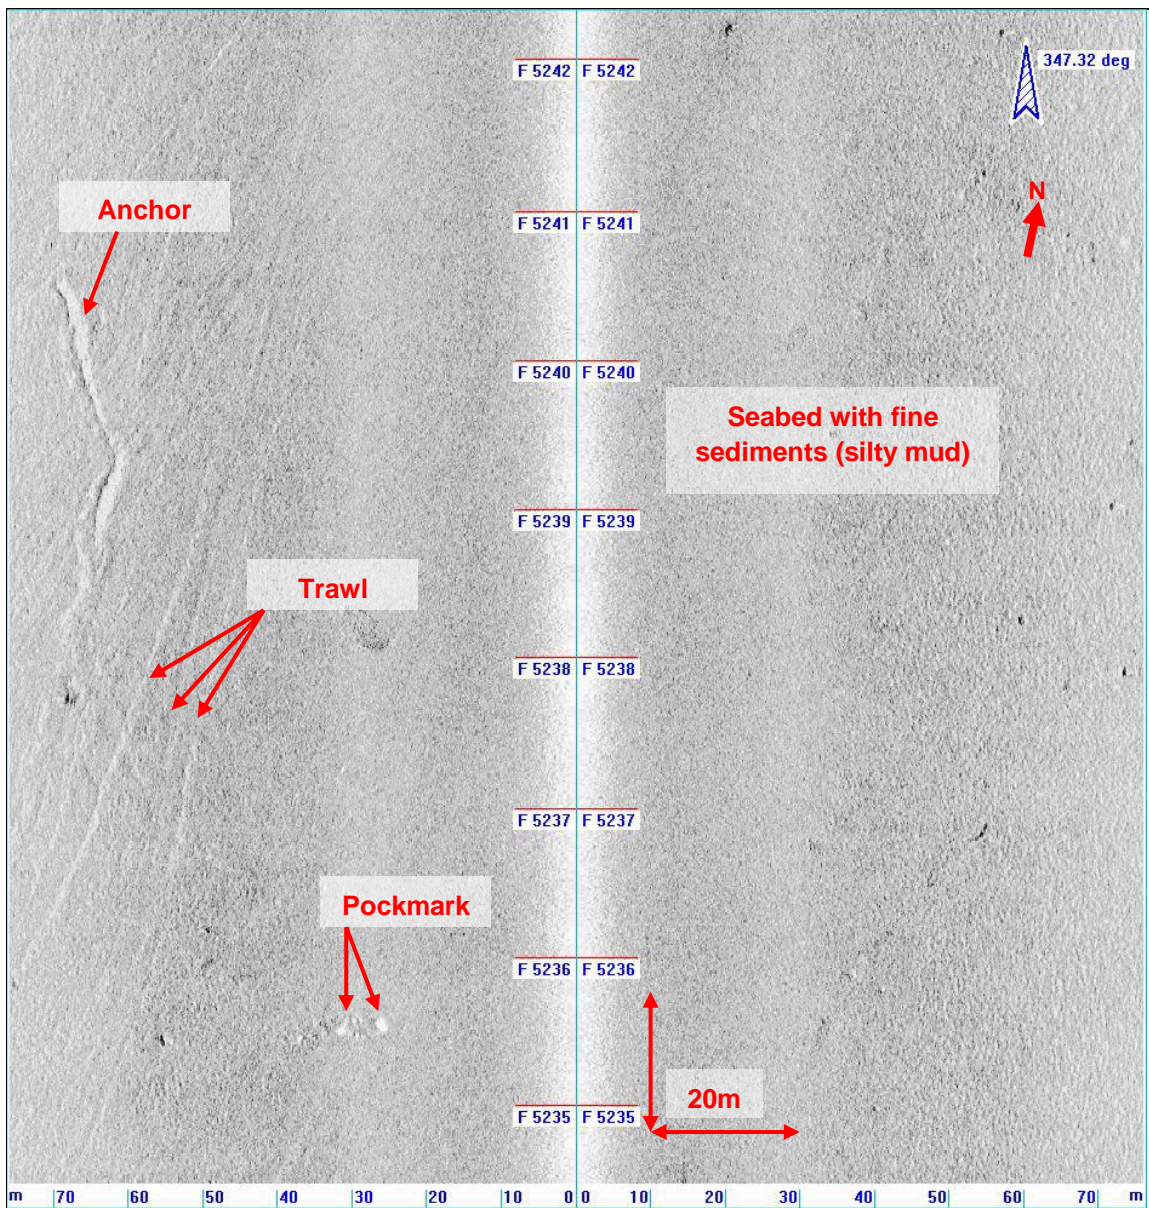
Figure 9.2 Example of Side Scan Sonar (SSS) Rectified Image Showing Pockmarks, Trawling Scars and an Anchor Scar and Fine Sediment Seabed
