**NCSC Paper 03/08**

**Advisory Council on the Environment  
Nature Conservation Subcommittee**

**Unauthorized developments in ecologically sensitive sites/rural areas-  
the Sai Kung Cases**

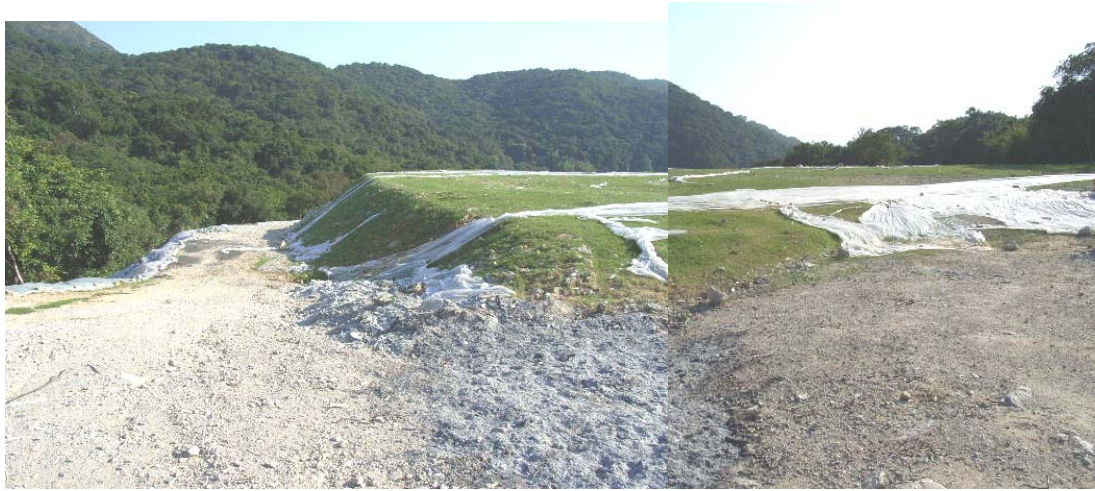
Site 1: Tam Wat

<b>Background</b>	<ul style="list-style-type: none"> <li>• Large scale land filling activities and excavation for access road were found in two locations. The first site is located to the south of Tam Wat village, and the second site is in the vicinity of She Tau Village.</li> <li>• The two areas concerned fall mainly on private land within “Village Development Type” (V) and GB zones on the Outline Zoning Plan.</li> </ul>
<b>Actions Taken by AFCD</b>	<ul style="list-style-type: none"> <li>• Upon receiving the referral from Plan D in November 2006, AFCD has taken up the investigation on unauthorized tree felling under the Forests and Countryside Ordinance, Cap. 96. However, no suspect and witness in respect of unauthorized tree felling were identified so far.</li> <li>• AFCD erected warning signs against tree felling in the areas.</li> <li>• Since then, the sites have been kept under close monitoring.</li> <li>• As the subject site is in the vicinity of Sai Kung West Country Park, AFCD’s park wardens have also stepped up patrolling to ensure that the unauthorized development will not encroach upon the country park.</li> </ul>

<b>departments</b>	<p>conducted to discuss possible control and remedial measures.</p> <ul style="list-style-type: none"> <li>• LandsD has erected bollards at the entrances to the illegal access roads in order to contain the problems, fenced off the areas with unauthorized retaining structures on slope and erected government warning notices against the illegal occupation of government land.</li> <li>• PlanD had issued Enforcement Notice and Reinstatement Notice to the landowners concerned under Town Planning Ordinance at She Tau Village.</li> </ul>
<b>Present Site Conditions (as at late July 2008)</b>	<ul style="list-style-type: none"> <li>• No further illegal tree felling, land filling and excavation were observed.</li> <li>• Hydroseed was found on part of the areas.</li> <li>• Fruit trees were planted on the land-filled area.</li> <li>• Part of the excavated area has been recovered by natural vegetation.</li> </ul>

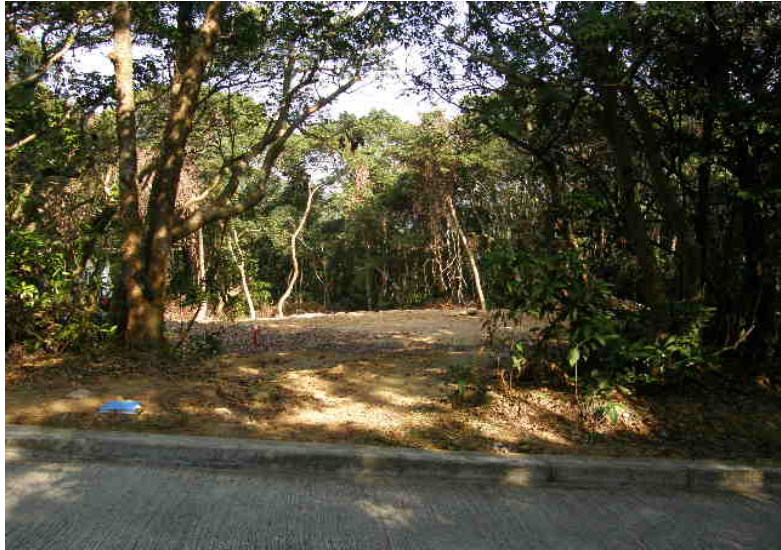
Site 3: Wong Mo Ying

<b>Background</b>	<ul style="list-style-type: none"> <li>• The subject lot is included in the Sai Kung West Country Park covering an area of approximate 20 x 25m. According to land record, it is an Old Schedule Agricultural Lot held under Block Government Lease.</li> <li>• Survey marking of lot boundary was found in October 2007 at the captioned lot.</li> </ul>
-------------------	---

<ul style="list-style-type: none"> <li>● On 25 Oct 2007, a local resident at Wong Mo Ying reported a case of suspected illegal tree felling at the subject lot. Police and AFCD staff were called on site for investigation.</li> <li>● Vegetation was cleared by end of 2007. Between mid-January and mid-March 2008, a soil platform was eventually formed at the subject lot. Height of the soil platform on the down slope side exceeded 2m.</li> <li>● No activity since mid-March.</li> <li>● No notification of any land use application received from LandsD as of 30.7.2008.</li> </ul>
<b>Actions Taken by AFCD</b>	<ul style="list-style-type: none"> <li>● Personal particulars of the tree fellers were taken on 25.10.2007. No prosecution under section 8(1) of Country Parks Regulations (Cap 208A) can be done as that provision does not apply to leased lot.</li> <li>● The land filling involve issues on land use, the case was referred to LandsD for possible actions. LandsD was requested to issue advisory letter to the land owner and demand information on intended works / land use.</li> <li>● The site has been kept under close monitoring. Sign was erected on site to warn against further works without prior consent from AFCD.</li> </ul>

land use.
<b>Present Site Conditions (as at late July 2008)</b>	<ul style="list-style-type: none"> <li>• No further activity since mid-March was observed.</li> <li>• Part of the excavated area has been recovered by natural vegetation.</li> </ul>

<b>Actions Taken by various departments</b>	<ul style="list-style-type: none"> <li>■ LandsD: No lease enforcement action against tree felling could be taken as there is no tree clause in the lease. Reviewing if land filling breaches any lease conditions.</li> <li>■ EPD: No evidence of flytipping. Reviewing if the soil platform requires an environmental permit. Liaising with LandsD to get information of intended</li> </ul>

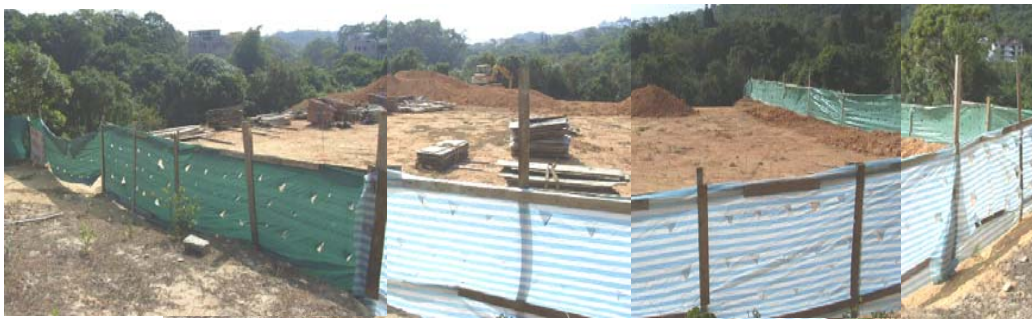
Site 4: Tai Mong Tsai  
contruction site:

<b>Background</b>	<ul style="list-style-type: none"> <li>• Various illegal accesses leading to an approved small house construction site were reported since December 2005.</li> <li>• The small house site is private land within a “V” zone but surrounded by GB zone on three sides. The site is surrounded by dense vegetation with no direct vehicular access.</li> <li>• Complaint on opening of an illegal access leading to the site was first received from a member of the public in December 2005. The access falls mainly on Government land.</li> <li>• Another illegal access with a temporary stream crossing was found in December 2007 leading to the same site. The access is close to the Tai Mong Tsai Lowland Pumping Station and within WSD’s water catchment area. The access falls mostly on Government land.</li> <li>• A third access was reported in February 2008. The access falls mainly on private land.</li> </ul>

<b>Present Site Conditions (as at late July 2008)</b>	<ul style="list-style-type: none"> <li>• No further illegal tree felling and excavation were observed at the first and second accesses.</li> <li>• The third access which falls on private land has been fenced off with hoarding.</li> </ul>

<b>Actions Taken by AFCD</b>	<ul style="list-style-type: none"> <li>• AFCD has started the investigation on unauthorized tree felling under the Forests and Countryside Ordinance, Cap. 96. However, no suspect and witness in respect of unauthorized tree felling could be identified so far.</li> <li>• Since the incidents also involved misuse of Government land and zoning issues, the findings were referred to LandsD and PlanD for actions.</li> <li>• AFCD has erected warning signs against tree felling in the area.</li> <li>• Since then, the sites have been kept under close monitoring</li> </ul>
<b>Actions Taken by various departments</b>	<ul style="list-style-type: none"> <li>• Joint site visit (AFCD, LandsD, DO, WSD and Police) had been conducted to discuss possible control and remedial measures. CEDD, BD and EPD have been alerted and kept the site under close monitoring.</li> <li>• LandsD has erected bollards at the entrances to the first and third illegal access to contain the problems.</li> <li>• A chain-link fence and metal gate were installed by WSD near the Pumping Station for blocking the second access.</li> <li>• For the third access, PlanD is considering enforcement action under the Town Planning Ordinance.</li> </ul>

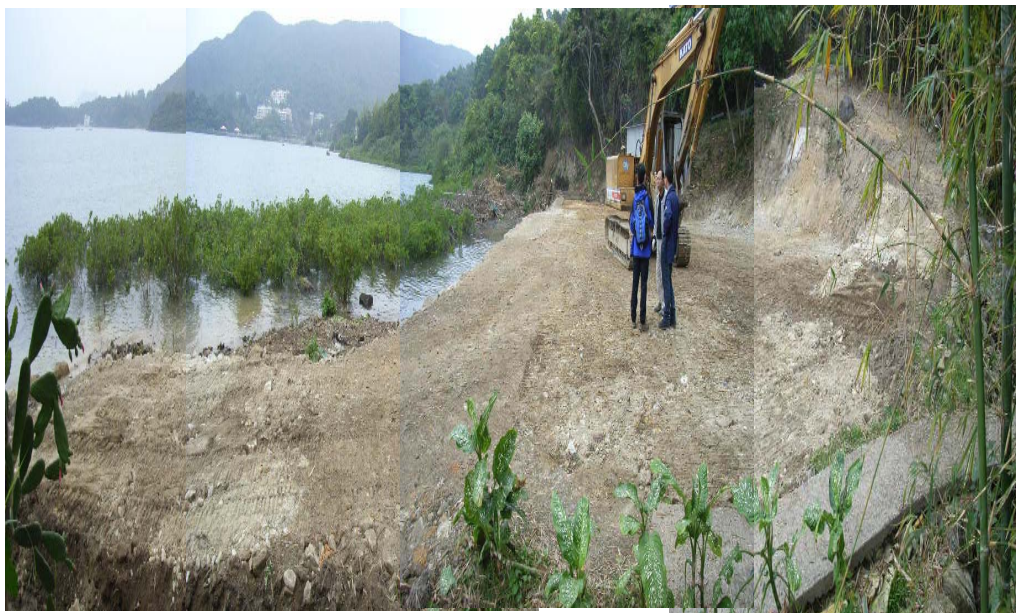
Site 5: Wong Keng Tei

<b>Background</b>	<ul style="list-style-type: none"><li>● An email was received from a member of the public on 26.2.2007 expressing his concerns about a possible development on a piece of private land at Wong Keng Tei, Sai Kung which might lead to the destruction of mangroves at the waterfront nearby.</li><li>● An area of about 10m x 17m of mangroves was cleared and about 50 nos of tree stumps were found. Both Government land and private land within "CPA" zone were involved.</li><li>● The site was found to be paved later on.</li></ul>
<b>Actions Taken by AFCD</b>	<ul style="list-style-type: none"><li>● Upon receiving the report, AFCD inspected the site on 28.2.2007. Apart from felling of mangroves, the incident also involved land use and zoning issues, thus the case was referred to LandsD and PlanD for actions.</li><li>● The site has been kept under close monitoring.</li><li>● On unauthorized tree felling, prosecution was initiated against unauthorized felling of mangroves and trees. The culprit was convicted and fined for HK\$12,000 in July 2007.</li></ul>

<p><b>Present Site Conditions</b> (as at late July 2008)</p>	<ul style="list-style-type: none"> <li>• No further mangrove / tree felling was observed.</li> <li>• Most of the concrete paving were removed.</li> <li>• Three banana trees and a few shrubs were planted on site, natural vegetation has recolonised the site.</li> </ul>
--	---

<b>Actions Taken by various departments</b>	<ul style="list-style-type: none"><li>● LandsD has erected bollards to stop vehicular access to the site.</li><li>● PlanD had issued Enforcement Notice and Reinstatement Notice to the landowner concerned under Town Planning Ordinance for the unauthorised land use.</li></ul>
