CONTRACT NO. GE/2022/08
GROUND INVESTIGATION – NEW TERRITORIES EAST

Task Order No. GE/2022/08.35A
Agreement No. CE 26/2022 (EP) -
Development of Integrated Waste Management Facilities
Phase 2 - Investigation, Design and Construction

FINAL FIELD WORK REPORT

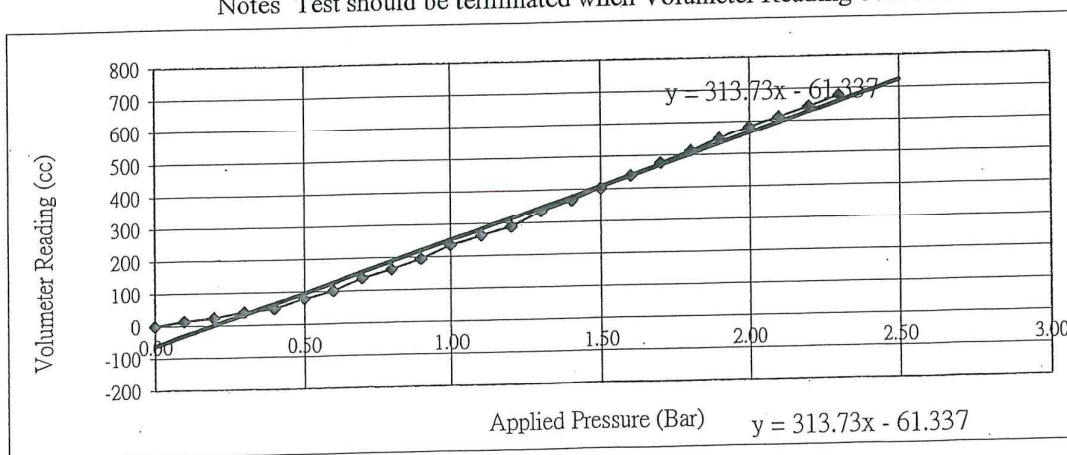
Calibration Procedure : The pressuremeter probe was pressurised in small increments and allowed to inflate under atmospheric conditions. Volume change was recorded against pressure. The pressure correction at a certain volume change represents the interior of probe.

Applied Pressure (Bar)	0.00	0.10	0.20	0.30	0.40	0.50	0.60
Volumeter Reading after 1-min holding (cc)	0	13	23	39	49	78	102
Applied Pressure (Bar)	0.70	0.80	0.90	1.00	1.10	1.20	1.30
Volumeter Reading after 1-min holding (cc)	138	164	194	235	263	288	335
Applied Pressure (Bar)	1.40	1.50	1.60	1.70	1.80	1.90	2.00
Volumeter Reading after 1-min holding (cc)	367	403	439	477	512	549	584
Applied Pressure (Bar)	2.10	2.20	2.30				
Volumeter Reading after 1-min holding (cc)	613	644	678

Notes Test should be terminated when Volumeter Reading over 700cc.

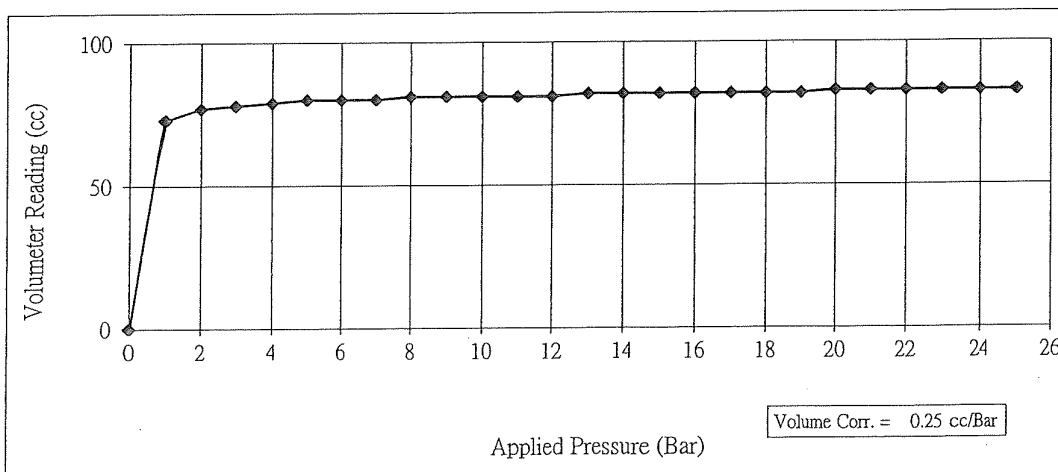
Calibration Procedure : The pressuremeter probe was pressurised in small increments and allowed to inflate under atmospheric conditions. Volume change was recorded against pressure. The pressure correction at a certain volume change represents the interior of probe.

Applied Pressure (Bar)	0.0	1.0	2.0	3.0	4.0	5.0	6.0
Volumeter Reading after 1-min holding (cc)	0	73	77	78	79	80	80
Applied Pressure (Bar)	7.0	8.0	9.0	10.0	11.0	12.0	13.0
Volumeter Reading after 1-min holding (cc)	80	81	81	81	81	81	82
Applied Pressure (Bar)	14.0	15.0	16.0	17.0	18.0	19.0	20.0
Volumeter Reading after 1-min holding (cc)	82	82	82	82	82	82	83
Applied Pressure (Bar)	21.0	22.0	23.0	24.0	25.0		
Volumeter Reading after 1-min holding (cc)	83	83	83	83	83

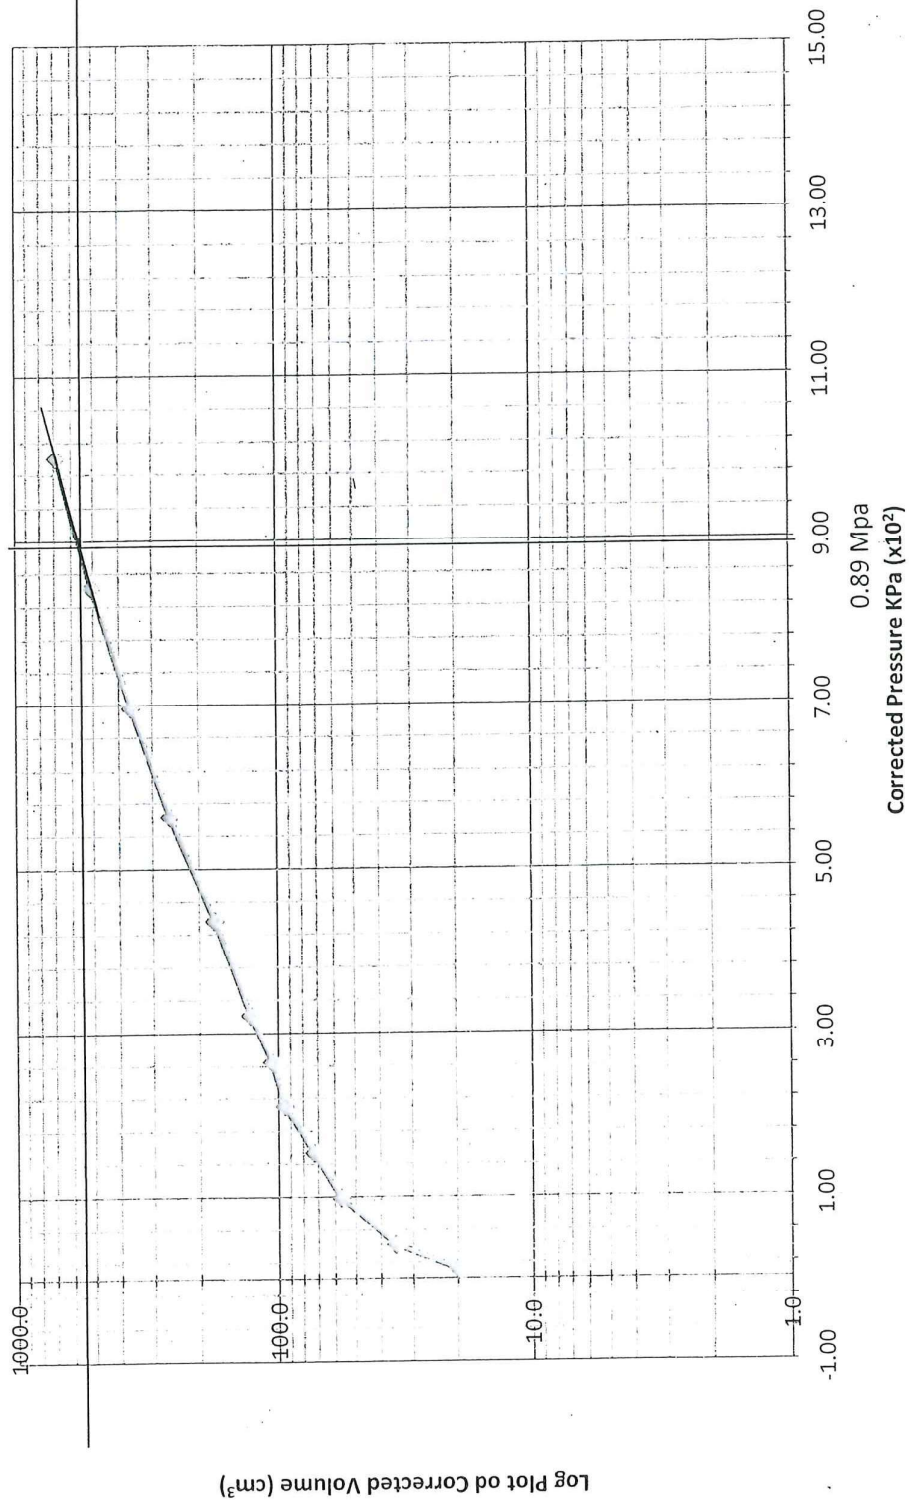
Pressuremeter Test
BH15 (9.50m-10.50m)
Limit Pressure

Two (2) pressuremeter tests were carried out in the drillhole at specified depths, using a Menard (G-Am) type equipment. The test pockets were formed by penetrating a Fugro sampler.

The pressuremeter test results including test data and graphic plots are presented in Appendix E.

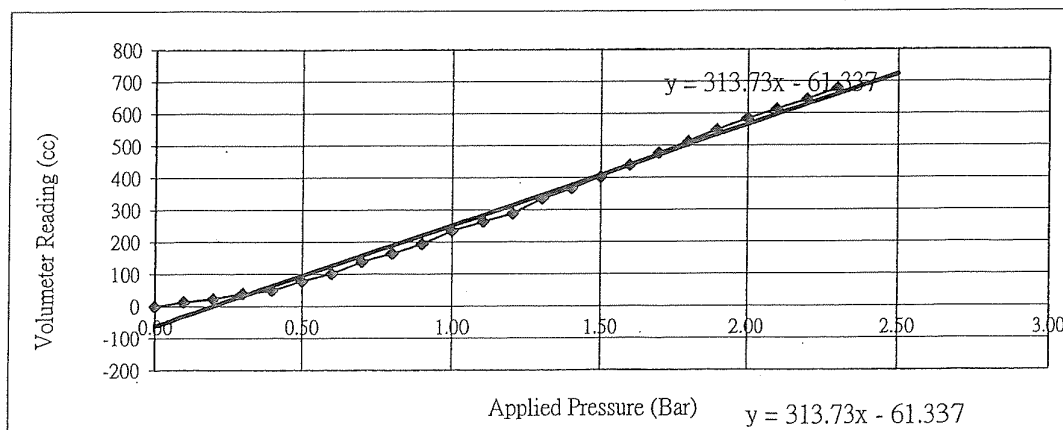
Calibration Procedure : The pressuremeter probe was pressurised in small increments and allowed to inflate under atmospheric conditions. Volume change was recorded against pressure. The pressure correction at a certain volume change represents the interior of probe.

Applied Pressure (Bar)	0.00	0.10	0.20	0.30	0.40	0.50	0.60
Volumeter Reading after 1-min holding (cc)	0	13	23	39	49	78	102
Applied Pressure (Bar)	0.70	0.80	0.90	1.00	1.10	1.20	1.30
Volumeter Reading after 1-min holding (cc)	138	164	194	235	263	288	335
Applied Pressure (Bar)	1.40	1.50	1.60	1.70	1.80	1.90	2.00
Volumeter Reading after 1-min holding (cc)	367	403	439	477	512	549	584
Applied Pressure (Bar)	2.10	2.20	2.30				
Volumeter Reading after 1-min holding (cc)	613	644	678

Notes Test should be terminated when Volumeter Reading over 700cc.

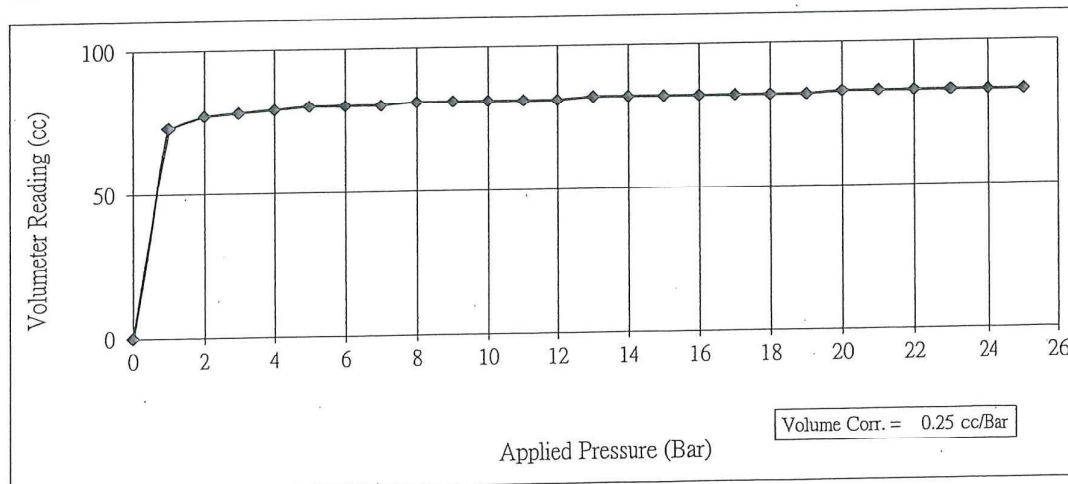
Calibration Procedure : The pressuremeter probe was pressurised in small increments and allowed to inflate under atmospheric conditions. Volume change was recorded against pressure. The pressure correction at a certain volume change represents the inertia of probe.

Applied Pressure (Bar)	0.0	1.0	2.0	3.0	4.0	5.0	6.0
Volumeter Reading after 1-min holding (cc)	0	73	77	78	79	80	80
Applied Pressure (Bar)	7.0	8.0	9.0	10.0	11.0	12.0	13.0
Volumeter Reading after 1-min holding (cc)	80	81	81	81	81	81	82
Applied Pressure (Bar)	14.0	15.0	16.0	17.0	18.0	19.0	20.0
Volumeter Reading after 1-min holding (cc)	82	82	82	82	82	82	83
Applied Pressure (Bar)	21.0	22.0	23.0	24.0	25.0		
Volumeter Reading after 1-min holding (cc)	83	83	83	83	83

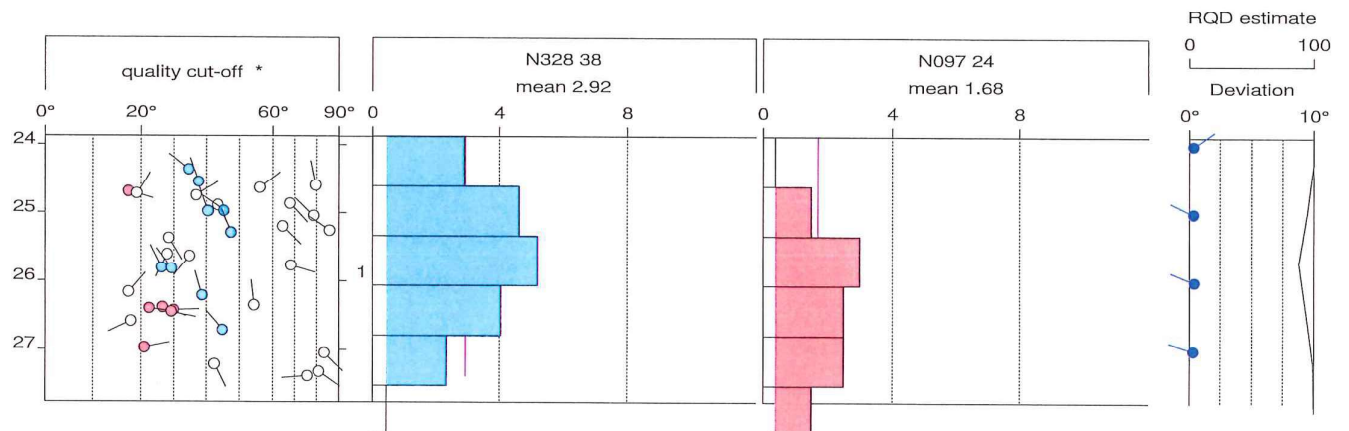
BHTV dips

open symbols not used in mean-dip/zone-axis calculation

One (1) acoustic borehole televiwer survey was carried out in drillhole at depths as instructed. The acoustic imaging equipment consists of a centralized sonde, with a rotating transducer and receiver orientated by a magnetometer and inclinometer capable of working in fluid filled holes. The sonde uses a focused ultrasound beam, measured in travel time and amplitude, to scan the borehole wall producing a full 360-degree image. The features azimuth and dip angle are derived by digital cross-referencing of the orientation data. The Travel Time and Amplitude, Joints Interpretation and Stereographic Plots Records are presented in Appendix F.

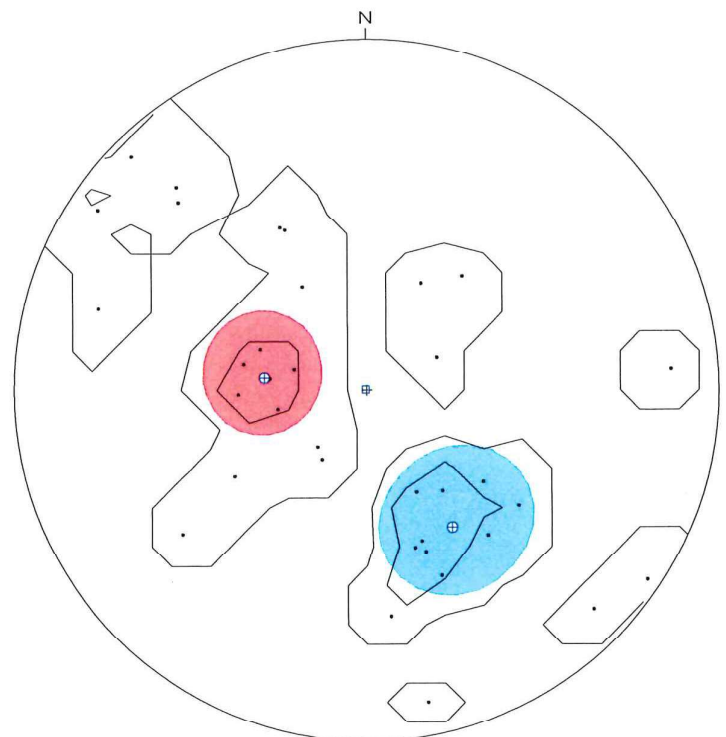
RGLDIPv6.2 DIP DATA INTERPRETATION: FRACTURE ANALYSIS

N328 38	N097 24
N328 38		14 N040
N097 24	14 N040

equal-area lower-hemisphere 0-90
contour-levels 1,3,

⊕ mean dip
□ well axis
