Pilot Green Transport Fund

Interim Report

Trial of Electric Van for University

**Interim Report
(Trial Period: 1 May – 31 October, 2016)**

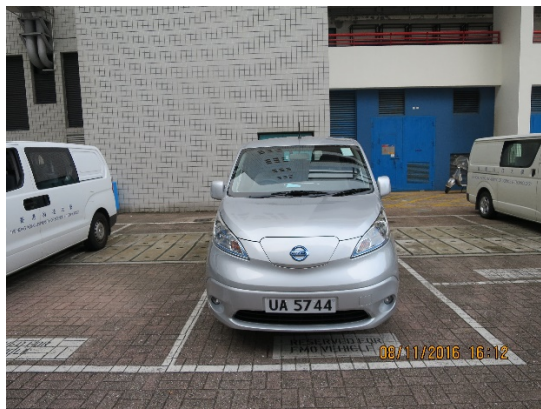
A silver Nissan EV van with license plate UA 5744 parked in a paved lot. The front view shows the car's headlights, grille, and front bumper. A timestamp '08/11/2016 16:12' is visible in the bottom right corner.

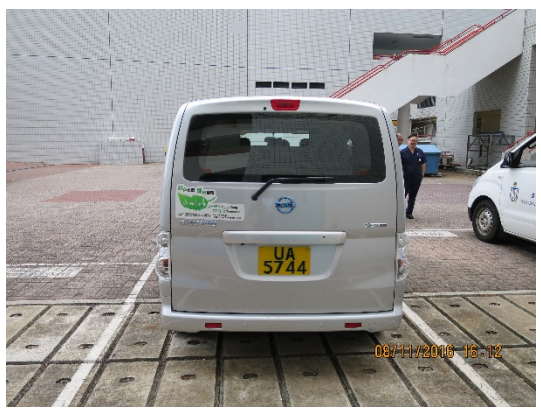
The rear view of the silver van UA5744, showing the back window, rear door, and license plate. A timestamp '08/11/2016 16:12' is visible in the bottom right corner.
UA5744 – front view	UA5744 – end view

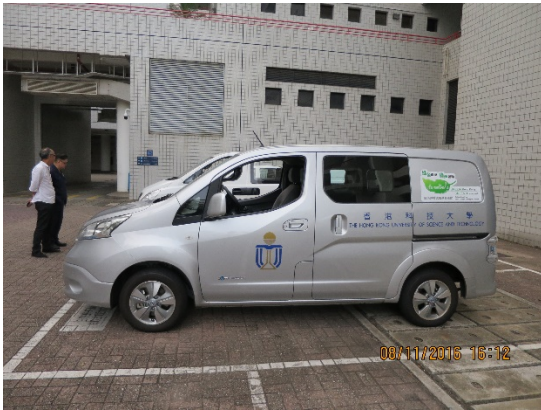
A side profile view of the silver van UA5744 parked in a lot. The side of the van features logos and text in Chinese and English. A timestamp '08/11/2016 16:12' is visible in the bottom right corner.

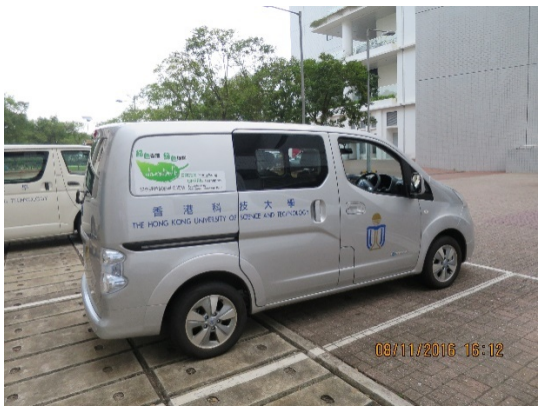
Another side profile view of the silver van UA5744, showing a different angle. A timestamp '08/11/2016 16:12' is visible in the bottom right corner.
UA5744 – side view 1	UA5744 – side view 2

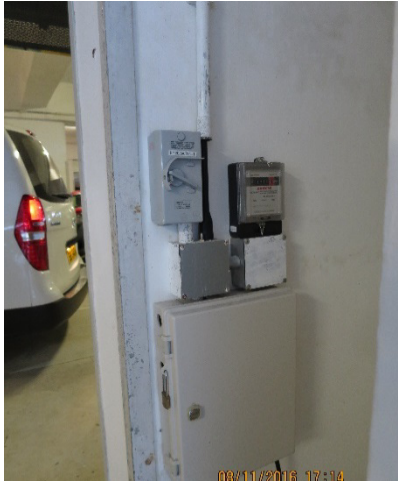
Battery charger with watt-hour meter

2.2 HKUST has installed a standard charging facility (limited by 10-ampere) at LG 5 indoor car park on-campus to charge the batteries of the EV as well as to record the electricity consumed for EV charging. The EV was charged overnight every day (from 17:00 to 08:00 on the next day).

A close-up photograph of a white battery charging station mounted on a wall. It includes a watt-hour meter and a charging cable. A timestamp '08/11/2016 17:34' is visible in the bottom right corner.
