6.1 Assessing the Effectiveness of Direct Technical Remedies

6.2 PREDICTED NOISE LEVELS

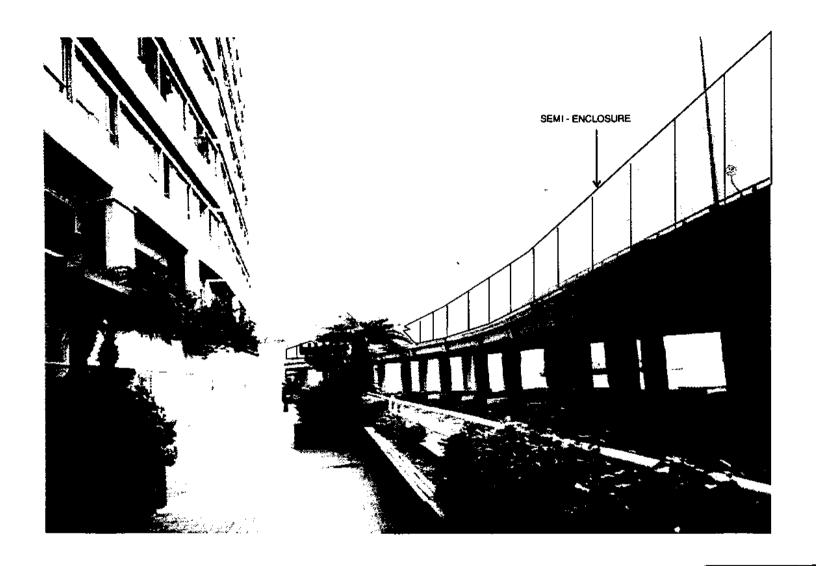
FIGURE 6.1a - DIRECT TECHNICAL REMEDIES PROPOSED ON FLYOVER H26 - IEC (PROVIDENT CENTRE)

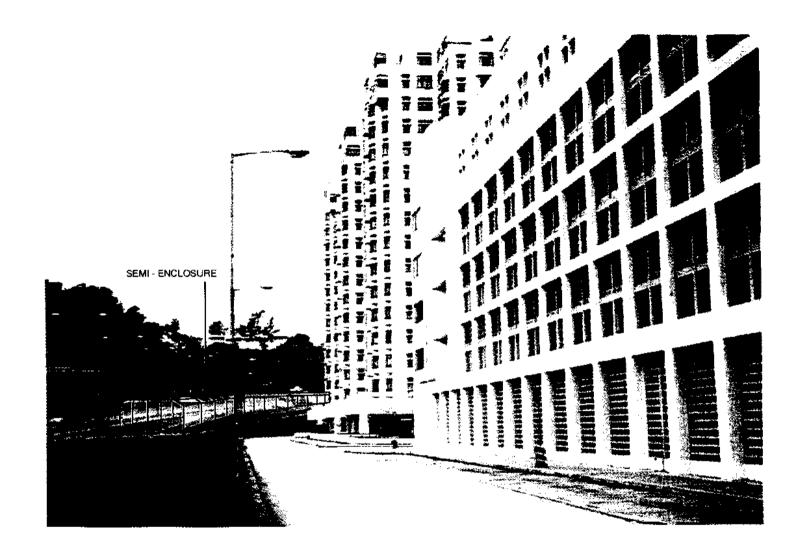
FIGURE 6.1b - DIRECT TECHNICAL REMEDIES PROPOSED ON FLYOVER H34 - IEC (HENG FA CHUEN)

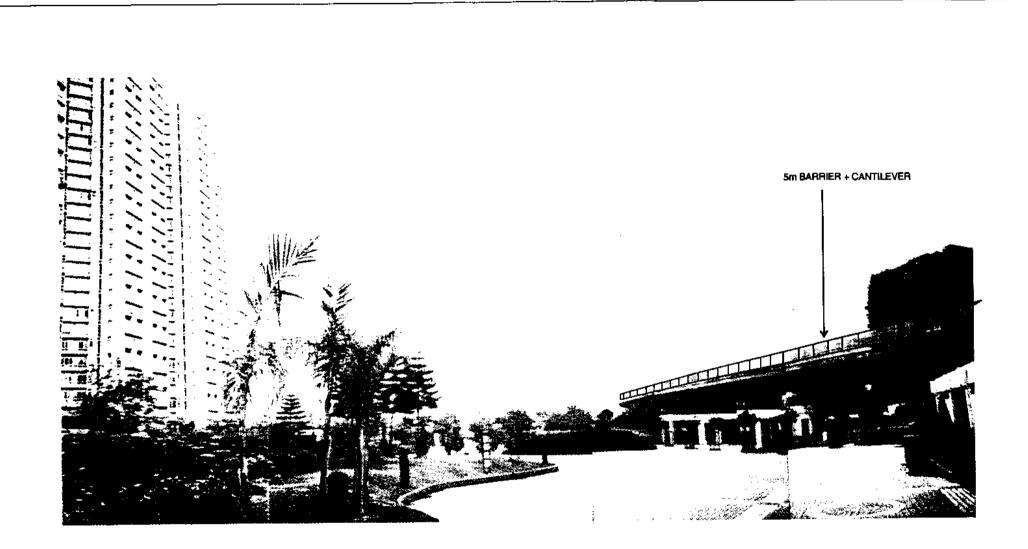
FIGURE 6.1c - DIRECT TECHNICAL REMEDIES PROPOSED ON FLYOVER K53 - KWUN TONG BYPASS (LAGUNA CITY)

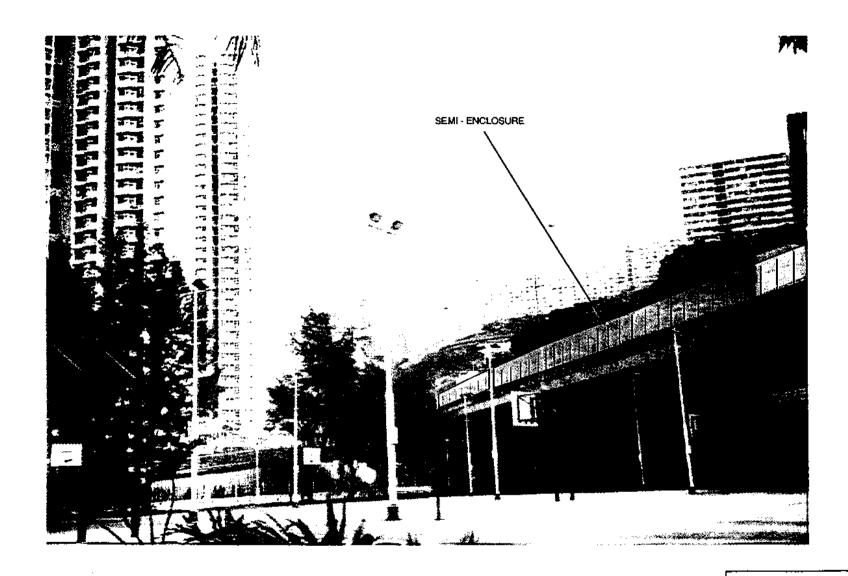
FIGURE 6.1d - DIRECT TECHNICAL REMEDIES PROPOSED ON FLYOVER K56 - TSEUNG KWAN O ROAD (TSUI PING ESTATE (SOUTH))

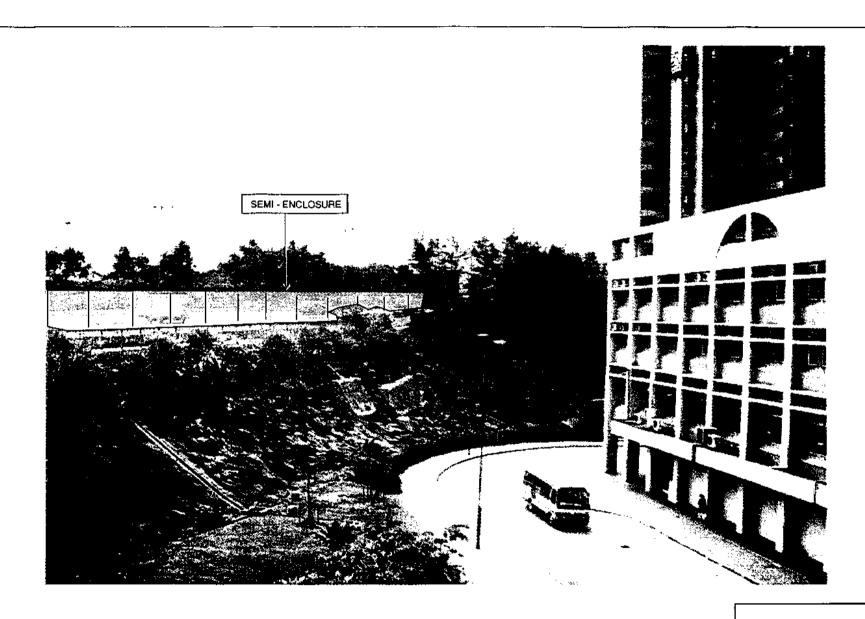
FIGURE6.1i - DIRECT TECHNICAL REMEDIES PROPOSED ON FLYOVER NT 71 - TSING TSUEN ROAD

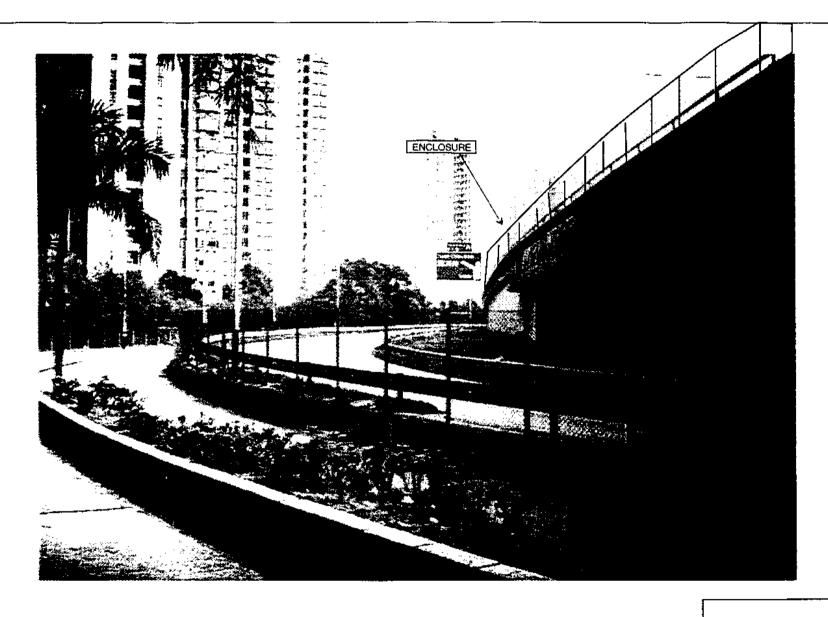
FIGURE 6.1j - DIRECT TECHNICAL REMEDIES PROPOSED ON FLYOVER NT25 - SHA TIN ROAD
