## Incident of Leachate from NENT Landfill Due to Damaged Temporary Lagoon

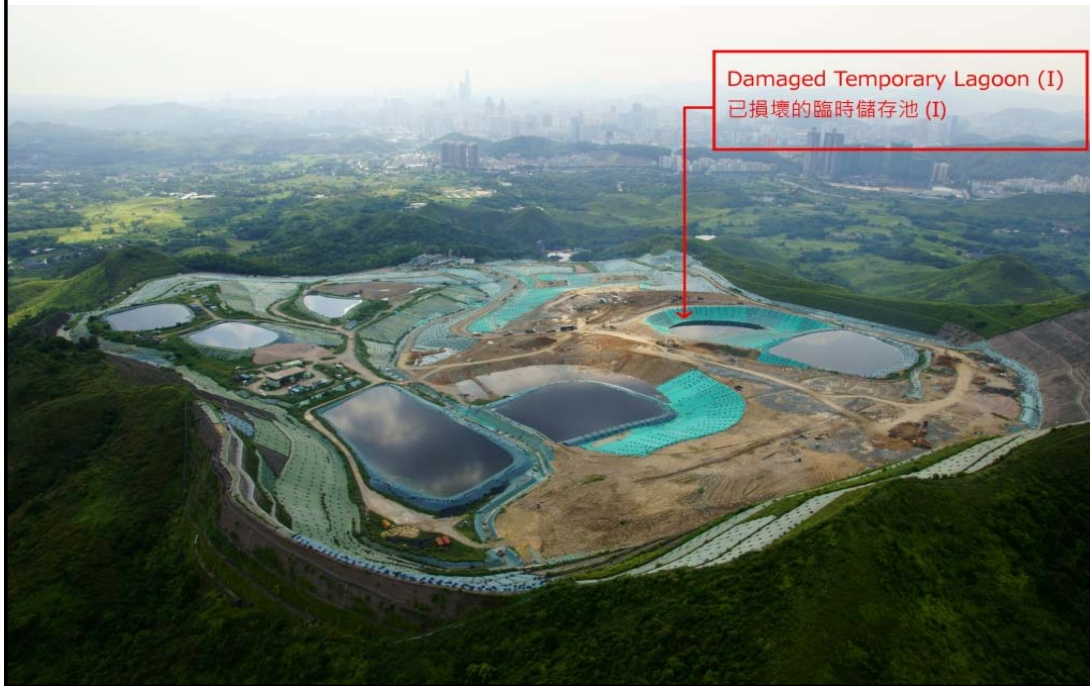
## Leachate Collection & Management System (Normal Operation)

### 滲濾液收集及處理系統 (一般情況)

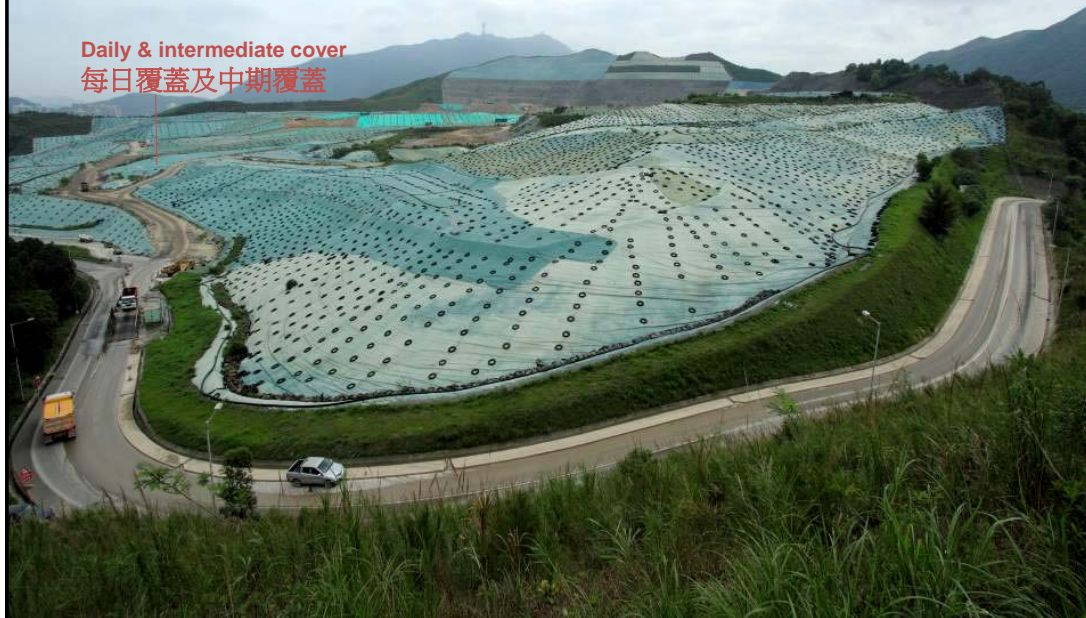
## Most Areas of Landfill Already Covered by Impermeable Liners

堆填區的大部份面積已用不滲漏膠墊覆蓋

Daily & intermediate cover  
每日覆蓋及中期覆蓋

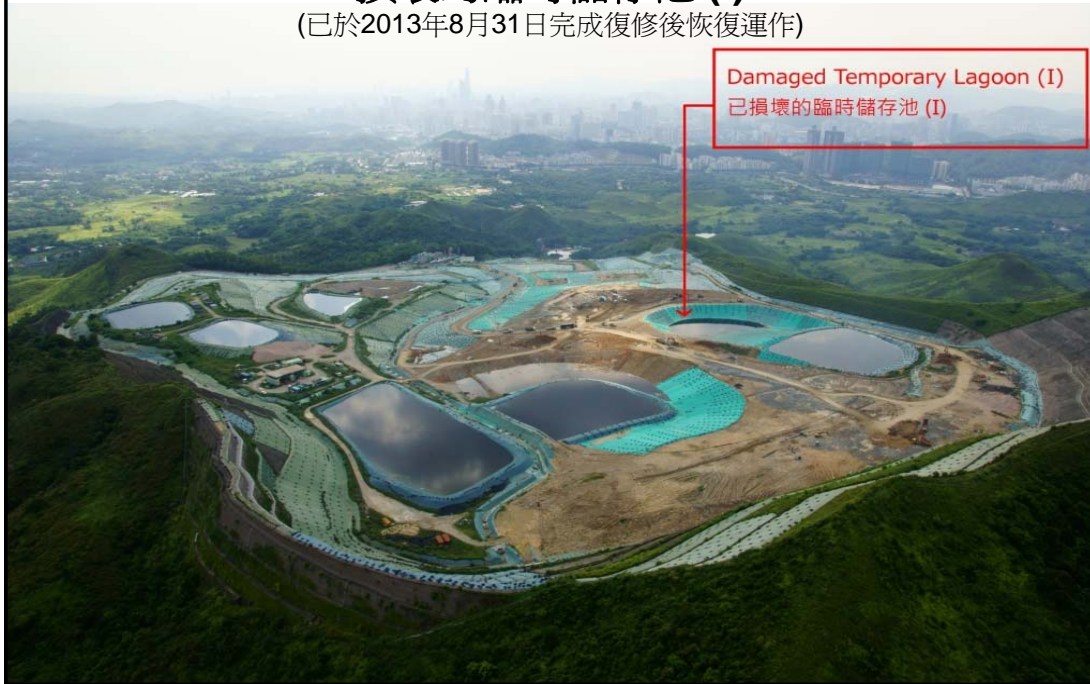
## Damaged Temporary Lagoon (I)

(Resumed Operation after Repairing Completed on 31 August 2013)

Damaged Temporary Lagoon (I)  
已損壞的臨時儲存池 (I)

- Increase uptake of pre-treated leachate by the current sewerage system as far as possible  
利用現有的污水收集系統，盡量接收更多預先處理的滲濾污水
- Increase tankering of pre-treated leachate direct to Shek Wu Hui STW  
增加水車將預先處理的滲濾污水直接運送往石湖墟污水處理廠

- Install on-site treatment facility to treat wastewater generated from site activities and proposed new vehicle wash up to standard for direct discharge to Kong Yiu Channel  
安裝場內污水處理設施，處理從工地活動及洗車設施所產生的污水，達到符合直接排放至缸窰河的標準
- Enhance overall leachate management (estimation of leachate generation and provision of adequate storage capacity etc.) and monitoring on site  
改善整體滲濾污水的管理 (估計滲濾污水的產生量及提供充足的儲存容量等)和現場監測工作
- Expedite the upgrading of the sewerage network  
加快開展該區污水系統網絡的改善工程
