Installation of Submarine Gas Pipelines and Associated Facilities from To Kwa Wan to North Point for Former Kai Tak Airport Development

Third Monthly Environmental Monitoring & Audit (EM&A) Report

14 September 2012

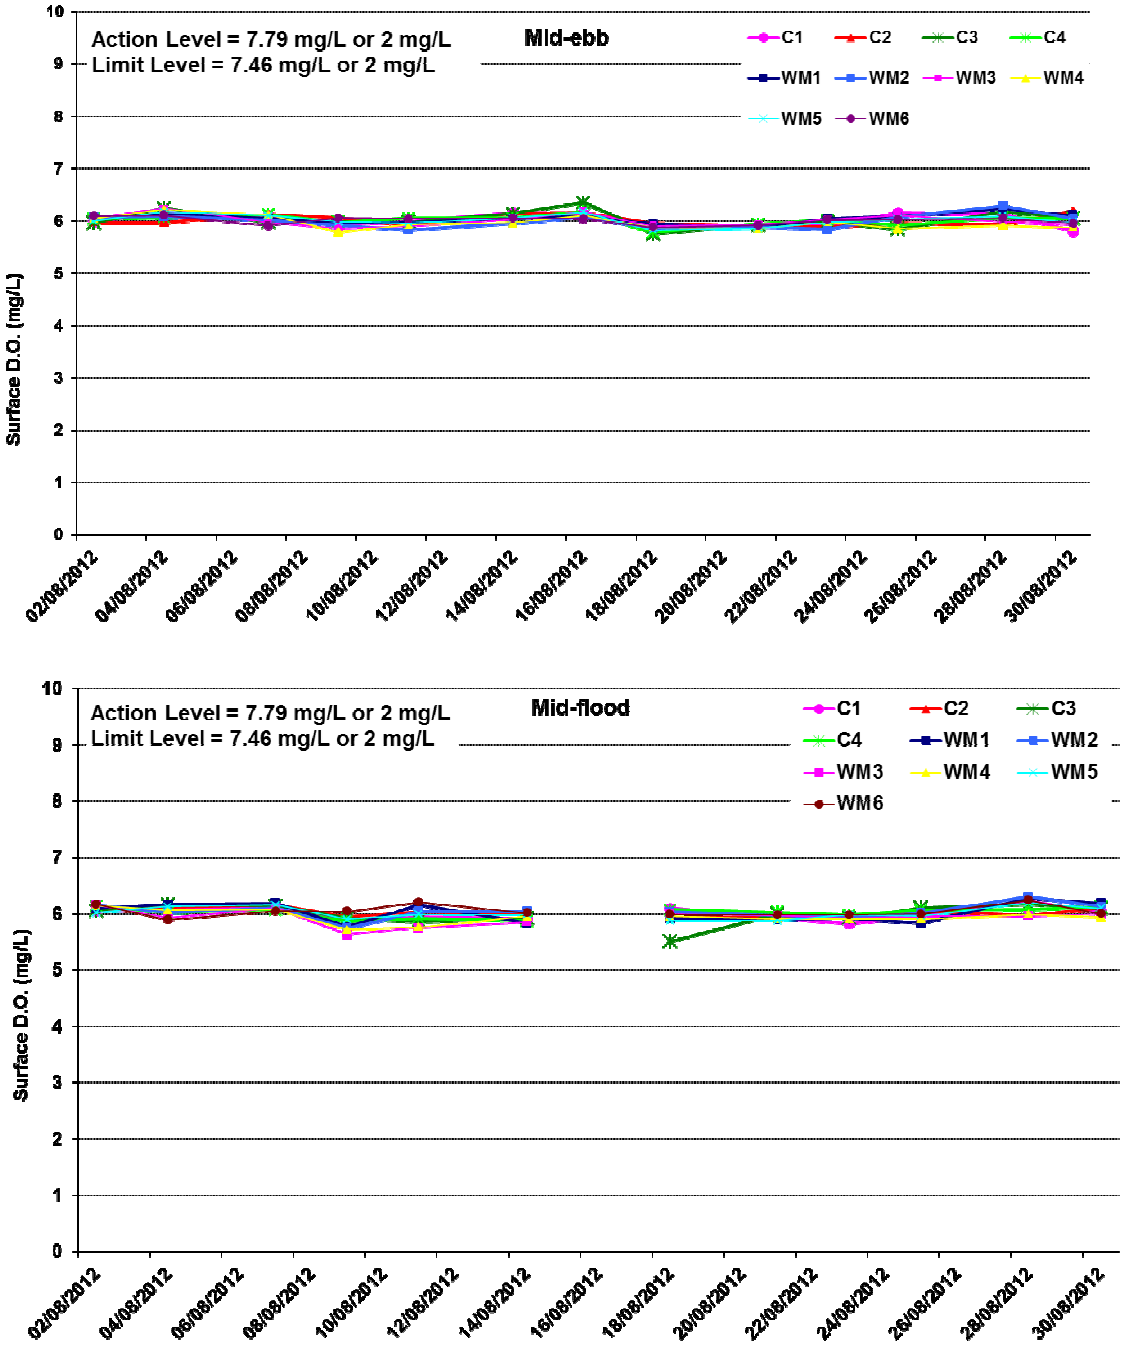
Figure B3 Impact Monitoring – Mean Level of Dissolved Oxygen (mg/L) in surface waters between 2 and 30 August 2012 at Monitoring Stations for Dredging Works. No monitoring was conducted on 16 August 2012 during mid-flood tide due to adverse weather condition.

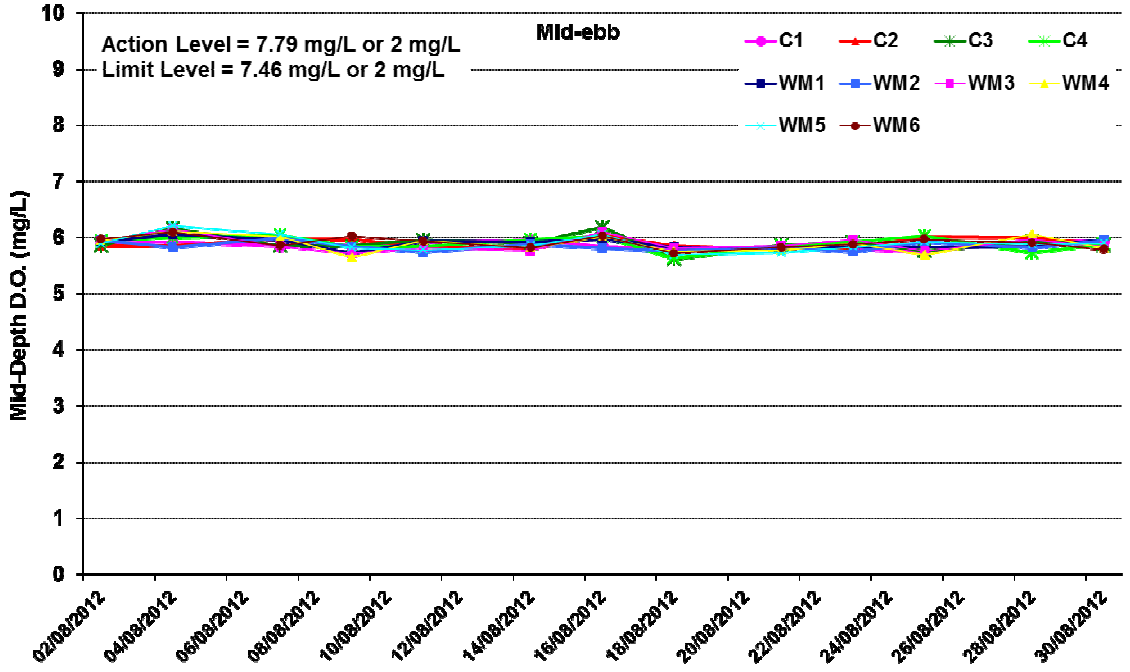
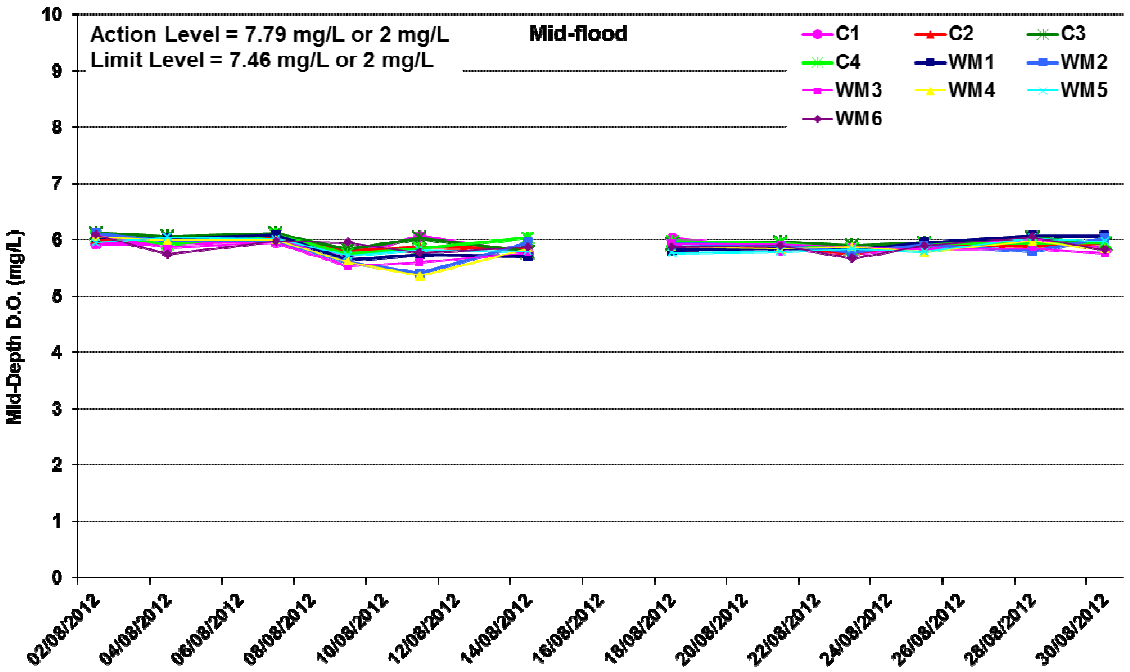
Figure B4 Impact Monitoring – Mean Level of Dissolved Oxygen (mg/L) in mid-depth waters between 2 and 30 August 2012 at Monitoring Stations for Dredging Works. No monitoring was conducted on 16 August 2012 during mid-flood tide due to adverse weather.

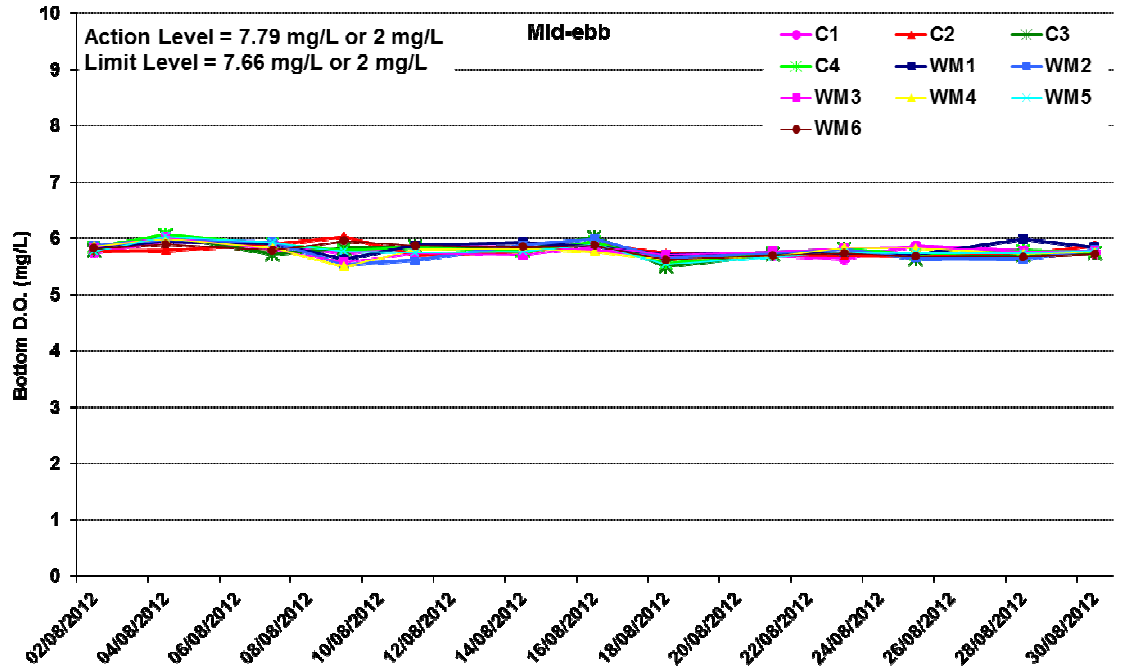
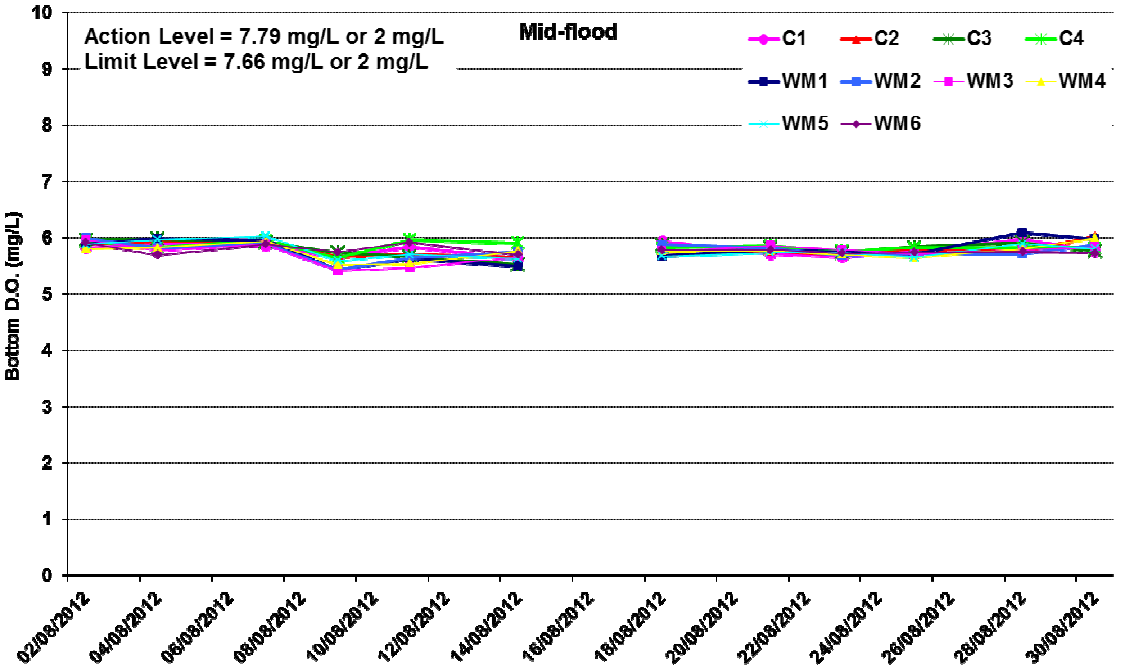
Figure B5 Impact Monitoring – Mean Level of Dissolved Oxygen (mg/L) in bottom water between 2 and 30 August 2012 at Monitoring Stations for Dredging Works. No monitoring was conducted on 16 August 2012 during mid-flood tide due to adverse weather condition.

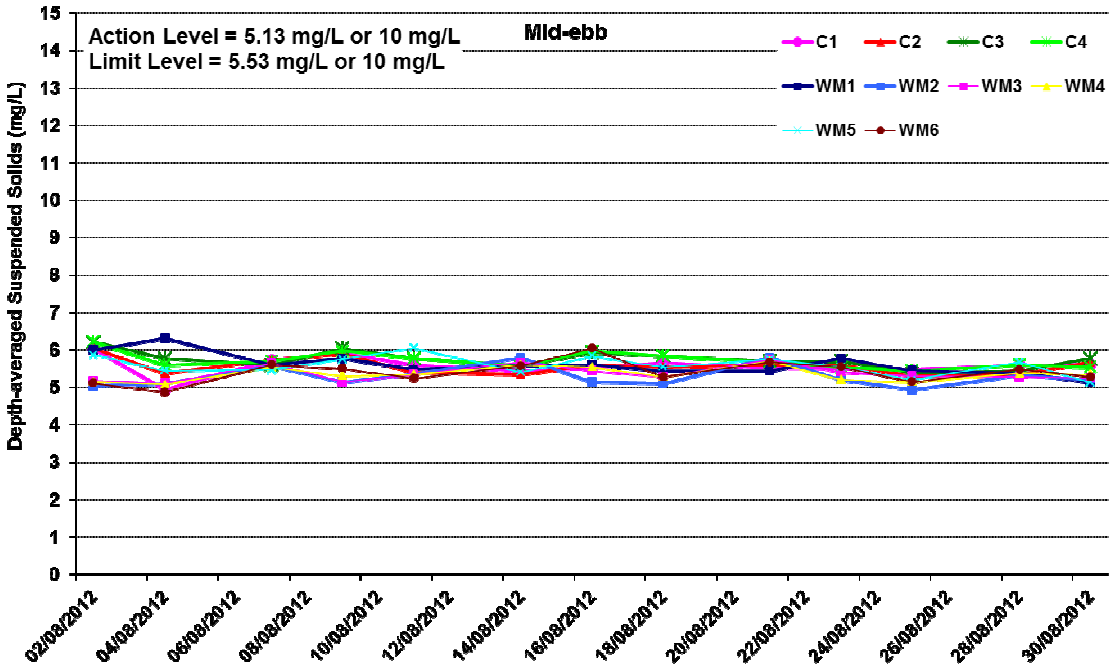
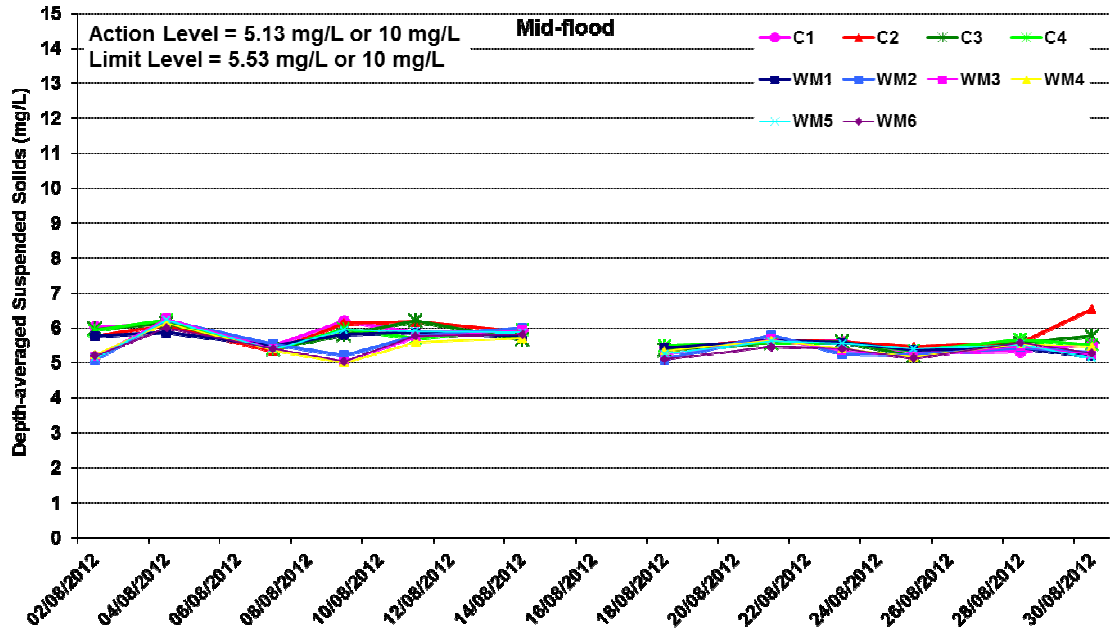
Figure B6 Impact Monitoring – Mean Depth-averaged Level of Suspended Solids between 2 and 30 August 2012 at Monitoring Stations for Dredging Works. No monitoring was conducted on 16 August 2012 during mid-flood tide due to adverse weather condition.

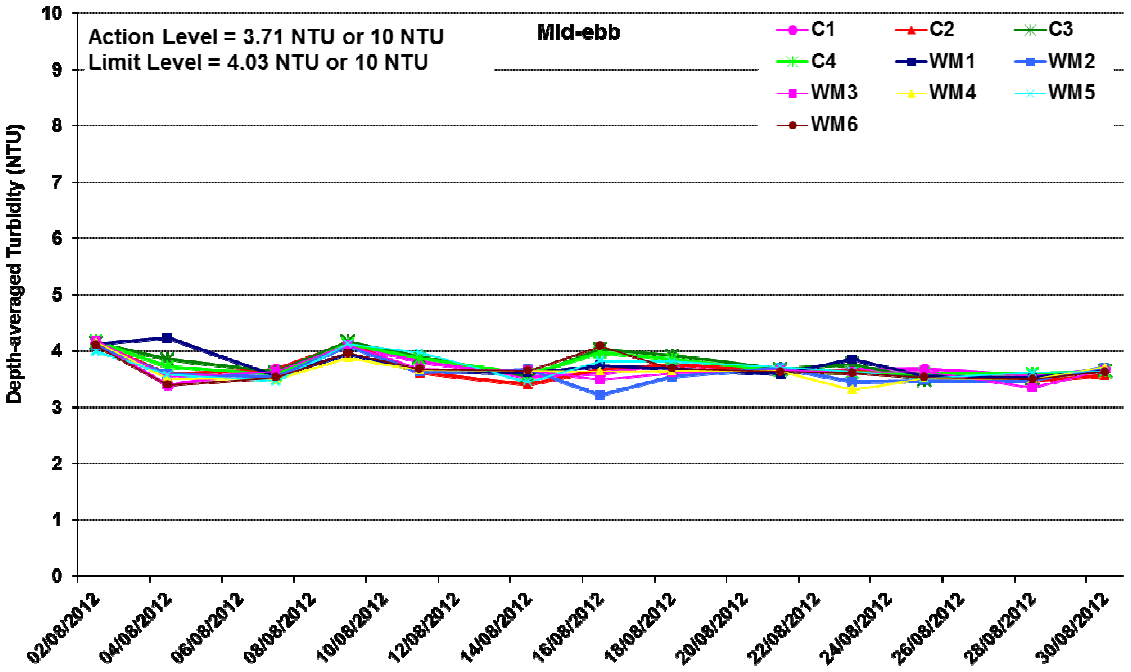
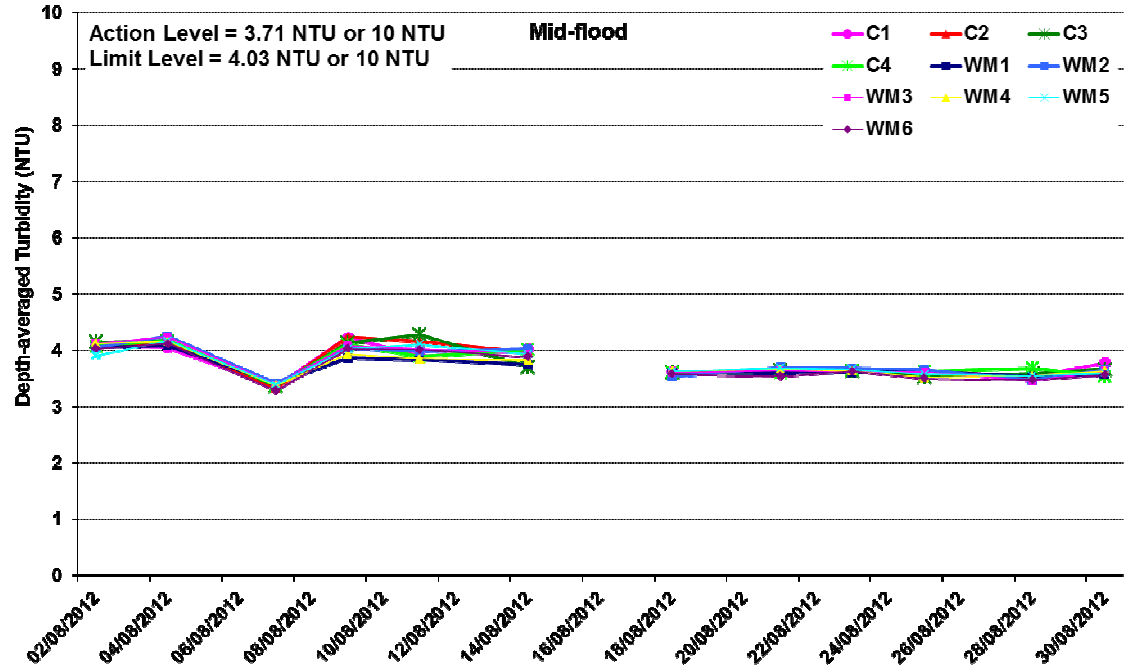
Figure B7 Impact Monitoring – Mean Depth-averaged Level of Turbidity (NTU) between 2 and 30 August 2012 at Monitoring Stations for Dredging Works. No monitoring was conducted on 16 August 2012 during mid-flood tide due to adverse weather condition.

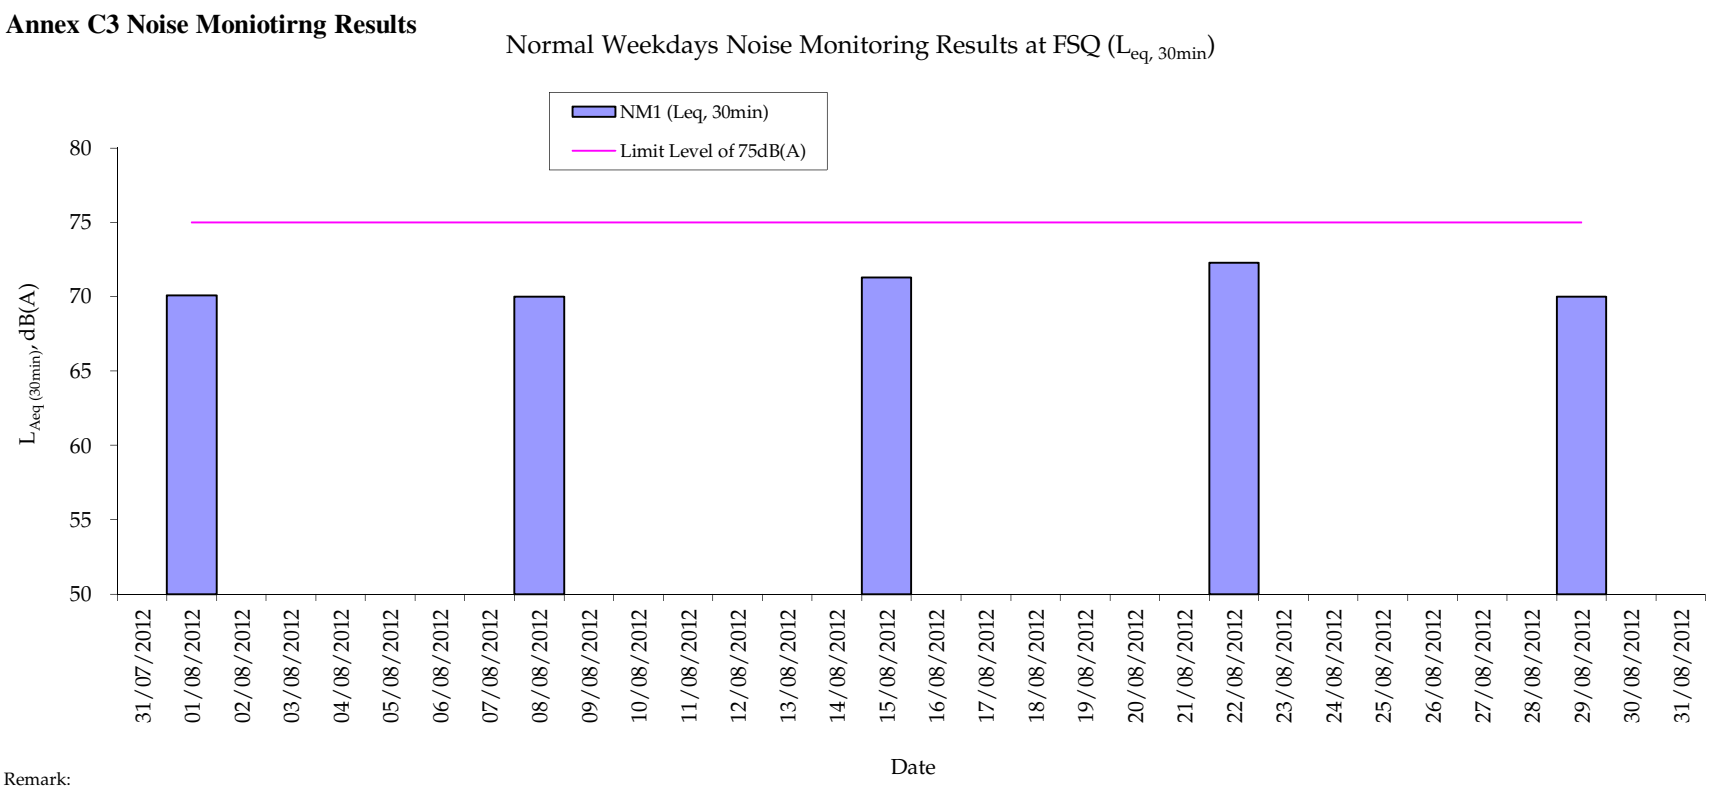
Annex C3 Noise Moniotirng Results

Remark:
- 75dB(A) was adopted as the Limit Level during normal weekdays in the reporting period

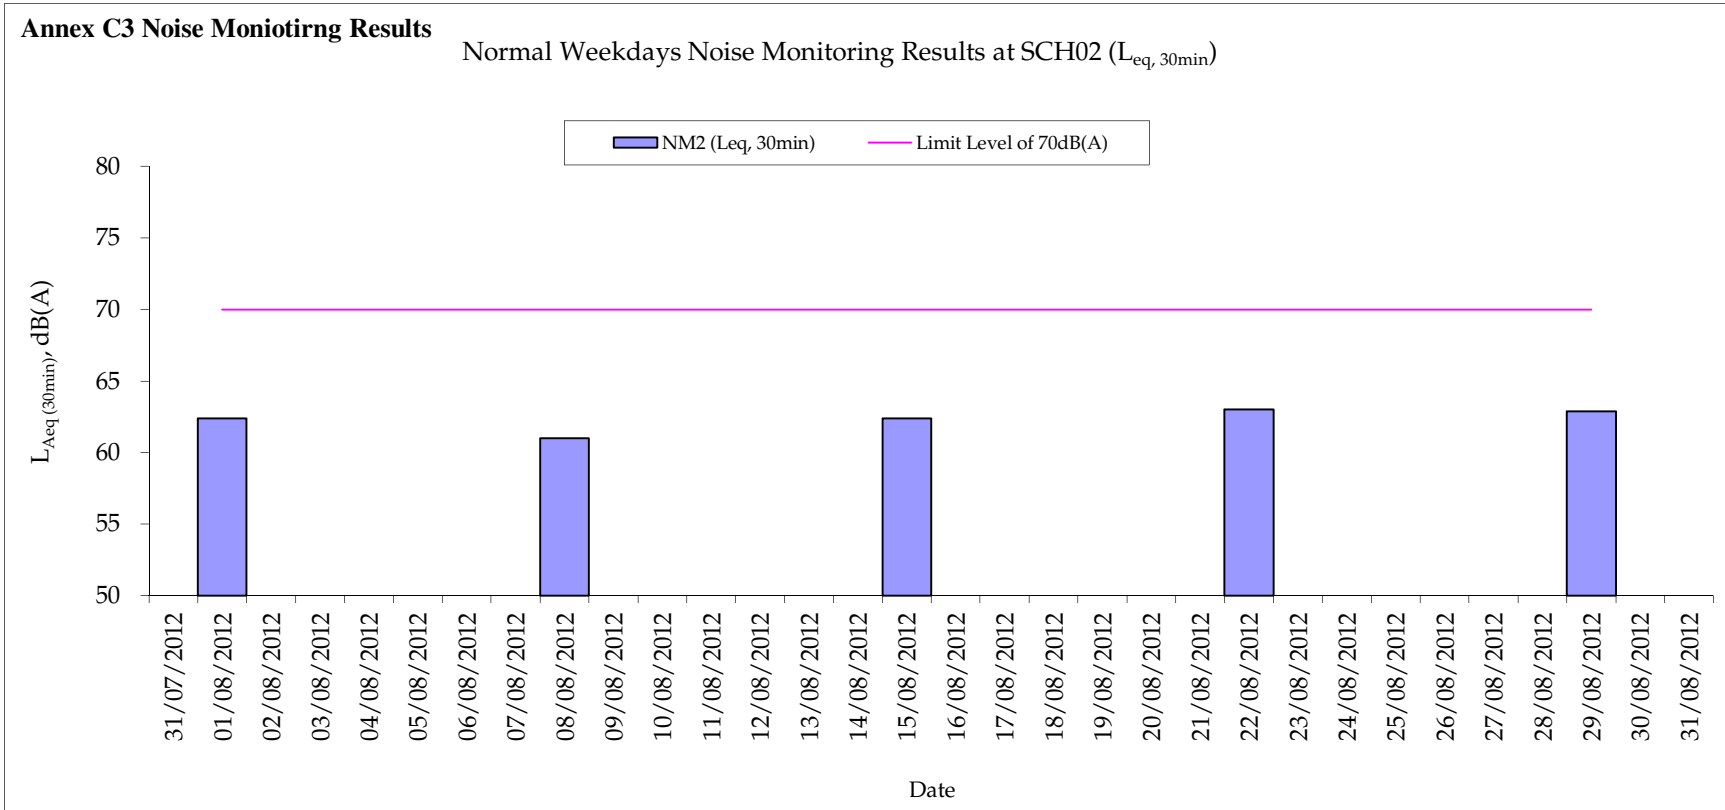
Annex C3 Noise Moniotirng Results

Remark:
- 70dB(A) was adopted as the Limit Level during school normal teaching period in the reporting period
