Installation of Submarine Gas Pipelines and Associated Facilities from To Kwa Wan to North Point for Former Kai Tak Airport Development

Sixth Monthly Environmental Monitoring & Audit (EM&A) Report

11 December 2012

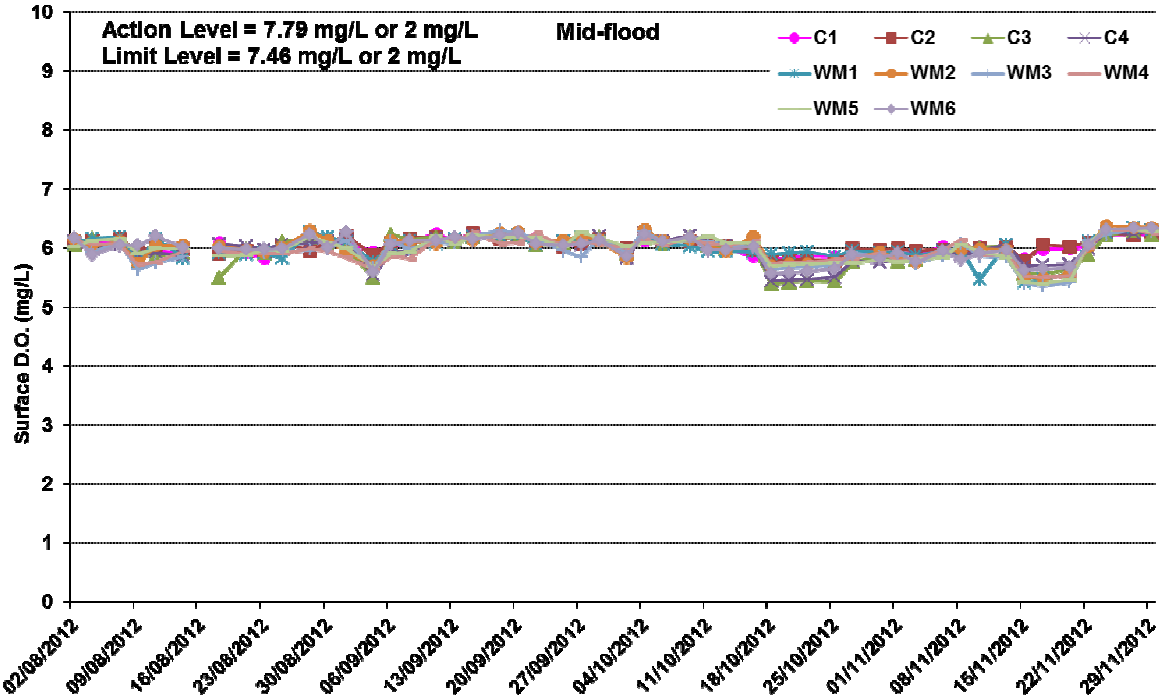
Figure B3 Impact Monitoring – Mean Level of Dissolved Oxygen (mg/L) in surface waters between 2 August and 29 November 2012 at Monitoring Stations for Dredging Works.

Exceedances were recorded on 1, 3, 6, 8, 10, 13, 15, 17, 20, 22, 24, 27 and 29 November 2012. Exceedances in the Action and Limit Levels of surface, mid-depth and bottom DO were observed. It is considered that the exceedances in DO levels are more likely to be representing natural background fluctuation in water quality rather than indicating any adverse water quality impacts from the Project since the levels of DO at the Impact Stations where exceedances were recorded were similar to those at the Control Stations, which are far away from the dredging locations which should not be affected by the dredging works. In addition, some exceedances were recorded when no dredging works were being undertaken for the Project during the period of water quality monitoring (eg on 3 November 2012 at mid-flood tide and on 6, 10, 29 November 2012 for the whole monitoring period).

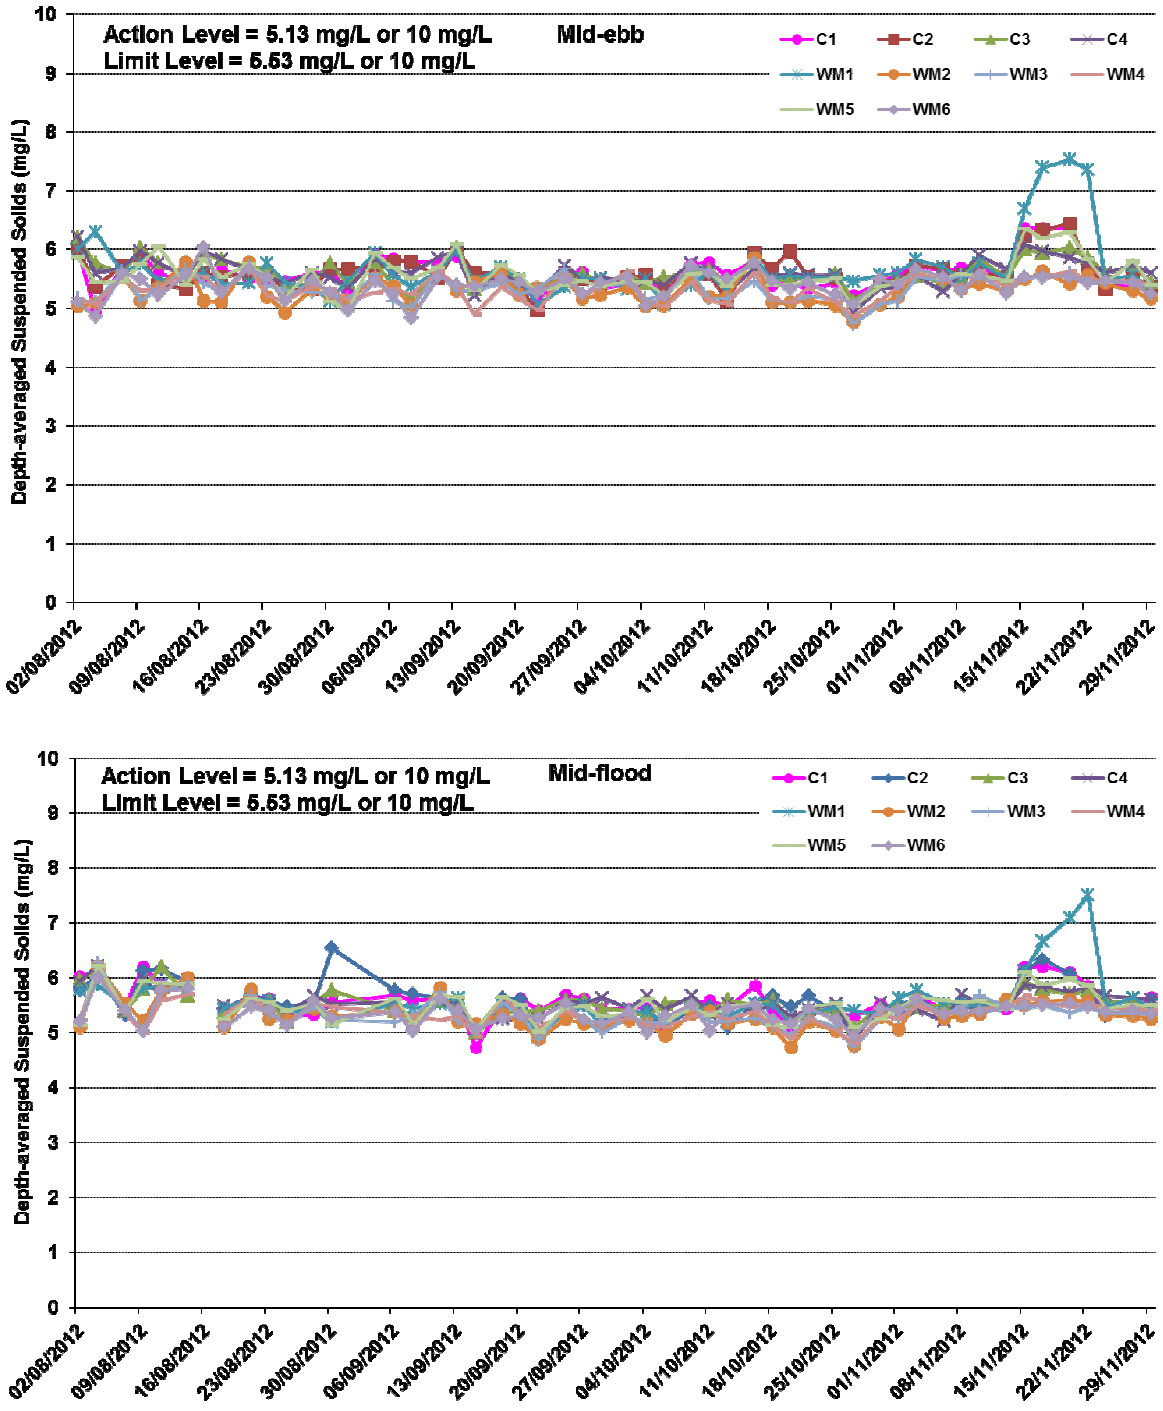
Figure B6 Impact Monitoring – Mean Depth-averaged Level of Suspended Solids (mg/L) between 2 August and 29 November 2012 at Monitoring Stations for Dredging Works.

Exceedances in the Action and Limit Levels of depth-averaged SS levels were recorded. As explained above, high level of SS in this area are considered to be sporadic and characteristic of water quality in this area of Hong Kong. The observed SS exceedances were thus not considered to be of environmental concern.
