Expansion of Hong Kong International Airport into a Three-Runway System

Construction Phase Monthly EM&A Report No. 3
(For March 2016)

April 2016

Airport Authority Hong Kong

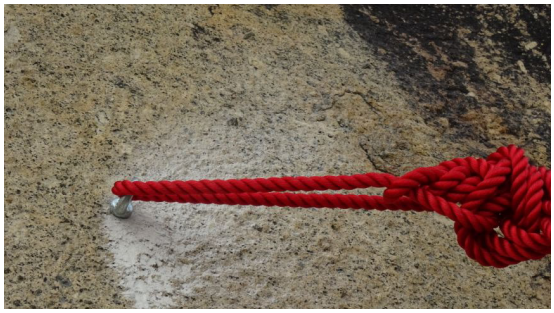
Installation of HDD plant at HDD launching site

Installation of safe access facilities around the daylighting location on Sheung Sha Chau Island

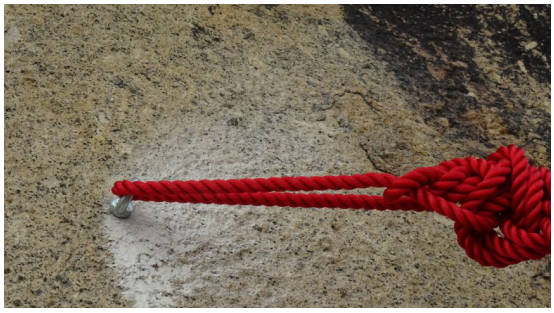
Installation of HDD plants at HDD launching site

Installation of safe access facilities around the daylighting location on Sheung Sha Chau Island

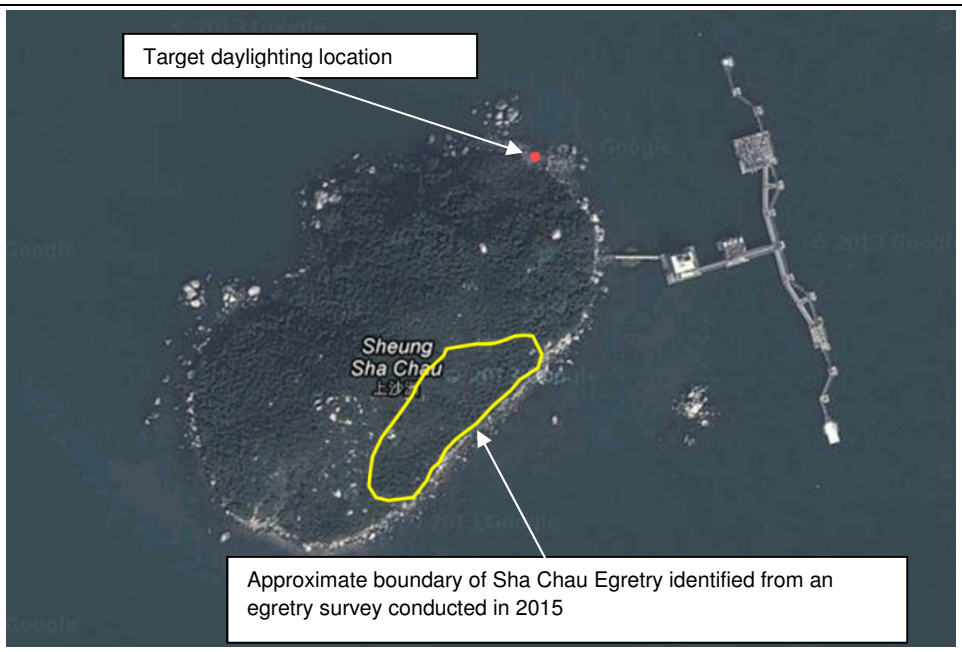
The target daylighting location is located at about 120m away from the nearest boundary of Sha Chau Egretry on Sheung Sha Chau Island
