CONTRACT NO. 1/WSD/19

IN-SITU REPROVISIONING OF SHA TIN WATER TREATMENT WORKS (SOUTH WORKS) – WATER TREATMENT WORKS AND ANCILLARY FACILITIES
Environmental Permit EP-494/2015

In-Situ Reprovisioning of Sha Tin Water Treatment Works (South Works) – Water Treatment Works and Ancillary Facilities
Environmental Permit EP-494/2015
Submission of 68th monthly EM&A Report

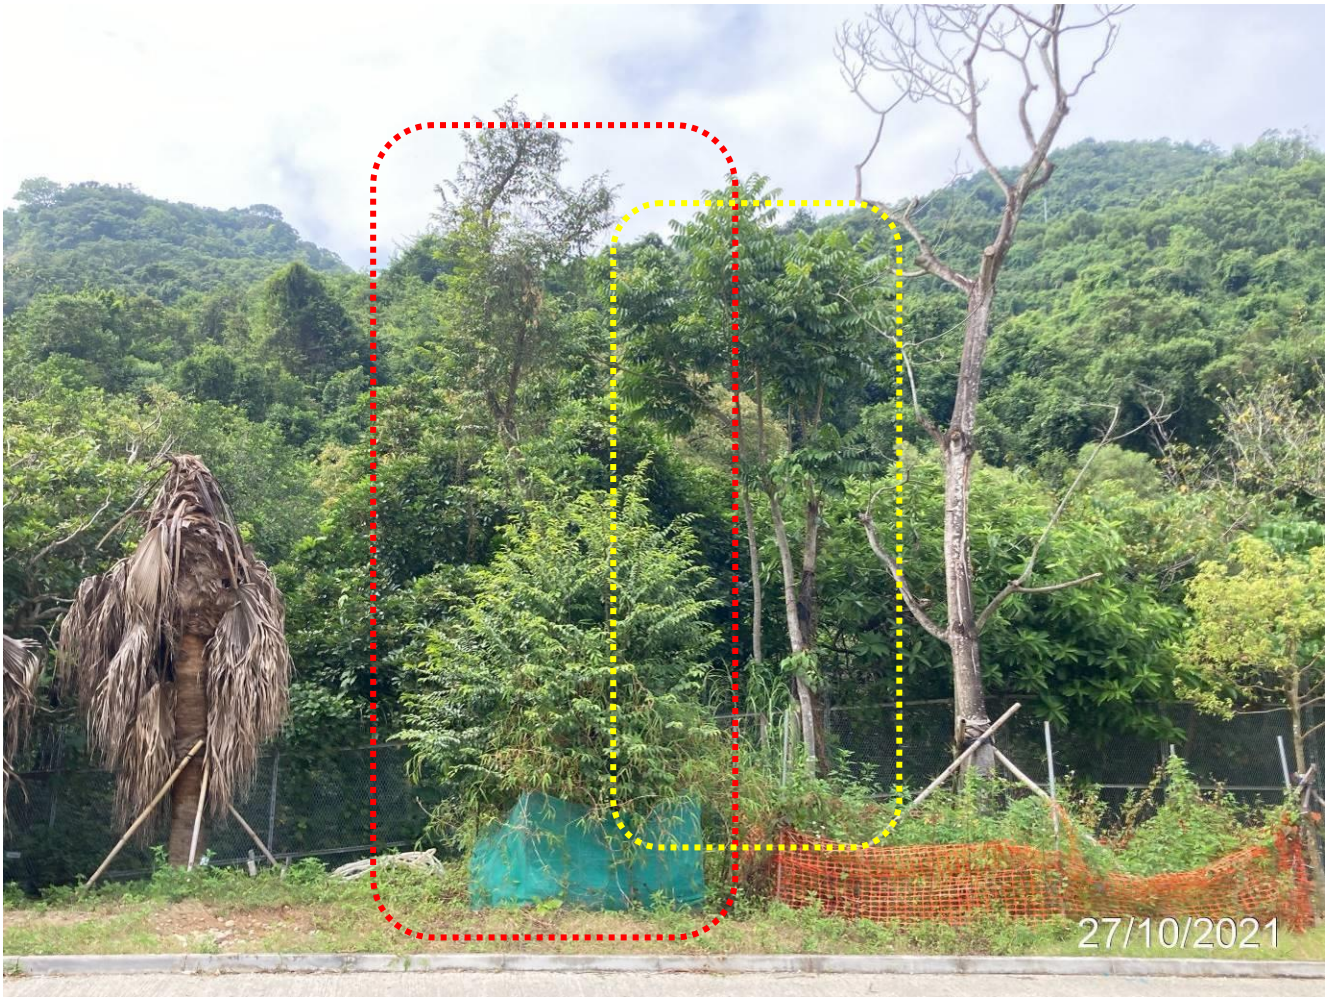
2.5.1 The condition of TA572 was observed in poor condition due to broken of main trunk. TA327 was also in poor condition; while already dead TA326 collapsed under Signal No. 10 typhoon Mangkhut in September 2018. Tree guying cables have been installed to provide external support to the two remaining transplanted trees.

2.5.8 Root ball of TA572 and TA327 tree should be kept moisture especially during dry and non-raining day.

Photo 7. Transplanted Incense Tree (*Aquilaria sinensis*) – TA327 (left); and Ailanthus (*Ailanthus fordii*) – TA572 (right)

Photo 8. Weeding around TA327 shall be conducted.
