CONTRACT NO. 1/WSD/19

IN-SITU REPROVISIONING OF SHA TIN WATER TREATMENT WORKS (SOUTH WORKS) – WATER TREATMENT WORKS AND ANCILLARY FACILITIES
Environmental Permit EP-494/2015

(a) Three hard copies,
(b) Two copies of the 69th monthly Environmental Monitoring and Audit (EM&A) Report (Rev.0). (Register No.: AEIAR-187/2015)

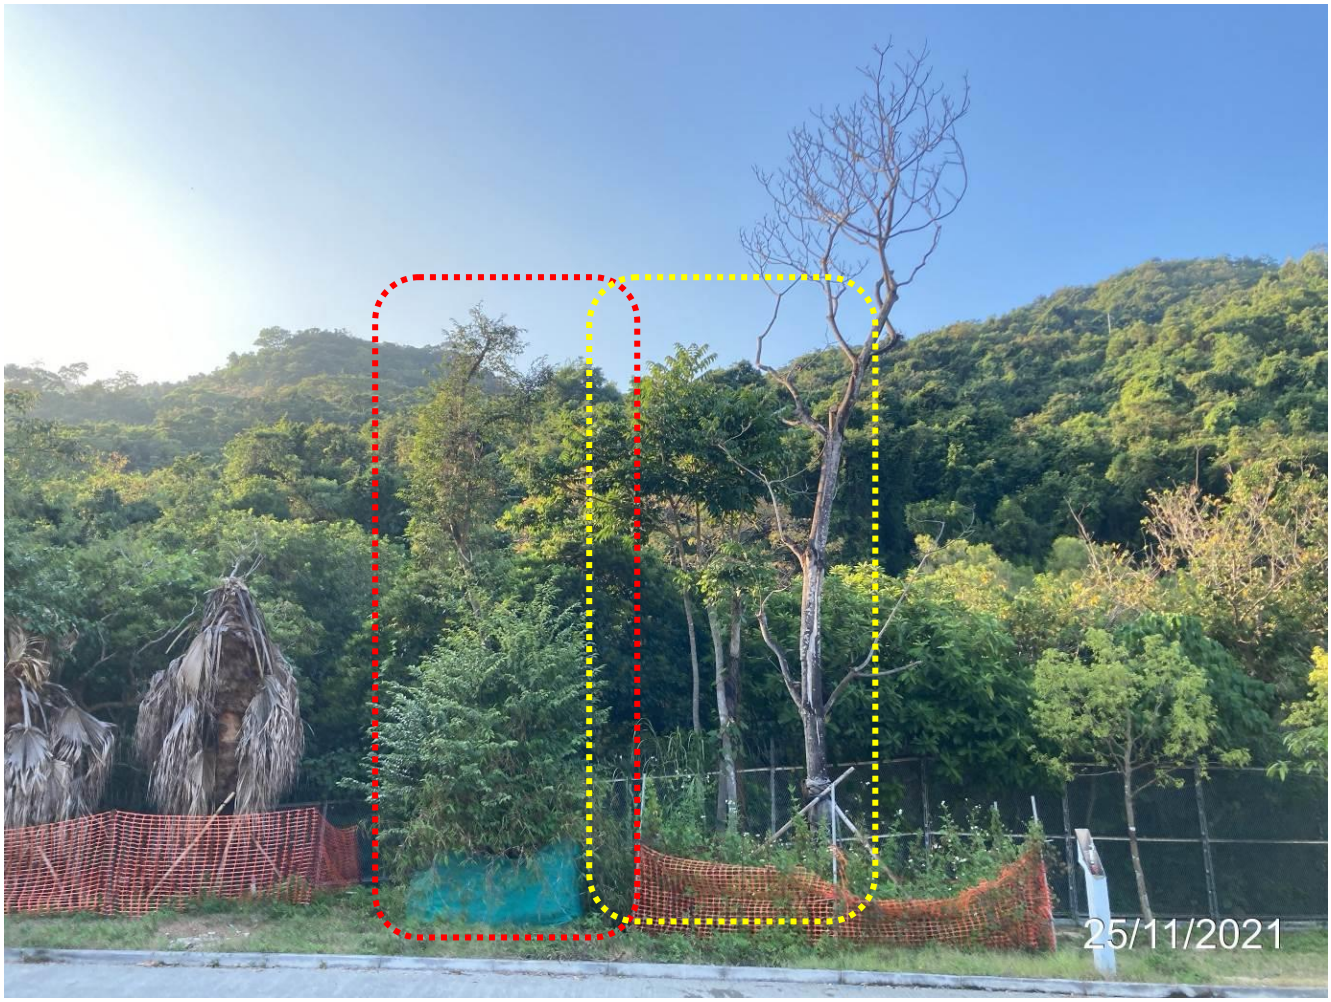
2.5.1 The condition of TA572 was observed in poor condition due to broken of main trunk. TA327 was also in poor condition; while already dead TA326 collapsed under Signal No. 10 typhoon Mangkhut in September 2018. Tree guying cables have been installed to provide external support to the two remaining transplanted trees.

Photo 7. Transplanted Incense Tree (*Aquilaria sinensis*) – TA327 (left); and Ailanthus (*Ailanthus fordii*) – TA572 (right)

Photo 8. Weeding around TA327 shall be conducted.

2.5.8 Root ball of TA572 and TA327 tree should be kept moisture especially during dry and non-raining day.
