WSD Contract No.: 3/WSD/20 -

Reclaimed Water Supply to Sheung Shui and Fanling

MONTHLY ENVIRONMENTAL MONITORING & AUDIT REPORT (NO.28) – MARCH 2024

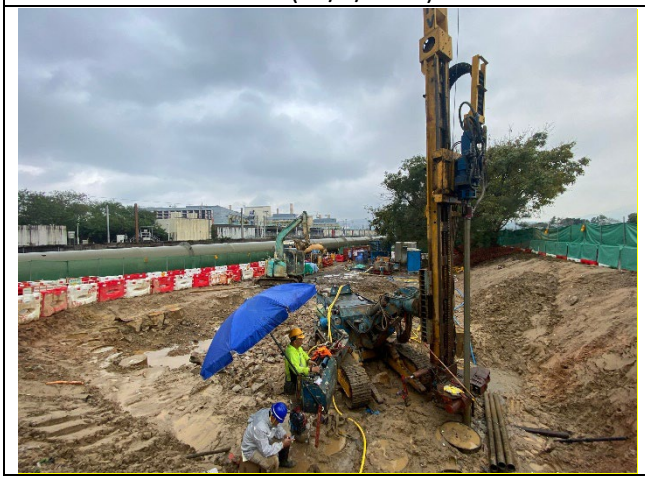
Photo 5 Drilling machine and excavator at BKREJV construction site at T3 (11/3/2024)	**Photo 6** White-throated Kingfisher at P7 (8/3/2024)
