Highways Department

Contract No. HY/2007/14 Widening of Tuen Mun Road at Tsing Tin Interchange

Monthly Environmental Monitoring and Audit Report - May 2009

Revision 2

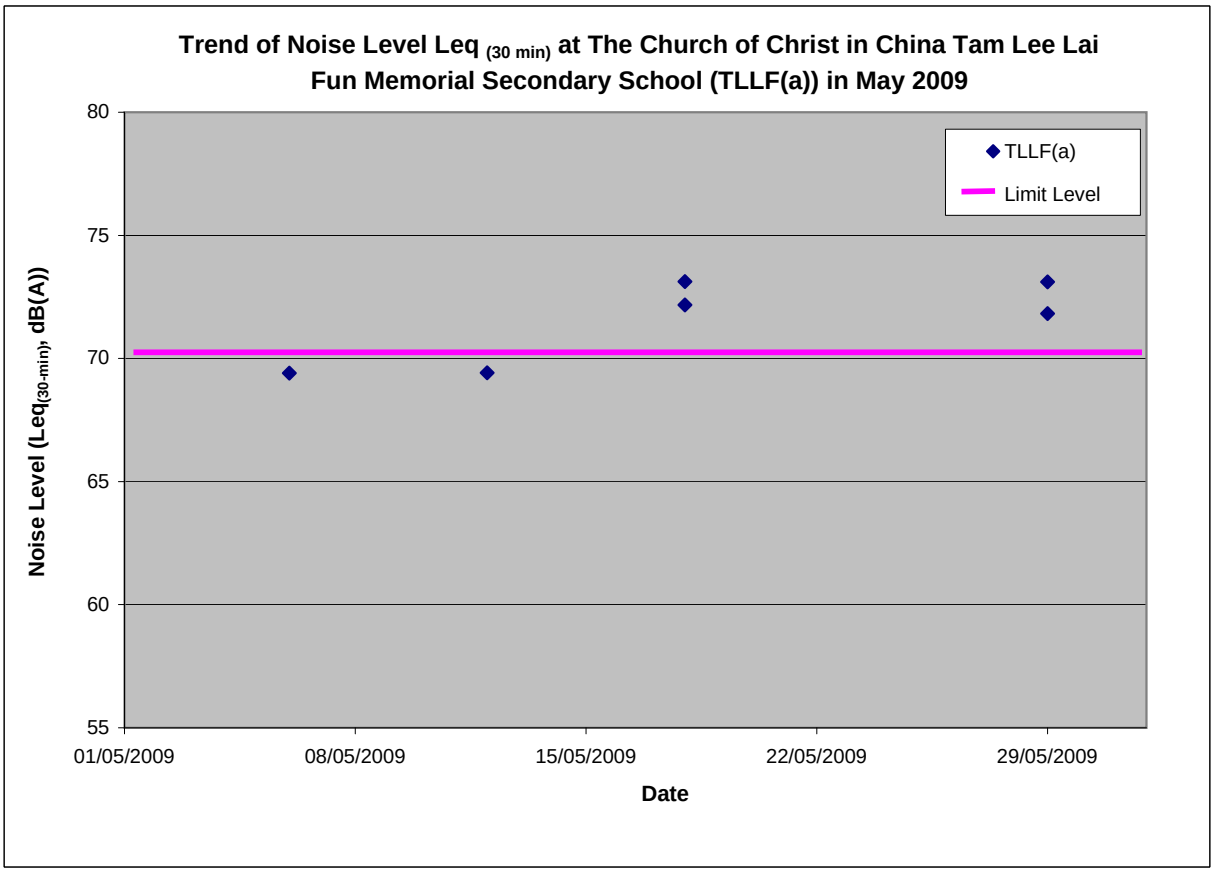
Two (2) limit level exceedance for noise measurement during non-restricted hours was recorded on 18 and 29 May 2009. On-site observations during the noise monitoring revealed that the noise source was mainly the traffic noise along Tuen Mun Road although it was also observed that the Contractor was undertaking the noise barriers construction works.

Together with the on-site observations and interpretation from the monitoring results, construction noise was considered insignificant and below the noise limit level. It was therefore concluded that the noise exceedance was not related to the construction activities. No further actions were applicable. It was however recommended that the Contractor shall maintain the existing practices stipulated in the EIA report in order to minimise the potential noise impact in future.

Notes:
Noise results on 18 and 29 May 2009 are not project-related exceedance

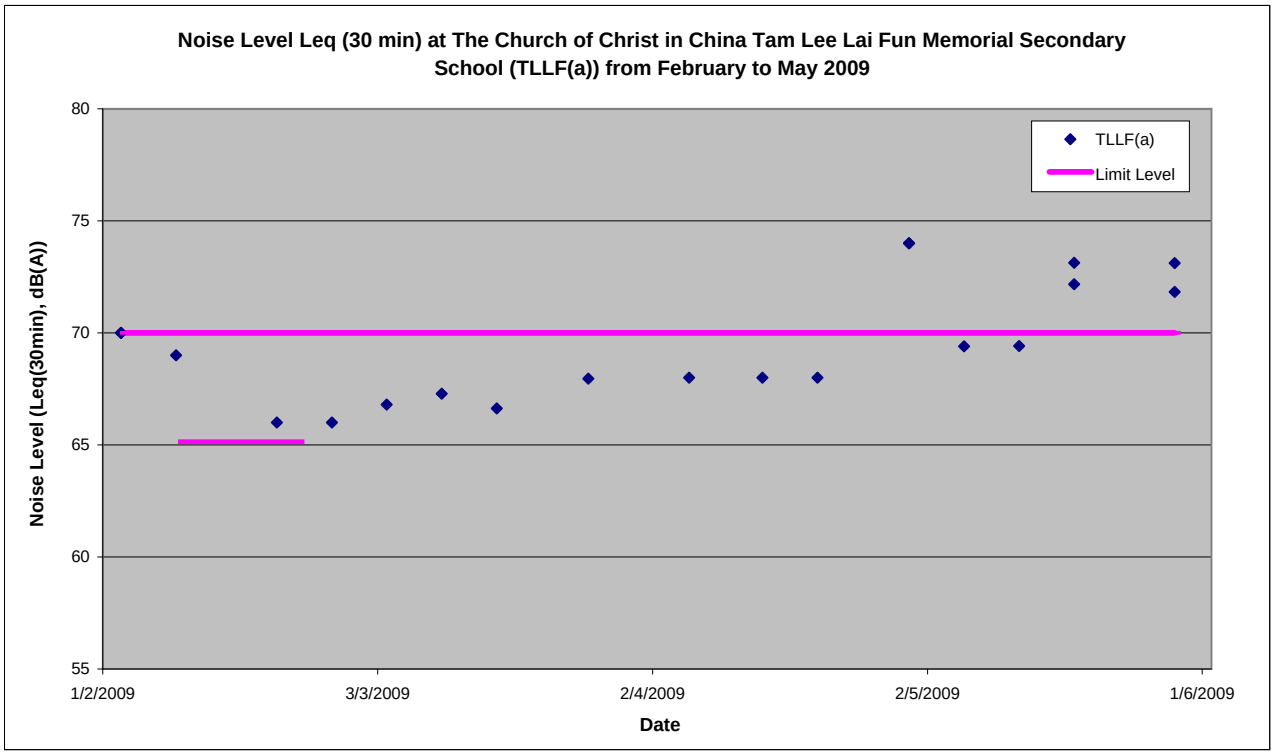
Notes:
All noise results exceeding limit level were not project-related.
