Contract No. HY/2010/02

Hong Kong – Zhuhai – Macao Bridge Hong Kong Boundary Crossing Facilities – Reclamation Works

Monthly EM&A Report for September 2013

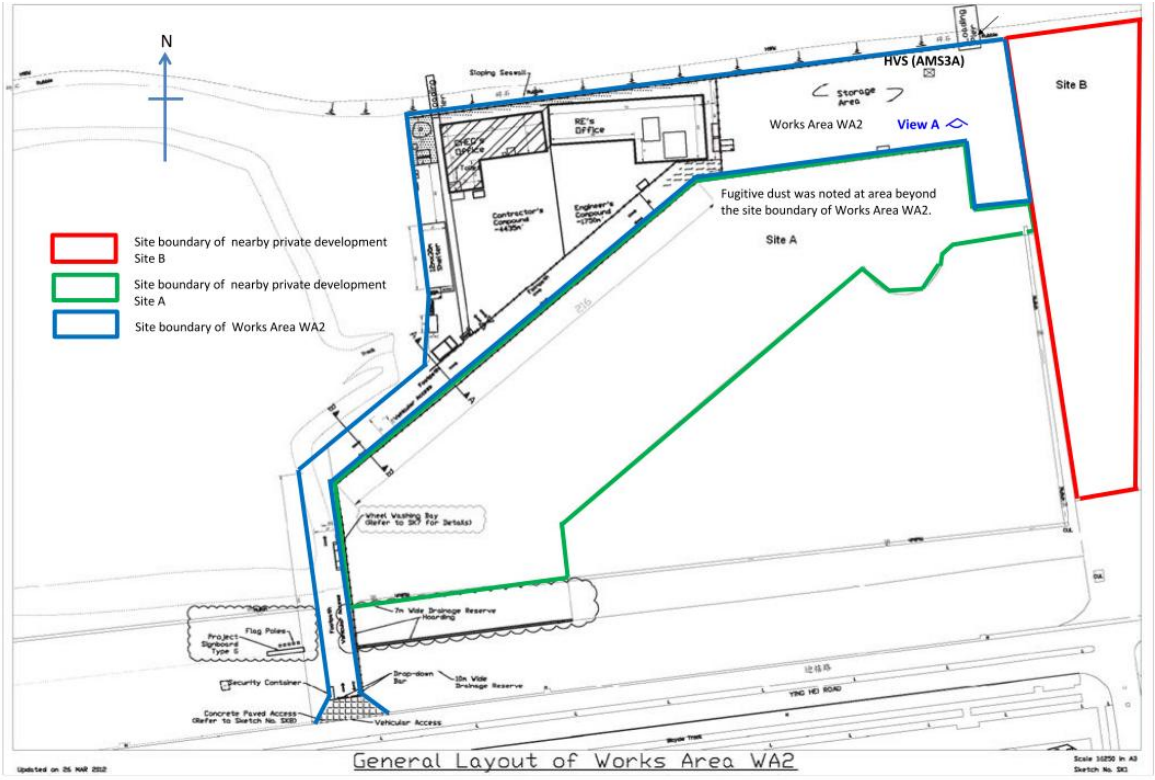
Conditions of the construction sites near Works Area WA2:

2.7.3.5 Photo record shows that fugitive dust was emitted from the construction sites of nearby private development project located close to the monitoring station AMS3A but beyond the site boundary of Works Area WA2. With reference to the prevailing East South East wind direction, construction works carried out at construction sites of nearby private development project may contribute to the measured dust levels at the monitoring station AMS3A. (Please also see photo and layout map below for reference of site conditions.)

View of Works Area WA2 : the hard paved ground next to monitoring station AMS3A (View A on layout map)

2.7.3.10 The Contractor was recommended to continue implementing existing dust mitigation measures.

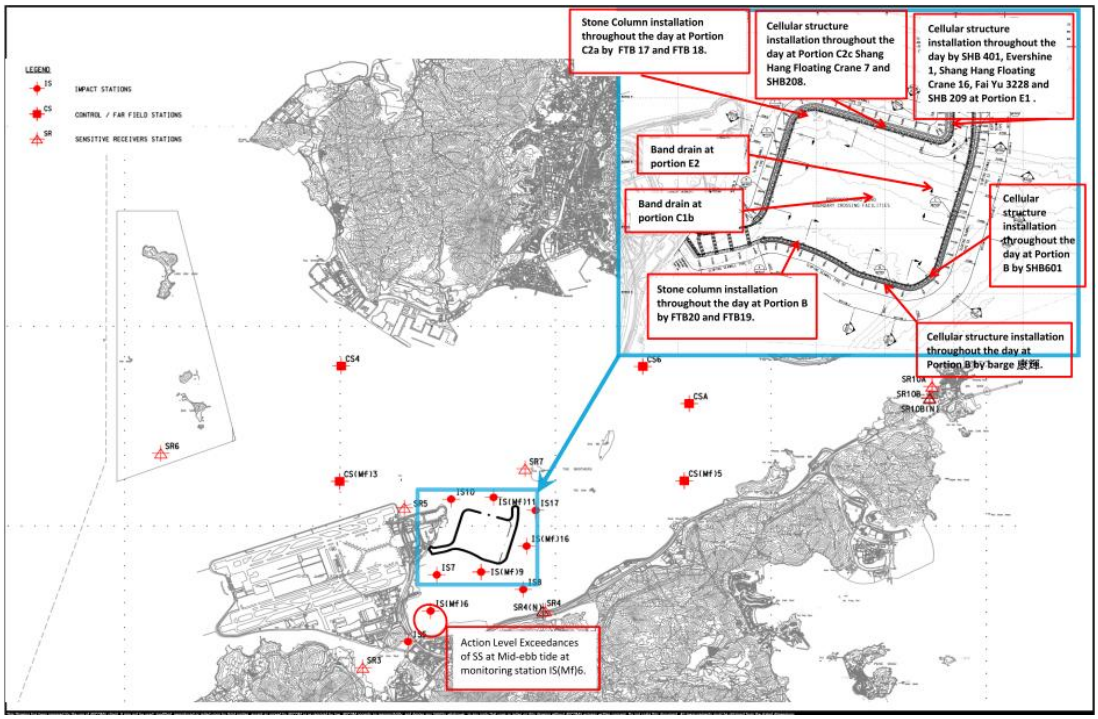
4.7.6 One (1) Action Level exceedance at measured Suspended Solids (mg/L) where recorded on 16 September 2013 during mid-ebb tide at monitoring station IS(Mf)6. For Action Level exceedances at measured Suspended Solids (mg/L), 25 mg/L was recorded at Monitoring Station IS(Mf)6.

4.7.6.1 For locations and type of active works carried out on 16 Sept 13, please refer to the above layout map.

4.7.6.2 For action level exceedance of depth averaged SS (in mg/L) recorded at IS(Mf)6 during mid ebb tide, Suspended solids values recorded at Impact Station IS7, IS(Mf)9 and IS8 located downstream to and closer to active works than IS(Mf)6 during Mid-Ebb tide were below the Action and Limit Level during the same tide on the same day. This indicates project works is unlikely to contribute to the action level exceedance recorded at IS(Mf)6.

4.7.6.7 Nevertheless, the Contractor was reminded to ensure provision of ongoing maintenance to the silt curtains and to carry out maintenance work once defects were found.

4.7.6.8 Maintenance work of the silt curtain was carried out by the Contractor on a daily basis except Sunday and public holiday.

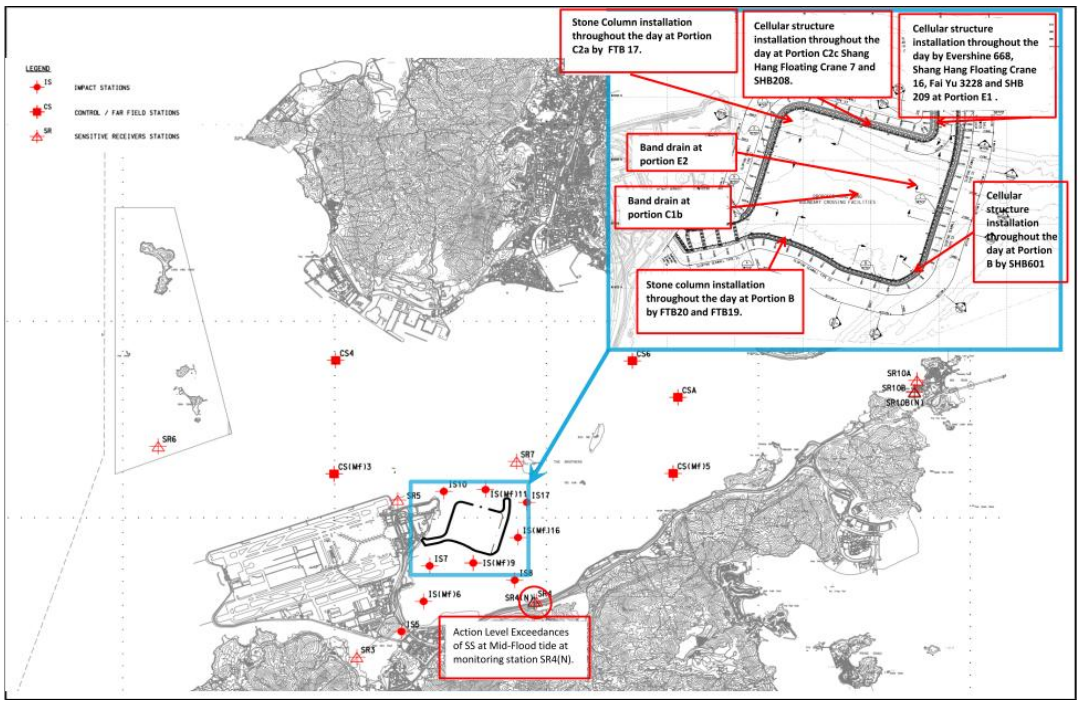
4.7.7 One (1) Action Level exceedance at measured Suspended Solids (mg/L) where recorded on 18 September 2013 during mid-flood tide at monitoring station SR4(N). For Action Level exceedance at measured Suspended Solids (mg/L), 24 mg/L was recorded at Monitoring Station SR4(N)

4.7.7.1 Please refer the above layout map for activity carried out on 18 Sept 13.

4.7.7.2 IS(Mf)9 and IS(Mf)16 are located closer to the active works than monitoring station SR4(N). Depth Averaged Suspended Solids (SS) values (in mg/L) recorded during the flood tide on the same day at

4.7.7.6 Nevertheless, the Contractor was reminded to ensure provision of ongoing maintenance to the silt curtains and to carry out maintenance work once defects were found.

4.7.7.7 Maintenance work of the silt curtain was carried out by the Contractor on a daily basis except Sunday and public holiday.

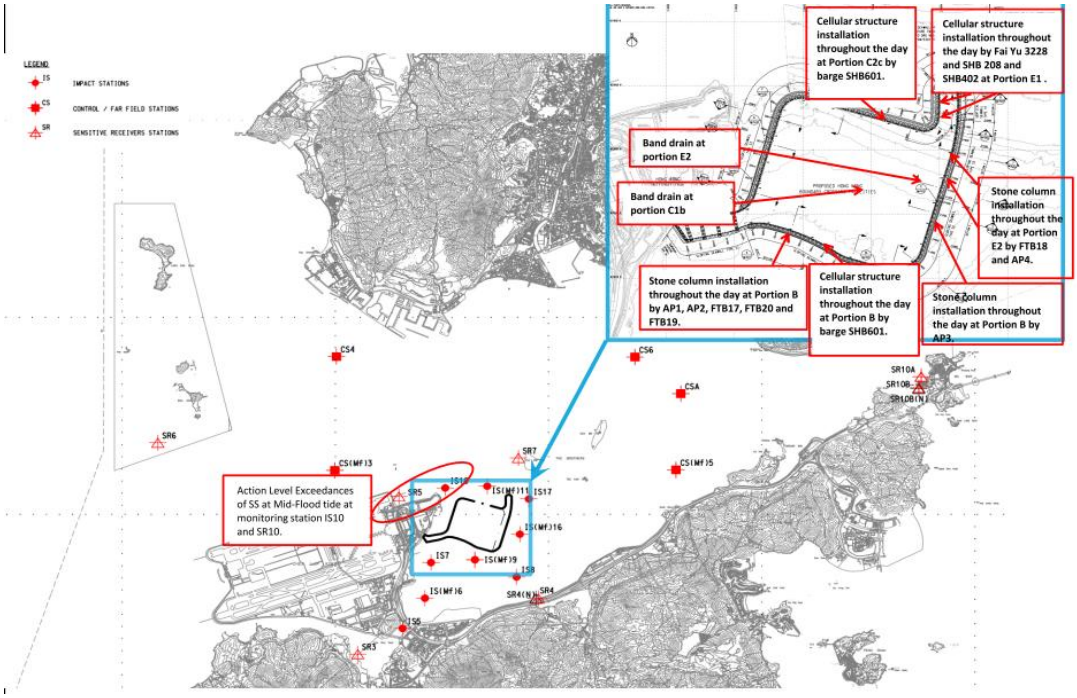
4.7.8 Two (2) Action Level exceedance at measured Suspended Solids (mg/L) where recorded on 30 Sept 13 during mid-flood tide at monitoring station SR5 and IS (10). For Action Level exceedance at measured Suspended Solids (mg/L), 24.5 mg/L were recorded at Monitoring Station SR5 and IS(10).

4.7.8.1 Please refer the above layout map for activity carried out on 30 Sept 13.

4.7.8.2 No active works were carried out portion C2a, Portion A and Portion C1a. Installation of band drain was carried out at Portion C1b and Cellular Structure installation was carried out at Portion C2c and E1 on 30 Sept 13. These works were unlikely to generate silt plumes or suspended solid. Stone column installation was conducted at Portion B and E2 which is far away from IS10 and SR5. (For location of each portion please refer to below Layout - Portion of Marine Work)

4.7.8.3 Suspended solids values recorded at Impact Stations IS(Mf)11 and IS7 which is closer to the active works at Portion E2 and Portion B respectively than monitoring station IS10 and SR5 were below the action and limit level which indicates that active works from portion E2 and B is unlikely to cause SS exceedance at monitoring station IS10 and SR5.

4.7.8.4 Turbidity level (NTU) results recorded at IS10 and SR5 were 14.2 NTU and 20.4 NTU respectively during flood tide on 30 Sept 13 which was below the Action and Limit Level which indicates turbidity level was not adversely affected.

4.7.8.5 When impact water quality monitoring was carried out during mid flood tide at monitoring location IS10 and SR5, no discoloration of sea water was observed and no silty plume were observed to flow from the inside to the outside of the site boundary.

4.7.8.7 Nevertheless, the Contractor was reminded to ensure provision of ongoing maintenance to the silt curtains and to carry out maintenance work once defects were found.
