Contract No. HY/2010/02

Hong Kong – Zhuhai – Macao Bridge Hong Kong Boundary Crossing Facilities – Reclamation Works

Quarterly EM&A Report for March 2014- May 2014

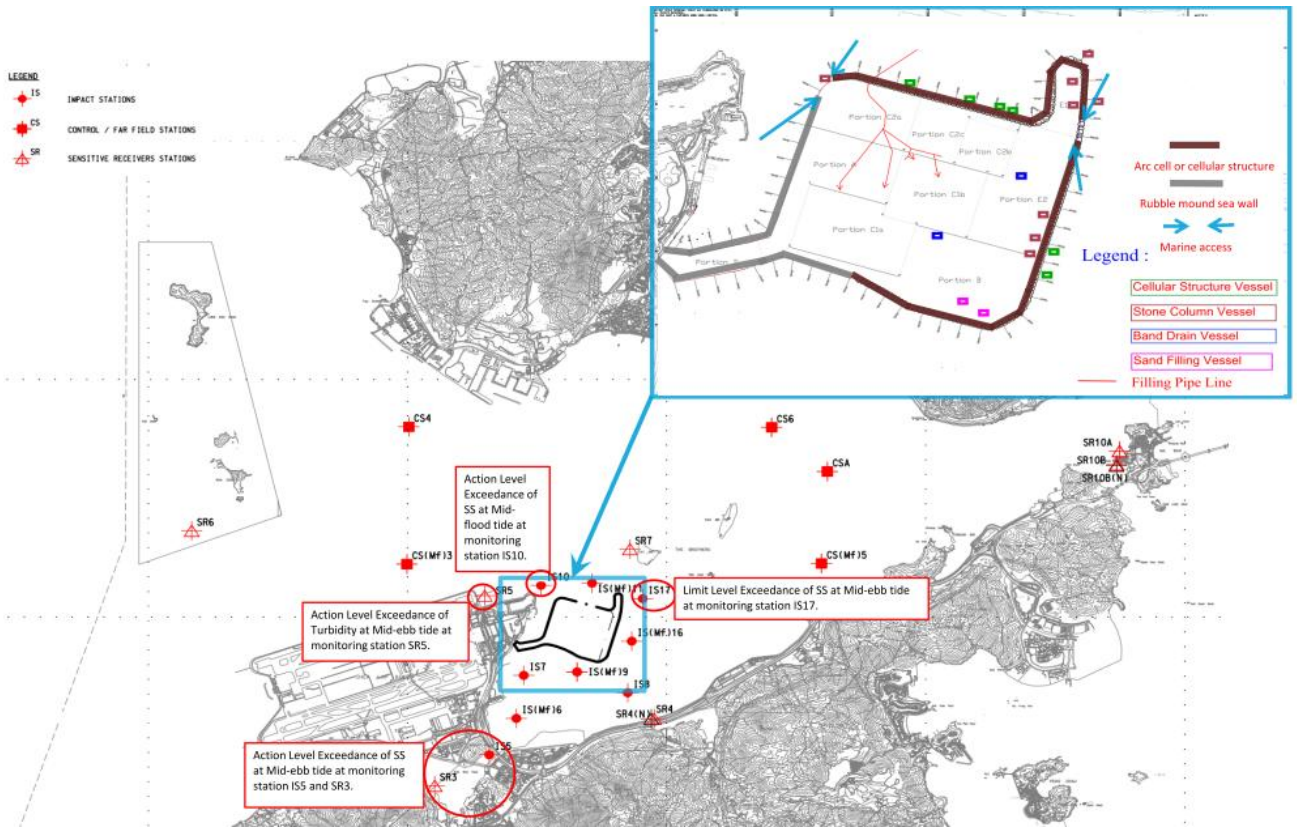
3.3.3 One (1) Limit level exceedance of SS was recorded at IS17 at ebb tide; three (3) Action Level exceedances of SS were recorded at IS5, SR3 at ebb tide and IS10 at flood tide; one (1) Action Level Exceedance on Turbidity was recorded at SR5 at ebb tide on 19 March 14.

3.3.3.1 Please see above layout map for work activities carried out on 19 March 14.

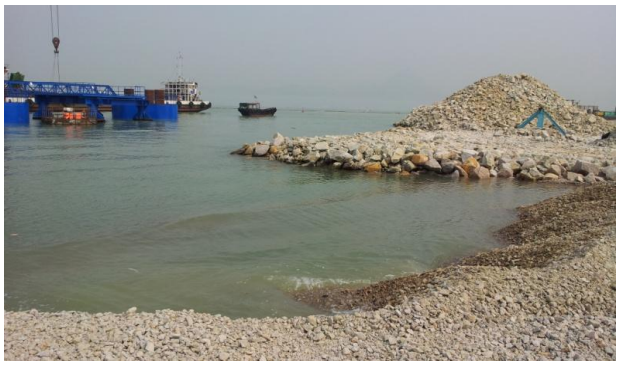
3.3.3.4 With reference to monitoring record and photo record taken on 19 and 20 March 2014, no silt plume was observed on sea near the northwest part of the site which is close to IS10. (Please see attached photo record)

3.3.3.5 Photo of sea condition taken near the northwest part of the site (Near IS10) on 19 March 14

3.3.3.6 Photo of sea condition taken near the northwest part of the site (Near IS 10) on 20 March 14

3.3.3.7 In accordance with the silt curtain integrity checking record, no disconnection was observed at the northwest part of site which is near IS10.

3.3.3.44 Nevertheless, the Contractor was reminded to ensure provision of ongoing maintenance to the silt curtains and to carry out maintenance work once defects were found.

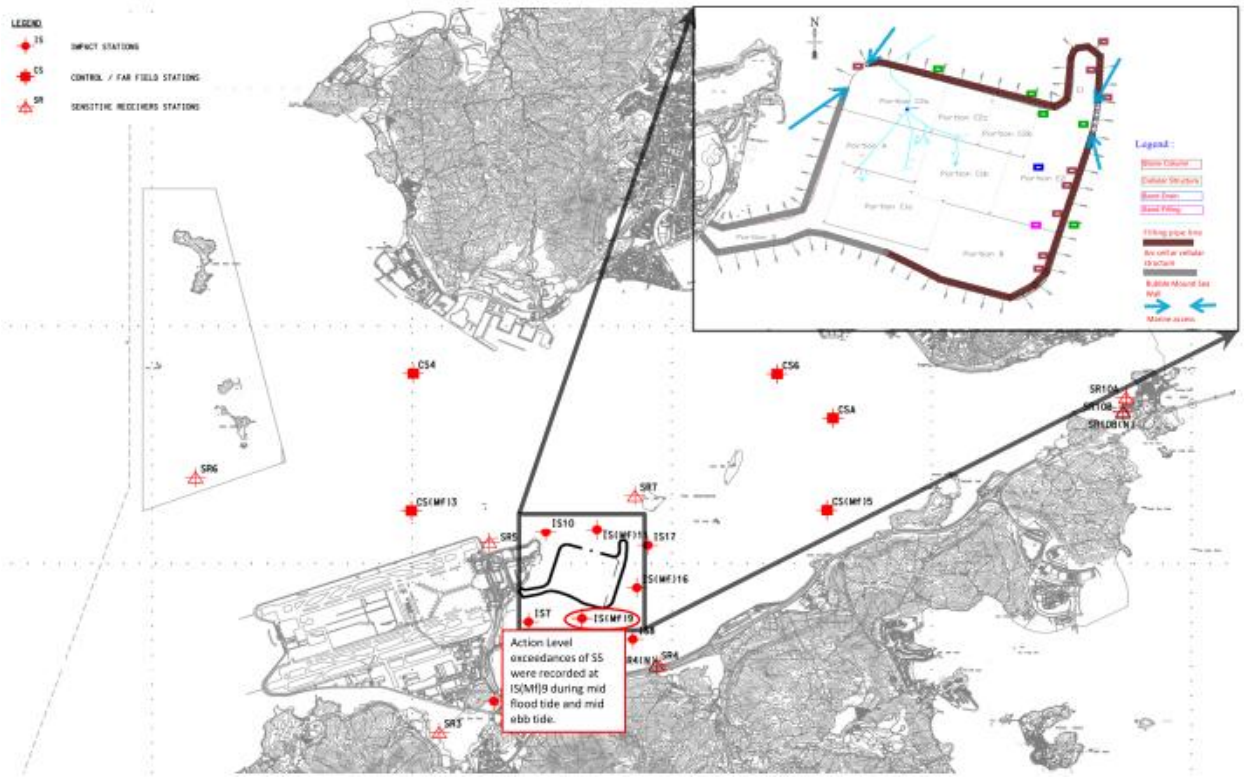
3.3.4 Two (2) Action Level exceedances of SS were recorded at IS(Mf)9 were recorded during mid flood tide and mid ebb tide respectively on 24 March 14.

3.3.4.1 Please see above layout map for work activities carried out on 24 March 14.

3.3.4.2 In accordance with the silt curtain integrity checking record, deficiency such as missing segments at one end of the perimeter silt curtain at the southern marine access was noted. This part of the perimeter silt curtain is close to IS(Mf)9. The Contractor was reminded to ensure provision of ongoing maintenance to the silt curtains and to carry out maintenance work once defects were found and maintenance work of the silt curtain was carried out by the Contractor on a daily basis except Sunday and public holiday.

3.3.4.6 Also, in accordance with the monitoring record, no silt plume was observed to flow from the inside of the perimeter silt curtain to the outside of the perimeter silt curtain during impact water quality monitoring on 24 March 2014. (Please refer to the photo attached which shows the sea condition near IS(Mf)9 on 24 March 2014.)

3.3.4.12 Nonetheless, the Contractor was reminded to ensure provision of ongoing maintenance to the silt curtains and to carry out maintenance work once defects were found.

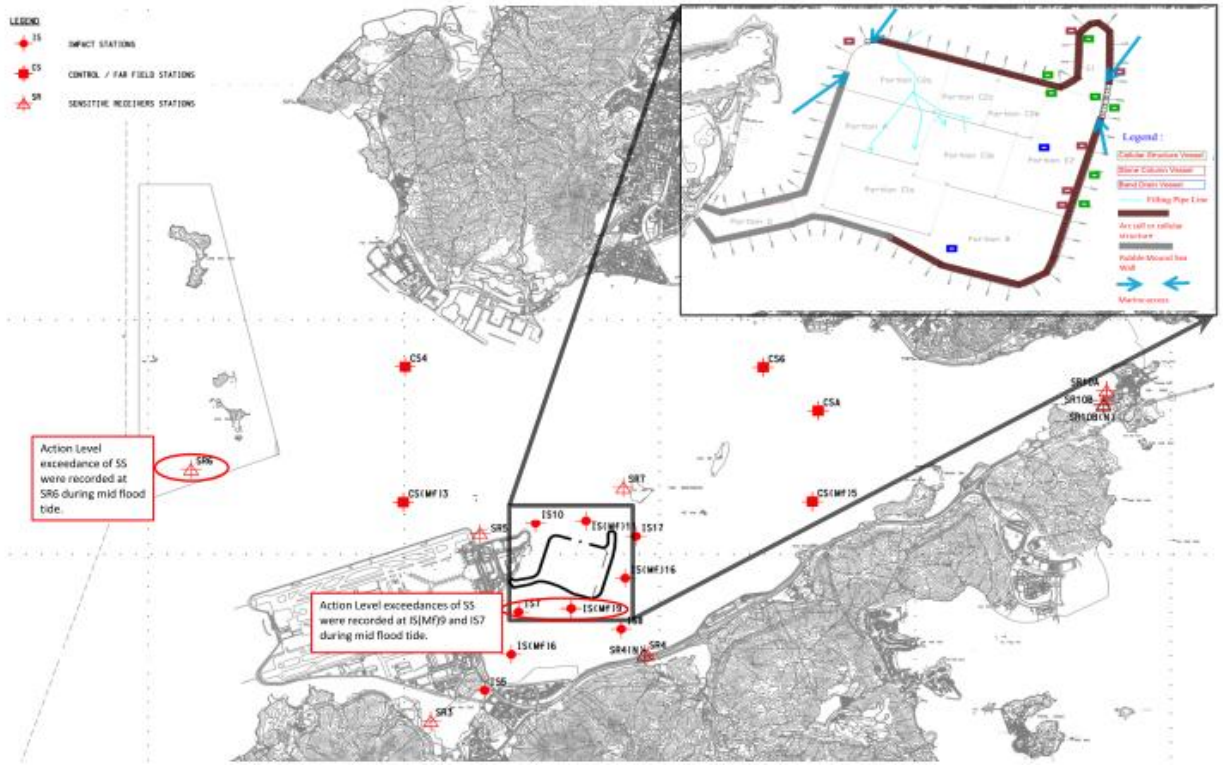
3.3.5 Three (3) Action Level exceedances of SS were recorded at IS(Mf)9, IS7 and SR6 during mid flood tide on 31 March 2014.

3.3.5.1 Please see above layout map for work activities carried out on 31 March 14.

3.3.5.4 With reference to layout map attached, construction activity close to IS(Mf)9 and IS7 such as band drain installation was conducted at southeast part of portion B, since band drain is considered unlikely to cause silt plume. Therefore, the exceedances are unlikely attributed to construction activity close to IS(Mf)9 and IS7.

3.3.5.5 In accordance with the silt curtain integrity checking record, defects such as missing segments at southern marine access at one end of the perimeter silt curtain was noted. This part of the perimeter silt curtain is close to IS(Mf)9. The Contractor was reminded to ensure provision of ongoing maintenance to the silt curtains and to carry out maintenance work once defects were found and maintenance work of the silt curtain was carried out by the Contractor on a daily basis except Sunday and public holiday.

3.3.5.6 However, in accordance with the monitoring record, no silt plume was observed outside the perimeter silt curtain near IS(Mf)9 and IS7 on 31 March 2014. (Please refer to the photo below which shows the sea condition near IS(Mf)9 on 31 March 2014.)

3.3.5.10 Nonetheless, the Contractor was reminded to ensure provision of ongoing maintenance to the silt curtains and to carry out maintenance work once defects were found.
