AGREEMENT NO. CE 45/2008 (CE)
LIANTANG/HEUNG YUEN WAI
BOUNDARY CONTROL POINT AND ASSOCIATED WORKS

MONTHLY ENVIRONMENTAL MONITORING AND AUDIT REPORT (NO.34) – MAY 2016

PREPARED FOR
CIVIL ENGINEERING AND DEVELOPMENT DEPARTMENT (CEDD)

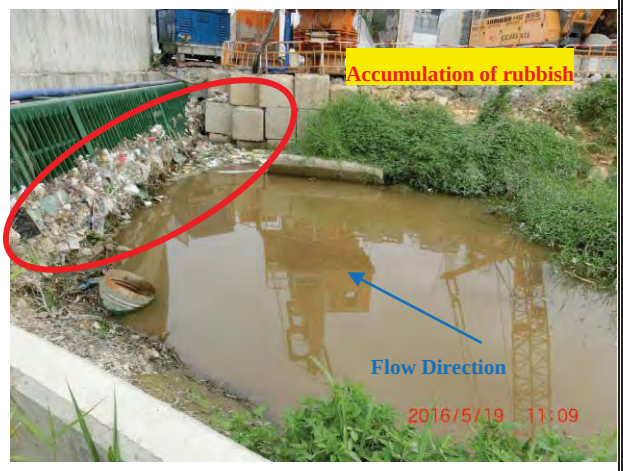
Photo 4
During water sampling on 19 May 2016, accumulation of rubbish were observed at the Box Culvert in WM1

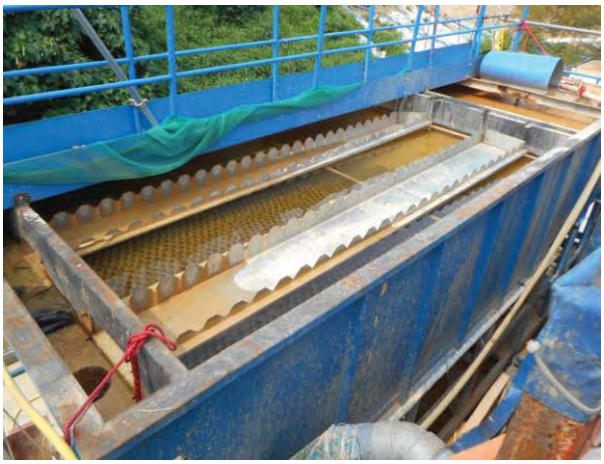
Photo 3
Self-monitoring for the treated water in the wastewater treatment facilities was conducted and the effluent was visually clear on 7 May 2016.

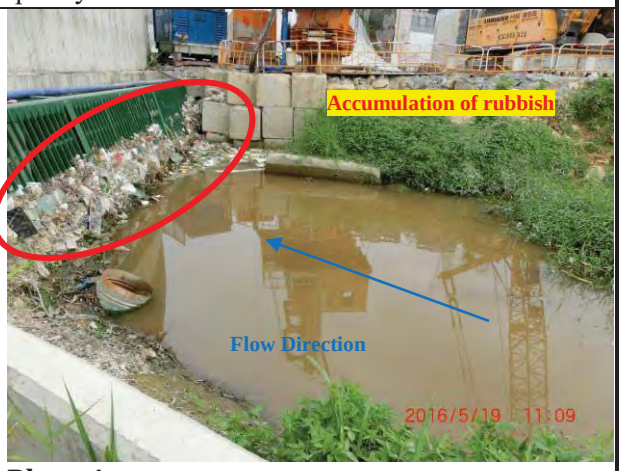
Photo 4
During water sampling on 19 May 2016, accumulation of rubbish were observed at the Box Culvert in WM1.

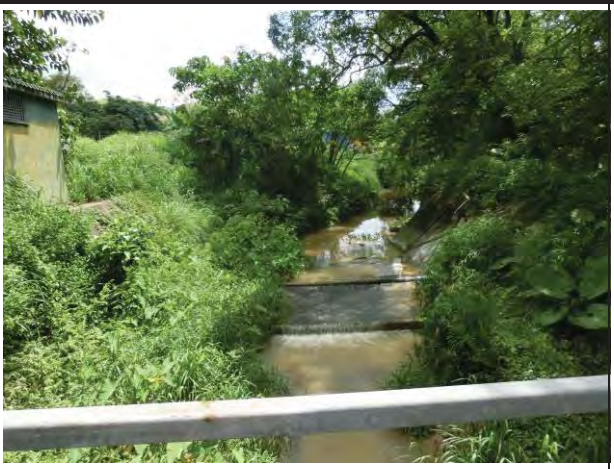
Photo 8

The water samples collected on 30 May 2016 at WM2A is more turbid than those collected at WM2A-C.
