JOB NO.: TCS00694/13

AGREEMENT NO. CE 45/2008 (CE)
LIANTANG/HEUNG YUEN WAI
BOUNDARY CONTROL POINT AND ASSOCIATED WORKS

MONTHLY ENVIRONMENTAL MONITORING AND AUDIT REPORT (NO.38) – SEPTEMBER 2016

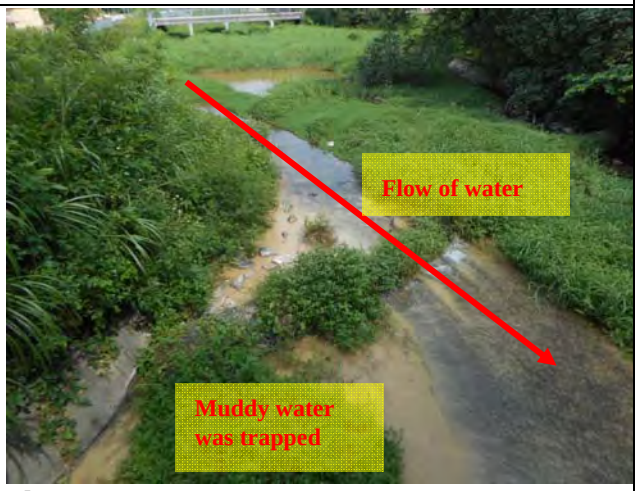
Photo 8
As advised by CCKJV, muddy water cumulated at Ng Tung River was observed out of the site boundary on 8 September 2016. It was suspected that muddy water was come from upstream after heavy rain on 7 September 2016.

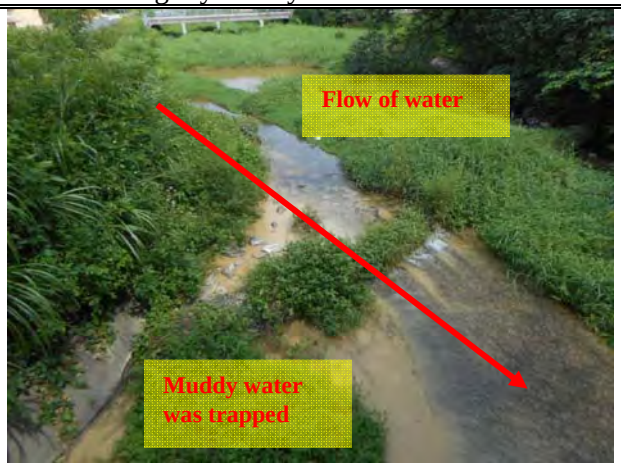
Photo 4
As advised by Contractor of Contract 6, muddy water cumulated at Ng Tung River was observed out of the site boundary on 8 September 2016. It was suspected that muddy water was come from upstream after heavy rain on 7 September 2016.

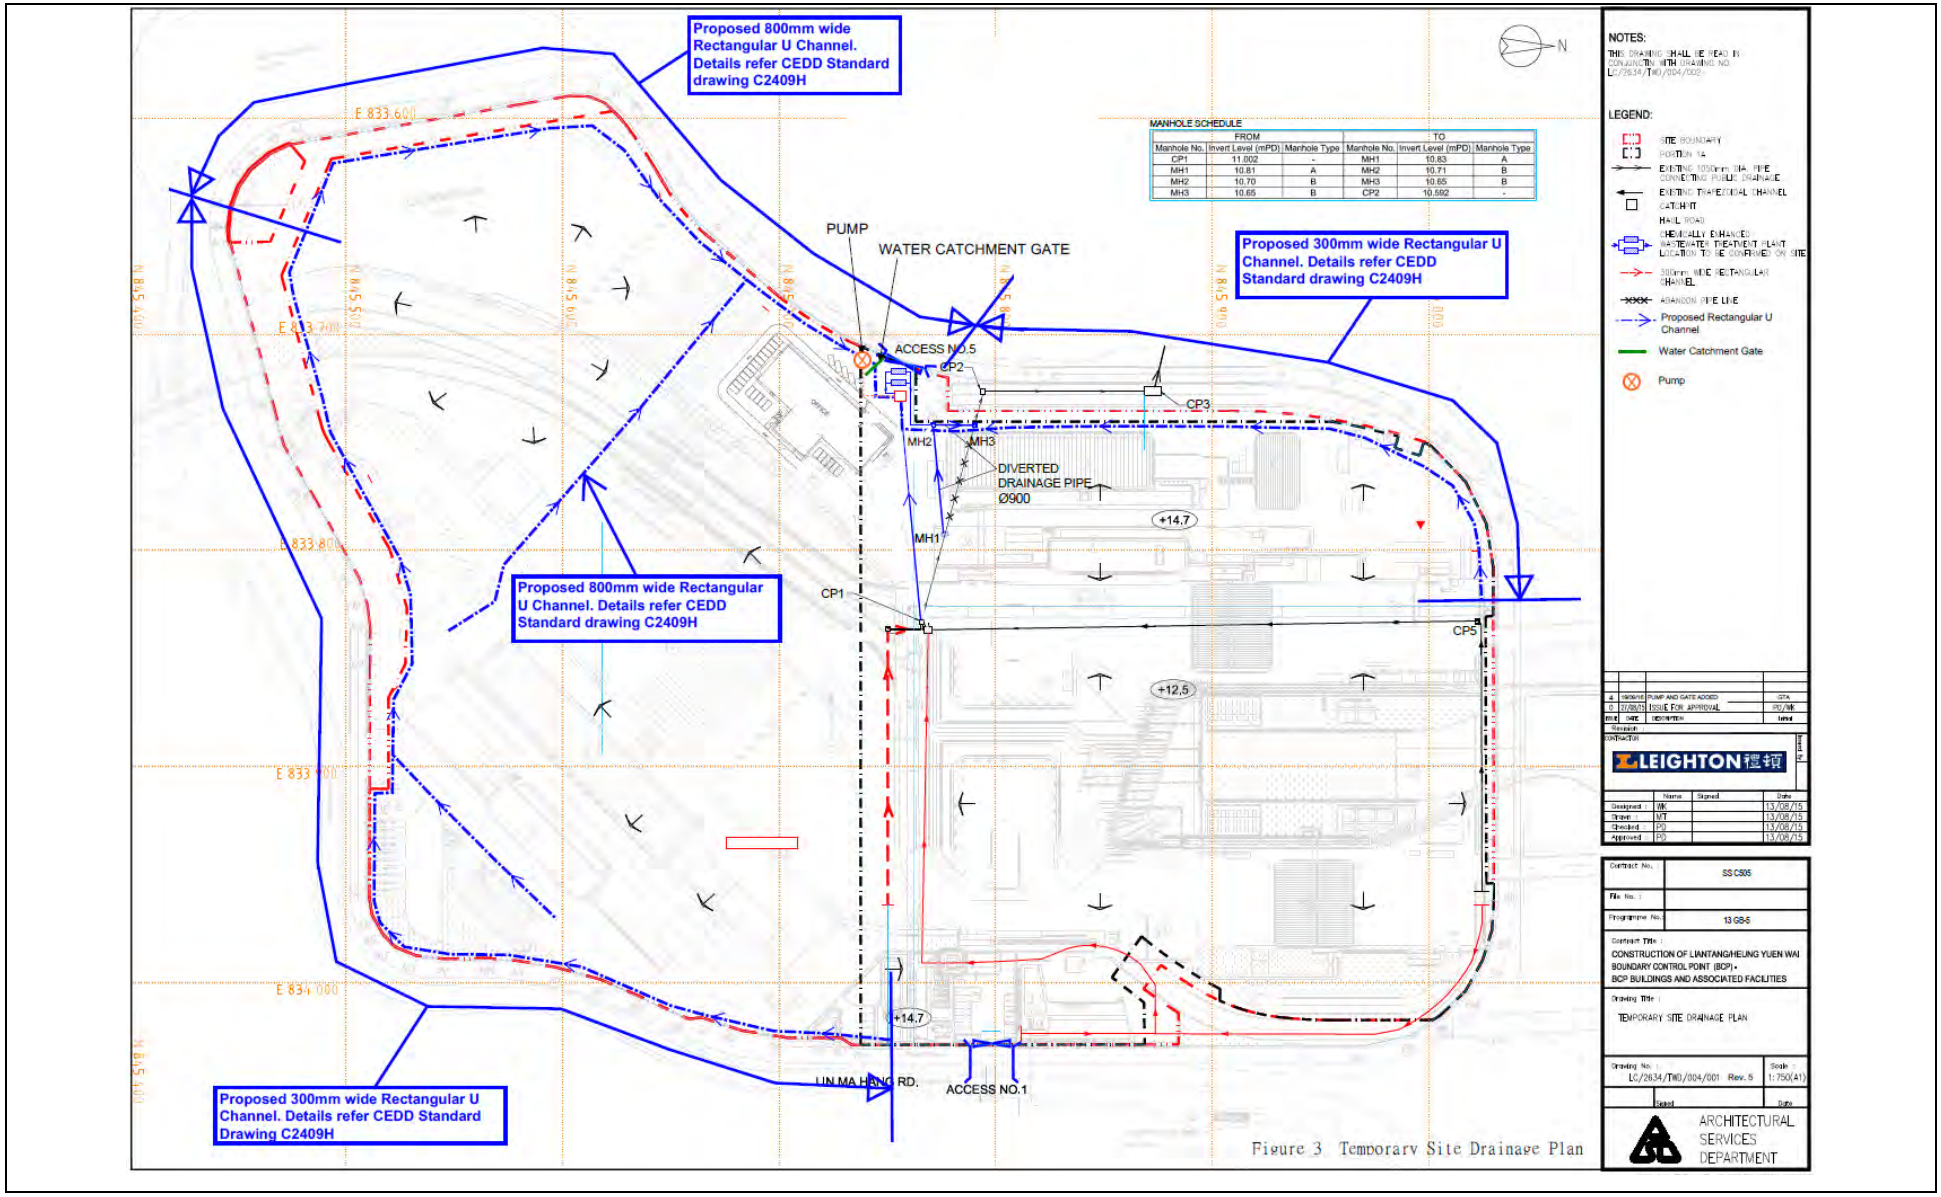
Figure 3 Temporary Site Drainage Plan

Photo 5
If water discharge is required, it will follow the temporary site drainage plan in which wastewater would be diverted to the perimeter channel and then collected to the wastewater treatment plant for treatment before discharge.
