JOB NO.: TCS00694/13

AGREEMENT NO. CE 45/2008 (CE)
LIANTANG/HEUNG YUEN WAI
BOUNDARY CONTROL POINT AND ASSOCIATED WORKS

MONTHLY ENVIRONMENTAL MONITORING AND AUDIT REPORT (NO.40) – NOVEMBER 2016

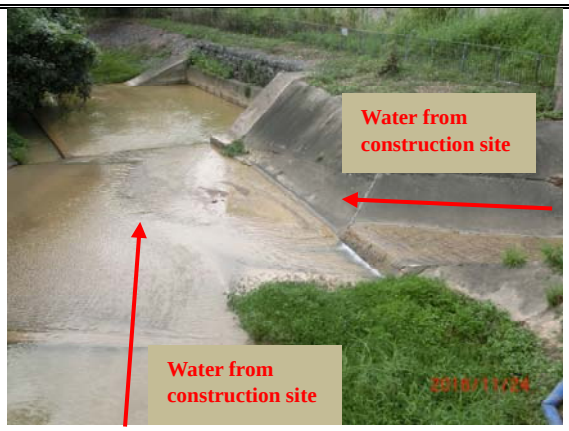
Photo 10
During site inspection at Ng Tung River on 24 November 2016, it was observed the water flowing from the construction sites clear. However, there was obvious thick sediment cumulated at the channel bed and muddy turbulence was readily formed under water flow.

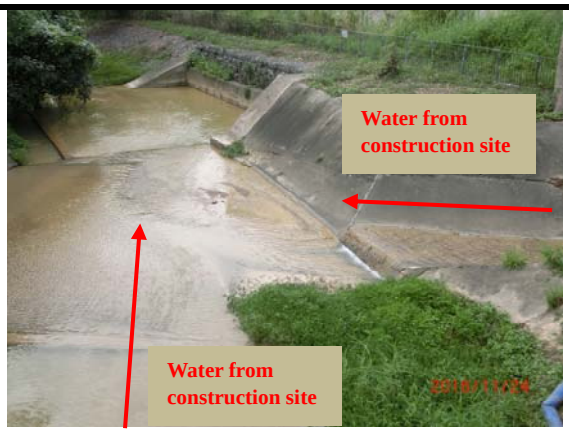
Photo 8
During site inspection at Ng Tung River on 24 November 2016, it was observed the water flowing from the construction sites clear. However, there was obvious thick sediment cumulated at the channel bed and muddy turbulence was readily formed under water flow.
