AUES JOB NO.: TCS00715/14

TUEN MUN - CHEK LAP KOK LINK
CONTRACT NO. HY/2013/12 –
NORTHERN CONNECTION TOLL PLAZA AND ASSOCIATED WORKS

11TH MONTHLY ENVIRONMENTAL MONITORING AND AUDIT (EM&A) REPORT – SEPTEMBER 2015

Date	Reference No.	Prepared By	Certified By
14 October 2015	TCS00715/14/600/R00136v2	Nicola Hon (Environmental Consultant)	T.W. Tam (Environmental Team Leader)

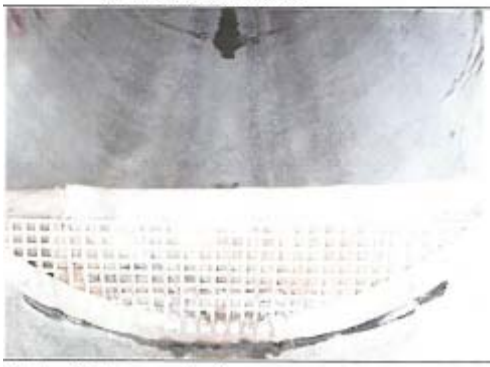
Photo 13: Improved silt screen
