TUEN MUN - CHEK LAP KOK LINK
CONTRACT NO. HY/2013/12 –
NORTHERN CONNECTION TOLL PLAZA AND ASSOCIATED WORKS

22ND MONTHLY ENVIRONMENTAL MONITORING AND AUDIT (EM&A) REPORT – AUGUST 2016

PREPARED FOR
CRBC AND KADEN JOINT VENTURE

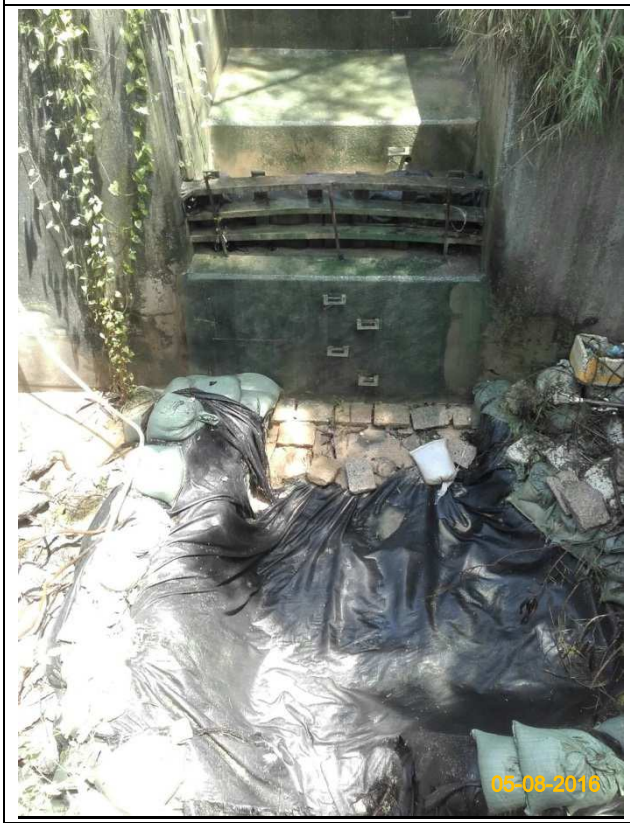
Item 4. Hydro-seeding or sheeting provided at stockpile.

Item 5. Hoarding with panel around works area & Item 6. Temporary traffic management lighting.

Item 7. Ensure no run-off into water body.

Item 9. Recycle of felled trees as facilities to reuse.

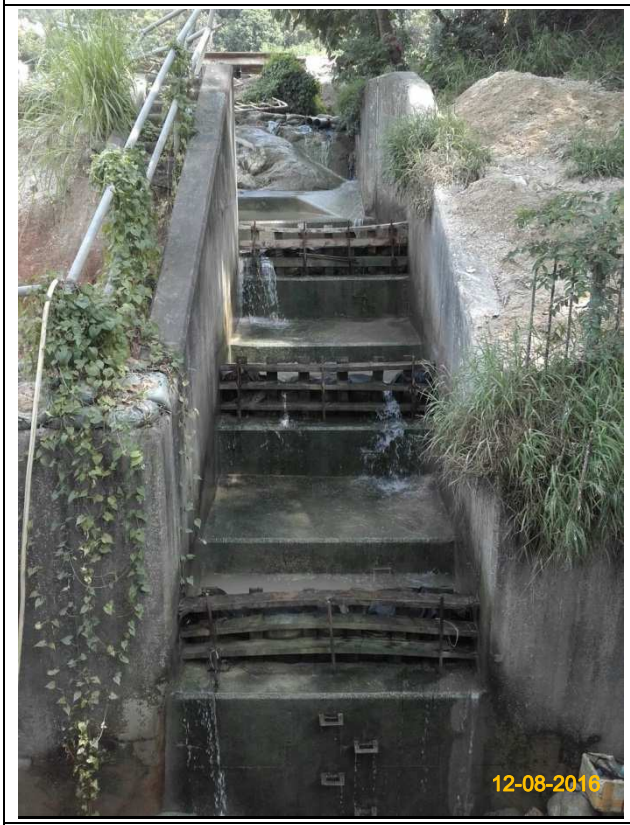
Item 4. Hydro-seeding or sheeting provided at stockpile.

Item 5. Hoarding with panel around works area & Item 6. Temporary traffic management lighting.

Item 7. Ensure no run-off into water body.

Item 9. Recycle of felled trees as facilities to reuse.

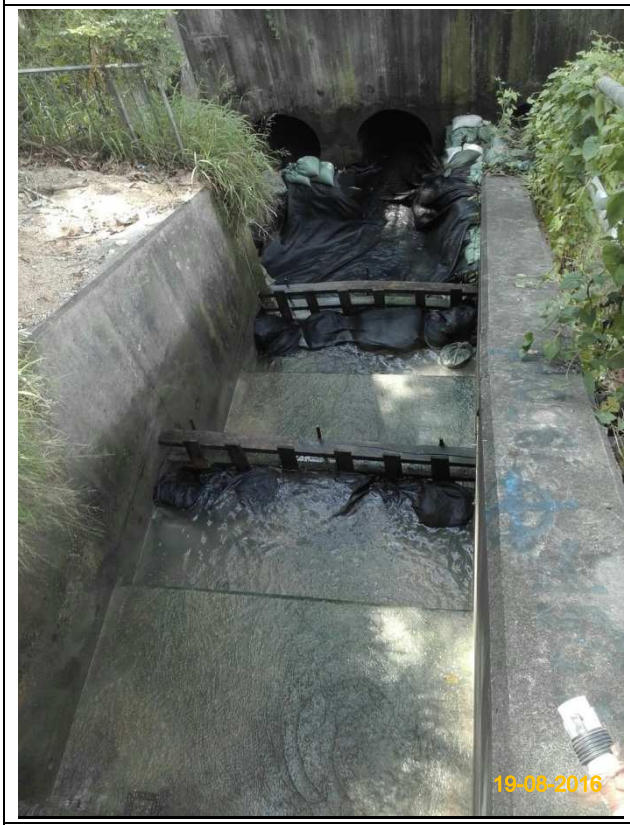
Item 4. Hydro-seeding or sheeting provided at stockpile.

Item 5. Hoarding with panel around works area & Item 6. Temporary traffic management lighting.

Item 7. Ensure no run-off into water body.

Item 9. Recycle of felled trees as facilities to reuse.

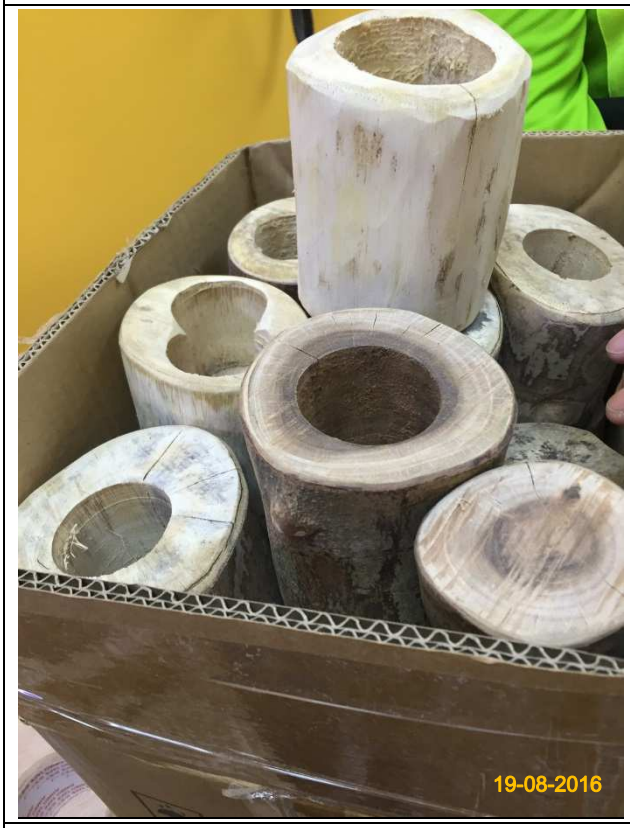
Item 5. Hoarding with panel around works area & Item 6. Temporary traffic management lighting.

Item 7. Ensure no run-off into water body.

Item 9. Recycle of felled trees as facilities to reuse.

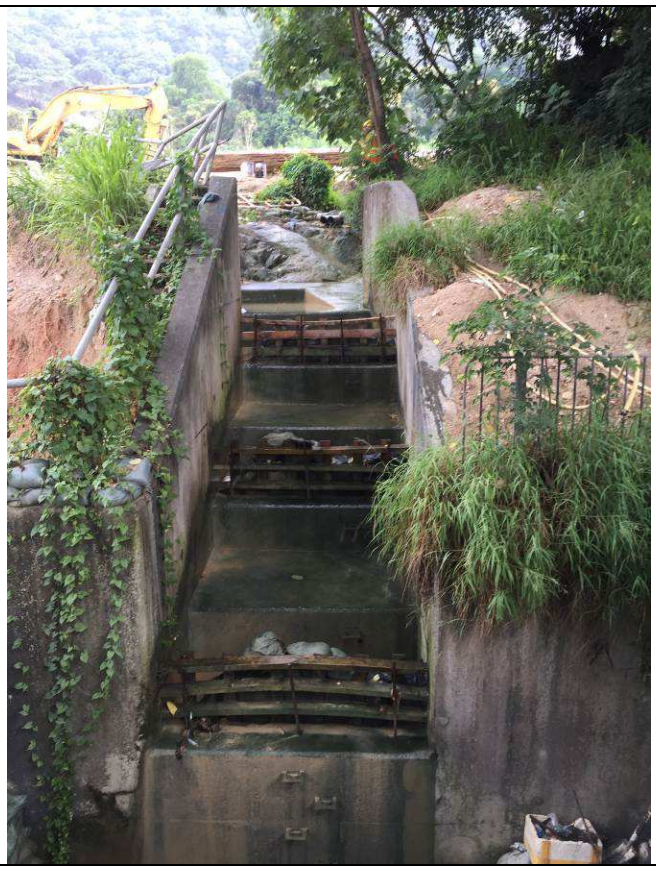
Inspection Date: 01-Aug-2016

Stream B Outfall: clean water is discharging.

Outfall 1: Clean water is discharging.

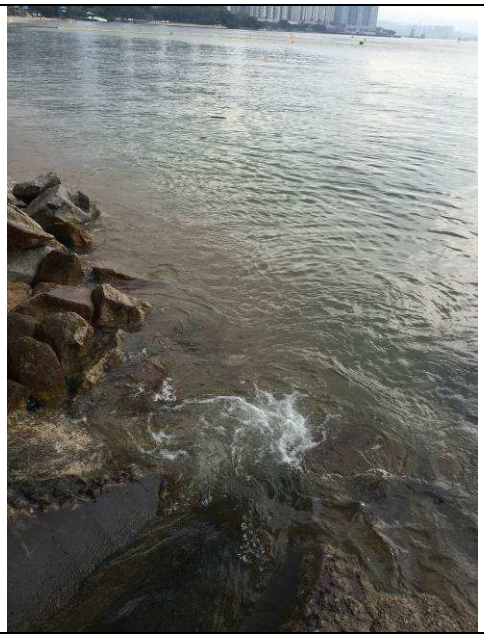
Inspection Date: 03-Aug-2016

Stream B Outfall: clean water is discharging.

Outfall 1: Clean water is discharging.

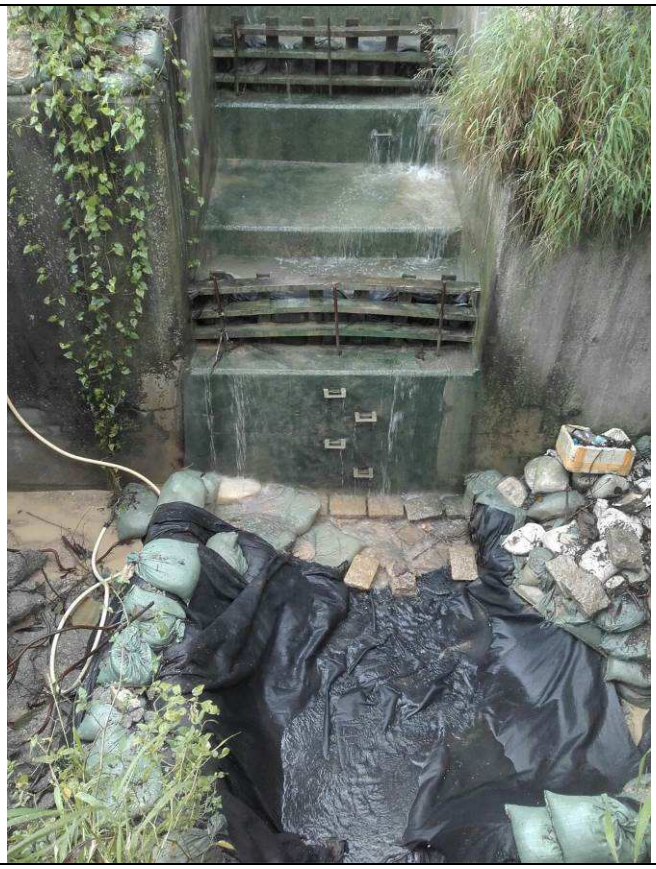
Inspection Date: 10-Aug-2016

Stream B Outfall: clean water is discharging.

Outfall 1: Clean water is discharging.

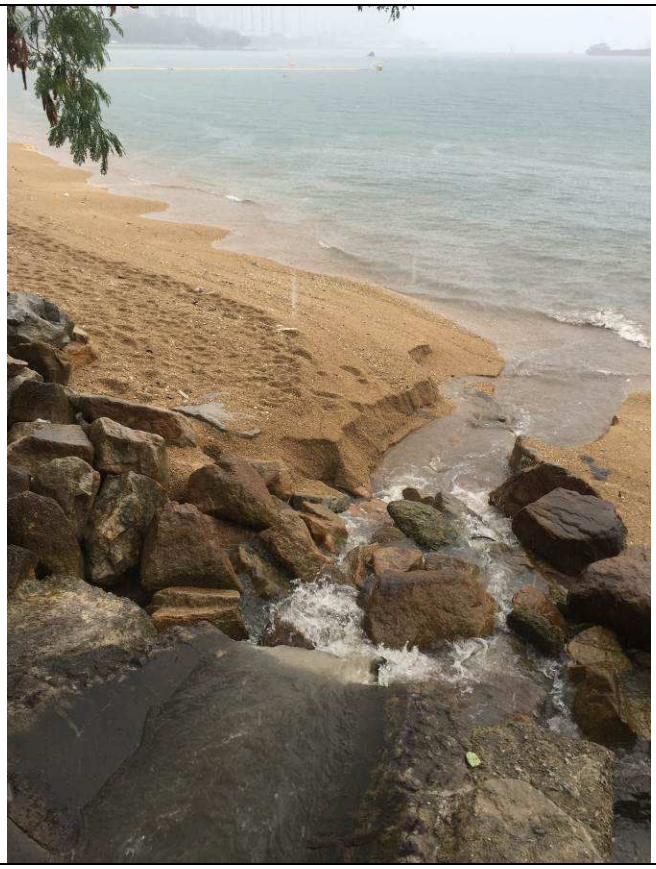
Inspection Date: 11-Aug-2016

Stream B Outfall: clean water is discharging.

Outfall 1: Clean water is discharging.

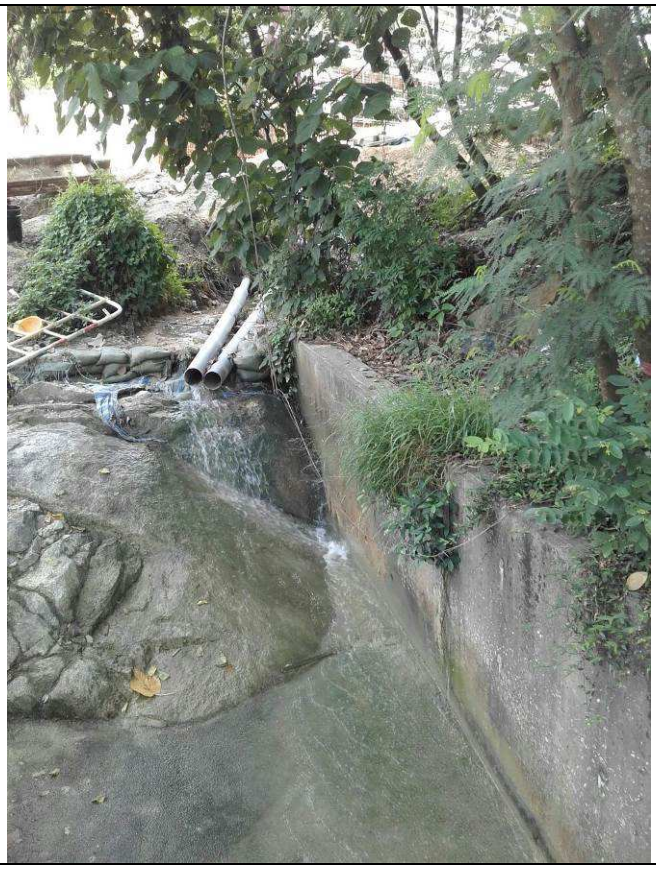
Inspection Date: 13-Aug-2016

Stream B Outfall: clean water is discharging.

Outfall 1: Clean water is discharging.

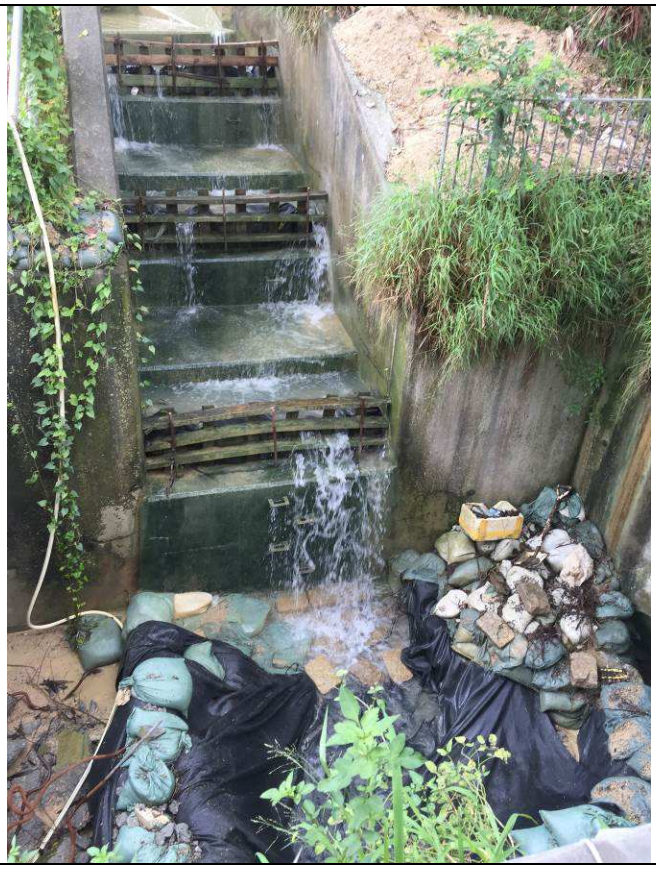
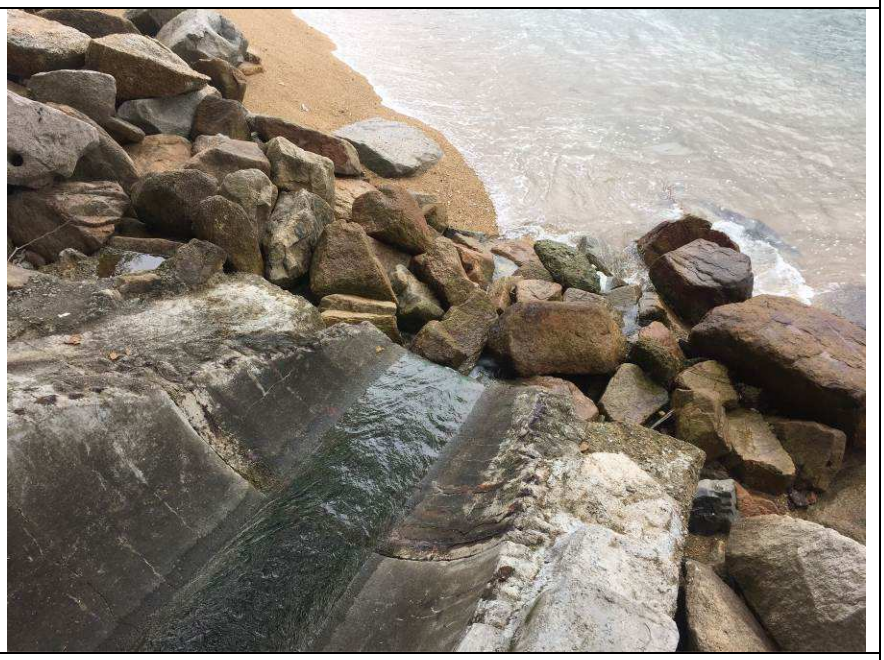
Inspection Date: 15-Aug-2016

Stream B Outfall: clean water is discharging.

Outfall 1: Clean water is discharging.

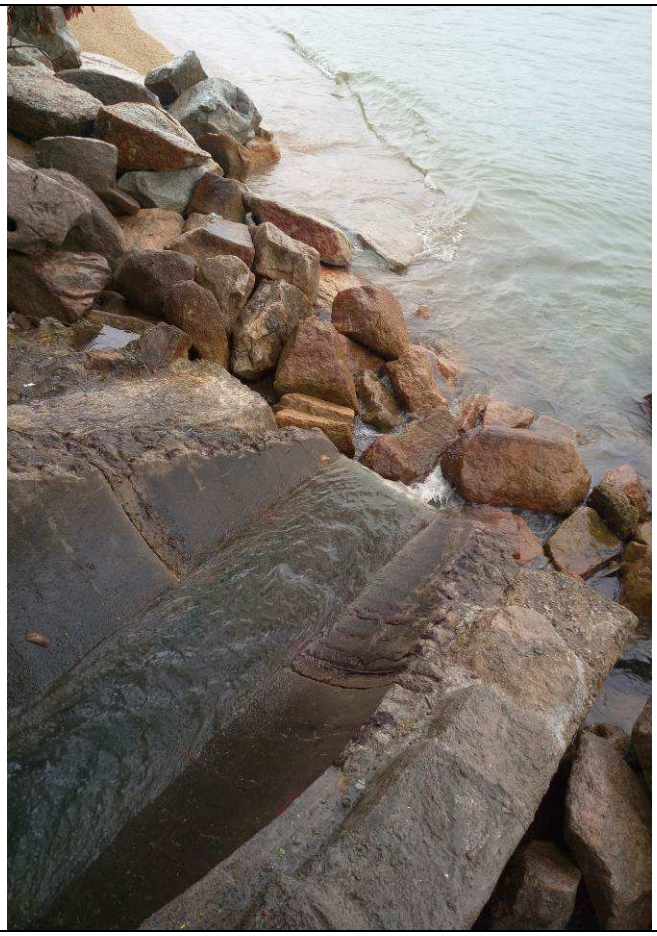
Inspection Date: 16-Aug-2016

Stream B Outfall: clean water is discharging.

Outfall 1: Clean water is discharging.

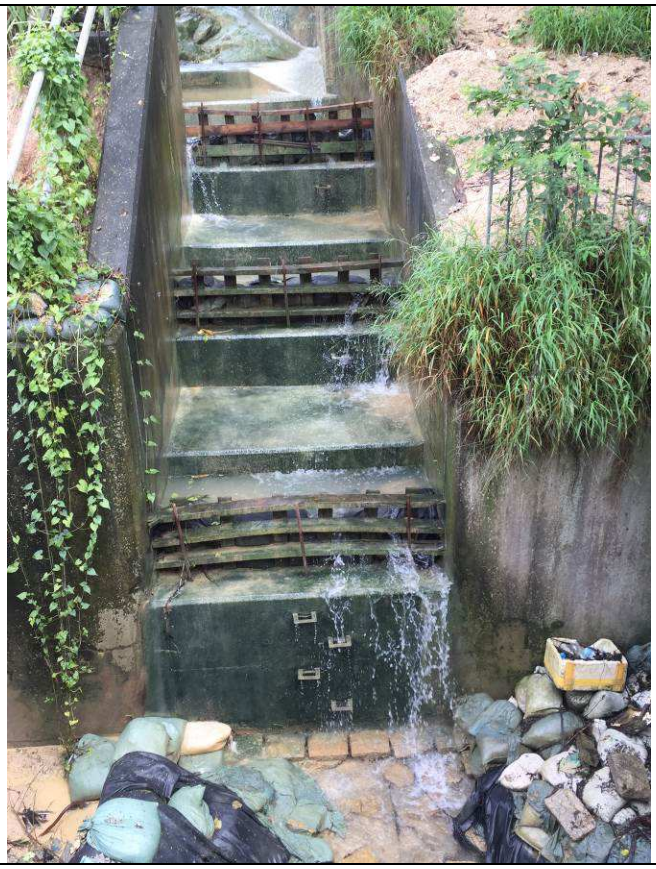
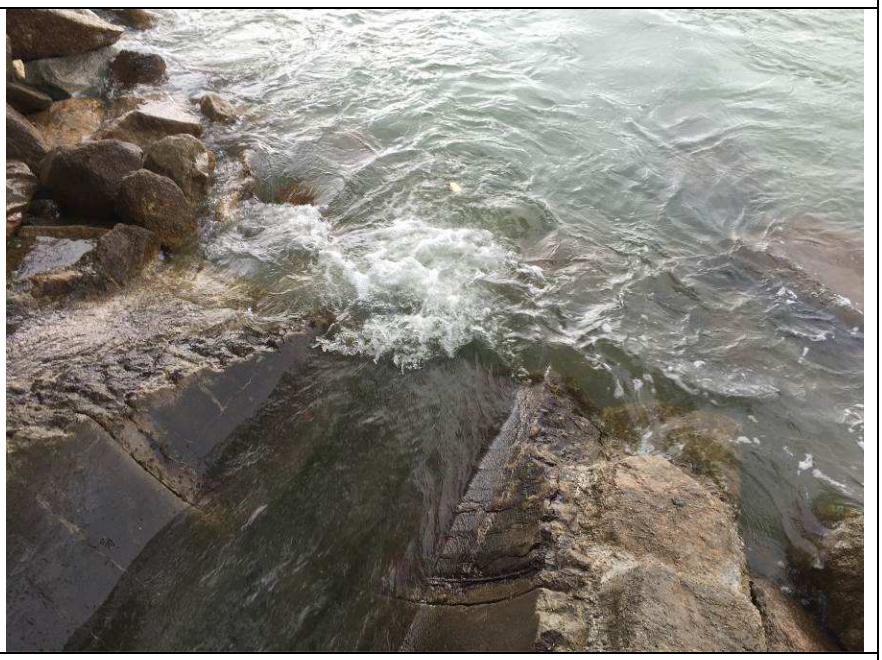
Inspection Date: 17-Aug-2016

Stream B Outfall: clean water is discharging.

Outfall 1: Clean water is discharging.

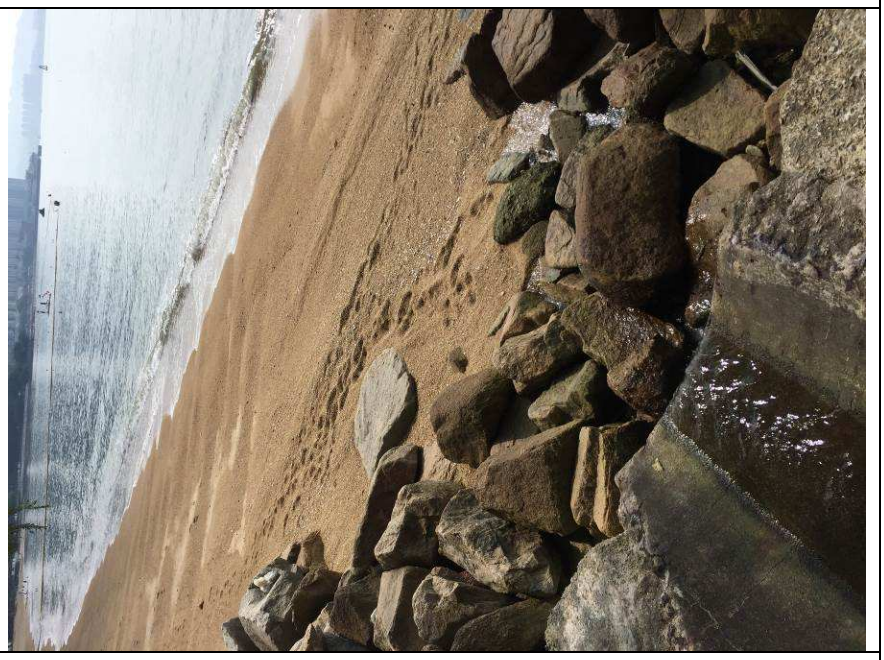
Inspection Date: 25-Aug-2016

Stream B Outfall: clean water is discharging.

Outfall 1: Clean water is discharging.

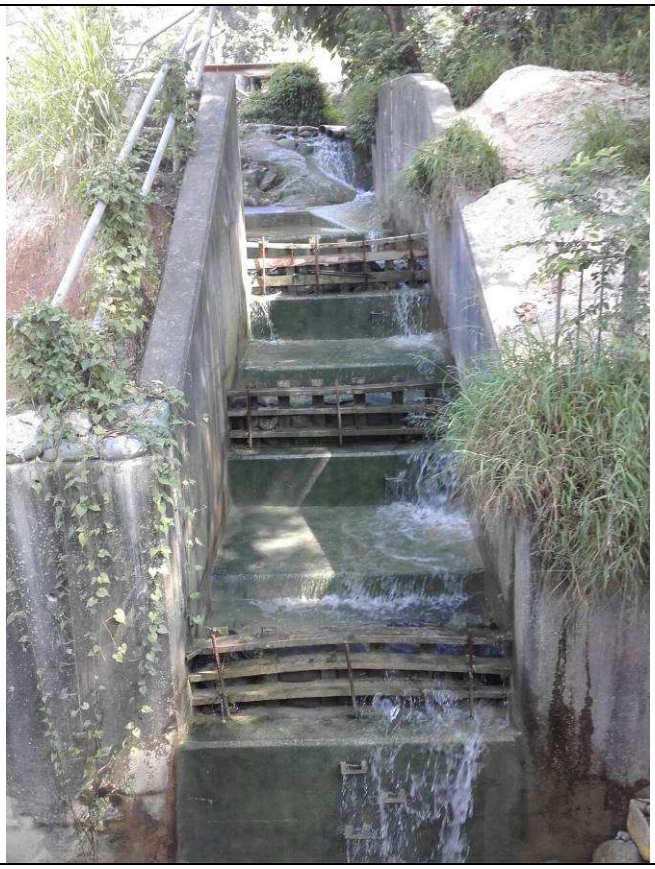
Inspection Date: 26-Aug-2016

Stream B Outfall: clean water is discharging.

Outfall 1: Clean water is discharging.

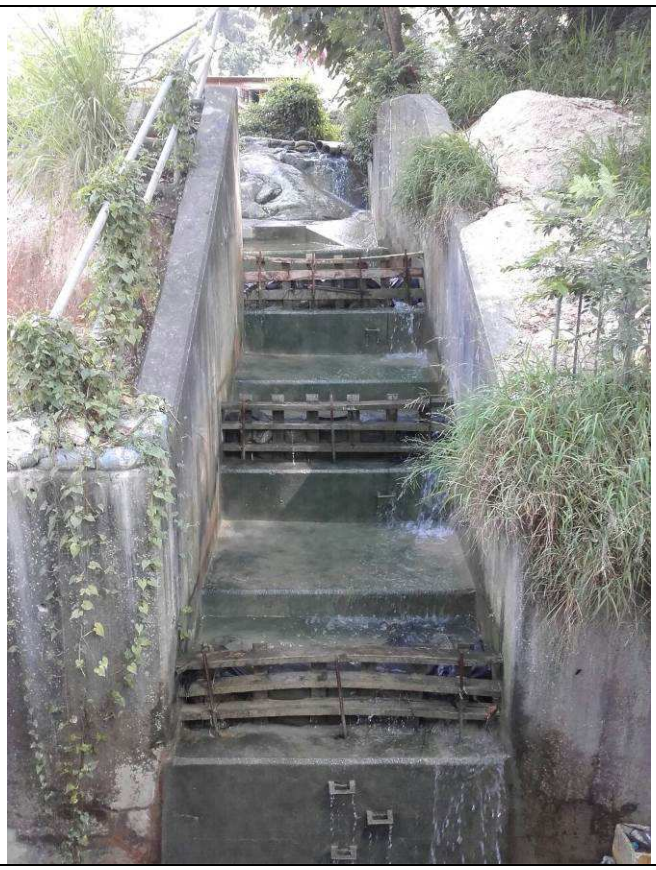
Inspection Date: 27-Aug-2016

Stream B Outfall: clean water is discharging.

Outfall 1: Clean water is discharging.

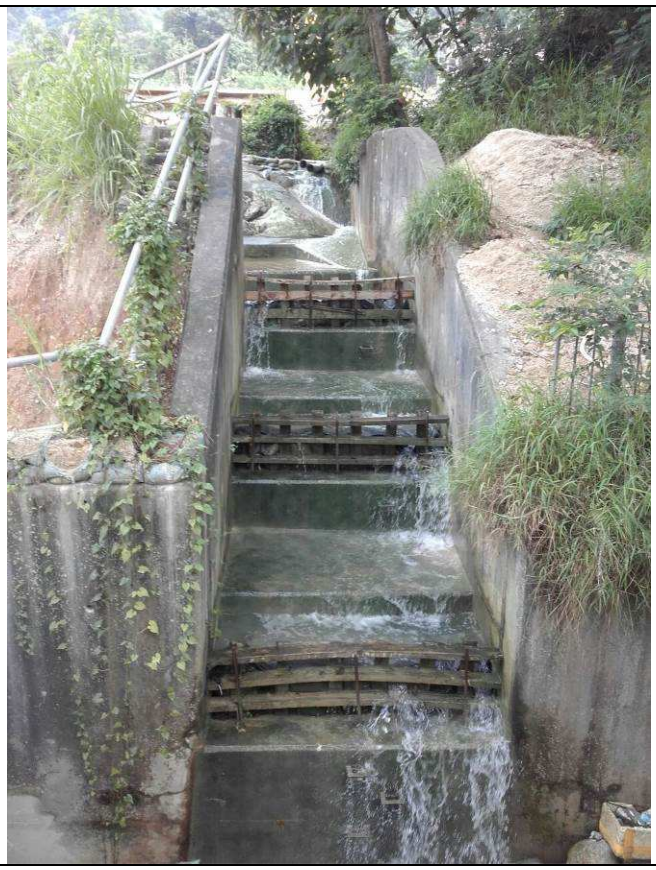
Inspection Date: 29-Aug-2016

Stream B Outfall: clean water is discharging.

Outfall 1: Clean water is discharging.

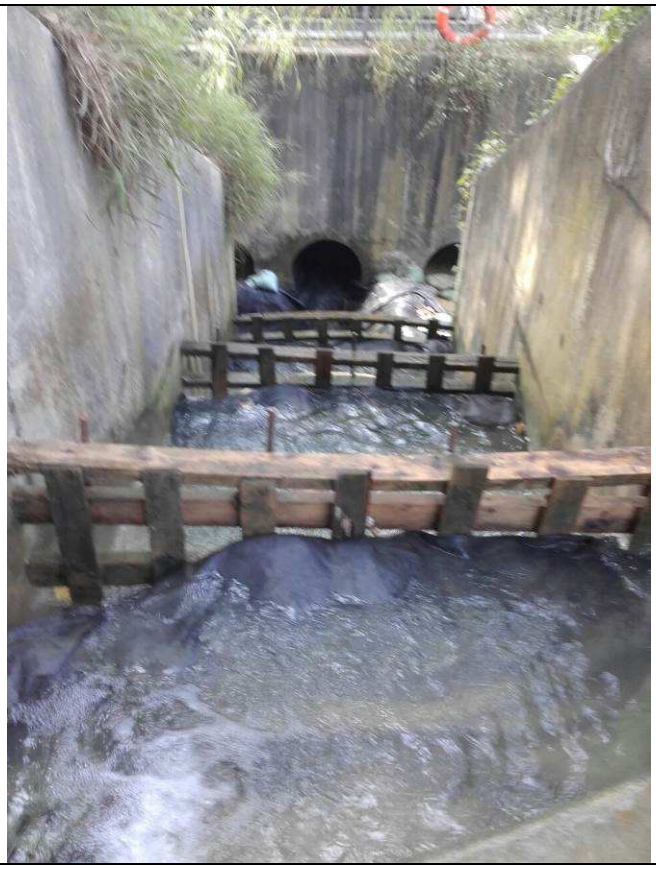
Inspection Date: 30-Aug-2016

Stream B Outfall: clean water is discharging.

Outfall 1: Clean water is discharging.

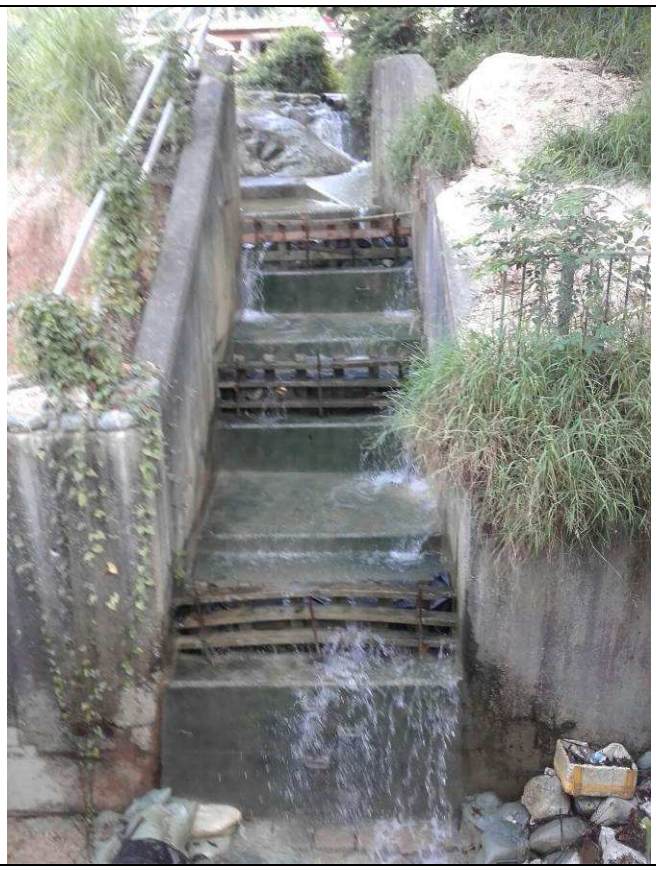
Inspection Date: 31-Aug-2016

Stream B Outfall: clean water is discharging.

Outfall 1: Clean water is discharging.
