TUEN MUN - CHEK LAP KOK LINK
CONTRACT NO. HY/2013/12 –
NORTHERN CONNECTION TOLL PLAZA AND ASSOCIATED WORKS

30TH MONTHLY ENVIRONMENTAL MONITORING AND AUDIT (EM&A) REPORT – APRIL 2017

PREPARED FOR
CRBC AND KADEN JOINT VENTURE

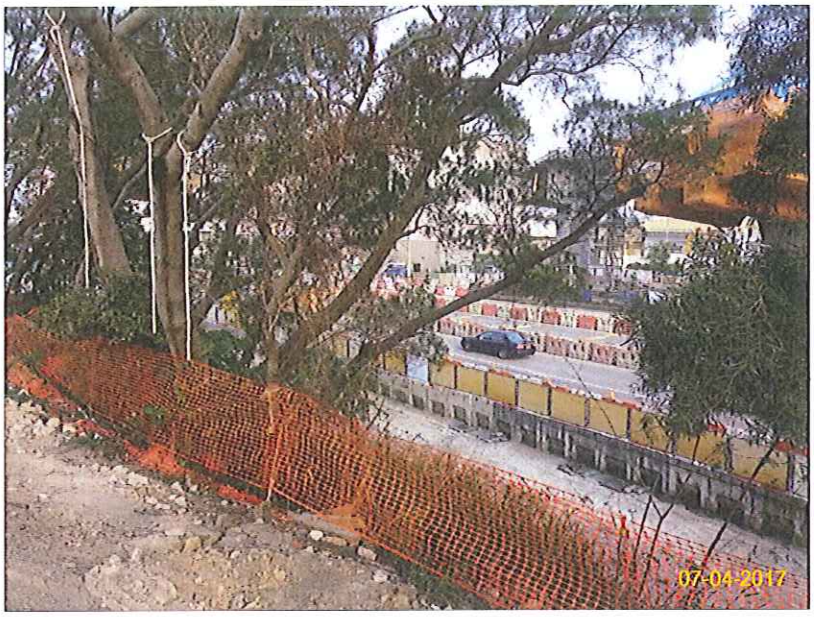
Item 1. Existing trees on boundary of the Project Area should be protected carefully during construction.

Item 2. Tree Transplanting works scheduled in May 2017, Root pruning and crown thinning works has been commenced on 8-Mar-17

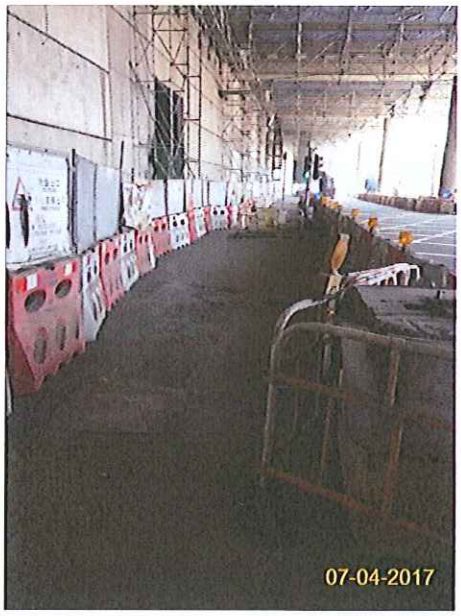
Item 4. Hydro-seeding or sheeting provided at stockpile.

Item 5. Hoarding with panel around works area & Item 6. Temporary traffic management lighting.

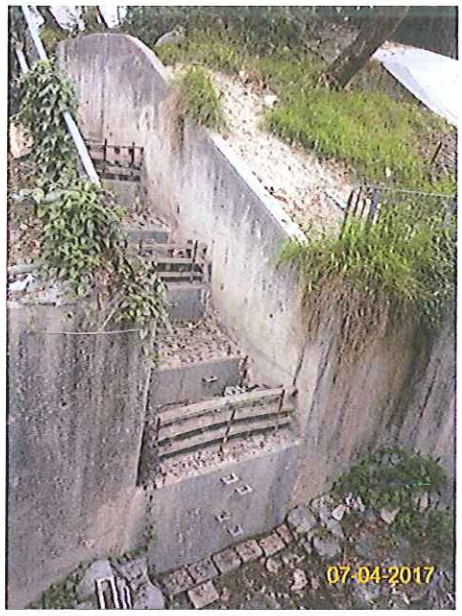
Item 7. Ensure no run-off into water body.

Item 9. Recycle of felled trees as facilities to reuse.

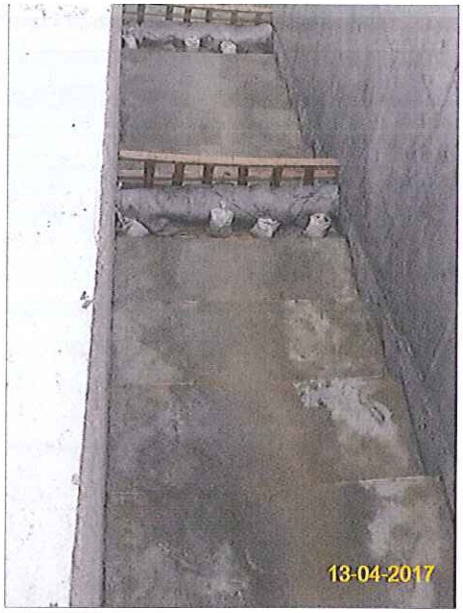
Item 5. Hoarding with panel around works area & Item 6. Temporary traffic management lighting.

Item 7. Ensure no run-off into water body.

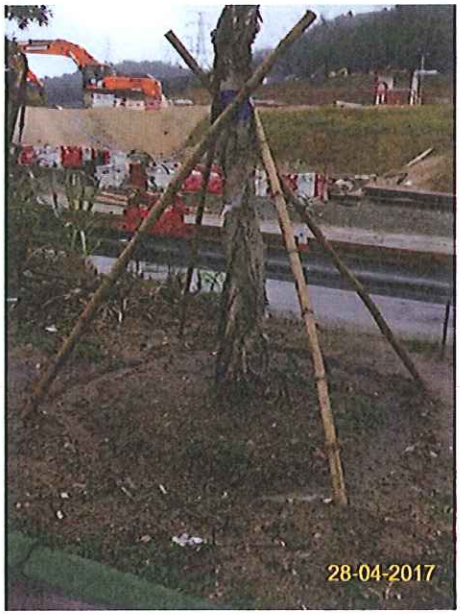
Item 1. Existing trees on boundary of the Project Area should be protected carefully during construction.

Item 2. Tree Transplanting works scheduled in May 2017, Root pruning and crown thinning works has been commenced on 8-Mar-17

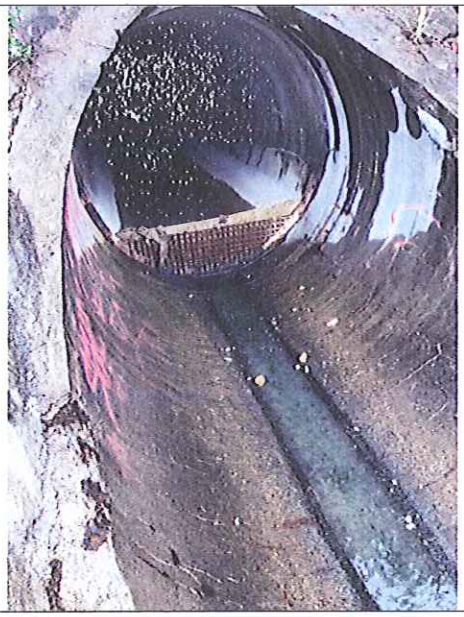
Inspection Date: 24-Apr-2017

Stream B Outfall: clean water is discharging.

Outfall 1: Clean water is discharging.
