AUES JOB NO.: TCS00715/14

TUEN MUN - CHEK LAP KOK LINK
CONTRACT NO. HY/2013/12 –
NORTHERN CONNECTION TOLL PLAZA AND ASSOCIATED WORKS

31ST MONTHLY ENVIRONMENTAL MONITORING AND AUDIT (EM&A) REPORT – MAY 2017

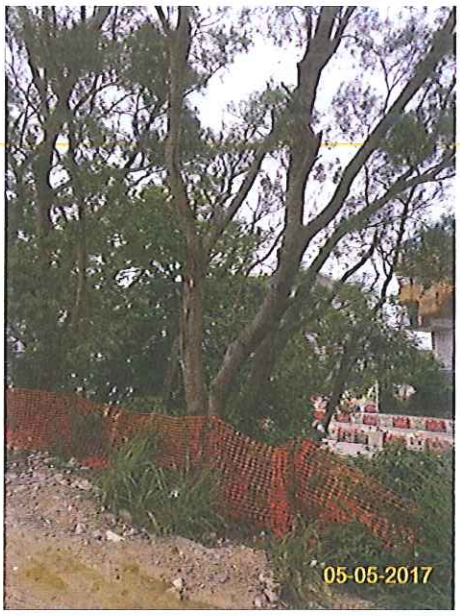
Item 1. Existing trees on boundary of the Project Area should be protected carefully during construction.

Item 2. Tree Transplanting works scheduled in May 2017, Root pruning and crown thinning works has been commenced on 8-Mar-17

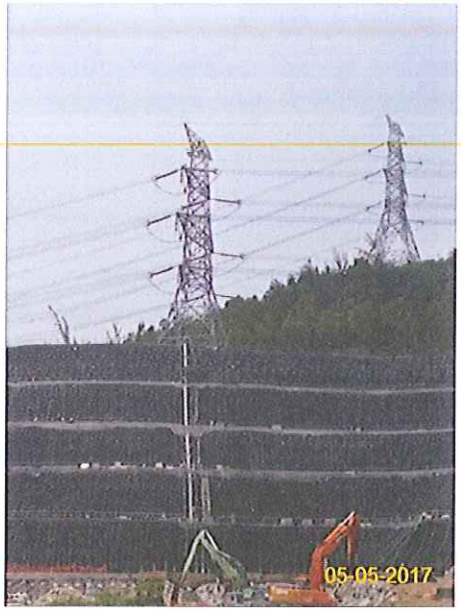
Item 4. Hydro-seeding or sheeting provided at stockpile.

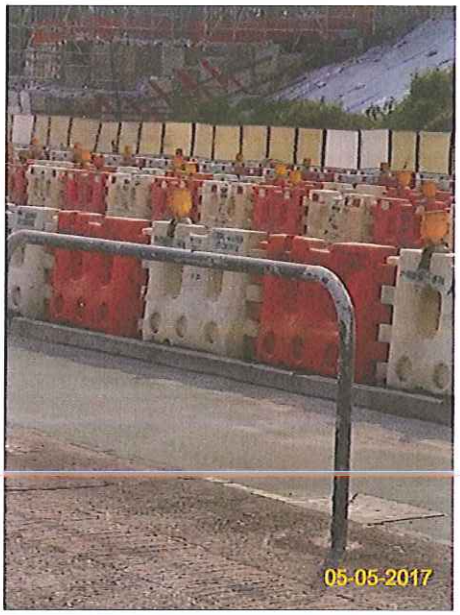
Item 5. Hoarding with panel around works area & Item 6. Temporary traffic management lighting.

Item 7. Ensure no run-off into water body.

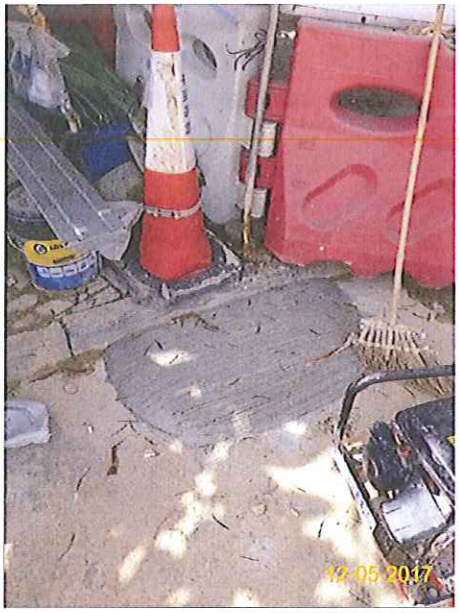
Item 5. Hoarding with panel around works area & Item 6. Temporary traffic management lighting.

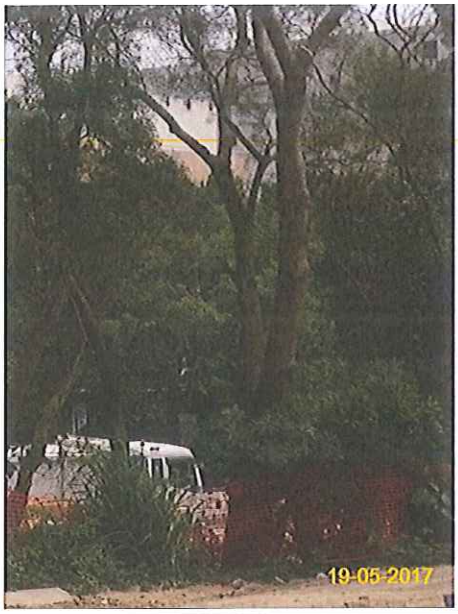
Item 1. Existing trees on boundary of the Project Area should be protected carefully during construction.

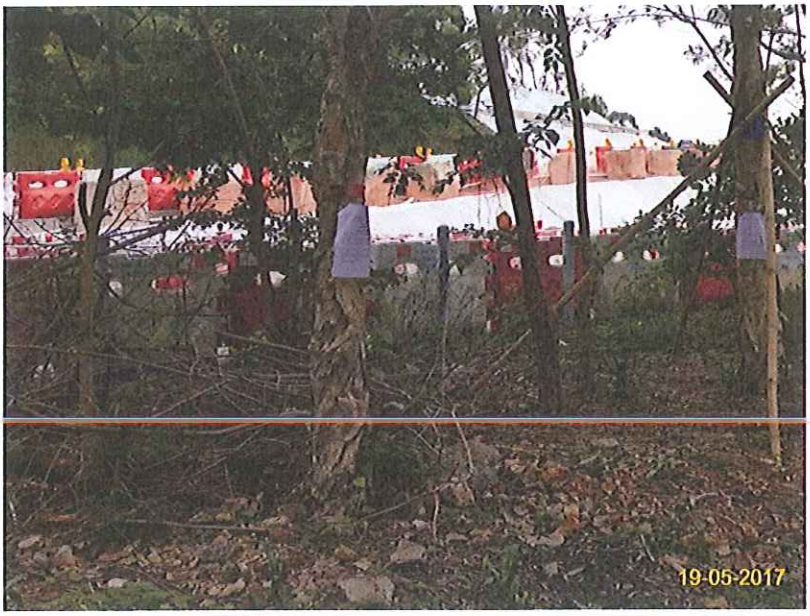
Item 2. Tree Transplanting works scheduled in May 2017, Root pruning and crown thinning works has been commenced on 8-Mar-17

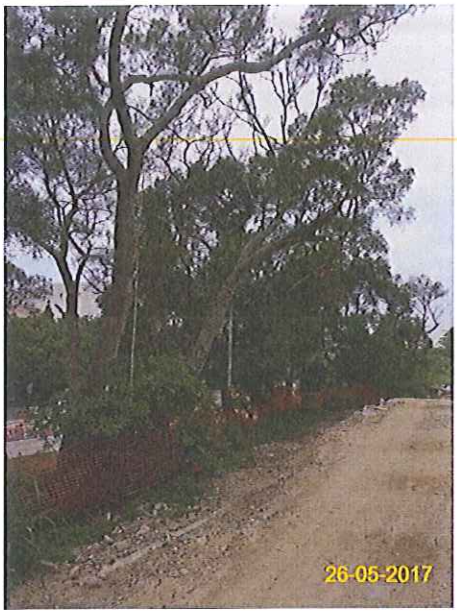
Item 1. Existing trees on boundary of the Project Area should be protected carefully during construction.

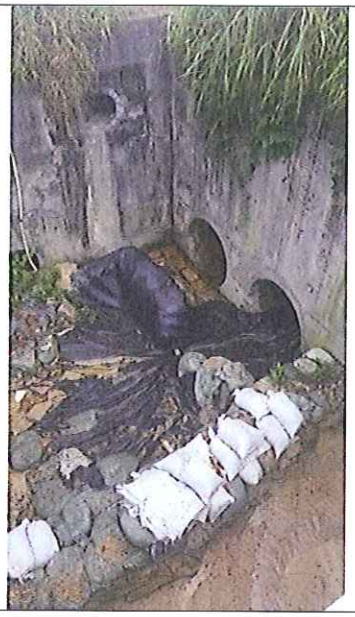
Inspection Date: 2017-05-04

Stream B Outfall: clean water is discharging.

Outfall 1: Clean water is discharging.

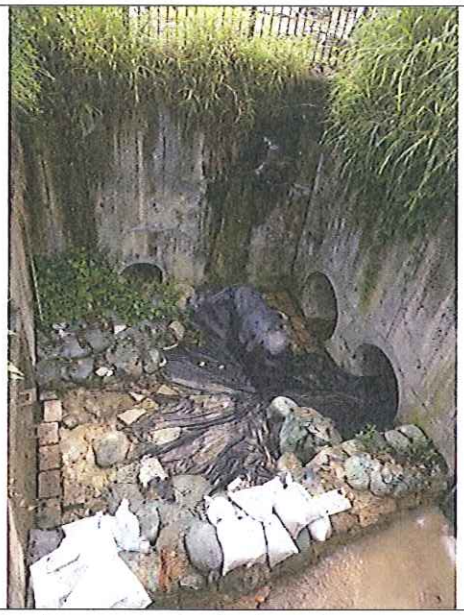
Inspection Date: 2017-05-06

Stream B Outfall: clean water is discharging.

Outfall 1: Clean water is discharging.

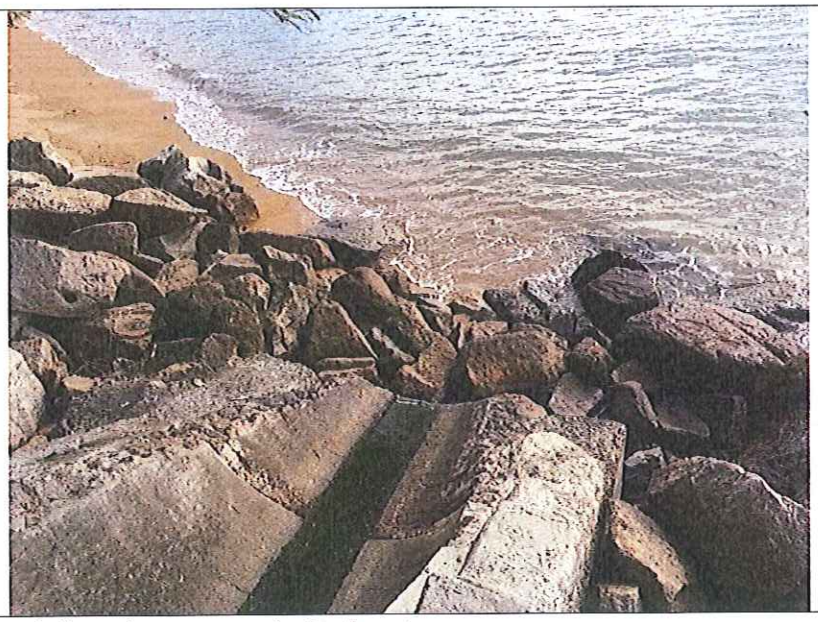
Stream B Outfall: Clean water is discharging.

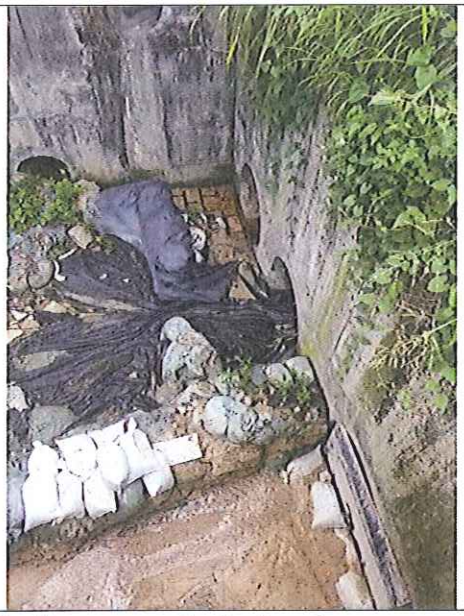
Inspection Date: 2017-05-11

Stream B Outfall: clean water is discharging.

Outfall 1: Clean water is discharging.

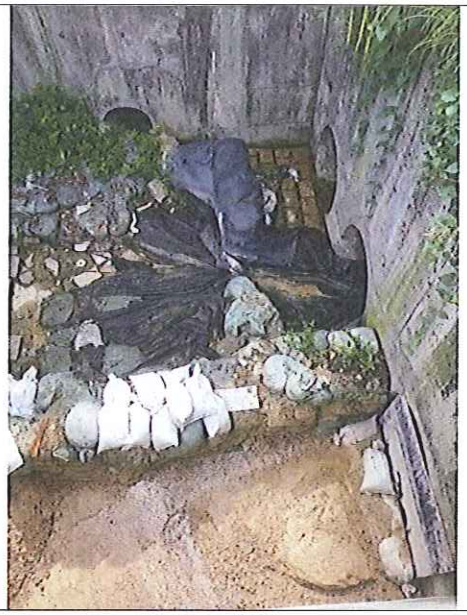
Inspection Date: 2017-05-12

Stream B Outfall: clean water is discharging.

Outfall 1: Clean water is discharging.

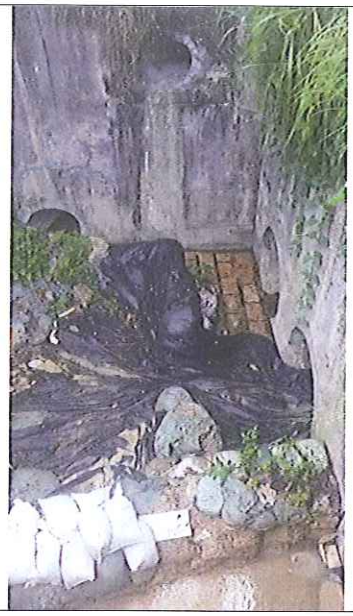
Inspection Date: 2017-05-15

Stream B Outfall: No water is discharging.

Outfall 1: Clean water is discharging.

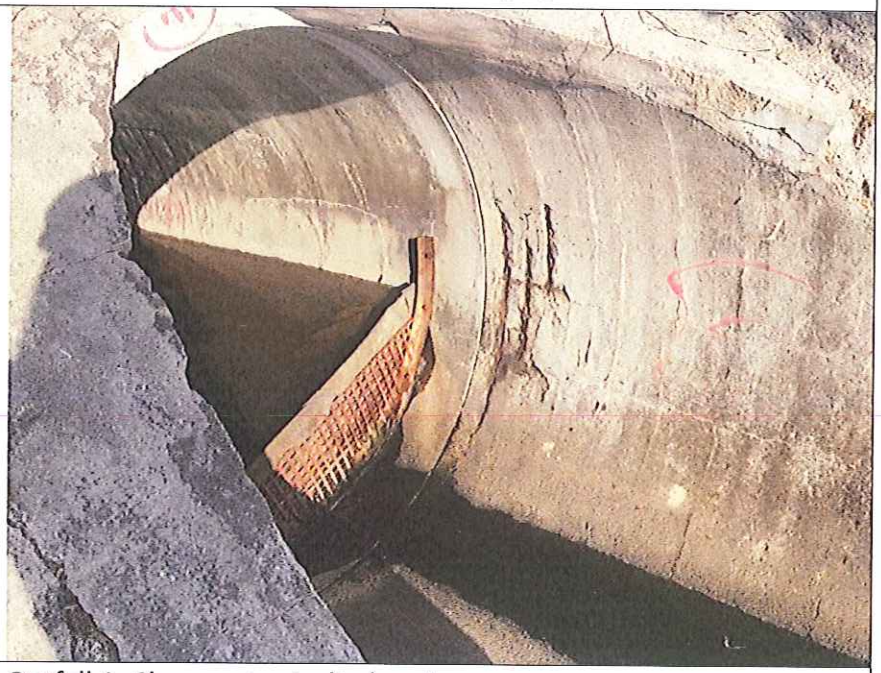
Stream B Outfall: clean water is discharging.

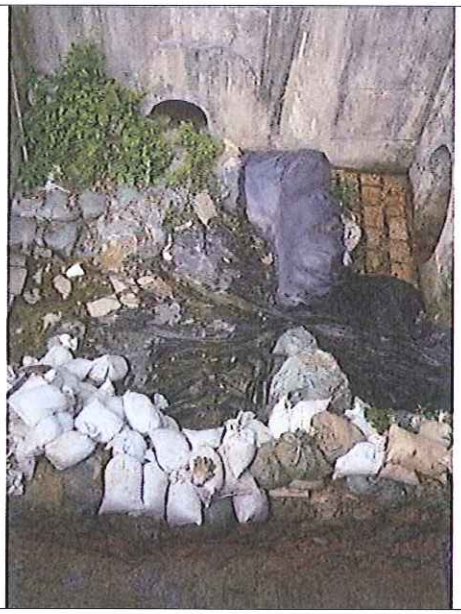
Inspection Date: 2017-05-18

Stream B Outfall: clean water is discharging.

Outfall 1: Clean water is discharging.

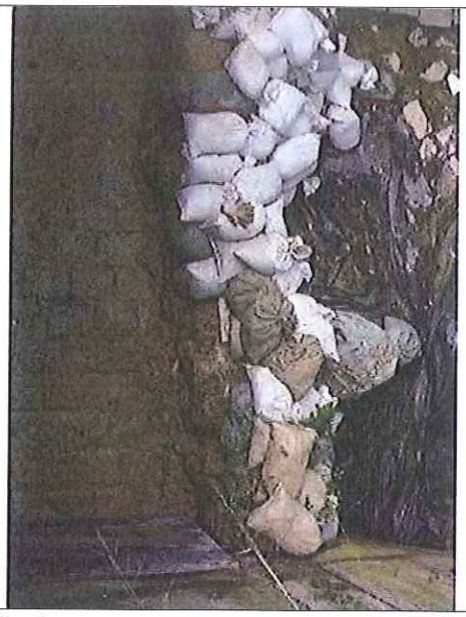
Inspection Date: 2017-05-19

Stream B Outfall: clean water is discharging.

Outfall 1: Clean water is discharging.

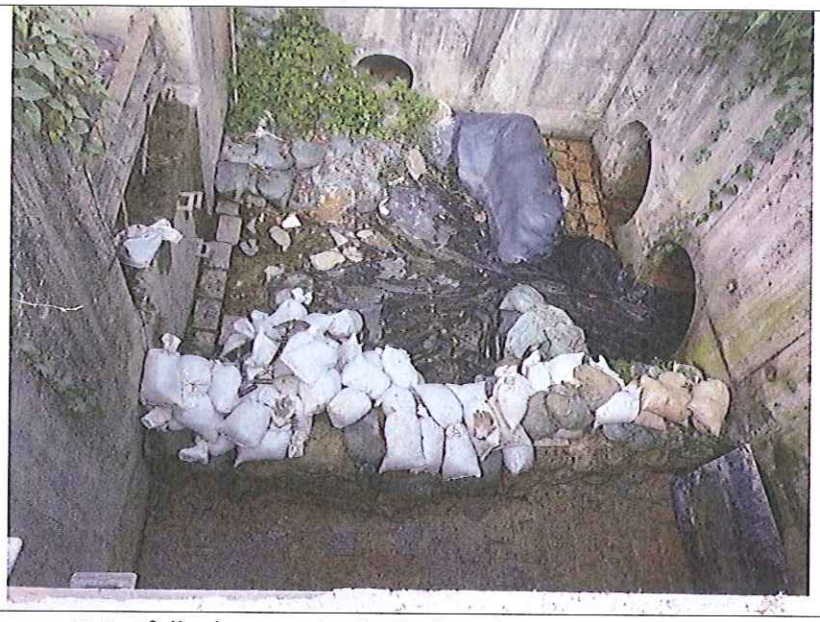
Inspection Date: 2017-05-20

Stream B Outfall: clean water is discharging.

Outfall 1: Clean water is discharging.

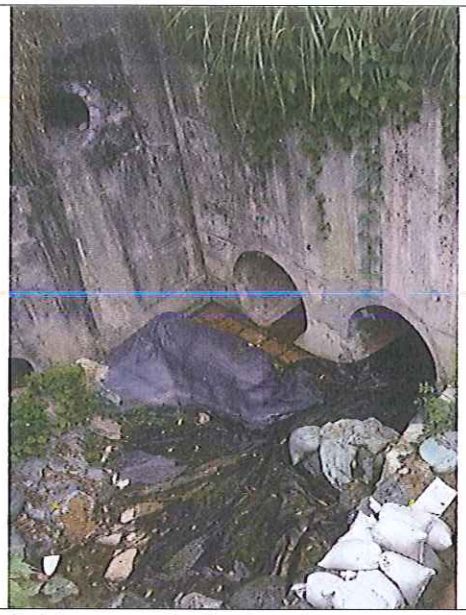
Inspection Date: 2017-05-22

Stream B Outfall: No water is discharging.

Outfall 1: Clean water is discharging.

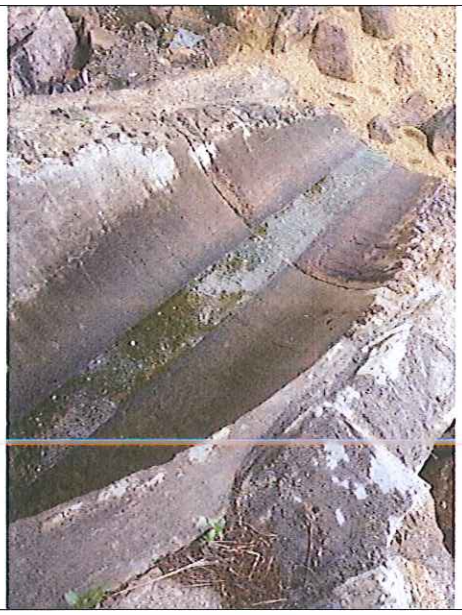
Stream B Outfall: No water is discharging.

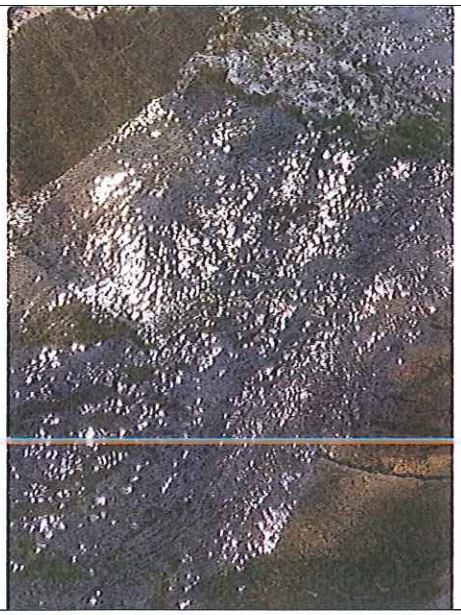
Stream B Outfall: clean water is discharging.

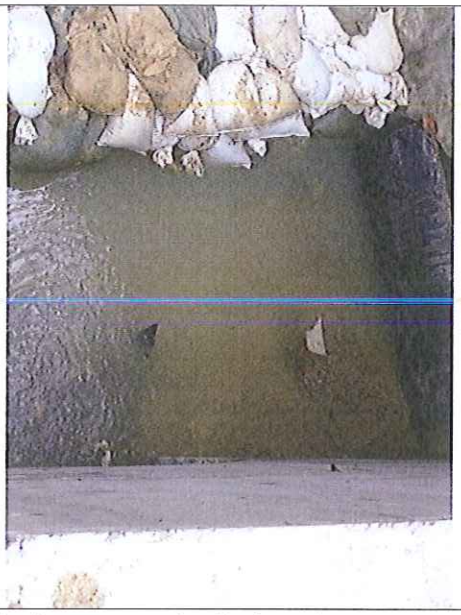
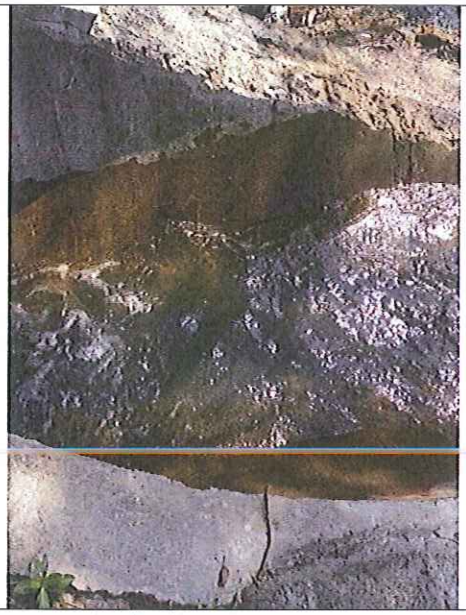
Inspection Date: 2017-05-26

Stream B Outfall: clean water is discharging.

Outfall 1: Clean water is discharging.

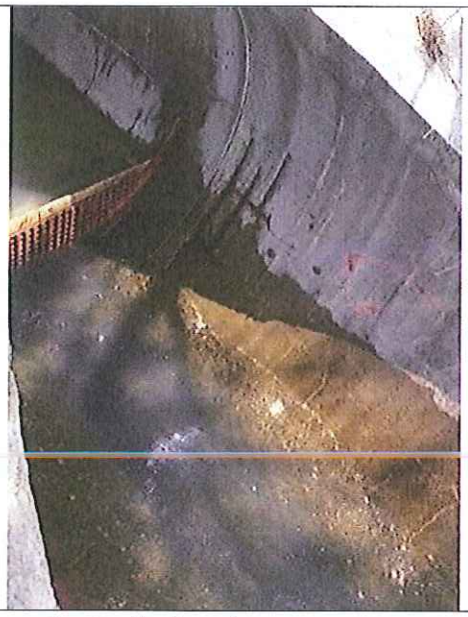
Stream B Outfall: Clean water is discharging.

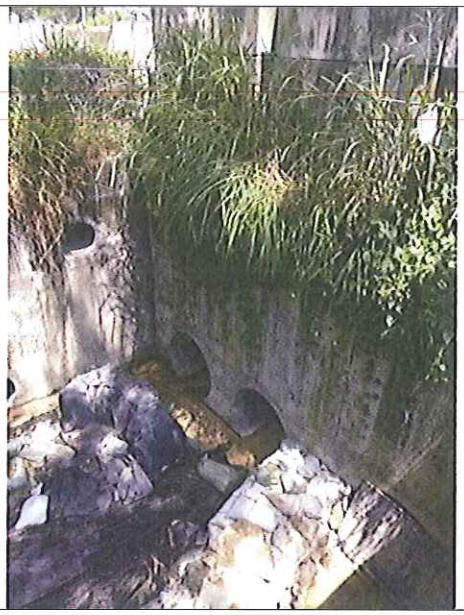
Inspection Date: 2017-05-31

Stream B Outfall: No water is discharging.

Outfall 1: Clean water is discharging.
