AUES JOB NO.: TCS00715/14

TUEN MUN - CHEK LAP KOK LINK
CONTRACT NO. HY/2013/12 –
NORTHERN CONNECTION TOLL PLAZA AND ASSOCIATED WORKS

32ND MONTHLY ENVIRONMENTAL MONITORING AND AUDIT (EM&A) REPORT – JUNE 2017

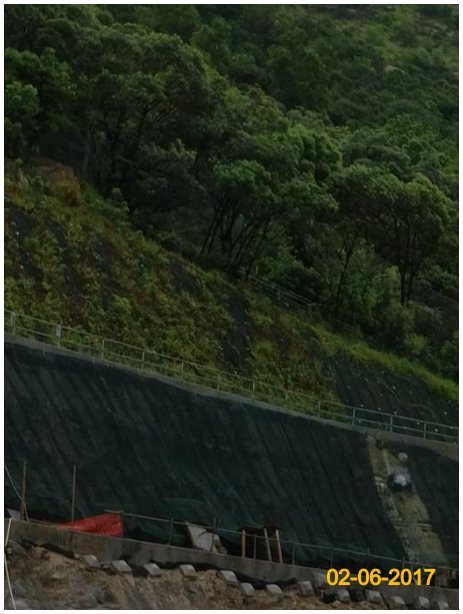
Item 1. Existing trees on boundary of the Project Area should be protected carefully during construction.

Item 2. Trees were transplanted straight to their final receptor site area.

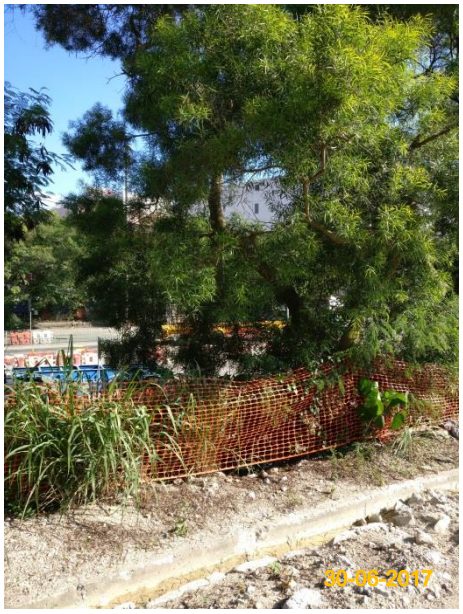
Item 1. Existing trees on boundary of the Project Area should be protected carefully during construction.

Item 2. Tree Transplanting works conducted on 22-May-17.

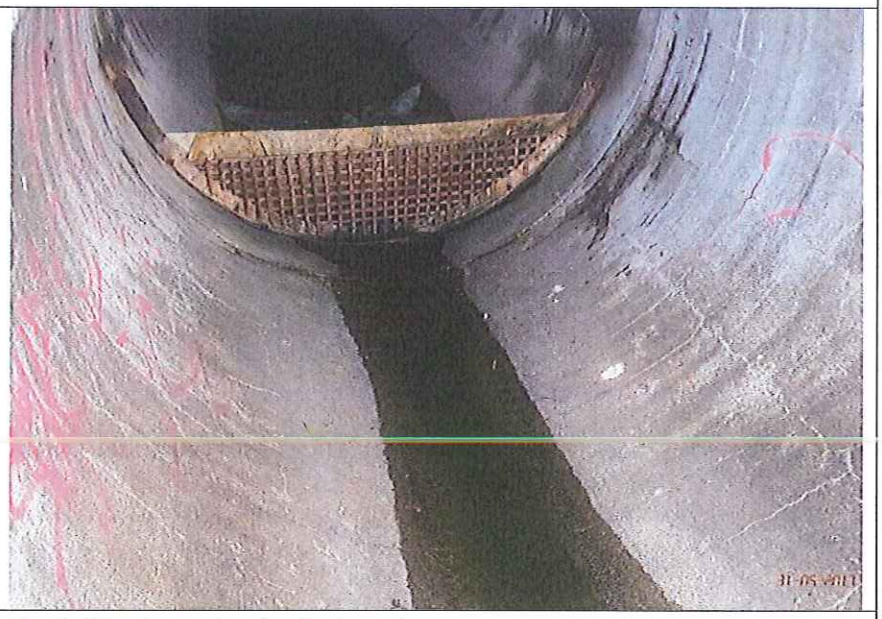
Inspection Date: 2017-06-01

Stream B Outfall: No water is discharging.

Outfall 1: No water is discharging.

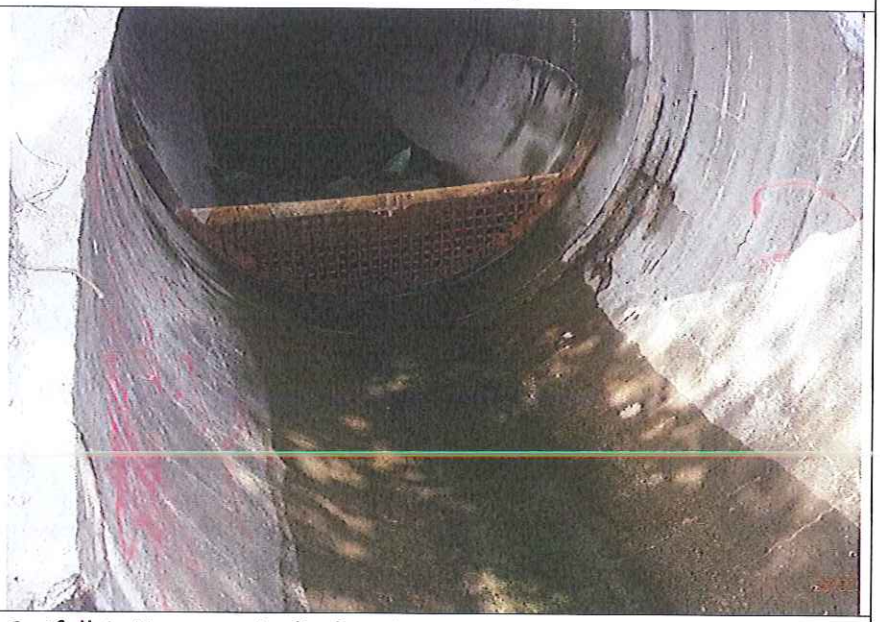
Inspection Date: 2017-06-02

Stream B Outfall: No water is discharging.

Outfall 1: No water is discharging.

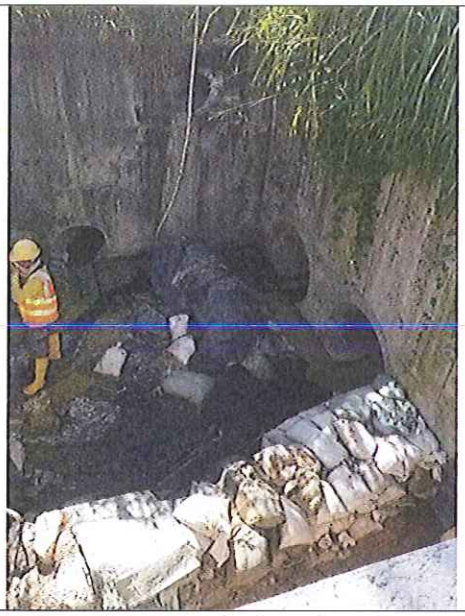
Inspection Date: 2017-06-10

Stream B Outfall: clean water is discharging.

Outfall 1: Clean water is discharging.

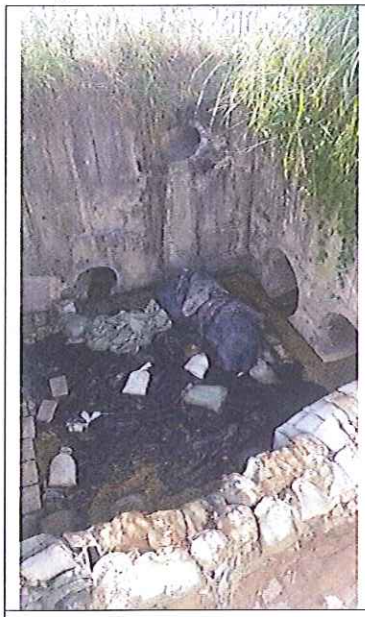
Inspection Date: 2017-06-12

Stream B Outfall: No water is discharging.

Outfall 1: No water is discharging.

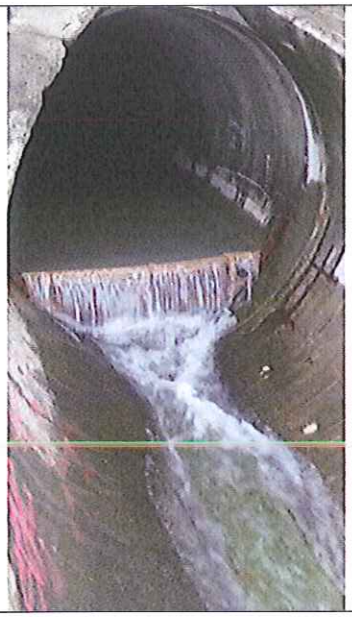
Inspection Date: 2017-06-13

Stream B Outfall: No water is discharging.

Outfall 1: Clean water is discharging.

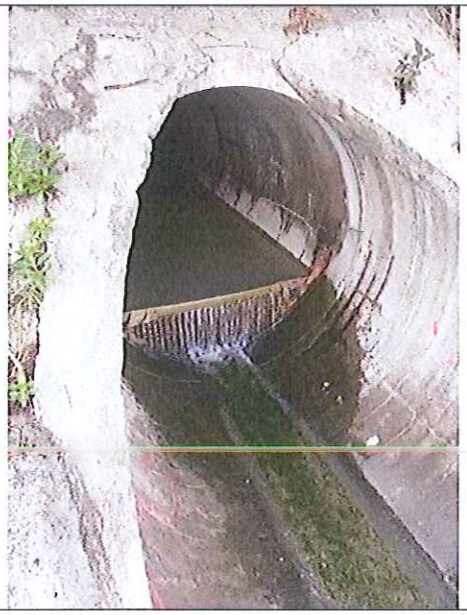
Inspection Date: 2017-06-15

Stream B Outfall: No water is discharging.

Outfall 1: No water is discharging.

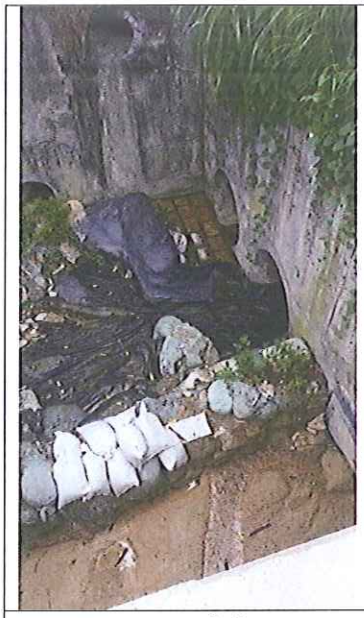
Inspection Date: 2017-06-19

Stream B Outfall: No water is discharging.

Outfall 1: No water is discharging.

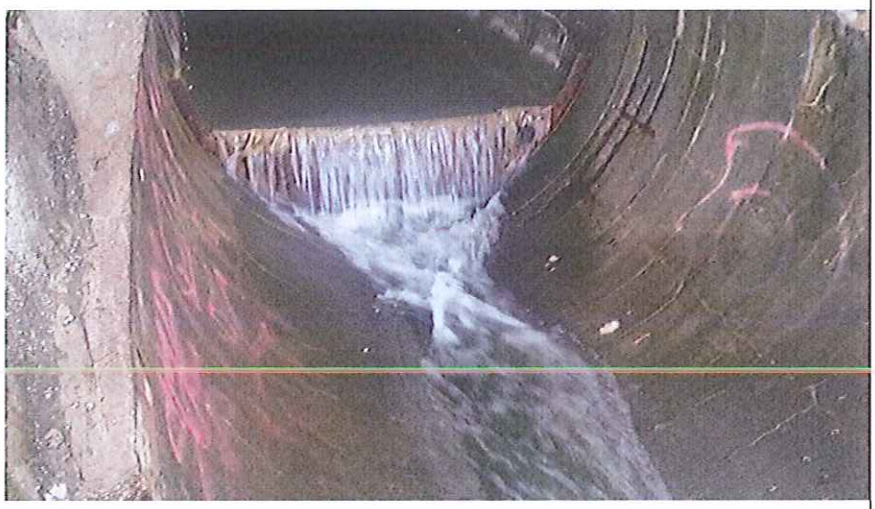
Inspection Date: 2017-06-20

Stream B Outfall: No water is discharging.

Outfall 1: Clean water is discharging.

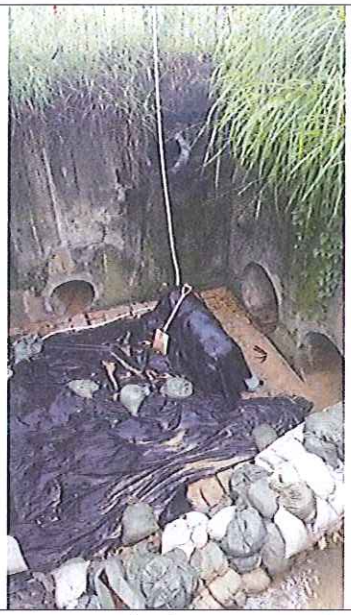
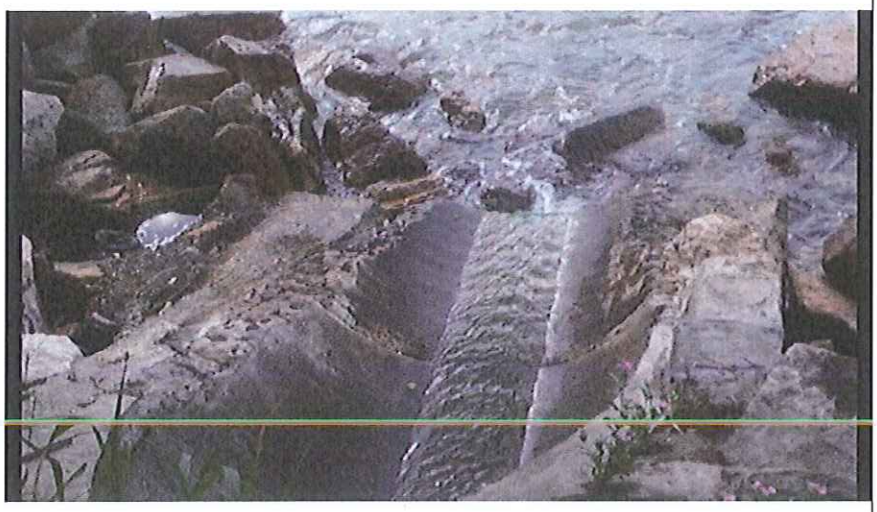
Inspection Date: 2017-06-22

Stream B Outfall: No water is discharging.

Outfall 1: No water is discharging.

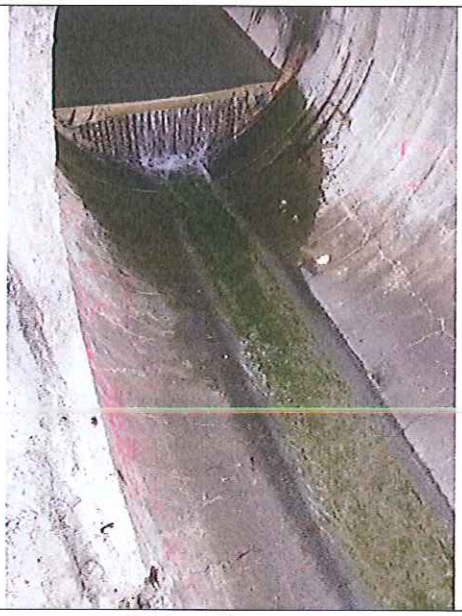
Inspection Date: 2017-06-24

Stream B Outfall: clean water is discharging.

Outfall 1: Clean water is discharging.

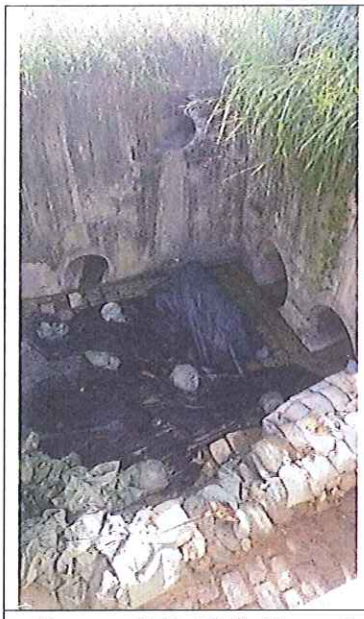
Inspection Date: 2017-06-26

Stream B Outfall: No water is discharging.

Outfall 1: No water is discharging.

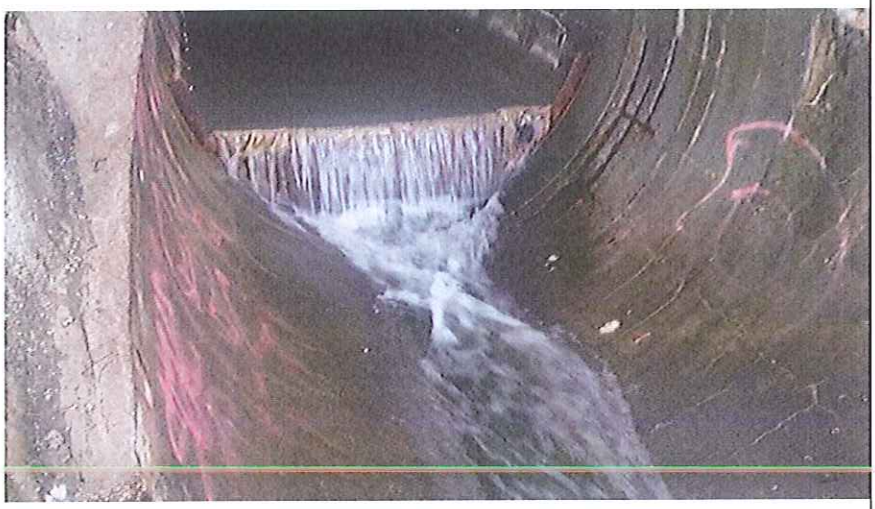
Inspection Date: 2017-06-30

Stream B Outfall: No water is discharging.

Outfall 1: Clean water is discharging.
