Contract No. HY/2012/08
Tuen Mun – Chek Lap Kok Link – Northern Connection Sub-sea Tunnel Section

Forty-ninth Monthly Environmental Monitoring & Audit (EM&A) Report

12 December 2017

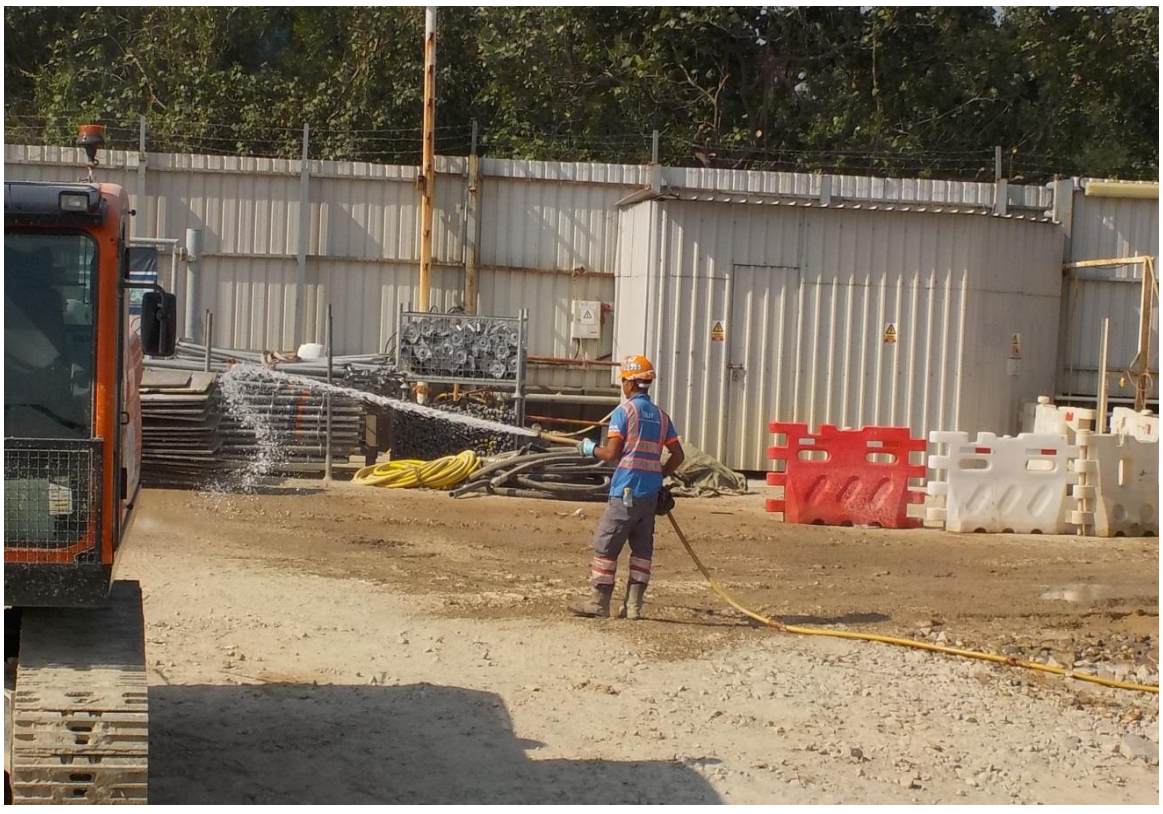
Water spraying was applied frequently during dry conditions. (Works Area Portion N-A)

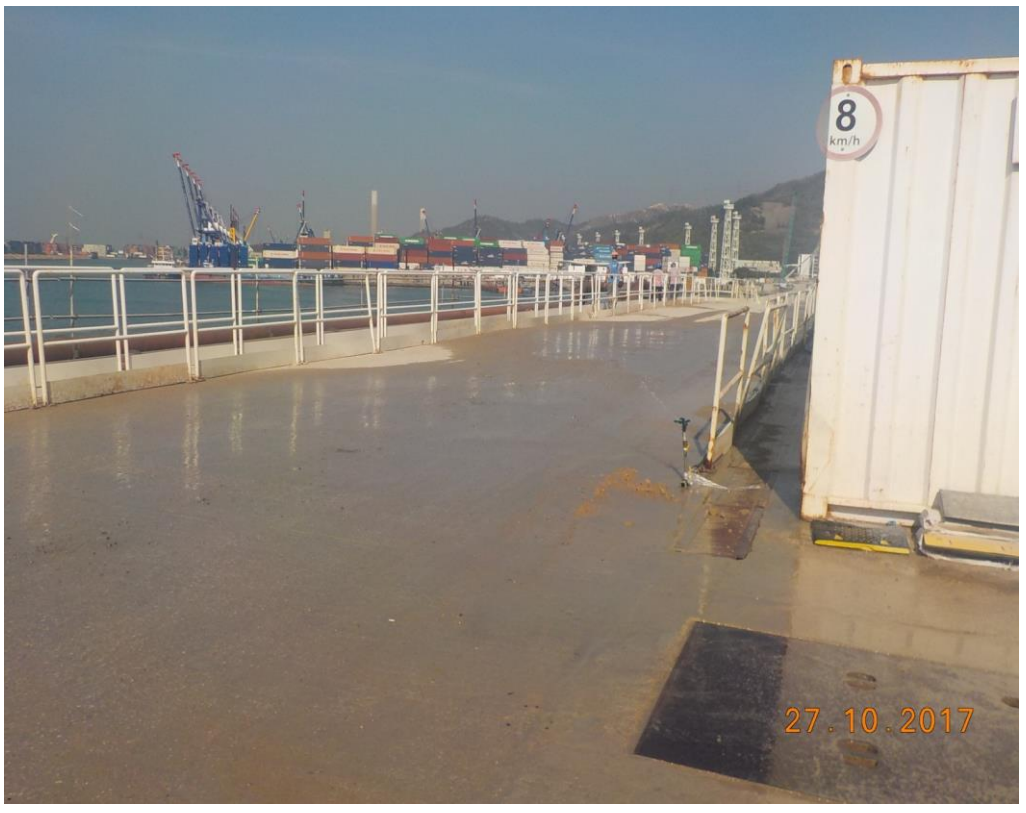
Water spraying was applied frequently during dry conditions.(Works Area Portion N-B)

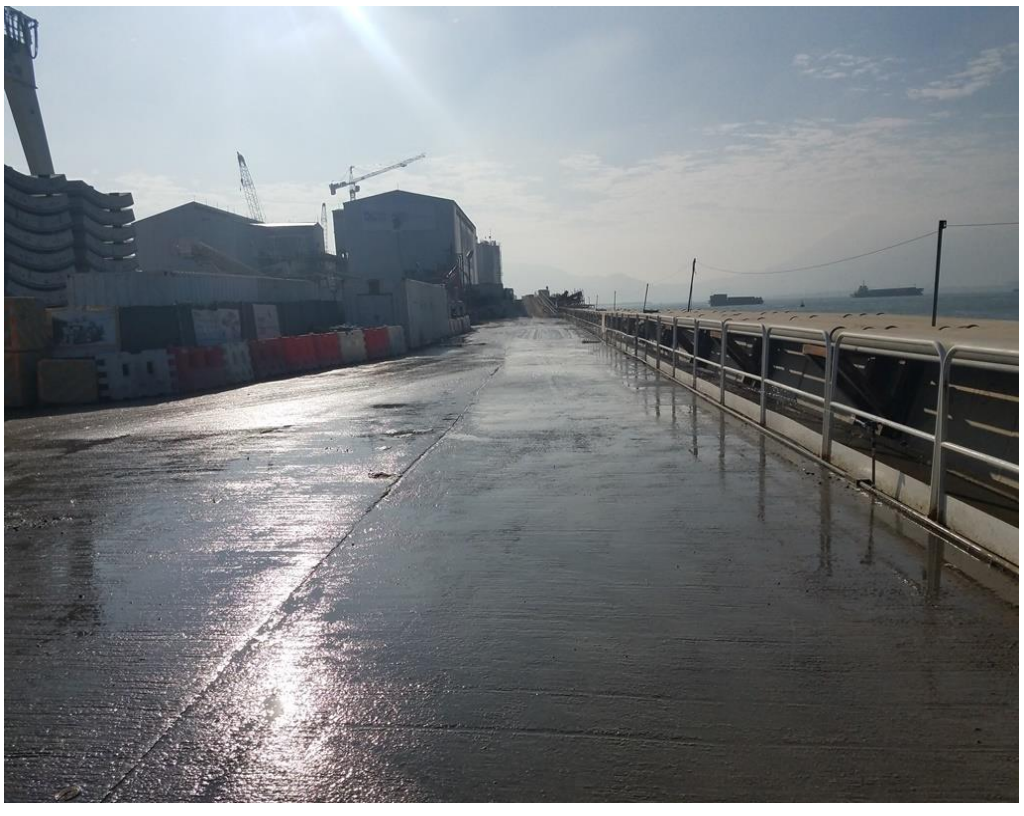
Water spraying was applied frequently during dry conditions.(Works Area Portion N-C)

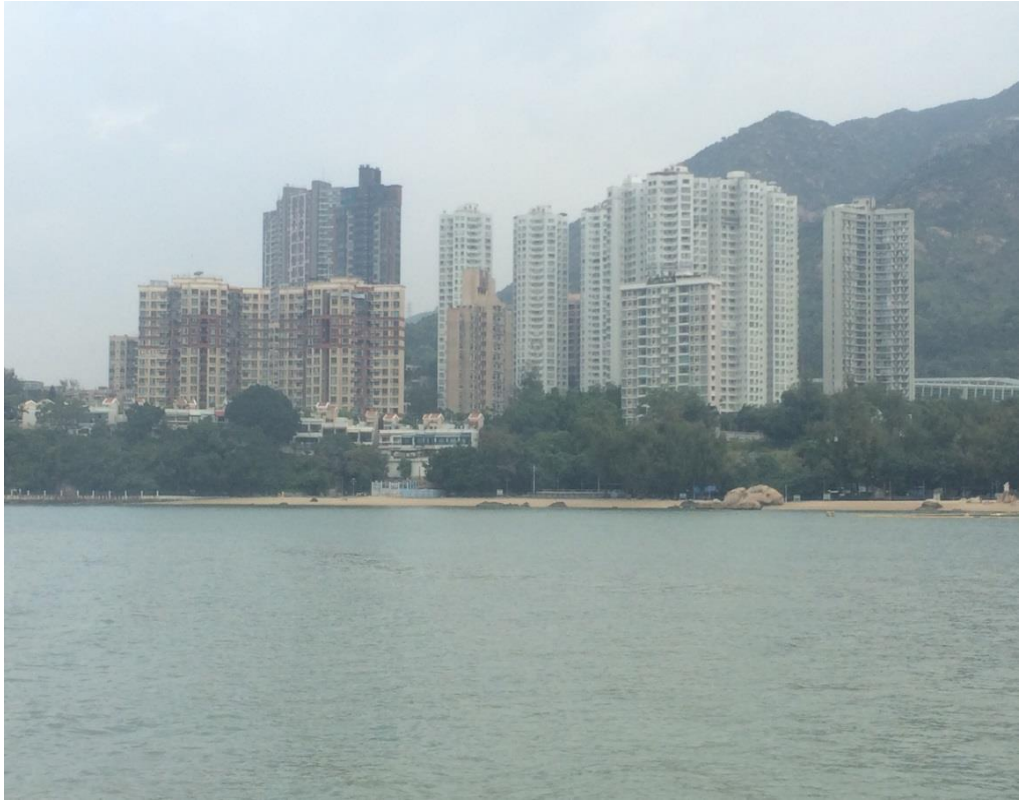
SR8 - Flood tide

SR10A - Flood tide

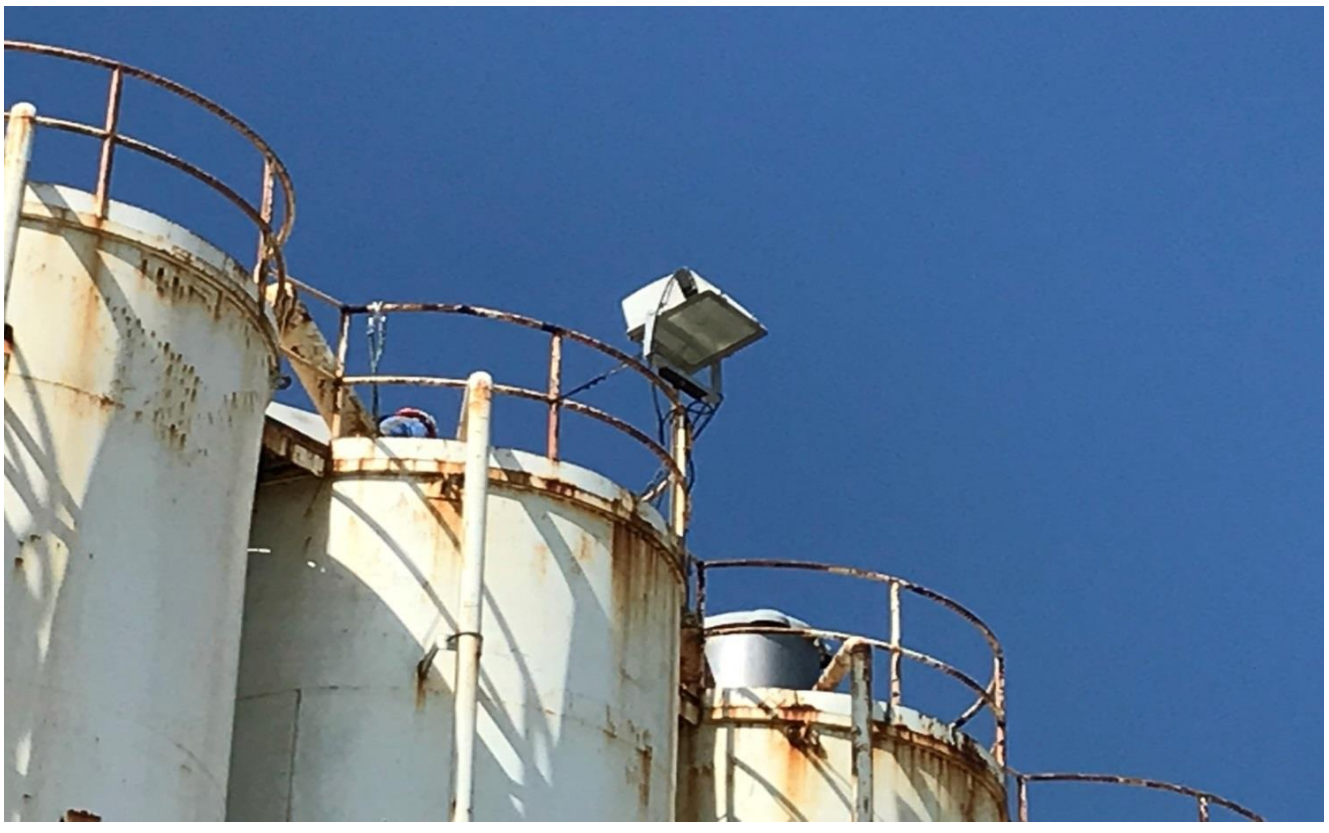
Direction of the lighting at STP silo is adjusted towards the ground.(Before)

Direction of the lighting at STP silo is adjusted towards the ground.(After)

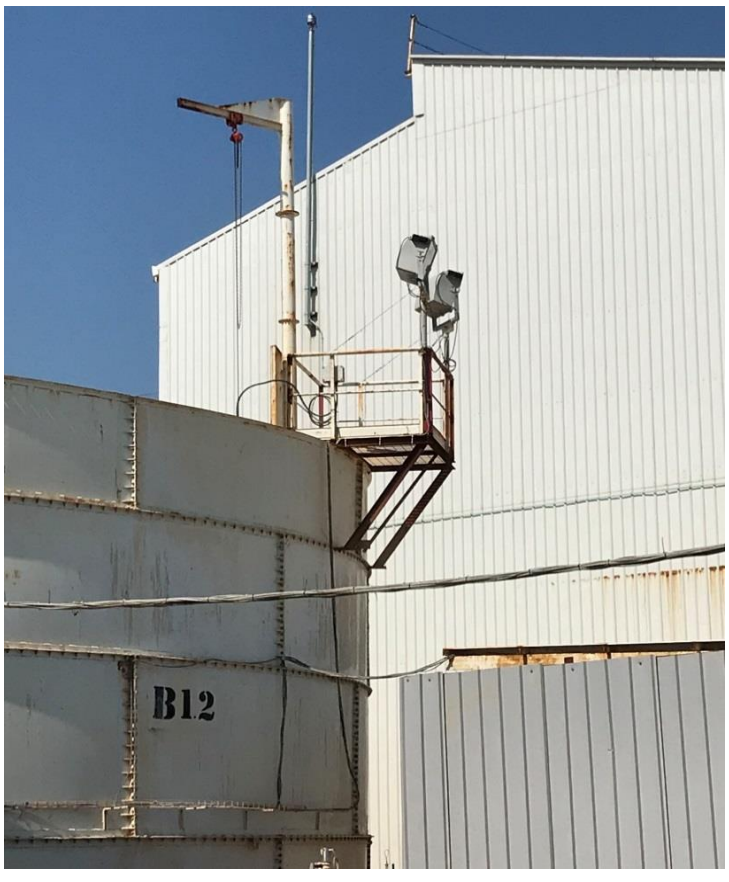
Direction of the lighting at STP is adjusted towards the ground.(Before)

Direction of the lighting at STP is adjusted towards the ground.(After)
