TUEN MUN - CHEK LAP KOK LINK
CONTRACT NO. HY/2013/12 –
NORTHERN CONNECTION TOLL PLAZA AND ASSOCIATED WORKS

41ST MONTHLY ENVIRONMENTAL MONITORING AND AUDIT (EM&A) REPORT – MARCH 2018

PREPARED FOR
CRBC AND KADEN JOINT VENTURE

Date	Reference No.	Prepared By	Certified By
5 October 2018	TCS00715/14/600/R0417v3	 Ben Tam (Environmental Consultant)	 T.W. Tam (Environmental Team Leader)

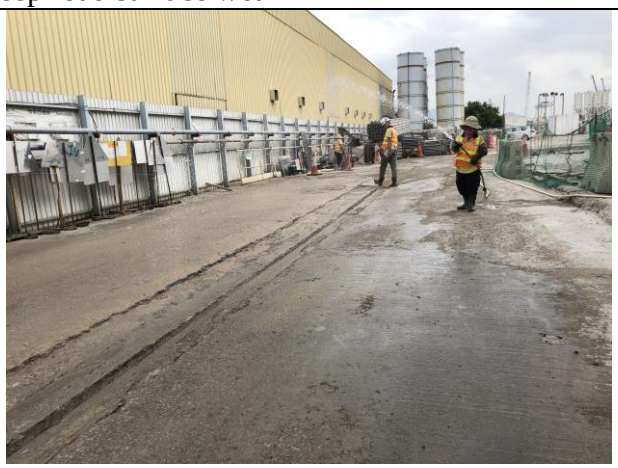
Photo 2 Water spraying by worker for un-accessible area.

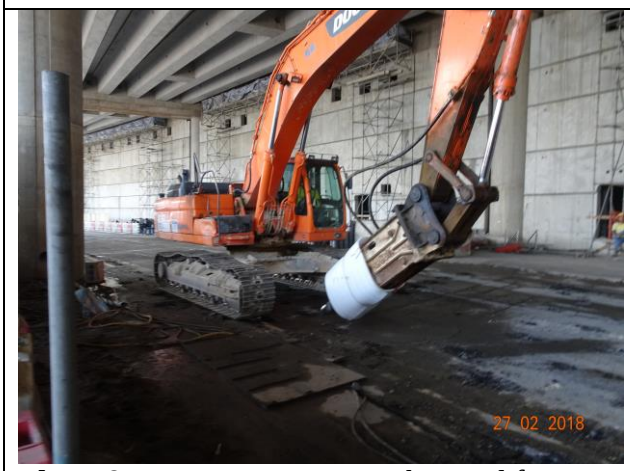
Photo 8 Site area keeping wet was observed at Portion H during the join site inspection on 27 February 2018

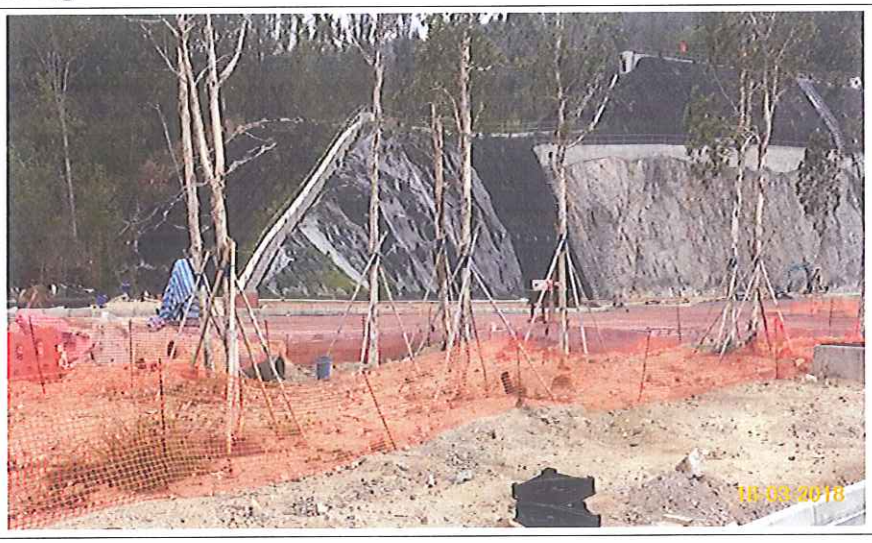
Item 1. Existing trees on boundary of the Project Area should be protected carefully during construction.
